# **Appendix A – Project Area Maps**

# East Bouldin Creek and Annie Street Storm Sewer Improvements

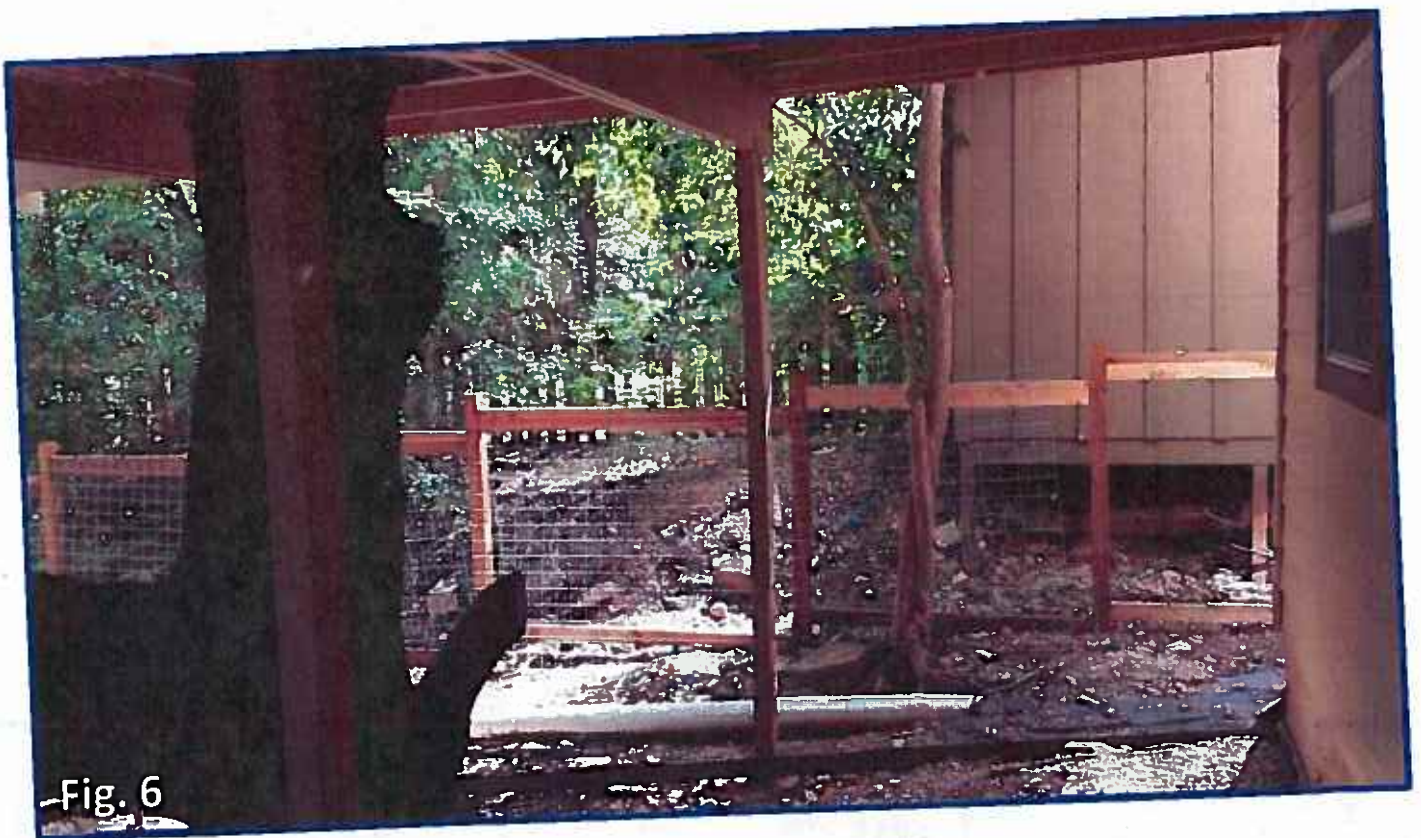
Fig. 6

We began installation of “hog panel” fence on the east side of the property (*Fig. 6*) following the April flash flood. This modification was made in order to prevent the fence from breaking loose in the future and to help mitigate the problem of water backing up on the street. Much of this construction was incomplete at the time of the May flood, but water rose far too rapidly for these unfenced areas to act as efficient flow conduits. Water still entered our house in May. We temporarily suspended construction after the May flood to allow the city to evaluate the storm drain running under our property. The fence was eventually completed prior to the October flood.

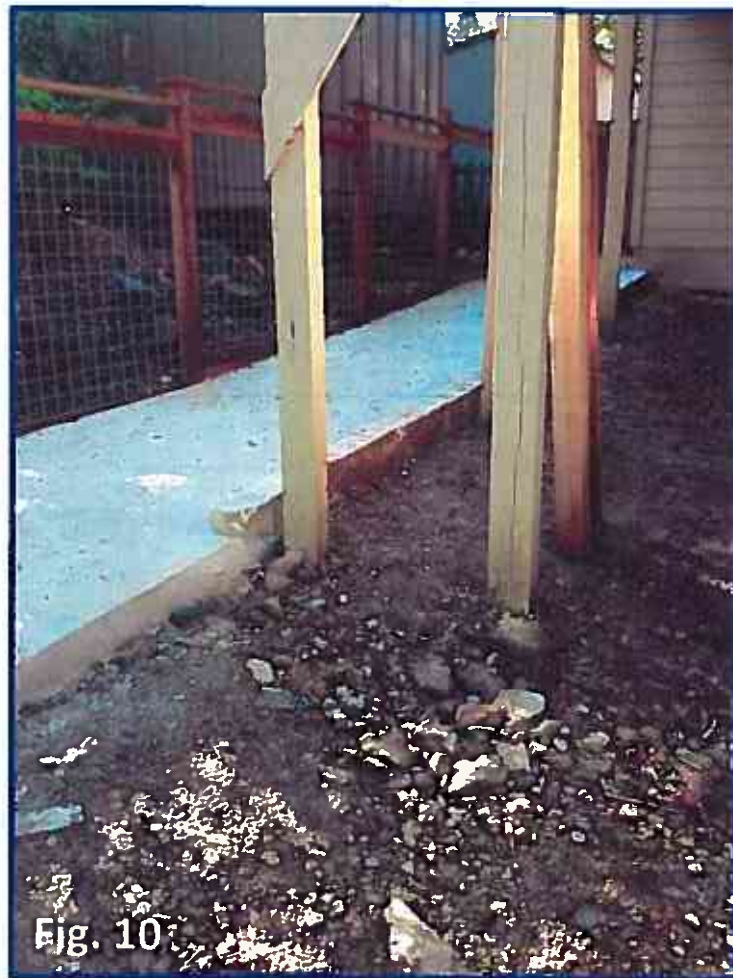
Fig. 10

It was clear after the May flash flood that we needed to do more to stop massive amounts of water from backing up on the street and flooding the interior of our house. The April and May floods damaged the northeast corner of the concrete foundation and exposed the large footings supporting the back deck. Several contractors came out and evaluated the problem. After considerable research, we chose to install a concrete flume (Fig. 10), low level deflection wall, and broader drain grate to efficiently move water along the east side of the house and mitigate future erosion. In addition, the surface drainage on the west side of the house was repaired.

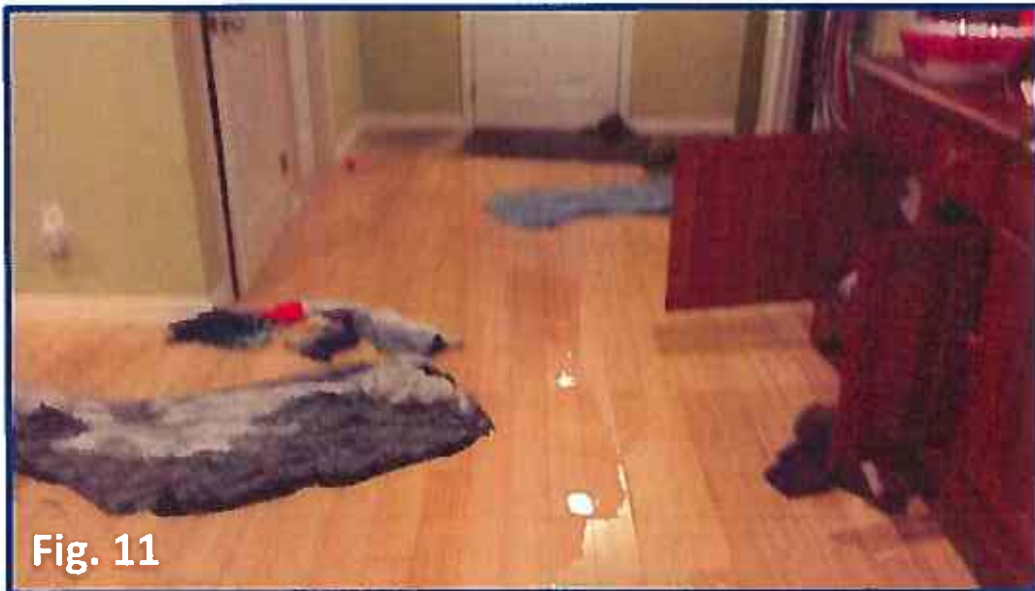
Fig. 11

Water began entering the house through the front door shortly after midnight on October 31<sup>st</sup> (*Fig. 11*). A photo taken within seconds after the flood started illustrates the initial velocity and force of the water through the recently constructed flume (*Fig. 12*). The peak depth was about almost midway up the fence prompting our daughter to call 911. There was a genuine concern that the structures on the east side could come loose and slam into the house, trapping the residents inside. The AFD simply recommended that she leave the house in spite of the fact that rapidly moving flood waters were more than a foot deep on three sides.

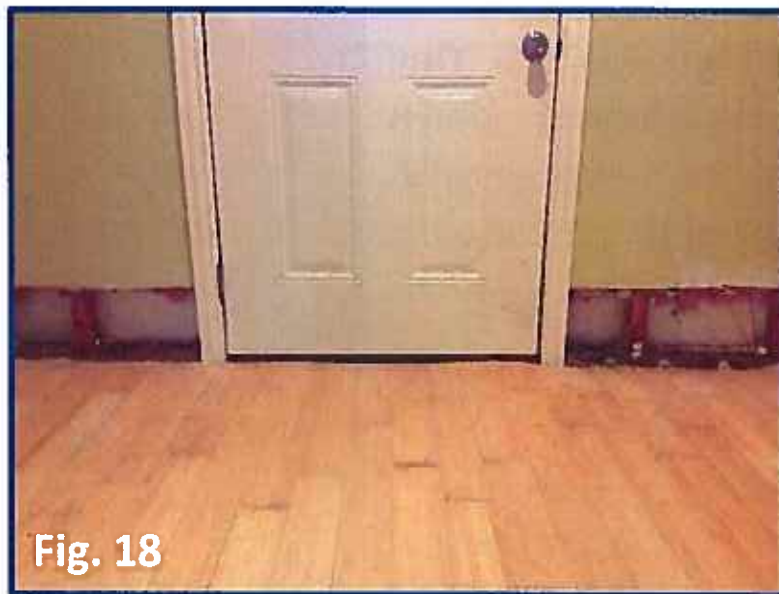
Fig. 18

Sheetrock and insulation throughout the first floor were badly damaged by the October flood. Material was removed (*Fig. 18*) and disposed in weekly garbage pickups over the course of a month(*Fig. 19*). The baseboards were also removed (*Fig. 20*) and will be disposed of over time.

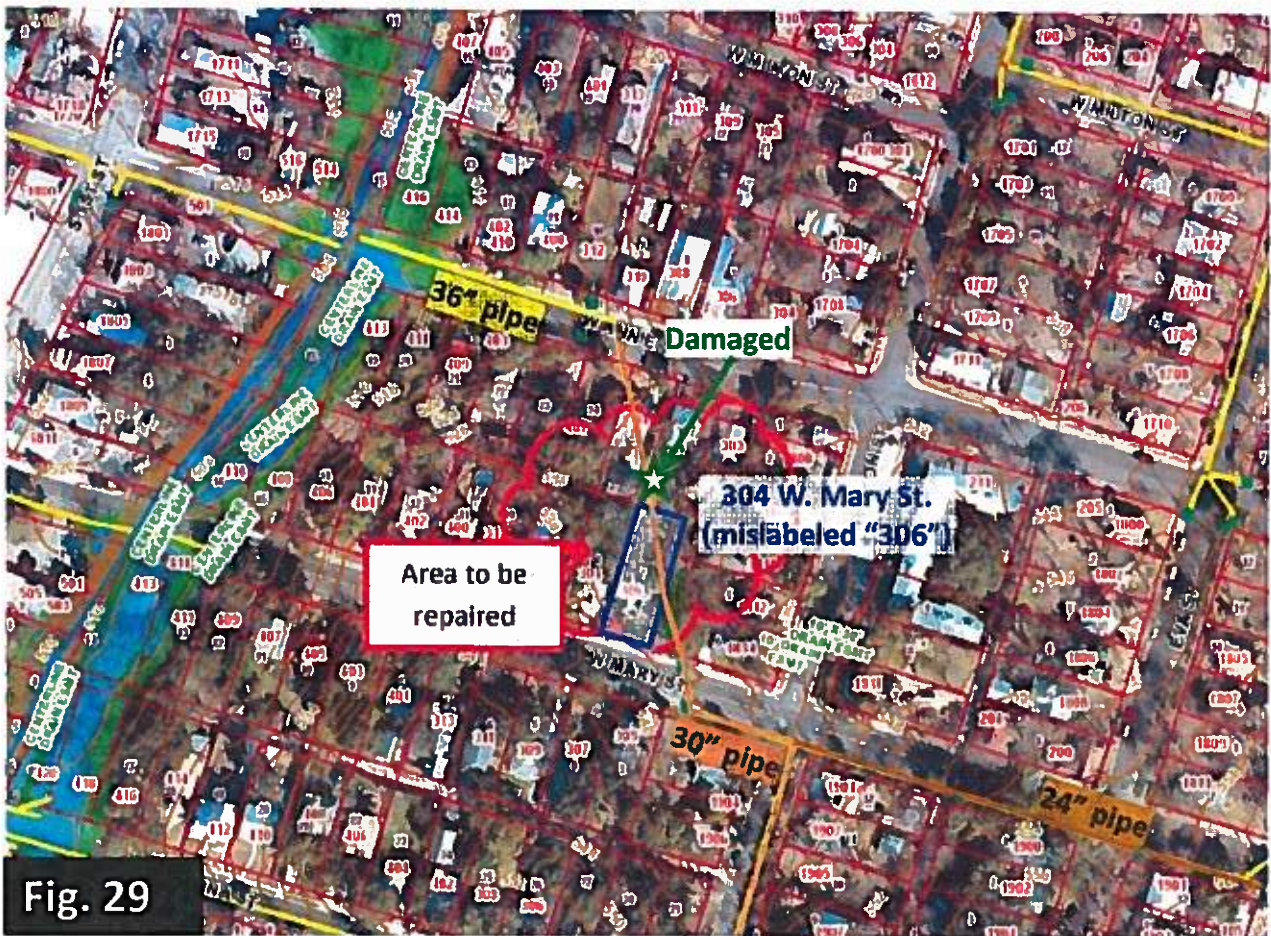
Fig. 29

The storm drain pipe under 307 W. Annie St. is damaged, but is not located in an easement (*Fig. 29*). The city did not get the owners permission to make repairs due to potential harm to the overlying elm tree. Even a 30 inch pipe in perfect condition is dramatically undersized for the drainage area it is expected to handle (*Table 1*). (Note that W. Mary is the only street without a direct outlet to East Bouldin Creek.)

- 30" diameter pipe under Newton St.
- 24" pipe from South Congress connects with a 30" pipe at Newton and W. Mary corner.
- 30" pipe badly damaged under 307 W. Annie.
- Drain pipe expands to 36" under W. Annie St.

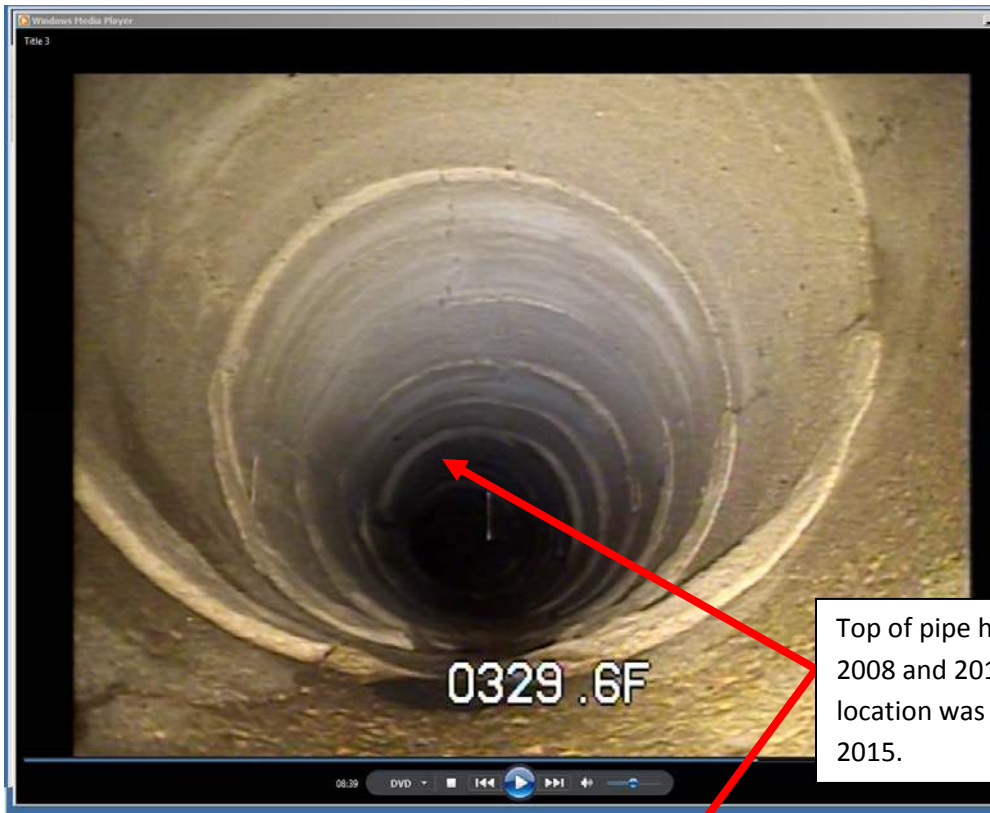
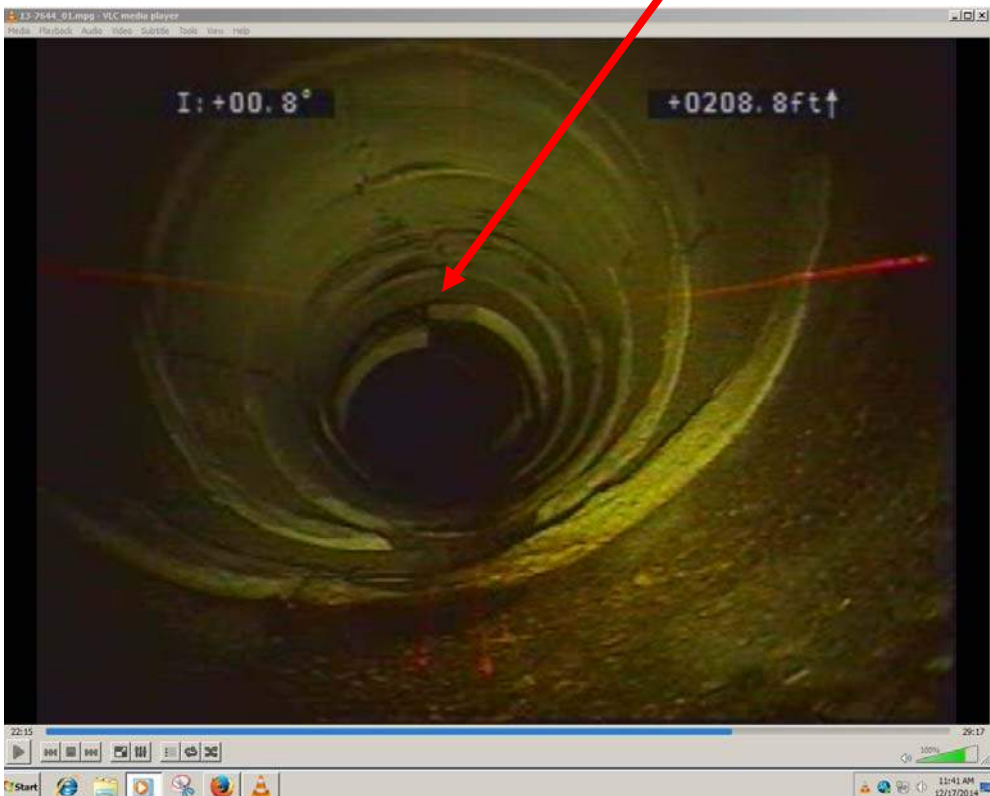
# Comparison #1 – Segment 13-7644\_01

Top of pipe has collapsed between 2008 and 2013. Spot repair at this location was completed in spring of 2015.

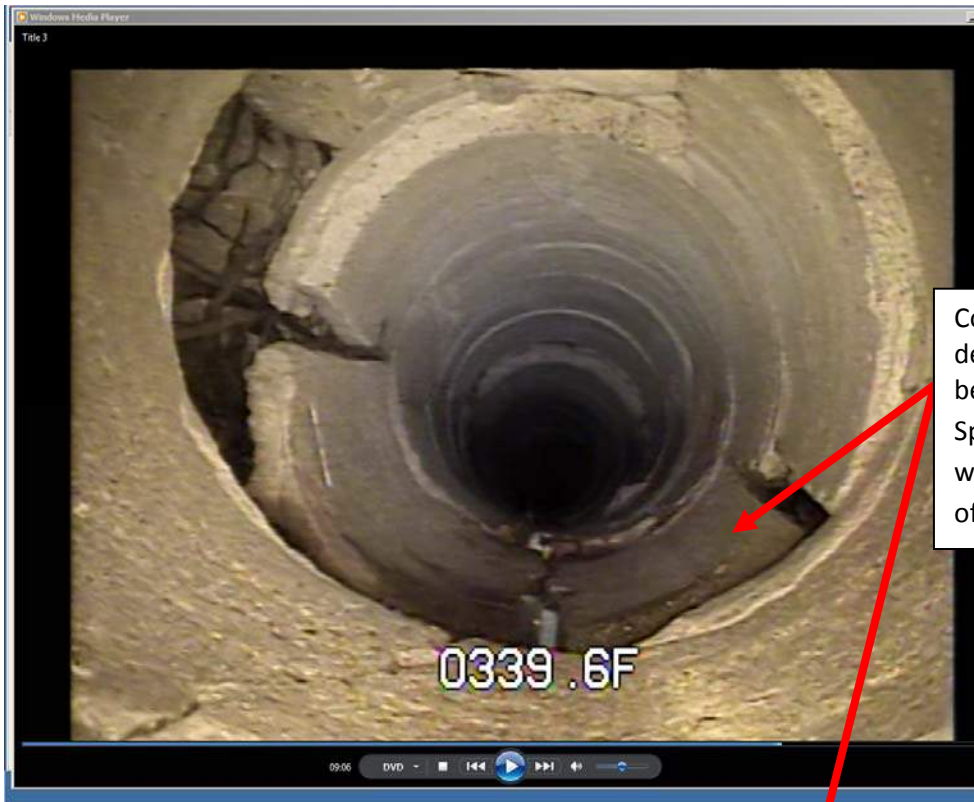
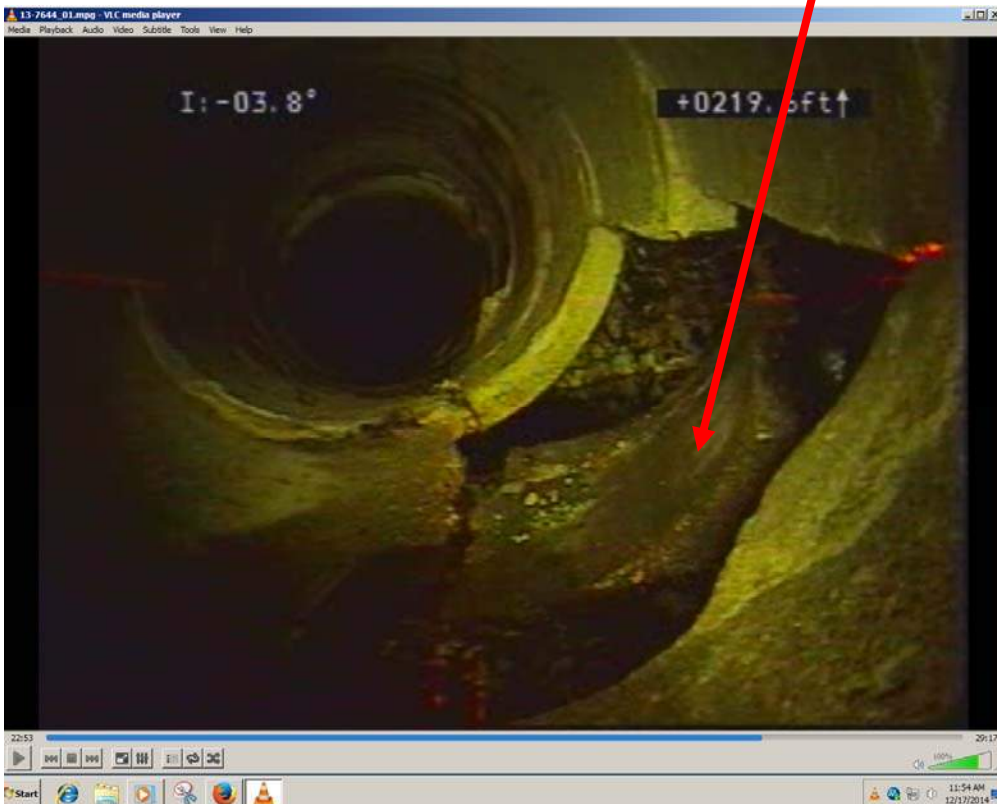
## Comparison #2 – Segment 13-7644\_01

Continued erosion and deterioration between 2008 and 2013. Spot repair at this location was completed in spring of 2015.

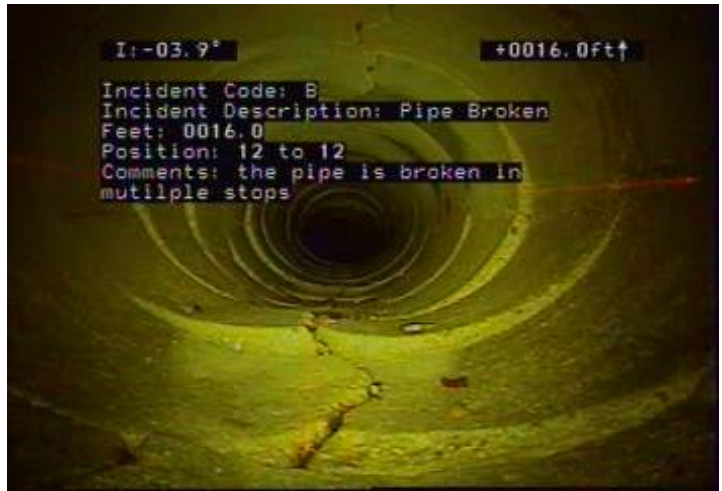
B - Pipe Broken @ 16.0 ft. the pipe is broken in mutilple stops

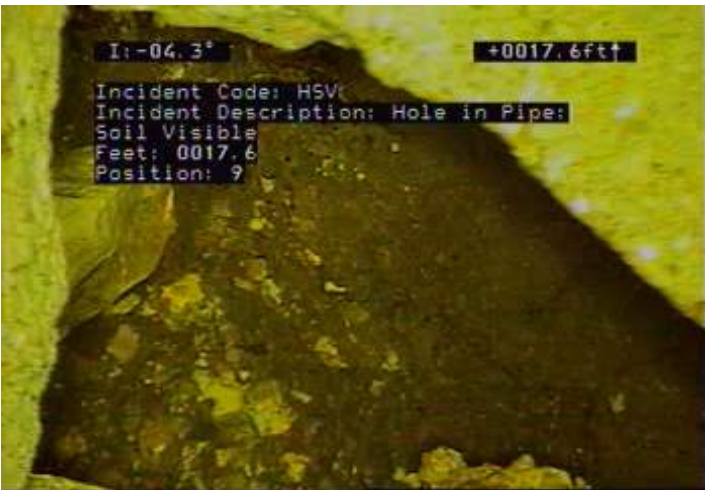
HSV - Hole in Pipe: Soil Visible @ 17.6 ft.

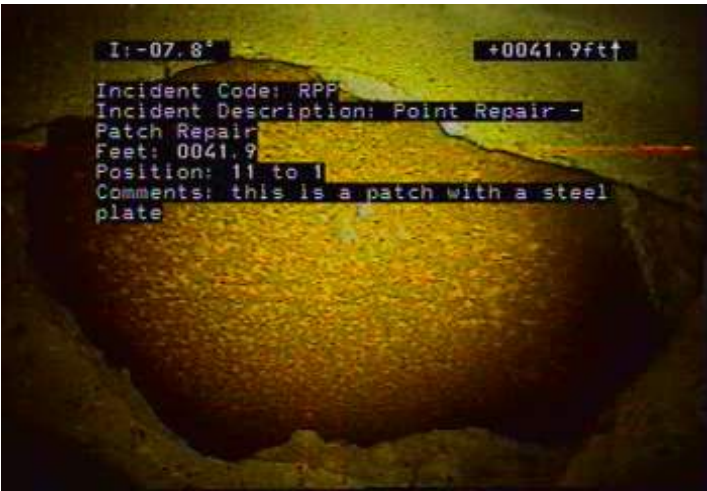
RPP - Point Repair - Patch Repair @ 41.9 ft. this is a patch with a steel plate

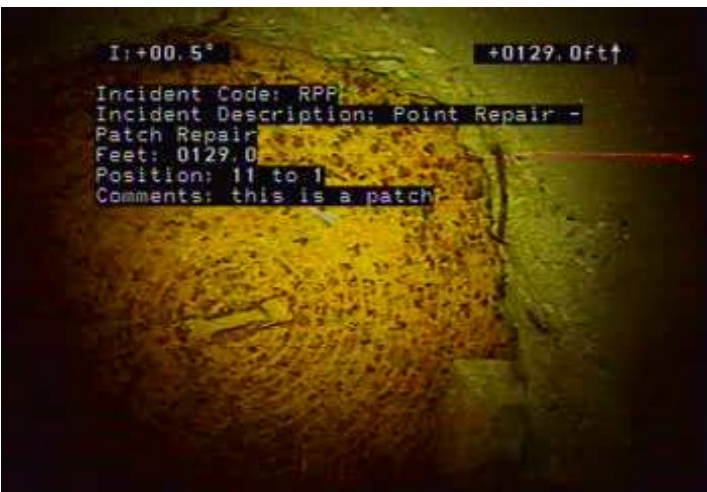
RPP - Point Repair - Patch Repair @ 129.0 ft. this is a patch

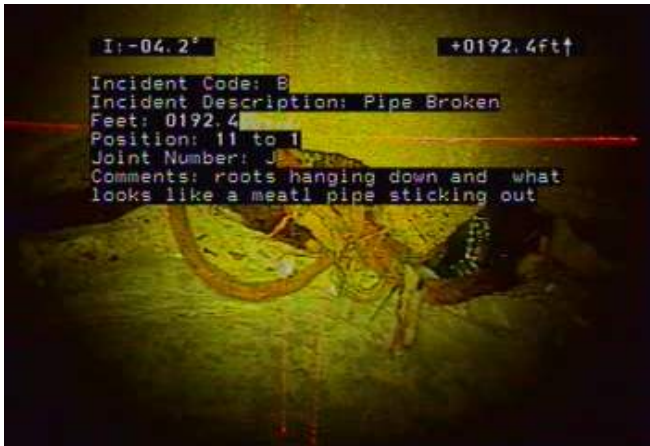
B - Pipe Broken @ 192.4 ft. roots hanging down and what looks like a meat pipe sticking out

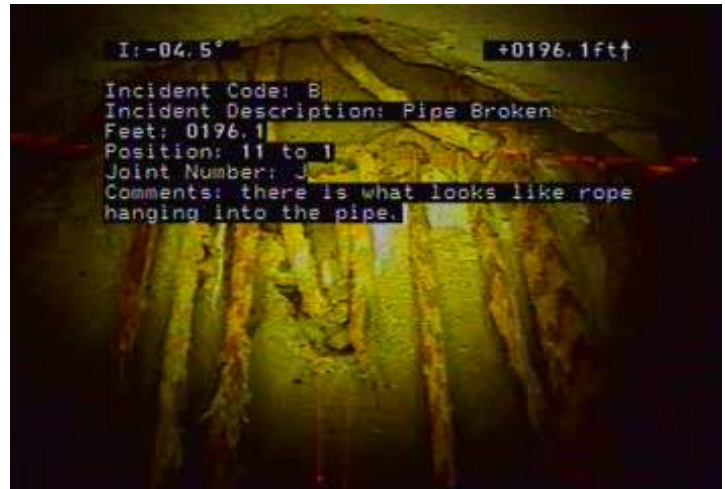
B - Pipe Broken @ 196.1 ft. there is what looks like rope hanging into the pipe.

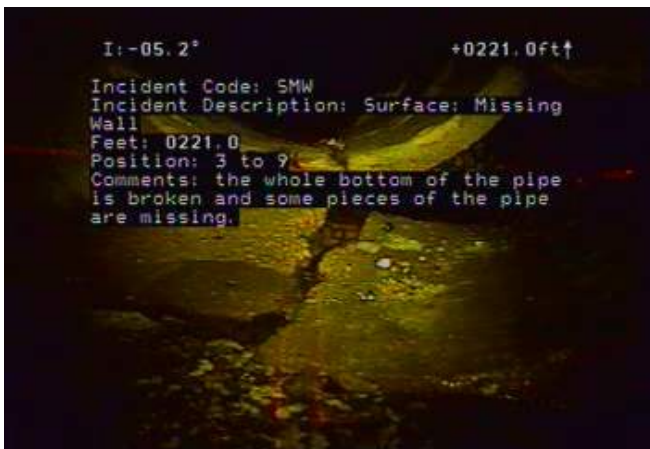
SMW - Surface: Missing Wall @ 221.0 ft. the whole bottom of the pipe is broken and some pieces of the pipe are missing.

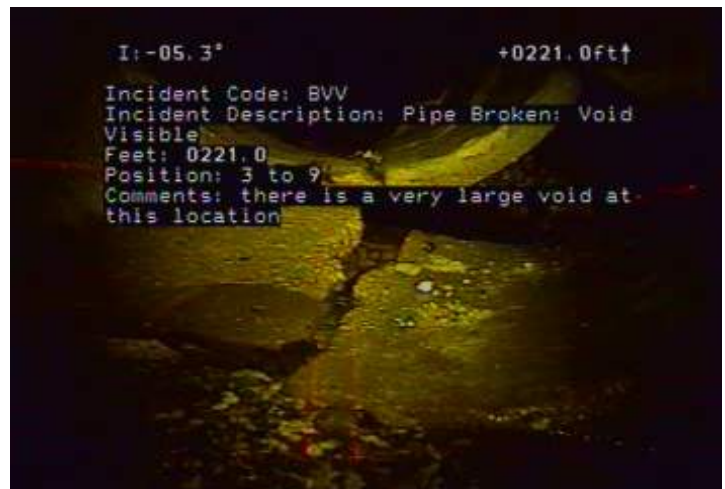
BVV - Pipe Broken: Void Visible @ 221.0 ft. there is a very large void at this location

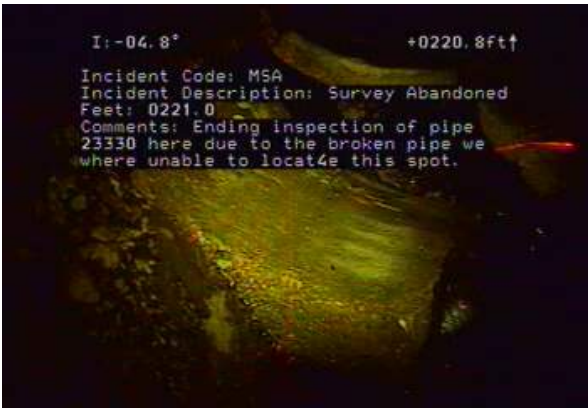
MSA - Survey Abandoned @ 221.0 ft.  
Ending inspection of pipe 23330 here due to the broken pipe we where unable to locat4e this spot.

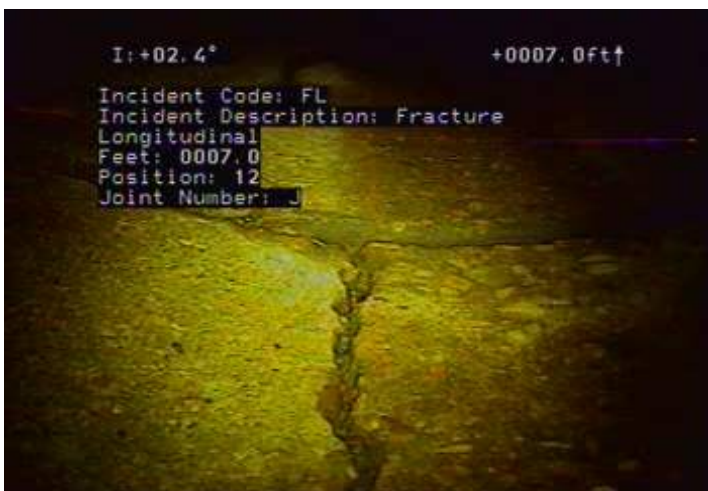
FL - Fracture Longitudinal @ 7.0 ft.

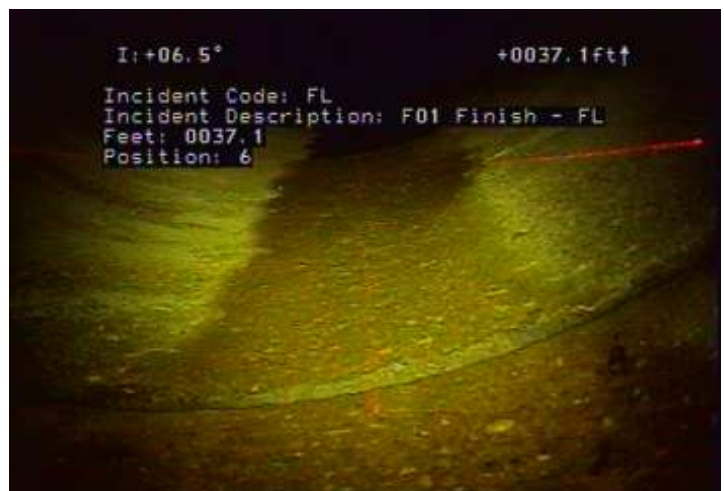
FL - Fracture Longitudinal @ 37.1 ft.

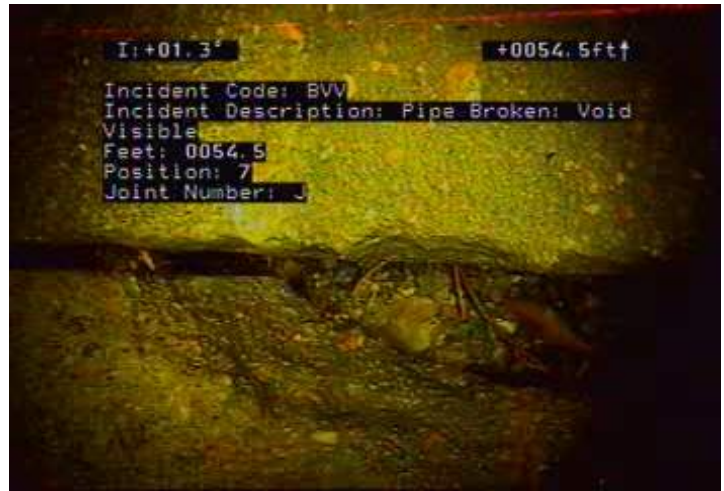
BVV - Pipe Broken: Void Visible @ 54.5 ft.

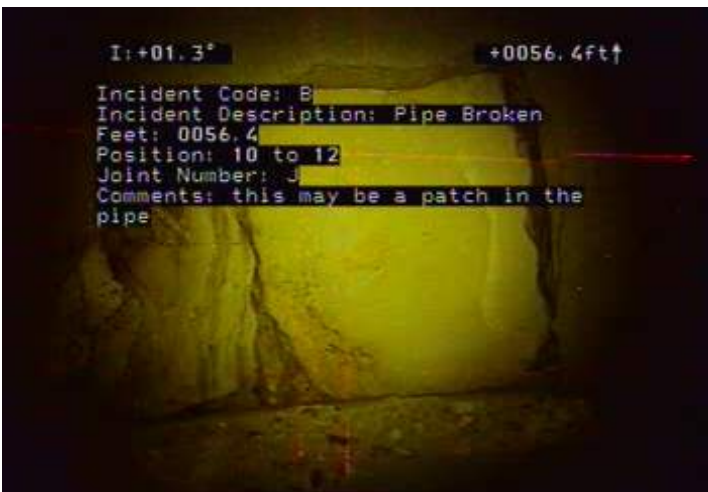
B - Pipe Broken @ 56.4 ft. this may be a patch in the pipe

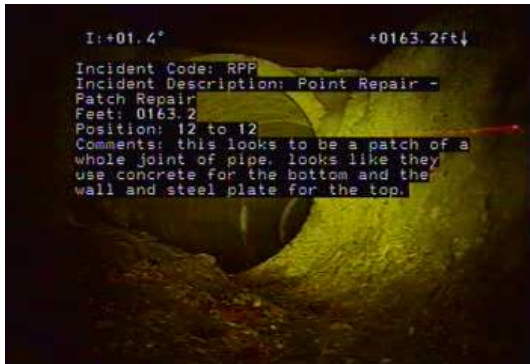
RPP - Point Repair - Patch Repair @ 163.2 ft. this looks to be a patch of a whole joint of pipe. looks like they use concrete for the bottom and the wall and steel plate for the top.

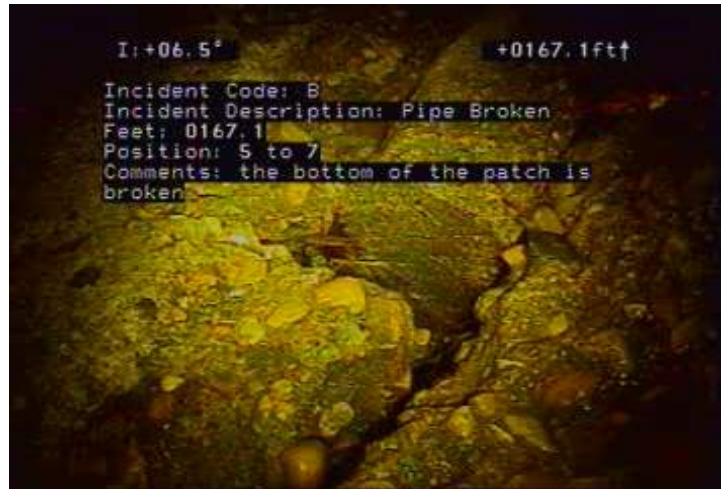
B - Pipe Broken @ 167.1 ft. the bottom of the patch is broken

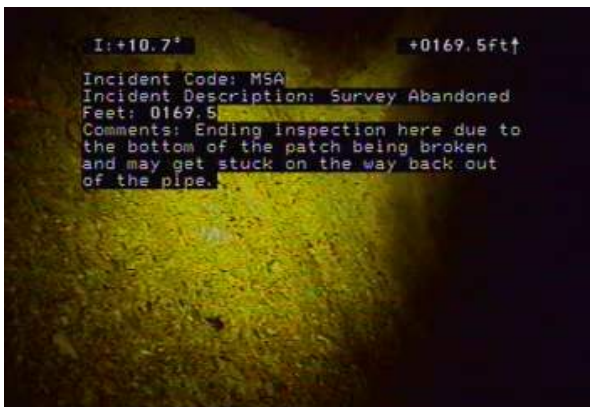
MSA - Survey Abandoned @ 169.5 ft. Ending inspection here due to the bottom of the patch being broken and may get stuck on the way back out of the pipe.

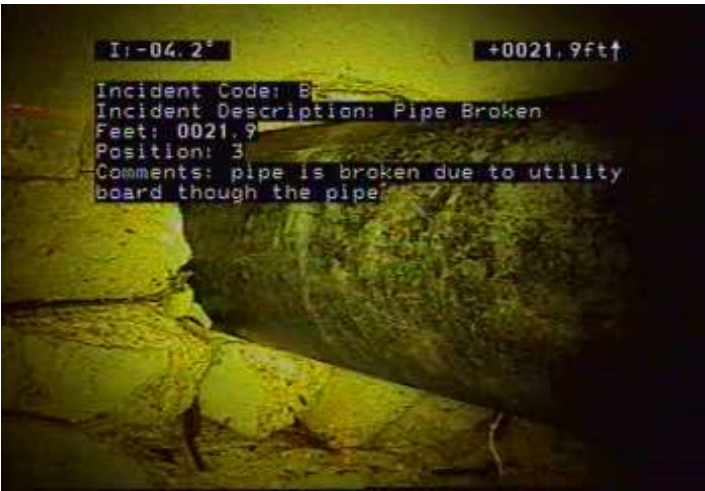
B - Pipe Broken @ 21.9 ft. pipe is broken due to utility board though the pipe

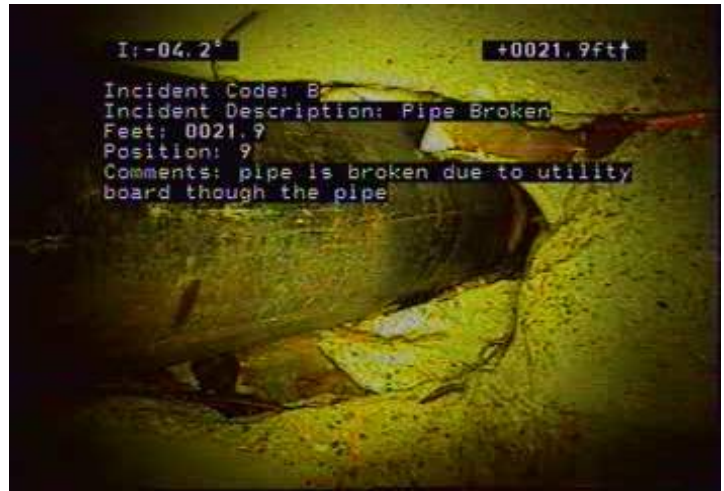
B - Pipe Broken @ 21.9 ft. pipe is broken due to utility board though the pipe

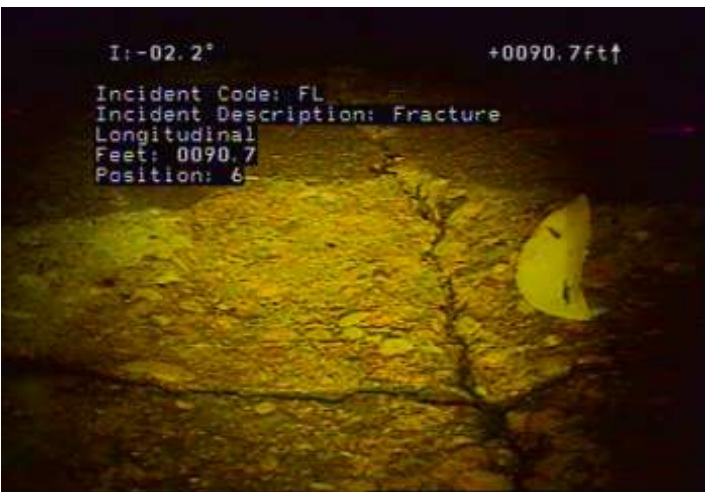
FL - Fracture Longitudinal @ 90.7 ft.

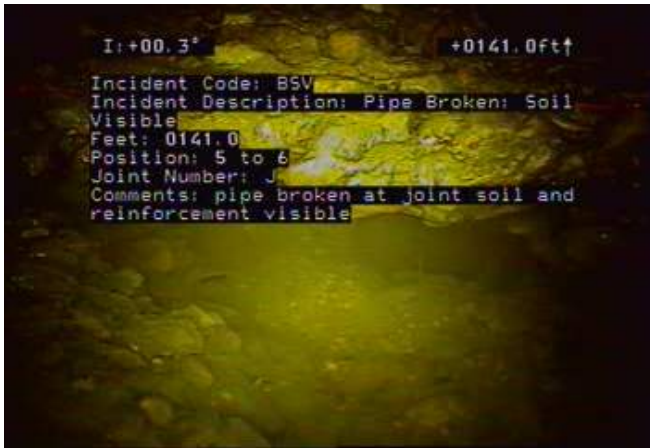
BSV - Pipe Broken: Soil Visible @ 141.0 ft. pipe broken at joint soil and reinforcement visible

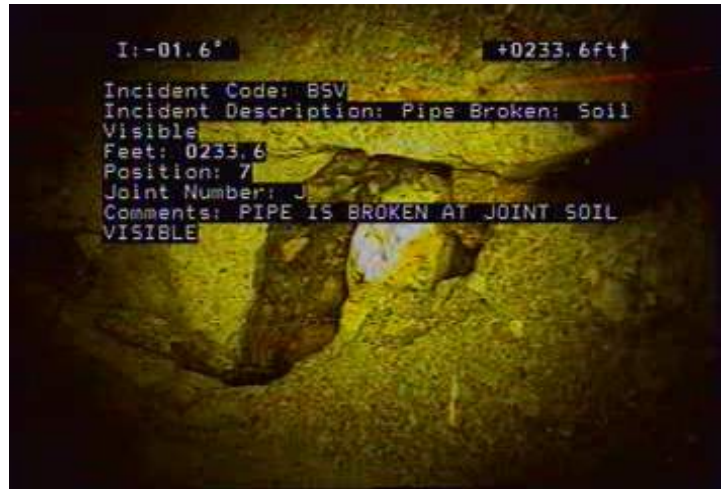
BSV - Pipe Broken: Soil Visible @ 233.6 ft. PIPE IS BROKEN AT JOINT SOIL VISIBLE

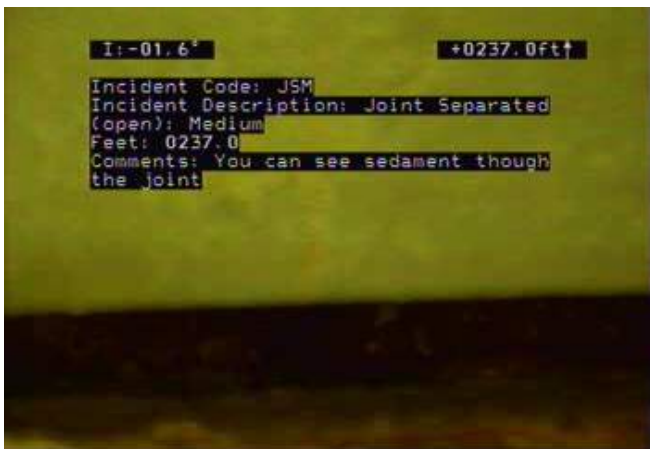
JSM - Joint Separated (open): Medium @ 237.0 ft. You can see sediment through the joint
