THE NORTH GROUNDS

ZILKER PONDS

SANDBOX GROVE

TREE COURT

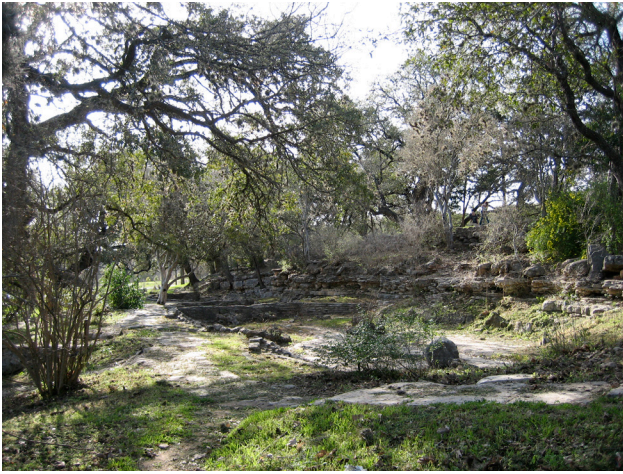
The stonework of the ponds themselves remain in reasonably good repair as is the stonework of the paths. But the four sets of steps are in various states of disintegration.

The empty vessels as they appear today. With better definition of landscape and paths, plus attention to interpretation, the ponds would be easier to understand and enjoy.

Drain the ponds permanently

Punch holes in the bottoms of the ponds to prevent standing water from accumulating. Fill the ponds with decorative gravel as a way to interpret the water's surface, but without water. The ponds do not appear to have level bottoms, and water tends to accumulate in the lower corners of the ponds. It is in those areas that holes should be drilled into the concrete bottoms of the ponds to allow water to seep out, rather than stagnate. When the drainage of the ponds has been addressed, gravel that contrasts in color and kind from the surrounding limestone should be installed, such as Texas Black basalt gravel or Fairfield Pink granite. If it is not possible to maintain the pond gravel free of leaves, installing flagstone pavement, perhaps in a sandstone, will contrast with the limestone of the retaining walls and walks, would be an acceptable alternative. The large flagstone patios that would be created would be a lovely overlook for the Pool area.

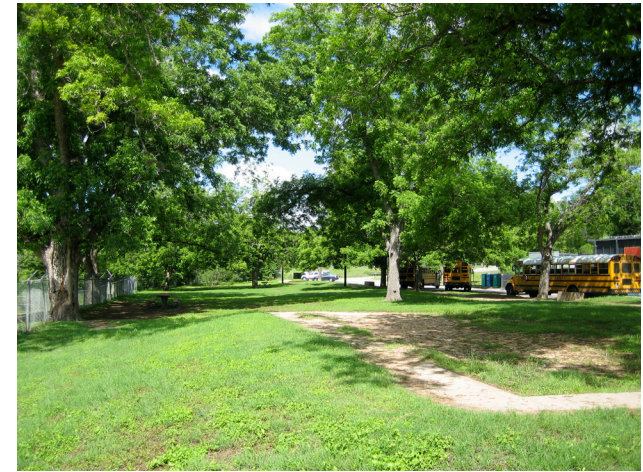
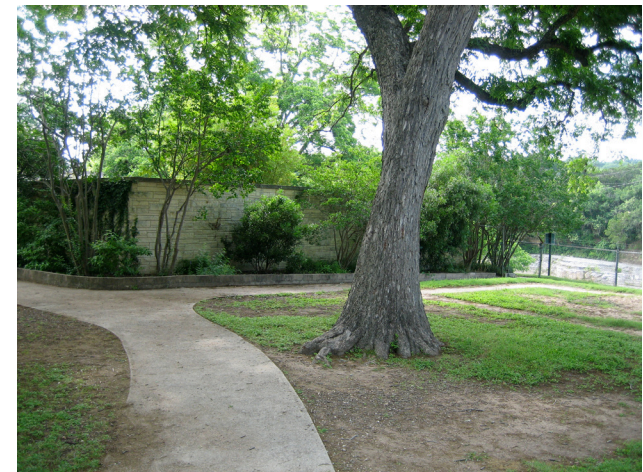
The Sandbox Grove is a tree-covered lawn located to the west of the existing Bathhouse. Its name is taken from the circa 1920 concrete sandbox in its northeast corner. The Sandbox Grove is often used for quiet pursuits like reading or working on laptops, but on summer weekends, it is a popular picnic area. During dry years, the lawn is patchy, and exhibits significant wear from the picnic traffic. Even during an especially wet year, significant areas of the lawn are threadbare. The grass is not irrigated, and there are no plans to do so. The concrete perimeter of the historic sandbox is in good repair, but the sandbox itself is not used. The sand itself is weed strewn and, presumably, a popular litter box for park animals.

Two views of the Sandbox Grove. The grass is worn, even during an exceptionally wet season (below). The sandbox itself is unmaintained.

Recognizing the Sandbox Grove as a popular picnic area, and recognizing that grass has not been successful in places, install a crushed granite picnic area. This will serve as a low-key

Using a low stone retaining wall as separation, add a seating area between the sandbox and the fence line for quiet Pool viewing. Add an accessible turnstile to the fence. Replace the sand in the sandbox with decorative gravel, and through a public process, commission and install permanent sculptures in the gravel. Add interpretive materials, with a potential topic being the rock outcroppings on the south side of the Pool that are part of the Balcones Fault. A limestone flag retaining wall, level with the top of the sandbox should be used to define an overlook area for the Pool. Benches and interpretive materials should be included. Presently there is chainlink fence in this area, topped with 3 strands of barbed wire. Replace this fencing with more ornamental metal grid fencing for a more welcoming overlook to the Pool.

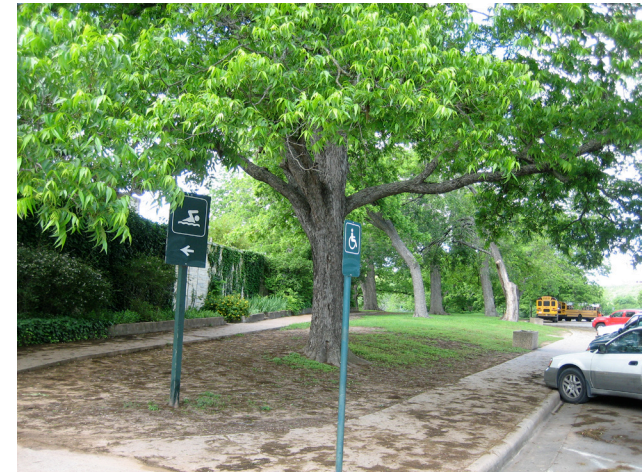
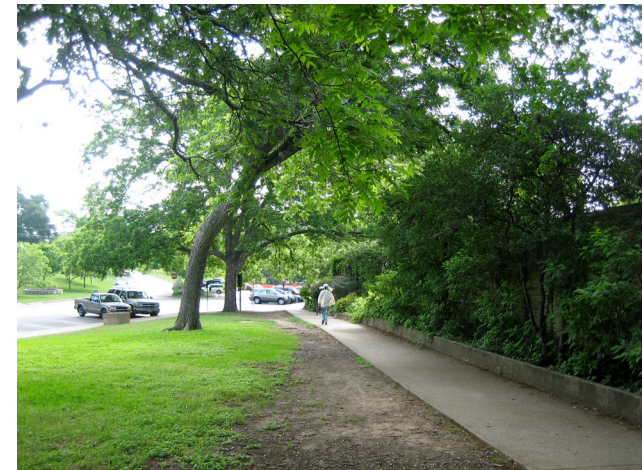
The Front Yard, to the north of the Men's public restroom and the Men's Dressing area of the existing Bathhouse, is generally characterized by St. Augustine grass under pecan trees. It is bounded by two east-west sidewalks that connect the main activity zones on the north side (the playscape, the concession stand, the main entry to the Pool) to the more subdued areas to the west (the Barton Creek greenbelt, the Sandbox Grove and parking). Due to the heavy foot traffic near the entry to the Sheffield Center, the grass is worn bare in that area. Along the edge of both of the sidewalks the grass is also worn, suggesting that the width of the walks is insufficient for current demands.

Front Yard grass worn by heavy foot traffic.

The Front Yard should generally remain as it is, a lawn under tree cover. To mitigate the excessive wear, additional width should be added to each of the sidewalks and to the area nearest the Bathhouse rotunda. Widening the walkway adjacent to the parking lot will require some regrading of the parts of this area, because there is a change of grade. With careful grading where the two walks join together at the front of the Bathhouse, a retaining wall should not be necessary. The additional paving should be a pervious paving material that allows rainwater to drain through it.

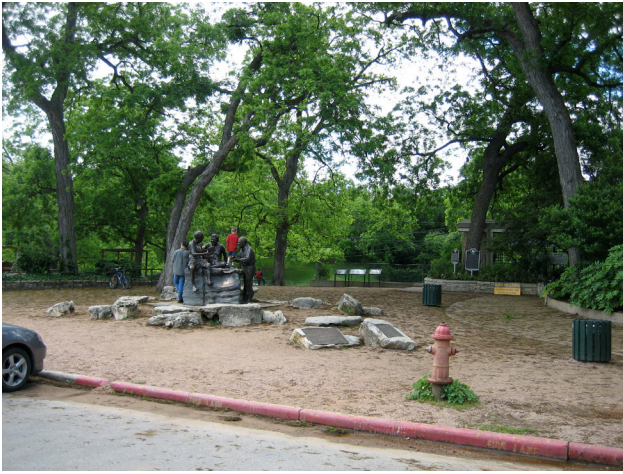
Tree Court with Philosopher's Rock in foreground. For most visitors, this is the place of introduction to the Pool. Note the drifts of crushed granite in the gutter.

- G. *Using flagstones, build a more stable walking surface to connect the zone in front of Bathhouse to Eliza Spring. One benefit would be a reduction in drifting granite gravel washing into storm drains and on into the creek.*

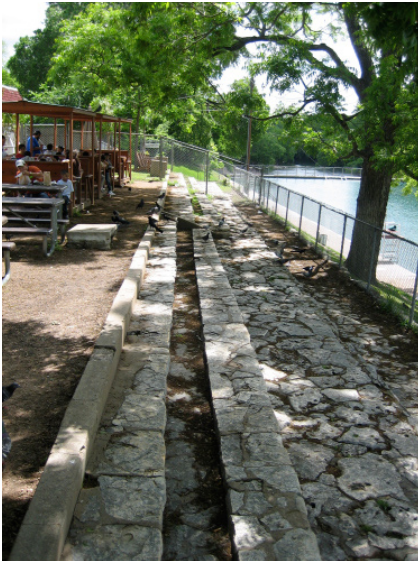
Potential for enhancing the overlook thwarted because picnic tables encroach and because the stadium seating is difficult to walk on.

Recognizing that its excellent views to the Pool are what makes the Tree Court most special, create a distinct sense of promenade along the entire length of the south edge. To that end, rework some of the stonework of the “stadium seating” to make this element easier to walk on. Replace the chain link fence, and commission a new decorative “art fence” to depict the story of the park and the Pool. Add benches along the promenade and add more interpretive materials to enrich the experience by presenting more of the story of the park.

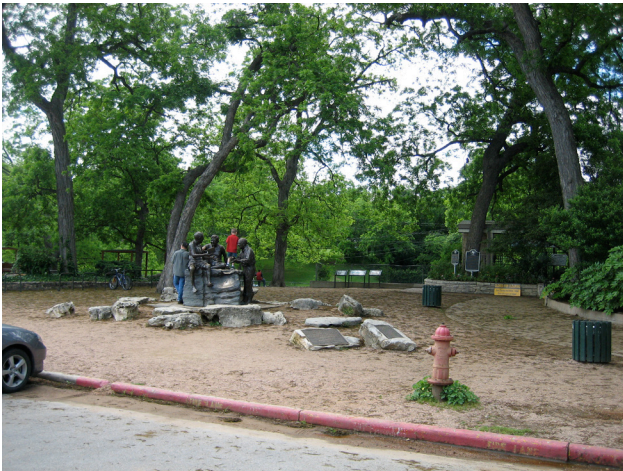
Growing conditions for trees in the Tree Court are difficult, because of the compacted soil and heavy traffic.

sunlit spots develop in the interior of the Tree Court, we recommend that Chinquapin oaks (*Quercus muhlenbergii*) and cedar elms (*Ulmus crassifolia*) be added to the existing pecan grove.

While there is not a functioning irrigation system for the Tree Court, this is one area to which irrigation should be extended, to run regularly for the two years required to establish the new trees, and intermittently after establishment to compensate for the heavy wear and compaction of the soil.

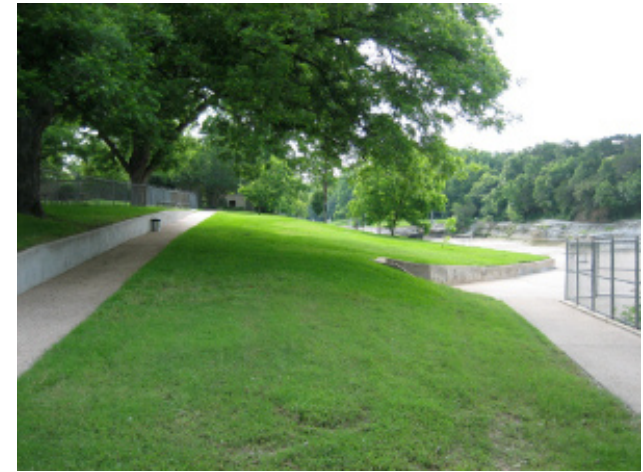
The slopes on the northside accessible route should be measured to verify that they meet the requirements of the ADA.

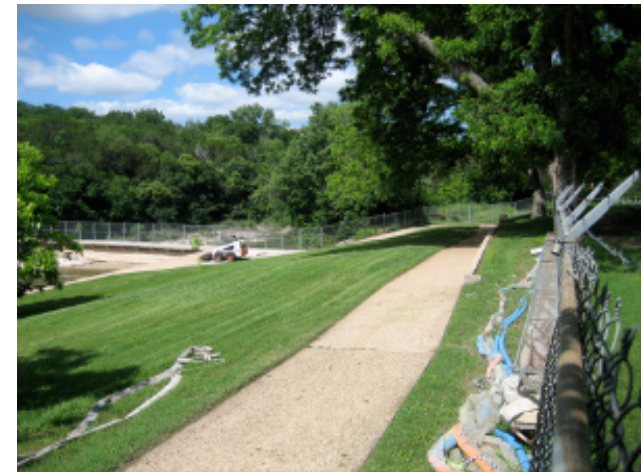
A sliver of grass atop a low retaining wall that is awkward to mow. It is also used for very visible pool equipment storage.

The grass between the accessible walk and the Pool fence is currently used to store pool hoses and other equipment. It is recommended that, where decomposed granite or flagstones are being added on the north side of the fence, in the Sandbox Grove, that the grass be removed on the south side of the fence as well, and replaced with native plants no taller than 2' to minimize the maintenance both within the Pool fence and in the Sandbox Grove. The planting bed between the accessible route and the Sandbox Grove requires dense spreading groundcover that can resist invasion by bermuda grass. A bed designed to include Gregg Dalea (*Dalea greggii*), wooly stemodia (*Stemodia lanata*), or big muhly (*Muhlenbergia lindheimeri*), among others, could serve that purpose. A portion of the bed could be left unplanted for the continued storage of pool equipment.

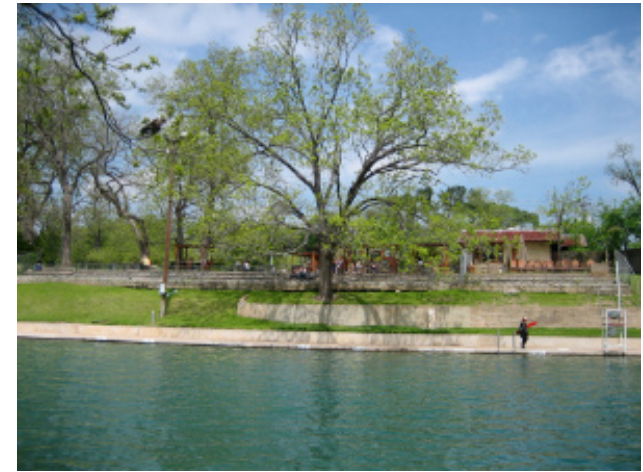
North Lawn below concession stand. Replace grass in area between middle retaining wall and toe of stone stadium seats with attractive, low-water-use native plants.

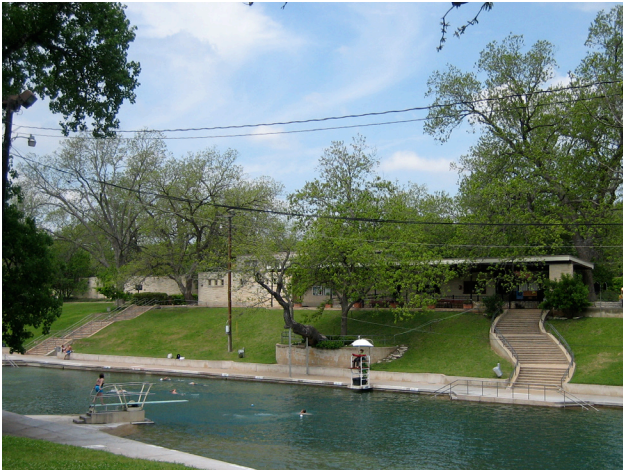
The most memorable element here is a large old pecan tree that leans out over the Pool walkway. Its root area is captured by a U-shaped concrete retaining wall. This tree is quite old (it can be seen in photos from the 1920s), and it does not appear to be in good health.

North Lawn below the Bathhouse. Two short term goals are to bury all overhead wiring and to replace site lighting.

Develop recommendations for treatment of the old pecan tree. If in the worst-case it does not survive, then it should be removed to allow the nearby pecan to take its place. Should the ancient pecan be removed or die, trailing plantings should be planted on the top of the retaining wall enclosing the ancient pecan; for example, nolina, silver ponyfoot, trailing lantana and rosemary.

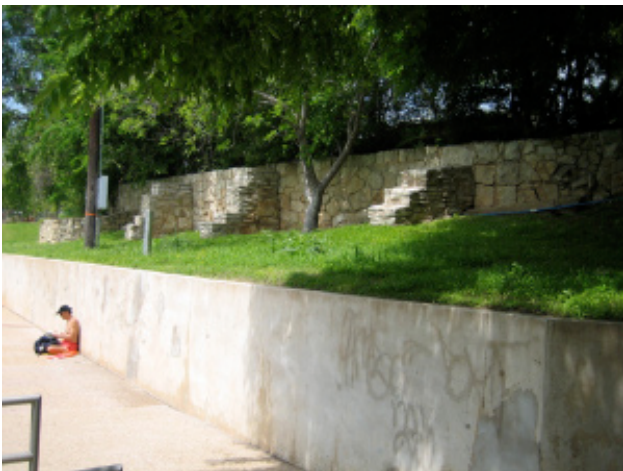
North Lawn near the downstream dam. Replace grass in this area with attractive, low-water use native plants.

One goal of this master plan is to reduce irrigation demands by identifying portions of the St. Augustine lawn that, due to inaccessibility, are not used for sunbathing and are difficult to irrigate and maintain. This portion of the North Lawn holds a number of opportunities in this regard, such as below the “stadium seating” or above certain retaining walls near the downstream dam. The grass should be removed in these areas, and should be replaced with carefully selected, drought-tolerant native Texas plantings. The lawn atop the retaining wall below the playscape fence is one such area: largely inaccessible, separated from the Pool sidewalk by a 4’-5’ retaining wall. We recommend removing the grass from this area and establishing a planting bed that does not require mowing or intensive maintenance. The native shrubs and perennials introduced should be not so tall as to block the view from behind the playscape fence: probably less than 4’ at the Pool edge of the planting bed. The section above the retaining wall, between the Pool and the playscape, could be planted with vegetation no taller than 3’, including some that would cascade over the tall retaining wall. Examples could include coralberry, nolina (away from walkways), cedar sage, and inland sea oats.
