Re: Austin Memorial Park Assessment

**EXISTING CONDITIONS ASSESSMENT REPORT**

Re: **Austin Memorial Park Cemetery  
Existing Conditions Assessment Report**

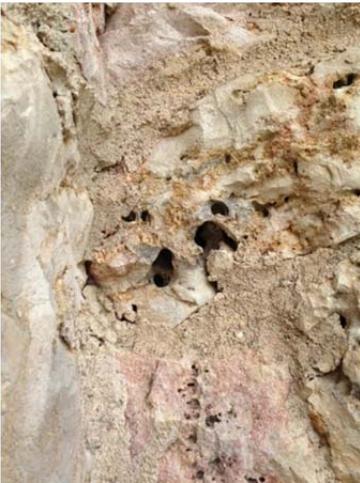
Figure B – Limestone exterior exhibiting pitting

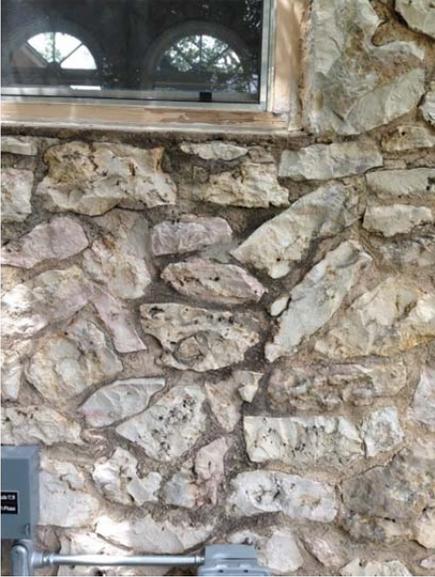
Biological growth is present in several locations at the building, it is most apparent on the north side of the residence, and in areas below windows (specifically below HVAC units), the rear wooden stairs from the sunroom and in low areas near the grade. It is observed as dark stained areas that lighten as they go up. (see figure C)

Figure C – Biological Growth below window south side of sunroom

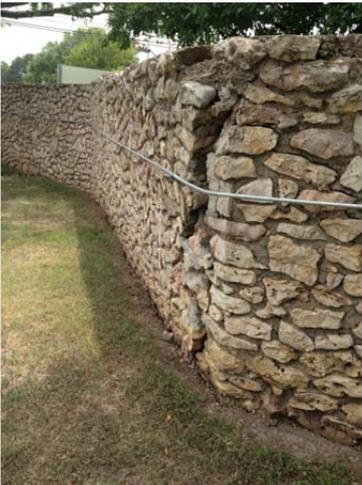
The Limestone landscape wall that runs north-south is a defining feature of the site and is need of stabilization. It appears to have shifted from soil movement. The shift has resulted in a cracked wall with the southern portion of the wall leaning to the east. (see figure D)

Figure D –large crack at landscape wall

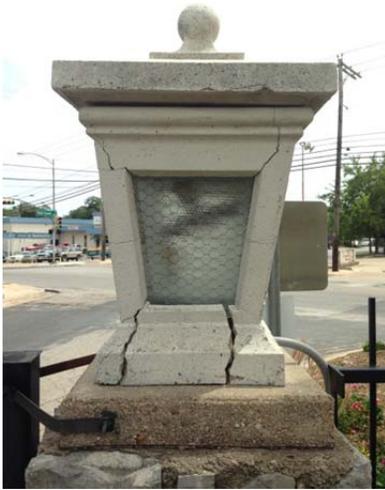
The most severe cracking and breakage in the cast stone occurs at the eastern lantern which appears to be completely broken with its weight holding it in place. The columns below exhibit some minor hairline cracks but the damage is superficial and the structurally the columns are fully functioning; however the cracks in the columns should be monitored. (see figure E)

Figure E – Broken cast Stone Lantern

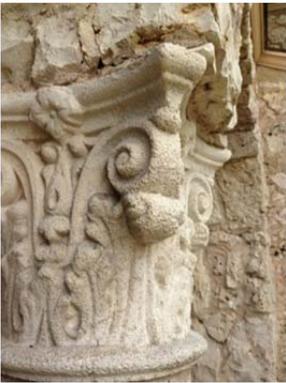
The capitals at the arcade columns appear to have suffered from the detrimental effects of weathering. The condition is inconsistent and appears mostly on the north side of the columns. It is observed as erosion of the finer detailed portions of the column capital (see figure G)

Figure G – Weathering and Erosion at column capital

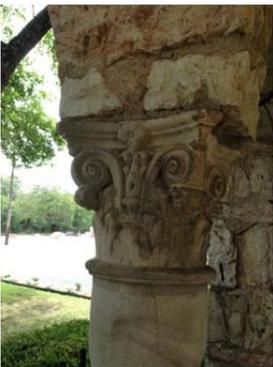
The cast stone columns on the south side appear to have a combination of biological growth and dirt giving the tops a dark and dirty appearance. (see figure H)

Figure H – Stained column capital, a result of biological growth and dirt

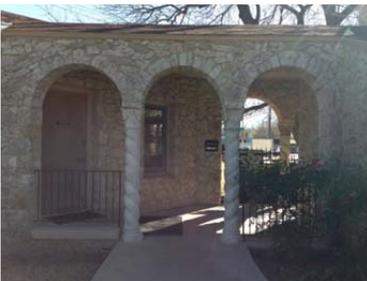
Figure J

Wrought Iron railings appear in three places at the building; at the balconets on the southside of the main office and at either side of the arcade. The balconet railings are more ornate and appear to be original, The top rails have suffered from corrosion and are in need of repair, while the other simpler rails are in adequate shape. (see figure J,J1,J2)

- Figure J- Wrought Iron rails at north side
- Figure J1- Decorative original rail at South side balconet
- Figure J2- Corrosion at balconet rail

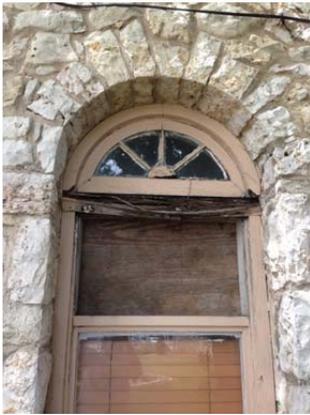
Figure K

Figure K-Rotted wood trim at window and missing glass

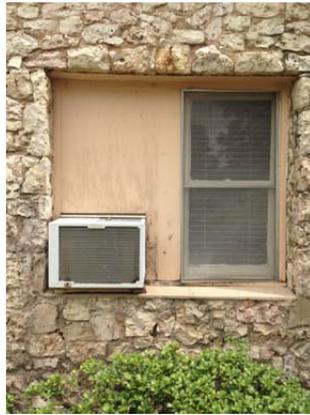
Figure K1

At the west side of the building there is a window missing and the void has been replaced with a plywood board (see figure K1). The balance of the windows are generally in average to poor condition, and are in need of removal/replacement of rotted parts, and general refurbishment.

Figure K1- Missing window at west side

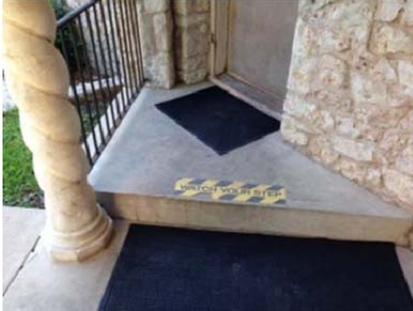
*Changes in level greater than 1/2 inch (13 mm) high shall be ramped, and shall comply with 405 or 406.*

Figure L- Non-compliant Step and Threshold at Office Entry

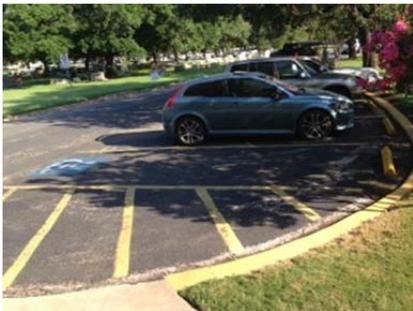
*Access aisles shall be marked so as to discourage parking in them.*

Figure M - Non-Compliant Access Aisle

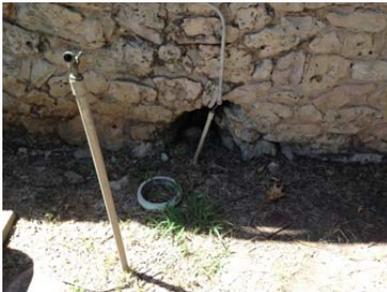
Figure S1

The exterior limestone at the maintenance building, suffers similar issues as the limestone at the main building especially in regards to pitting. The areas of limestone close to grade are darker and more stained, and on the east side there is much more biological growth and associated staining specifically adjacent to the HVAC line sets. There is also a large 6-10" hole at grade on the east side. (see figure S,S1)

S- Biological growth and consequent staining due to moisture, likely from HVAC  
S1- Hole at east side of stone wall

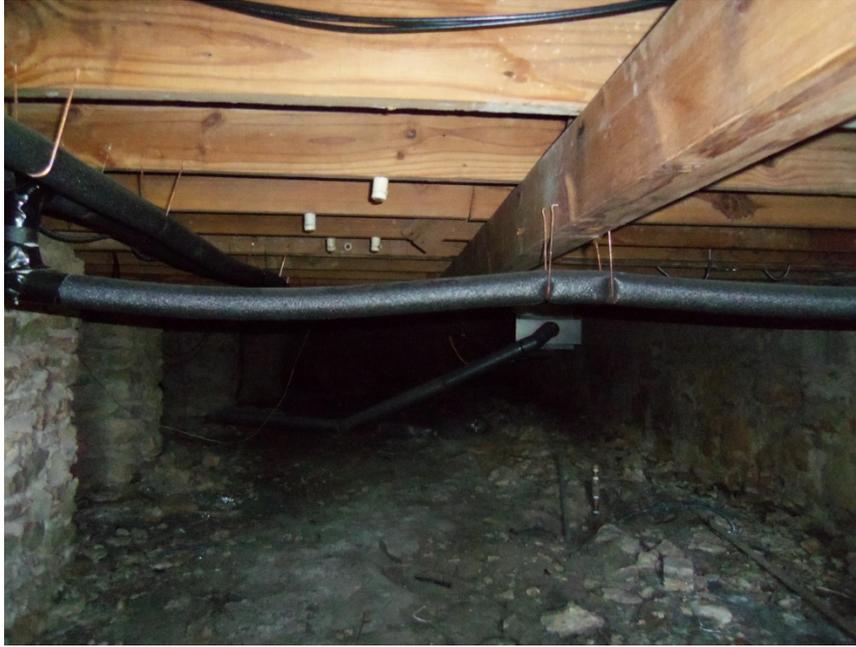
Figure 1 – Main Building elevated framing

The elevated wood floor framing was observed for both the main building foundation and the storage room foundation. As can be seen in Figures 1 and 2 the elevated framing system for both areas are in good condition. It was not verified that the beams framing into the masonry block pilasters had positive

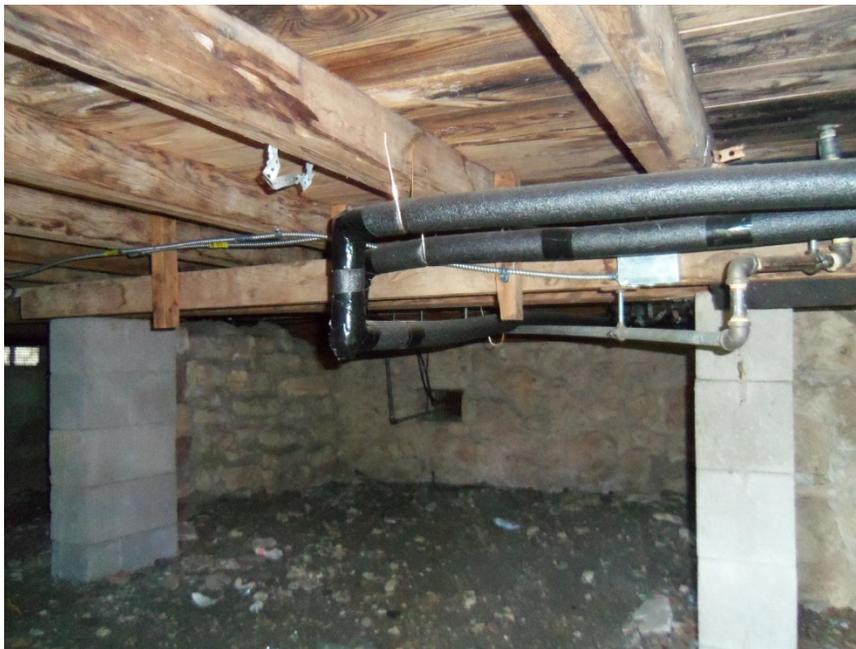
Figure 2 – Storage elevated framing

attachment to the pilasters. As can be seen in Figure 2 and Figure 3, both types of pilasters appear to be in good condition. No cracks in the interior of architectural finishes were observed that would be indicative of differential structural movement of the foundation in either the main building or the storage room.

It is our opinion that both foundation systems are performing well and do not require any structural repair. We do recommend that some type of positive attachment between the wood beams and masonry pilasters be verified to exist and if none are present, that a Simpson Strong-Tie product be provided to achieve the positive attachment.

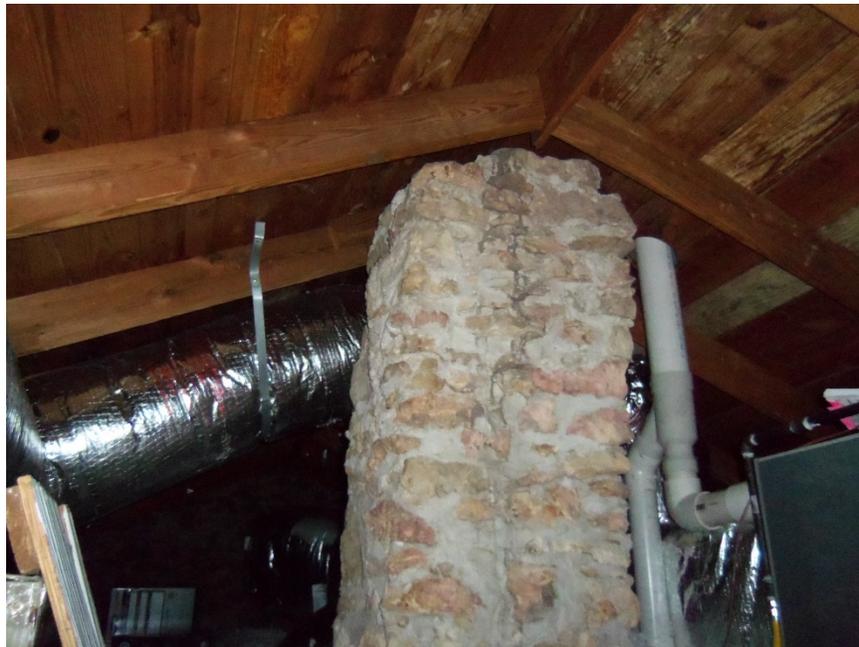
Figure 4 – Main building attic

We were able to gain access to the attic and review the roof framing. The roof framing appeared to be in good condition, see Figure 4. The ridge beam frames into a built up stone pilaster that does not continue all the way to the foundation. The ceiling joists were unable to be directly observed due to ceiling insulation and MEP equipment, however they appear to be in good condition based on the general levelness and lack of cracking in the architectural finishes on the ceilings. The interior of the standalone office and vault were unable to be observed, however the exterior appeared to be in good condition.

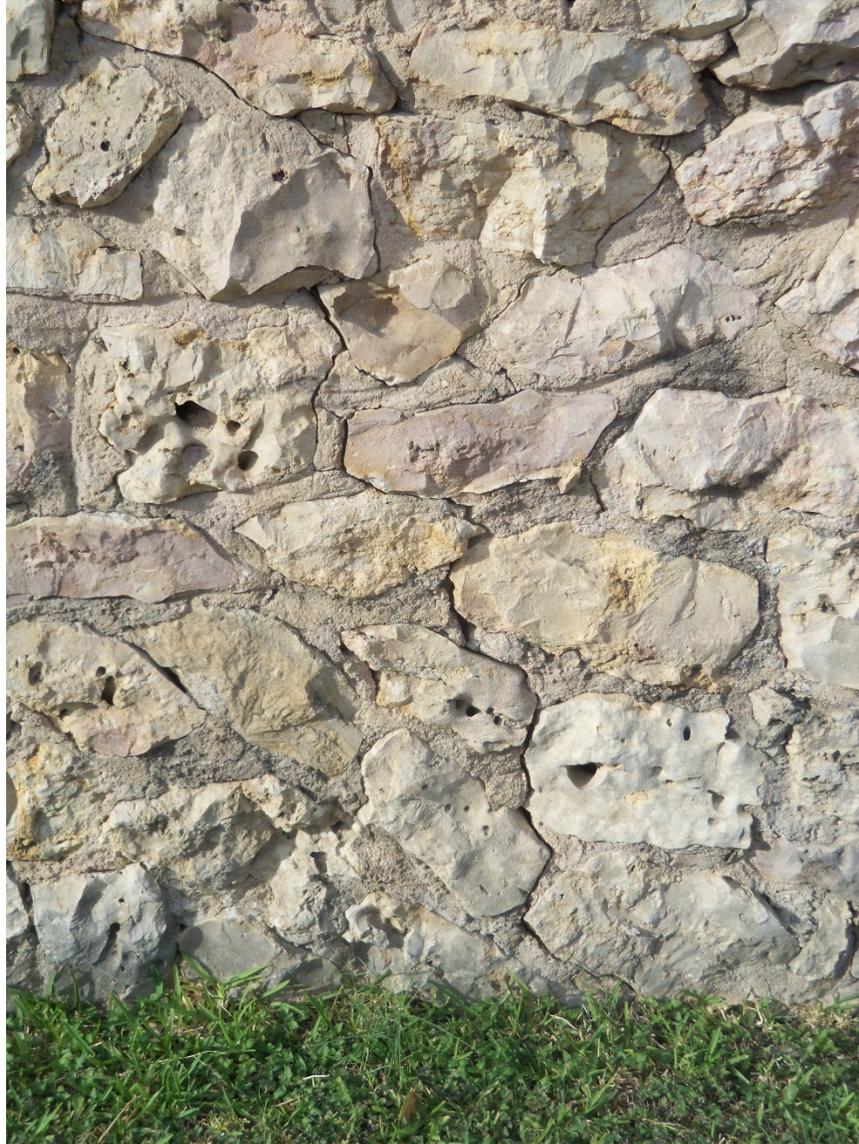
Figure 5 – Exterior Mortar Joint Crack

The slab-on-grade foundation appears to be in adequate condition in the break room; however, a large crack through the mortar joint at the perimeter wall was observed both on the interior and the exterior sides (see Figures 5 and 6). Given the lack of distress or cracking in any of the finishes this crack does not appear to pose a threat to the structural integrity of the building.

In summary, the maintenance building appears to be in good structural condition and does not require any structural repair work to be done. Both the crack through the mortar in the exterior of the masonry wall in the break room and the damaged slab on grade areas in the site storage room can be repaired at the owner's discretion as they do not appear to be causing any distress to the structure at this time.

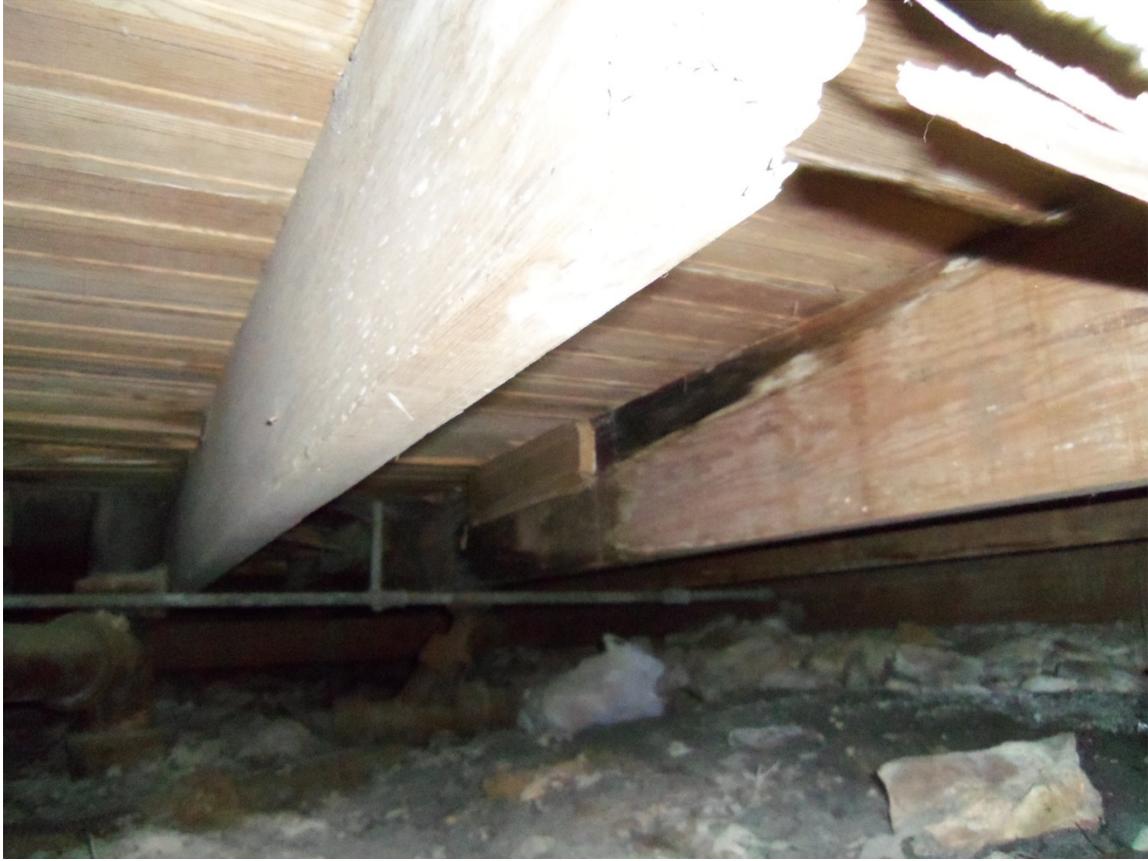
Figure 7 – Maintenance Office Elevated Floor Framing

The elevated floor framing was observed to be in good condition as can be seen in Figure 7. There were no observed signs of structural distress, such as cracks in the interior architectural finishes which would indicate either settlement or differential movement of the elevated floor framing system.

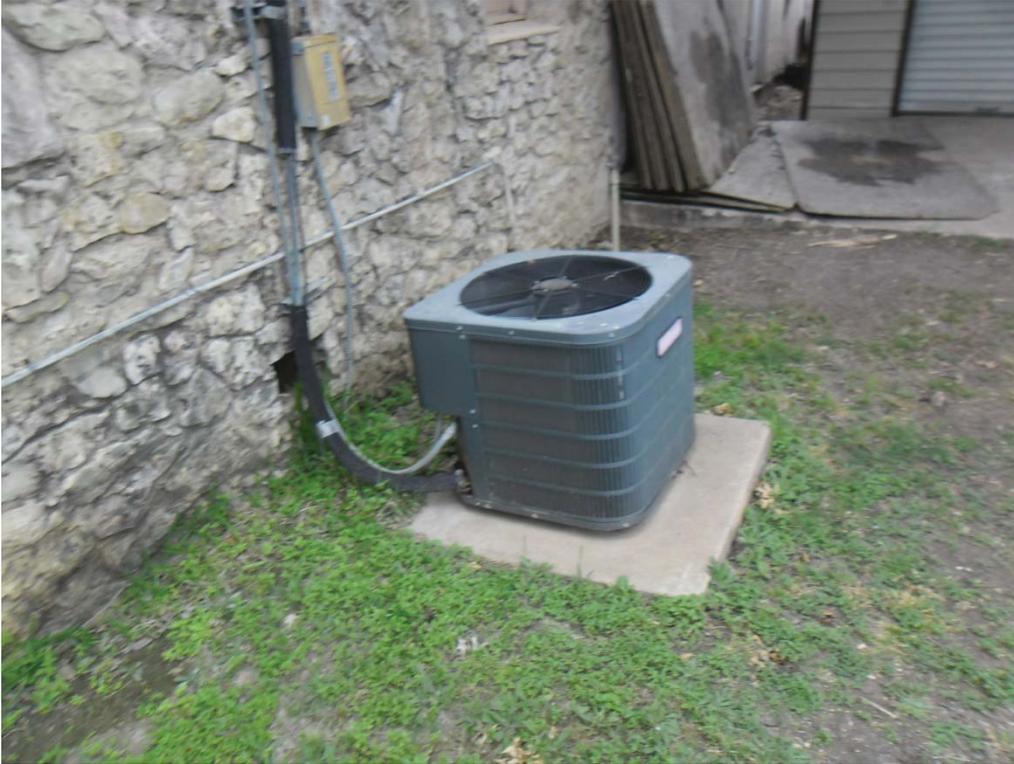
Exhibit 5 - Maintenance Out-Building Condensing Unit

The maintenance out-building is conditioned by an air-conditioner and gas furnace which appears to be over 15 years old and that is reported to be non-functional. **See Exhibit 5.** The single-occupant restroom has no mechanical exhaust.

The maintenance out-building MEP systems need major renovation in coordination and conjunction with architectural repairs and renovation.

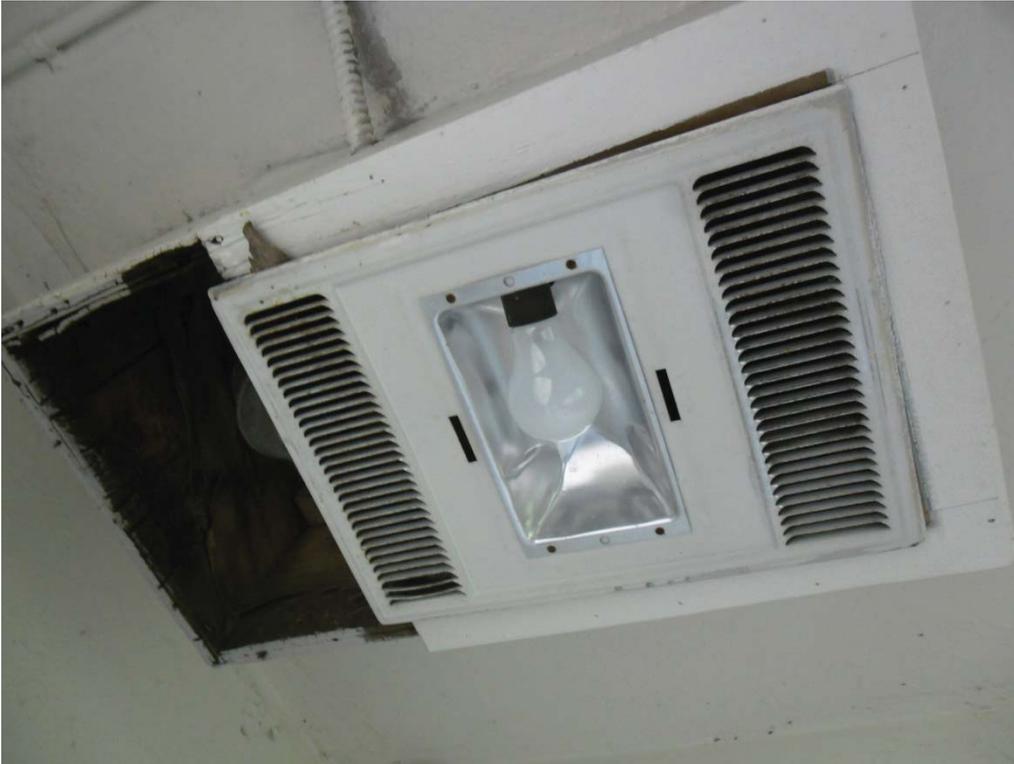
Exhibit 6 - Combination Heat, Light, & Fan unit

The tower men's and women's restrooms are exhausted by means of a combination heat, light, fan unit. **See Exhibit 6.** Each element is separately switched however, neither the fan nor the heater energized when the switch was moved to the "On" position. The combination heat, light, fan unit is in poor condition and likely beyond its useful life.

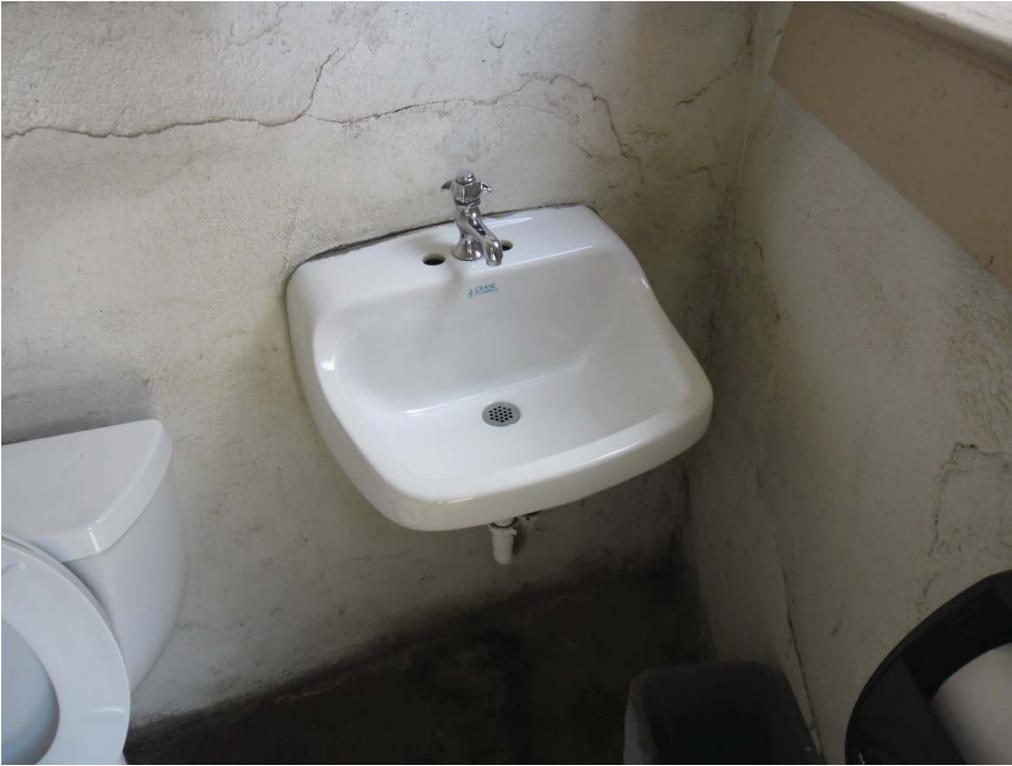
**Exhibit 9 - Tower Restroom Lavatory**

The tower men's and women's restrooms plumbing fixtures are in poor condition due to years of public use and should be replaced. **See Exhibits 9 & 10.**
