## Arborist Report (keith) Tree Condition Assessment

Date/Time	21/08/2023
Client Company	COA Forestry
Address, Zip	Barton Springs Pool
Site Image

Introduction	This report contains tree condition information and recommendations for a pecan tree overhanging Barton Springs Pool. I have been asked to evaluate the tree based on a results from a lab result diagnosing the tree to have the kretzschmaria fungus.
Methods	Data in this report is collected using level 2 assessment techniques unless otherwise indicated. All photos were taken from the ground unless otherwise indicated that drone camera or aerial ascent into the tree was performed. No ground penetrations were conducted unless otherwise indicated. Recommendations are based on a combination industry best practices, 3-5 year timeline of risk assessment, species profile and my 30 years experience working with trees.

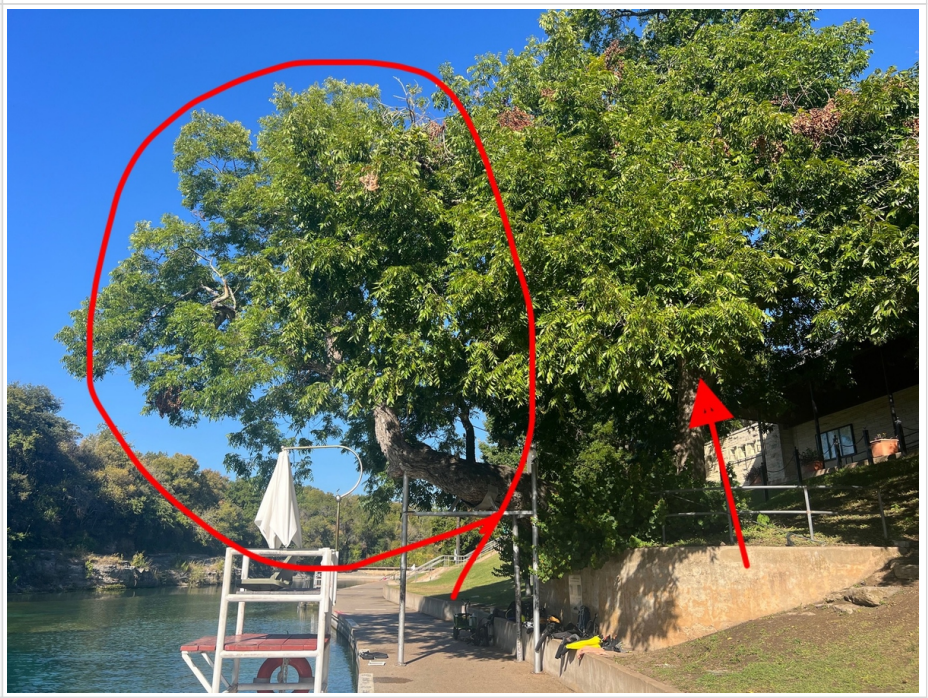
<b>photo 1 description</b>	<p>Red circle indicates canopy of the tree. Red arrow indicates canopy of an adjacent tree.</p>

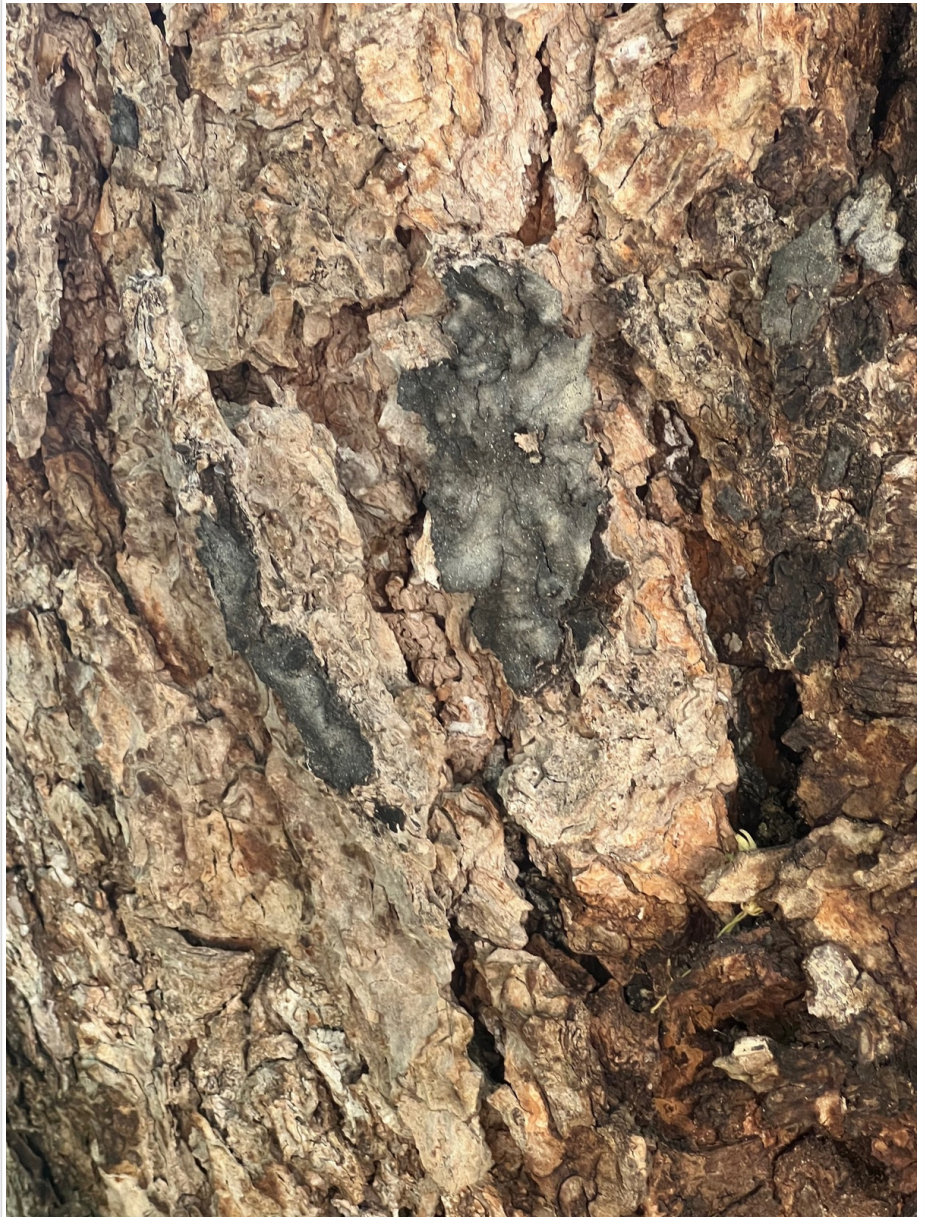
photo 2

Photo of fungi identified by lab to be kreitzschmaria. I concur this fungal mat appears to be the identified fungi.

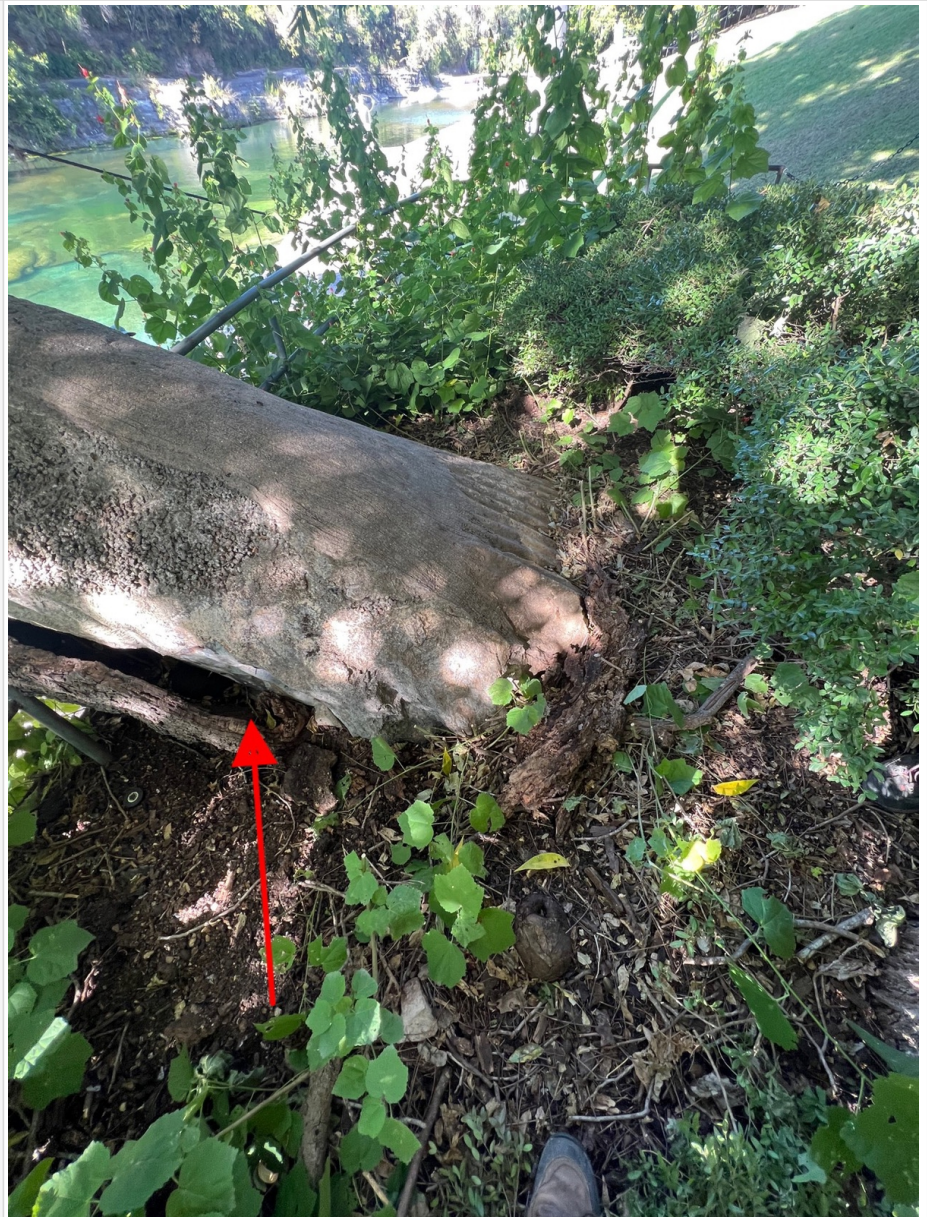
photo 3

Shows the base of the tree. This concrete was installed many, many years ago. The gap between the concrete and tree tissue appears to have grown substantially since last I remember.

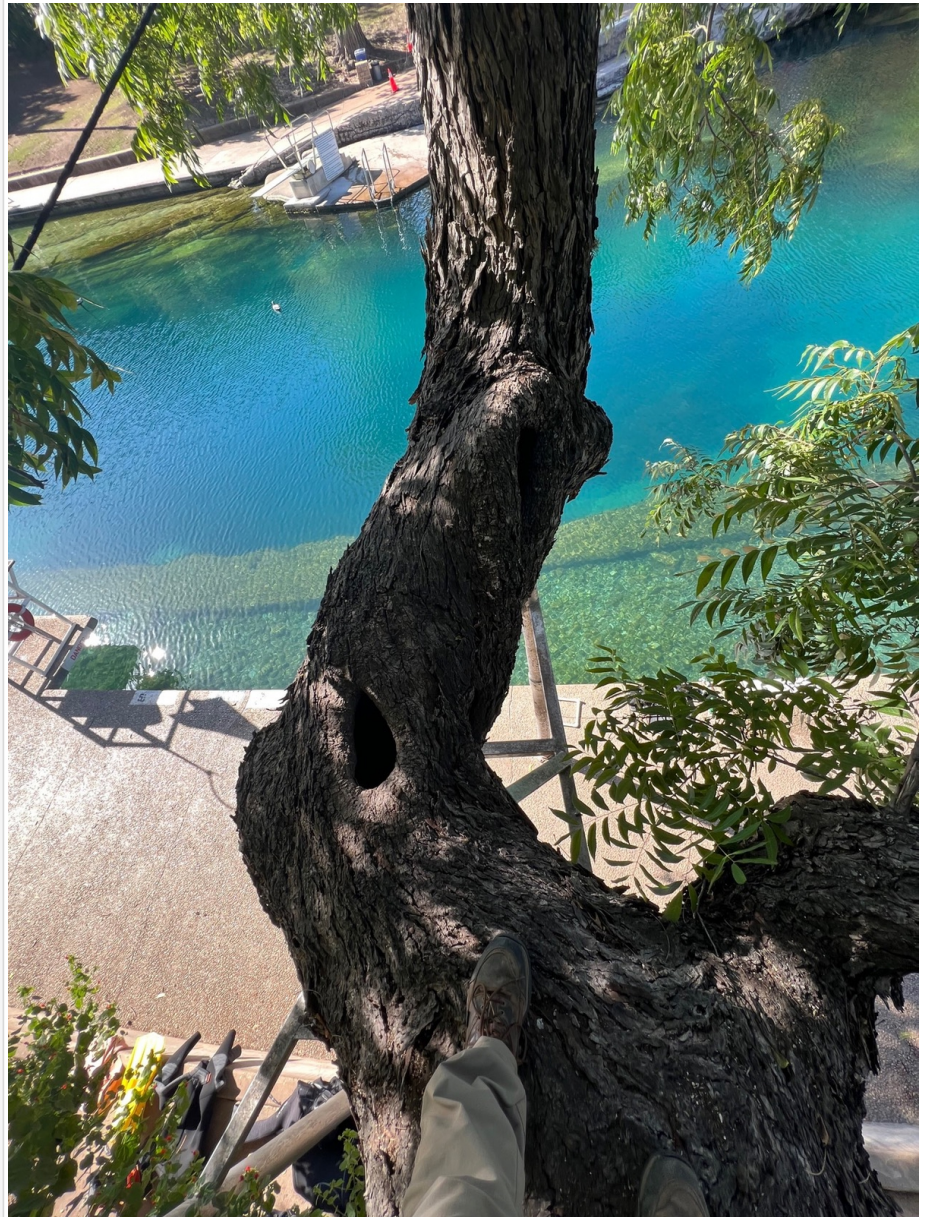
photo 4

Shows some of the defects in the main stem just past the concrete and the metal support structure can be seen.
