Montopolis Recreation Center

Condition Appraisal
June 1, 2011

Reference: Condition Appraisal of the Montopolis Recreation Center

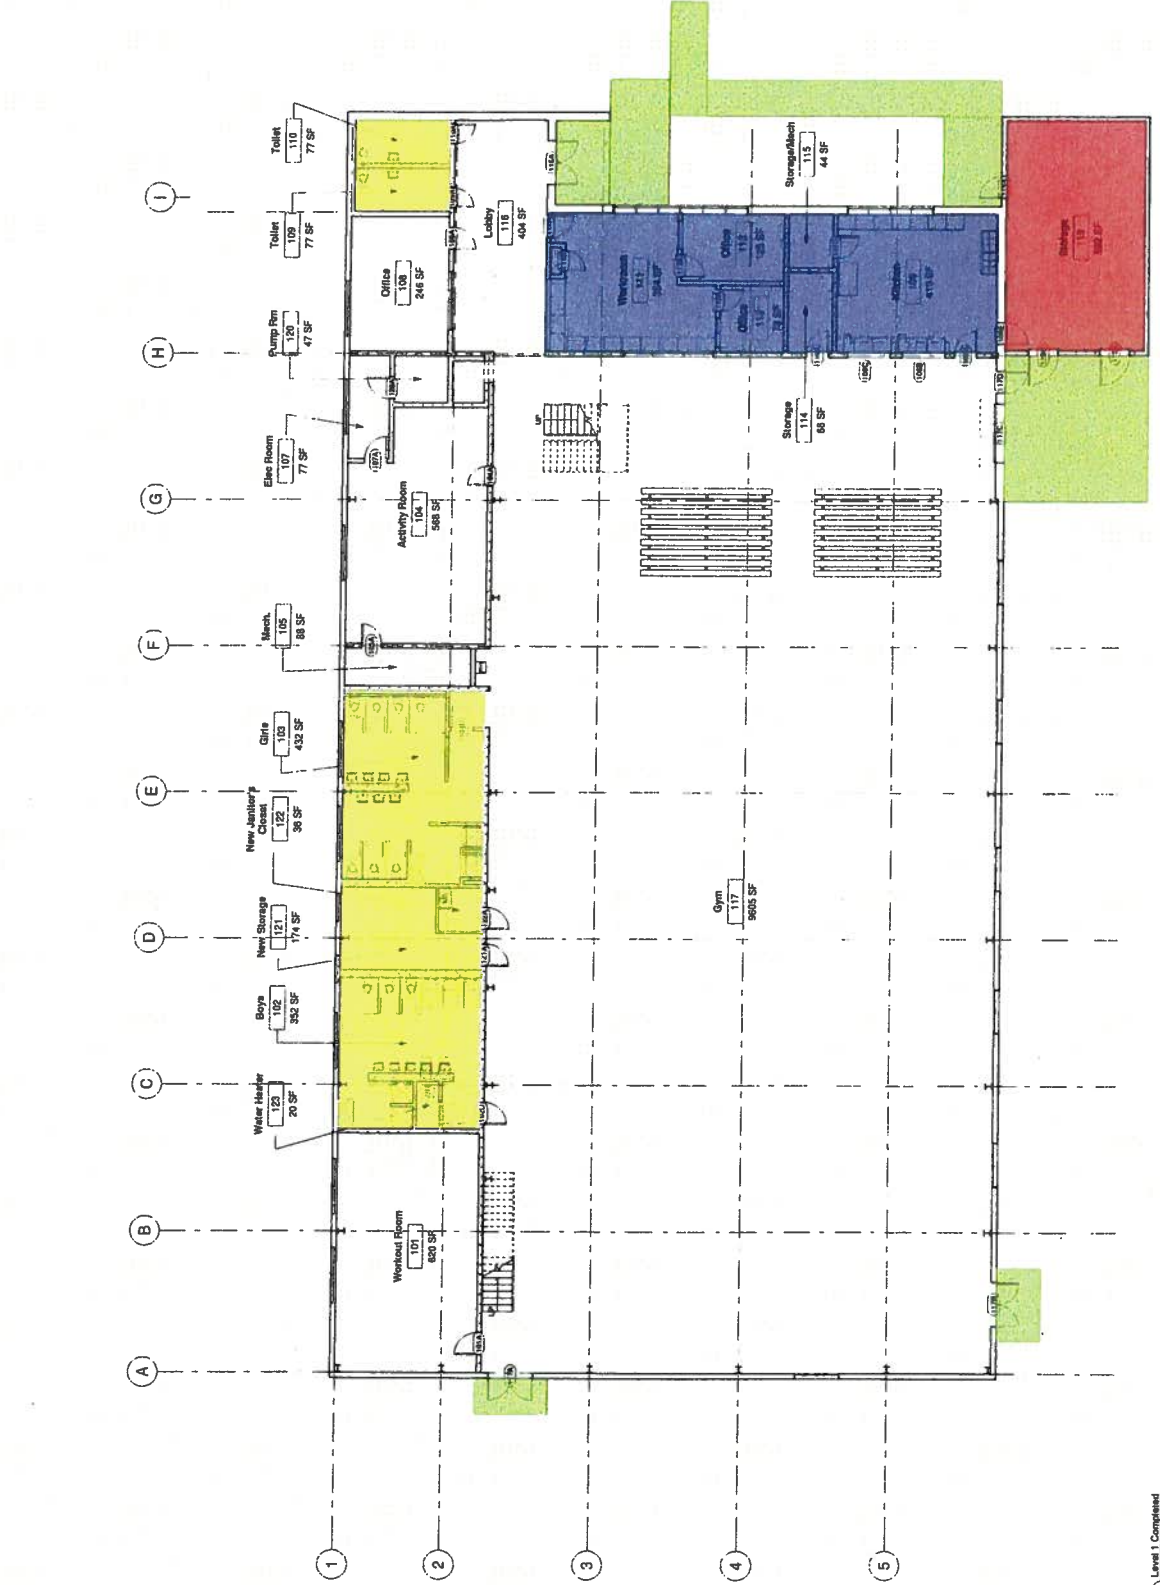
A104

AREAS IN NEED OF IMMEDIATE REPAIR:

- LOCKER ROOMS
- KITCHEN/OFFICES
- STORAGE
- ADA SITE ISSUES

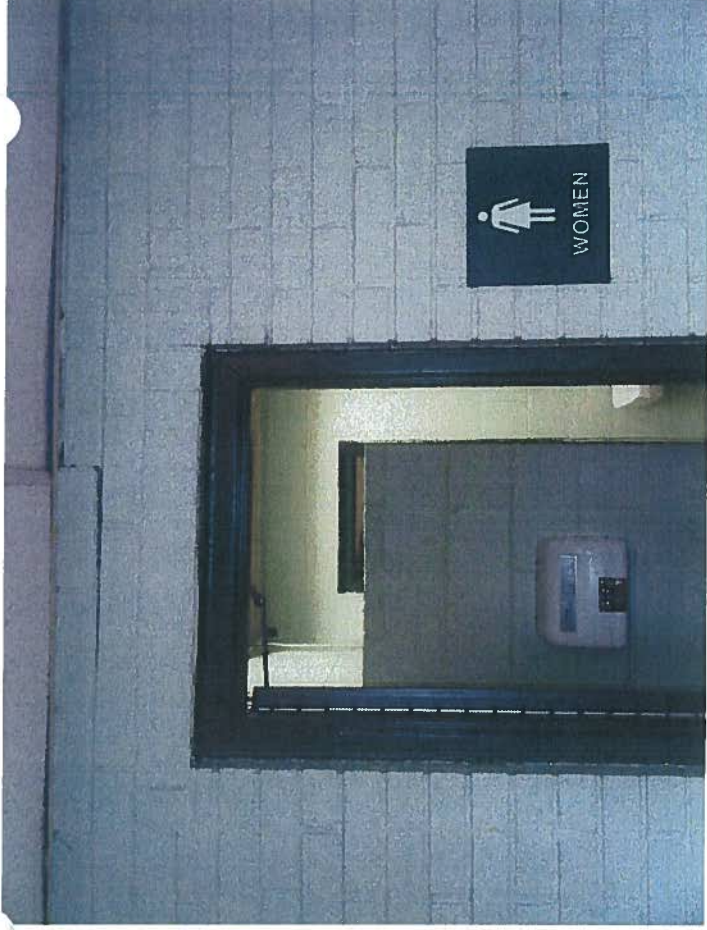
Cracking in CMU Wall

In the remaining areas of the first floor including the workout, activity, mechanical, toilets and offices the CMU and drywall cracks should be addressed by repointing the CMU joints and repairing the drywall cracks. In the second floor areas the drywall cracking should be addressed as needed.

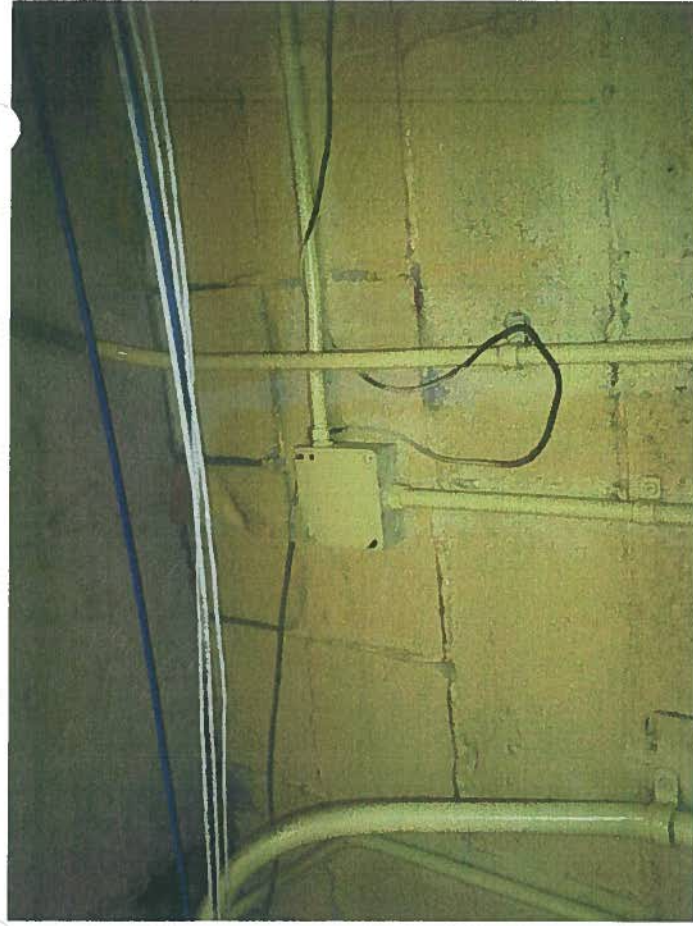
Exposed Wiring

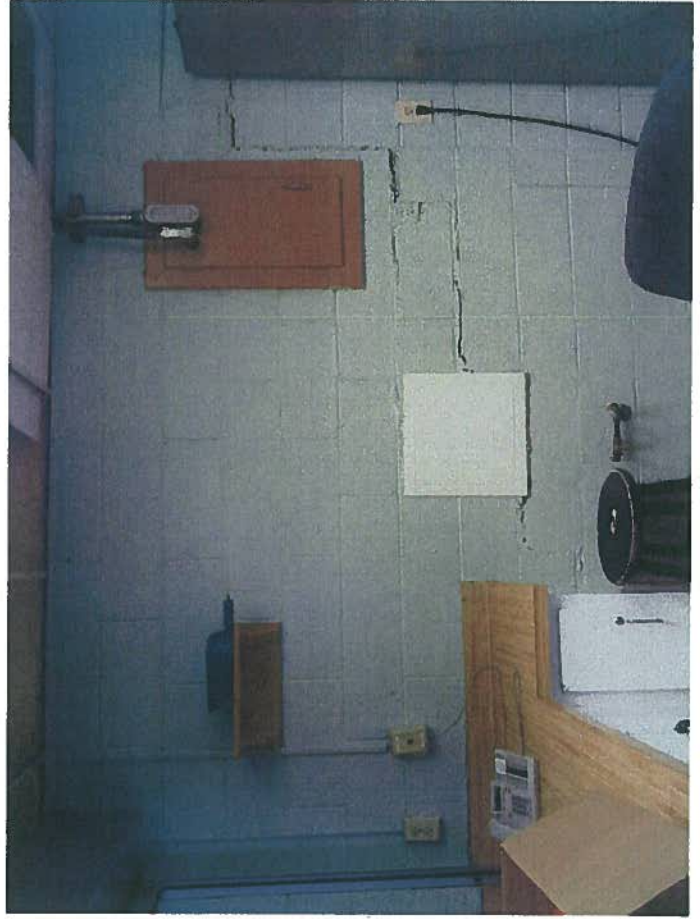
Cracks in CMU Wall

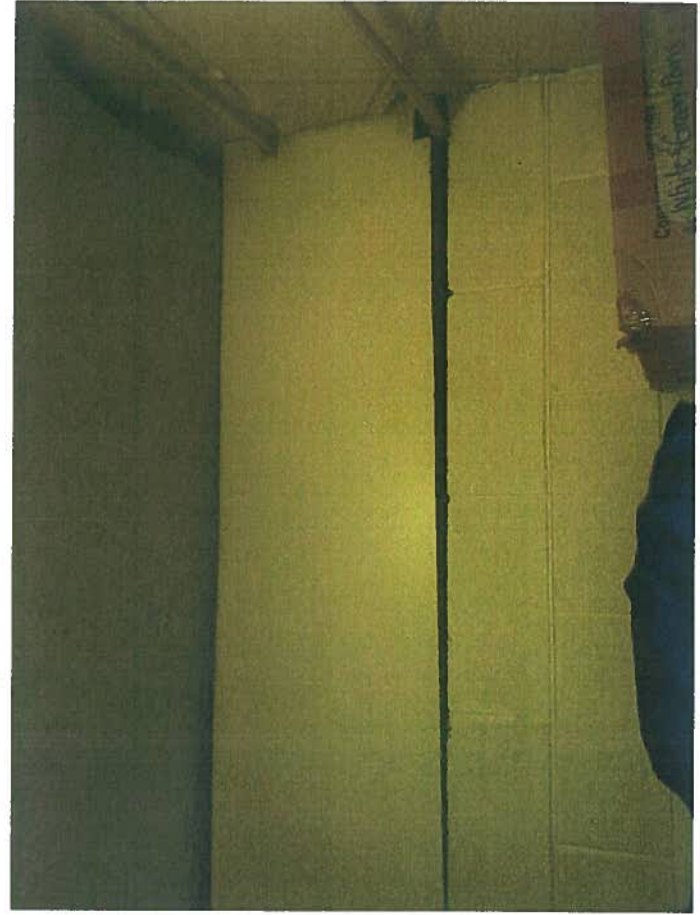
Cracks in CMU Wall

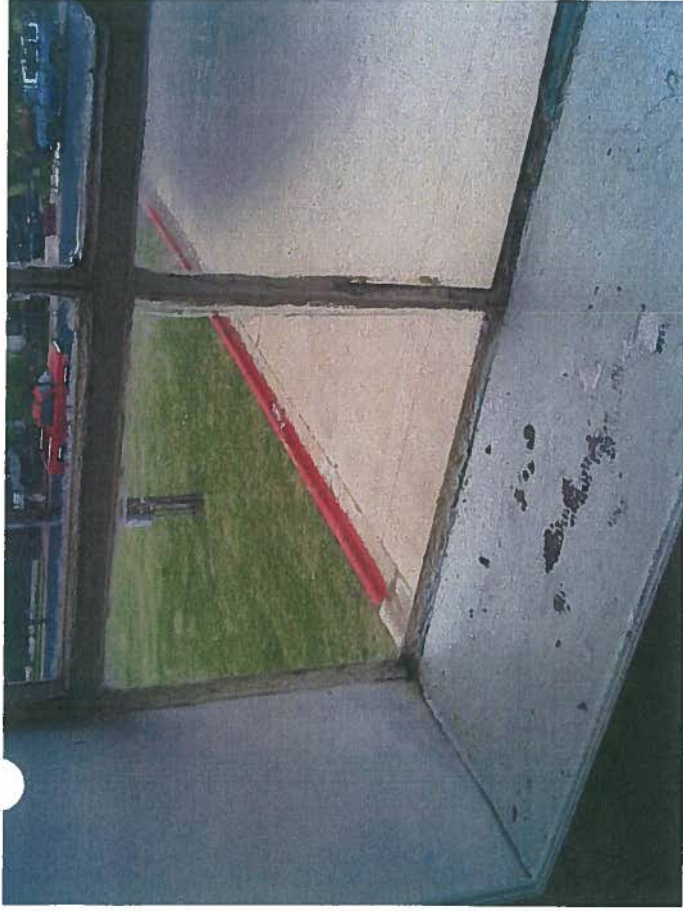
8. Windows: Windows throughout the entire building are in poor condition as they are single pane, outdated (installed in 1975), sealant is failing and the majority inoperable.

Deteriorating Windows

Windows need to be replaced because of their poor condition, which includes air leaks, broken glass, and un-insulated glass.

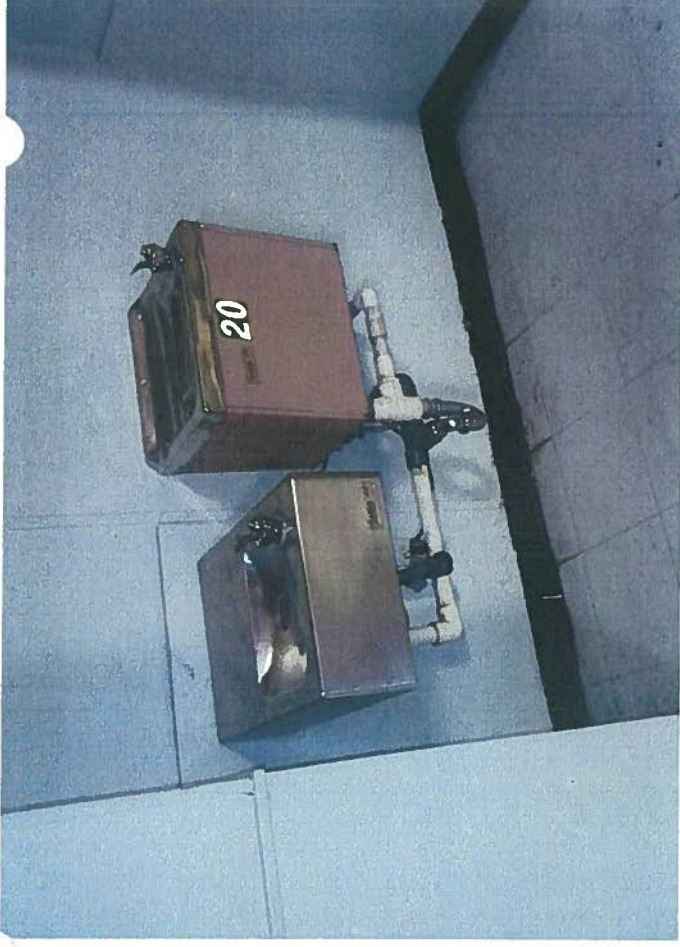
Water Fountains (Not ADA/TAS Accessible)

Various plumbing fixtures located within the building do not meet ADA requirements and should be considered for replacement and or relocation. In an attempt to reduce water usage, it is our recommendation that all manual faucets at restroom and toilet lavatories be replaced with motion sensor controlled faucets with low flow aerators. We recommend that single lavatory mixing valves be installed at all lavatories as is currently required by the City of Austin plumbing design standard. All water closets and urinals should be considered for replacement with low-flow 1.28 gpf water closets and 0.5 gpf urinals with motion sensor activated flushometers. The existing non-functional shower valve assemblies should be demolished and replaced with low flow showerheads and working mixing valves. All drinking fountains that do not currently meet ADA requirements should be considered for replacement in order to meet code.

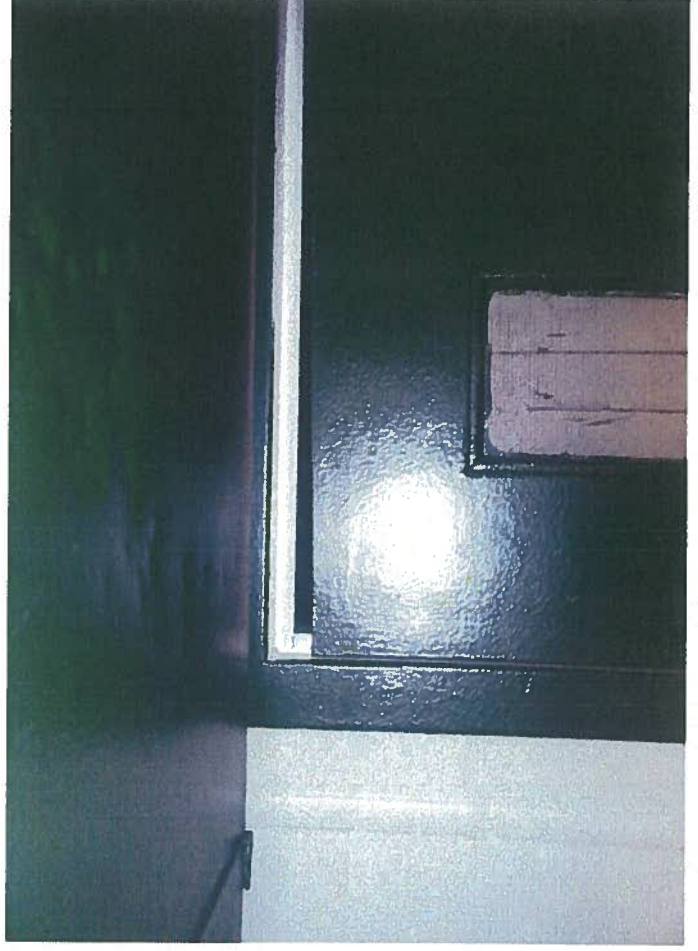
Doors cut to allow opening under AC ducts

Doors & Hardware need replacement at almost every location due to hardware not meeting ADA guidelines as the majority are not lever type and are in poor condition. Doors requiring replacement is due to several factors: poor condition, tops shaved off to allow full opening under air conditioning ducts, not a minimum of 3'-0" wide (ADA), or part of a renovation (Restrooms and Kitchen).

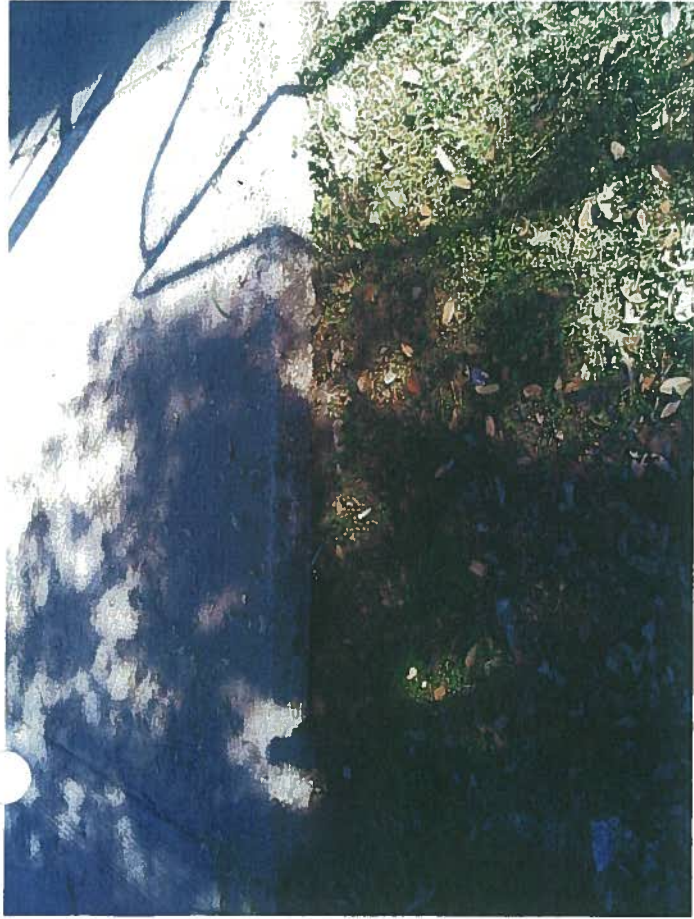
ADA/TAS Non-compliant at exits

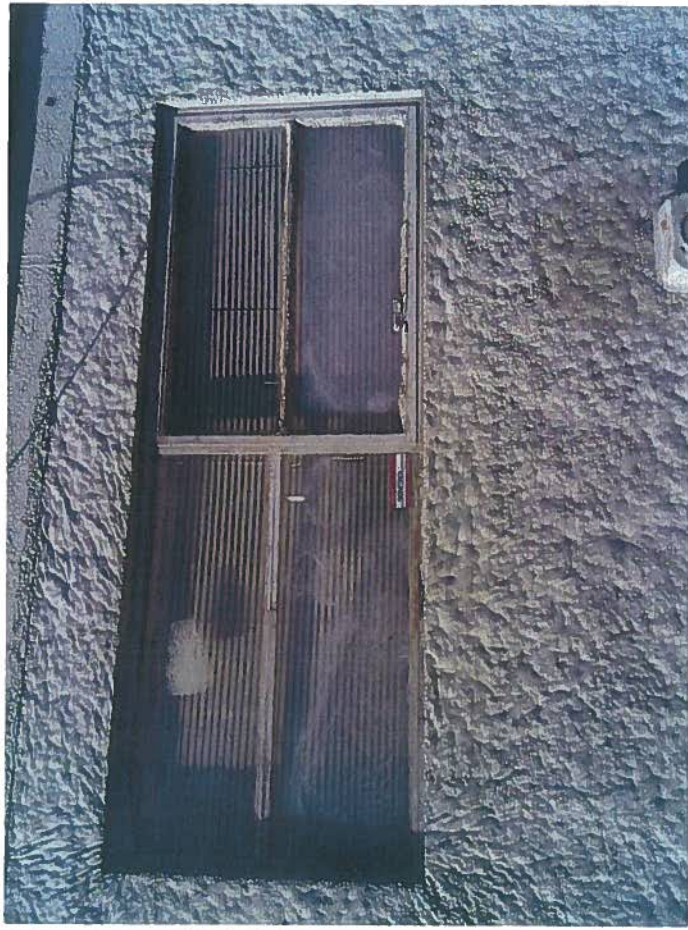
Exhaust fan openings

Exhaust fans, ductwork and air devices serving the two entry toilets and two large restrooms are not functional and it is recommended that they be demolished and replaced with new fans sized to provide the code required amount of air changes for the respective spaces. The existing elevator equipment room and pump room housing the main electrical gear do not have cooling air being supplied to the spaces as is necessary to prevent the risk of overheating the critical equipment. It is highly recommended that a dedicated mini ductless split system with electric cooling be added to the elevator equipment room, and that a transfer grille and ventilation fan with temperature sensor be added to the pump room to allow for the transfer of hot air out of the space.

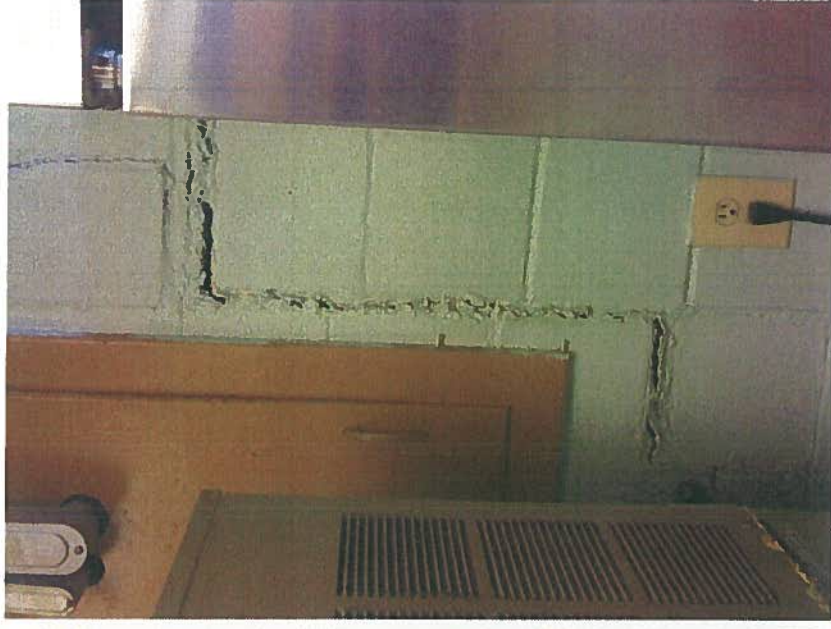
CMU Cracking

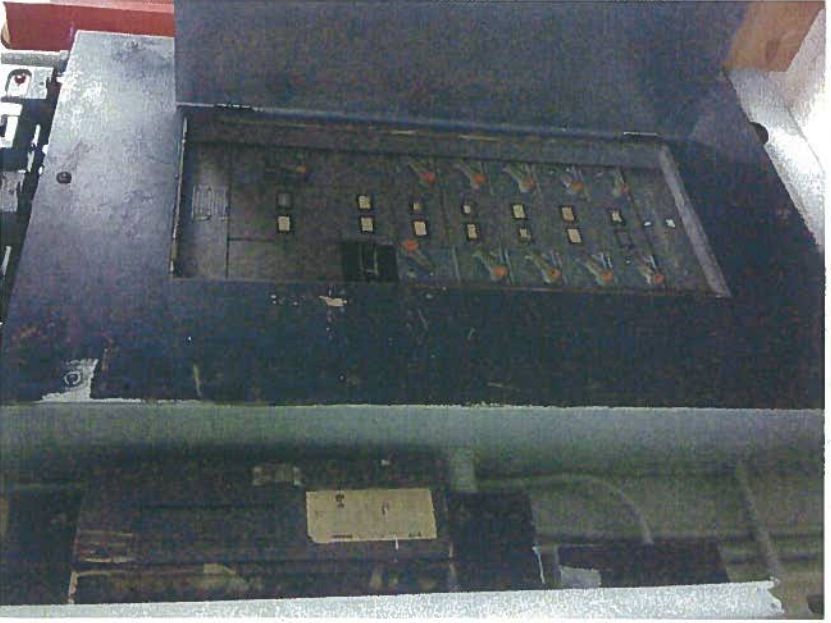
3. Electrical Switchgear: The building's existing electrical switchgear and panels vary in appearance from practically new to antique and falling apart. Various electrical panels should be replaced due to their poor condition and some relocated due to non-compliance with the National Electric Code (NEC).

Electrical switchgear

Electrical panel 'L' (125 Amp, 120/240 VAC, 3 phase) located in the first floor pump room is in poor condition with noticeable burn marks and rust present at its enclosure. We recommend that this panel be demolished and replaced along with the main distribution panel located in same room. Electrical panel 'K' (100 Amp, 120/240 VAC, 3 phase) is an old Federal Pacific panel and is currently located in storage room 114. The National Electric code strictly prohibits electrical panels from being located in storage closets and we strongly recommend that this panel be demolished, replaced and relocated to a new location that meets code requirements. Panels AC-1 and AC-2 are in fair condition with signs of wear, rust and physical damage to their enclosures. Because these electrical panels are located in the gymnasium and are subject to physical abuse, we recommend that a protective grate with accessible door be located around the panels for protection. The protective casing shall be specified to meet all design and clearance requirements as are mandated by code.
