Appendix C - CBRE Condition Assessments

1. Alamo Recreation Center.....	3
2. Austin Recreation Center.....	83
3. Danny G McBeth Recreation Center.....	156
4. Delores Duffie Recreation Center.....	254

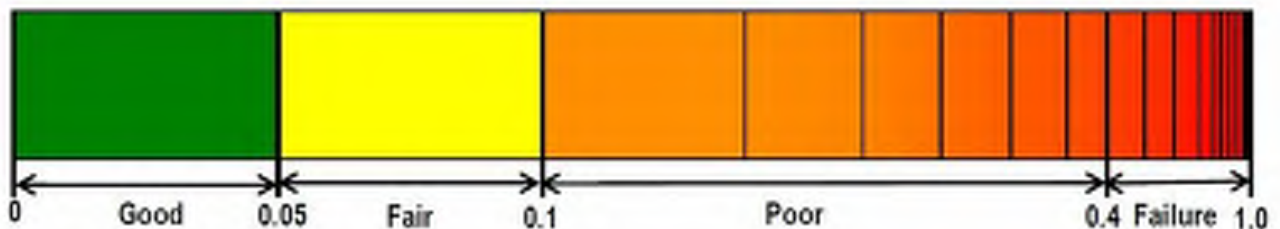
Therefore, the lower the FCI, the lower the need for remedial or renewal funding relative to the facility's value. For example, an FCI of 0.07 signifies a 7% deficiency ratio which is generally considered to be in the fair range. An FCI of 0.7 means that 70% of the building needs extensive repairs or replacement. The FCI is a relative indicator of condition and should be tracked over time to maximize its benefit.

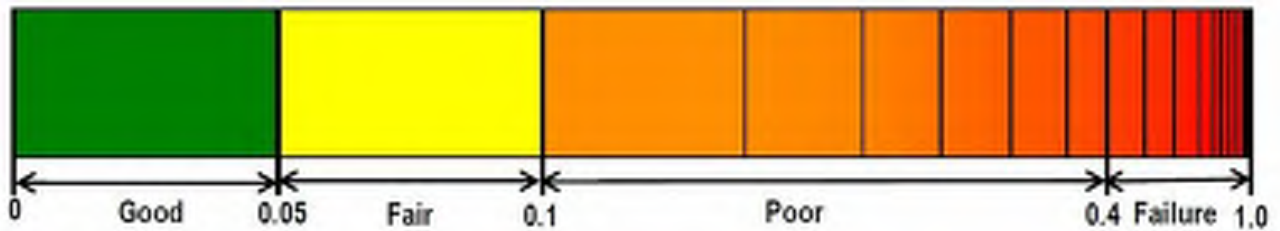
Therefore, the lower the FCI, the lower the need for remedial or renewal funding relative to the facility's value. For example, an FCI of 0.07 signifies a 7% deficiency ratio which is generally considered to be in the fair range. An FCI of 0.7 means that 70% of the building needs extensive repairs or replacement. The FCI is a relative indicator of condition and should be tracked over time to maximize its benefit.

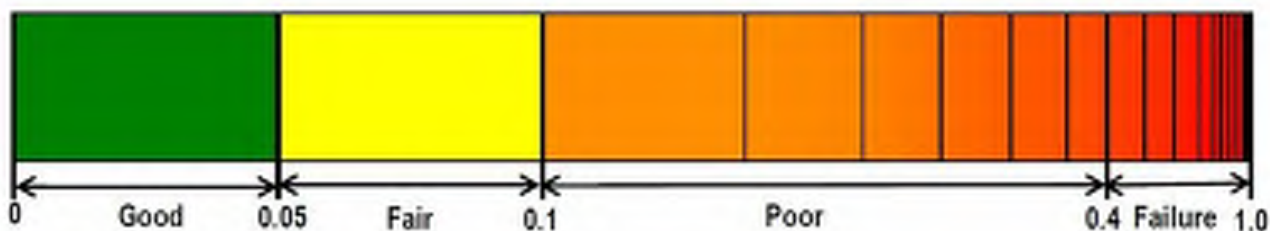
Therefore, the lower the FCI, the lower the need for remedial or renewal funding relative to the facility's value. For example, an FCI of 0.07 signifies a 7% deficiency ratio which is generally considered to be in the fair range. An FCI of 0.7 means that 70% of the building needs extensive repairs or replacement. The FCI is a relative indicator of condition and should be tracked over time to maximize its benefit.

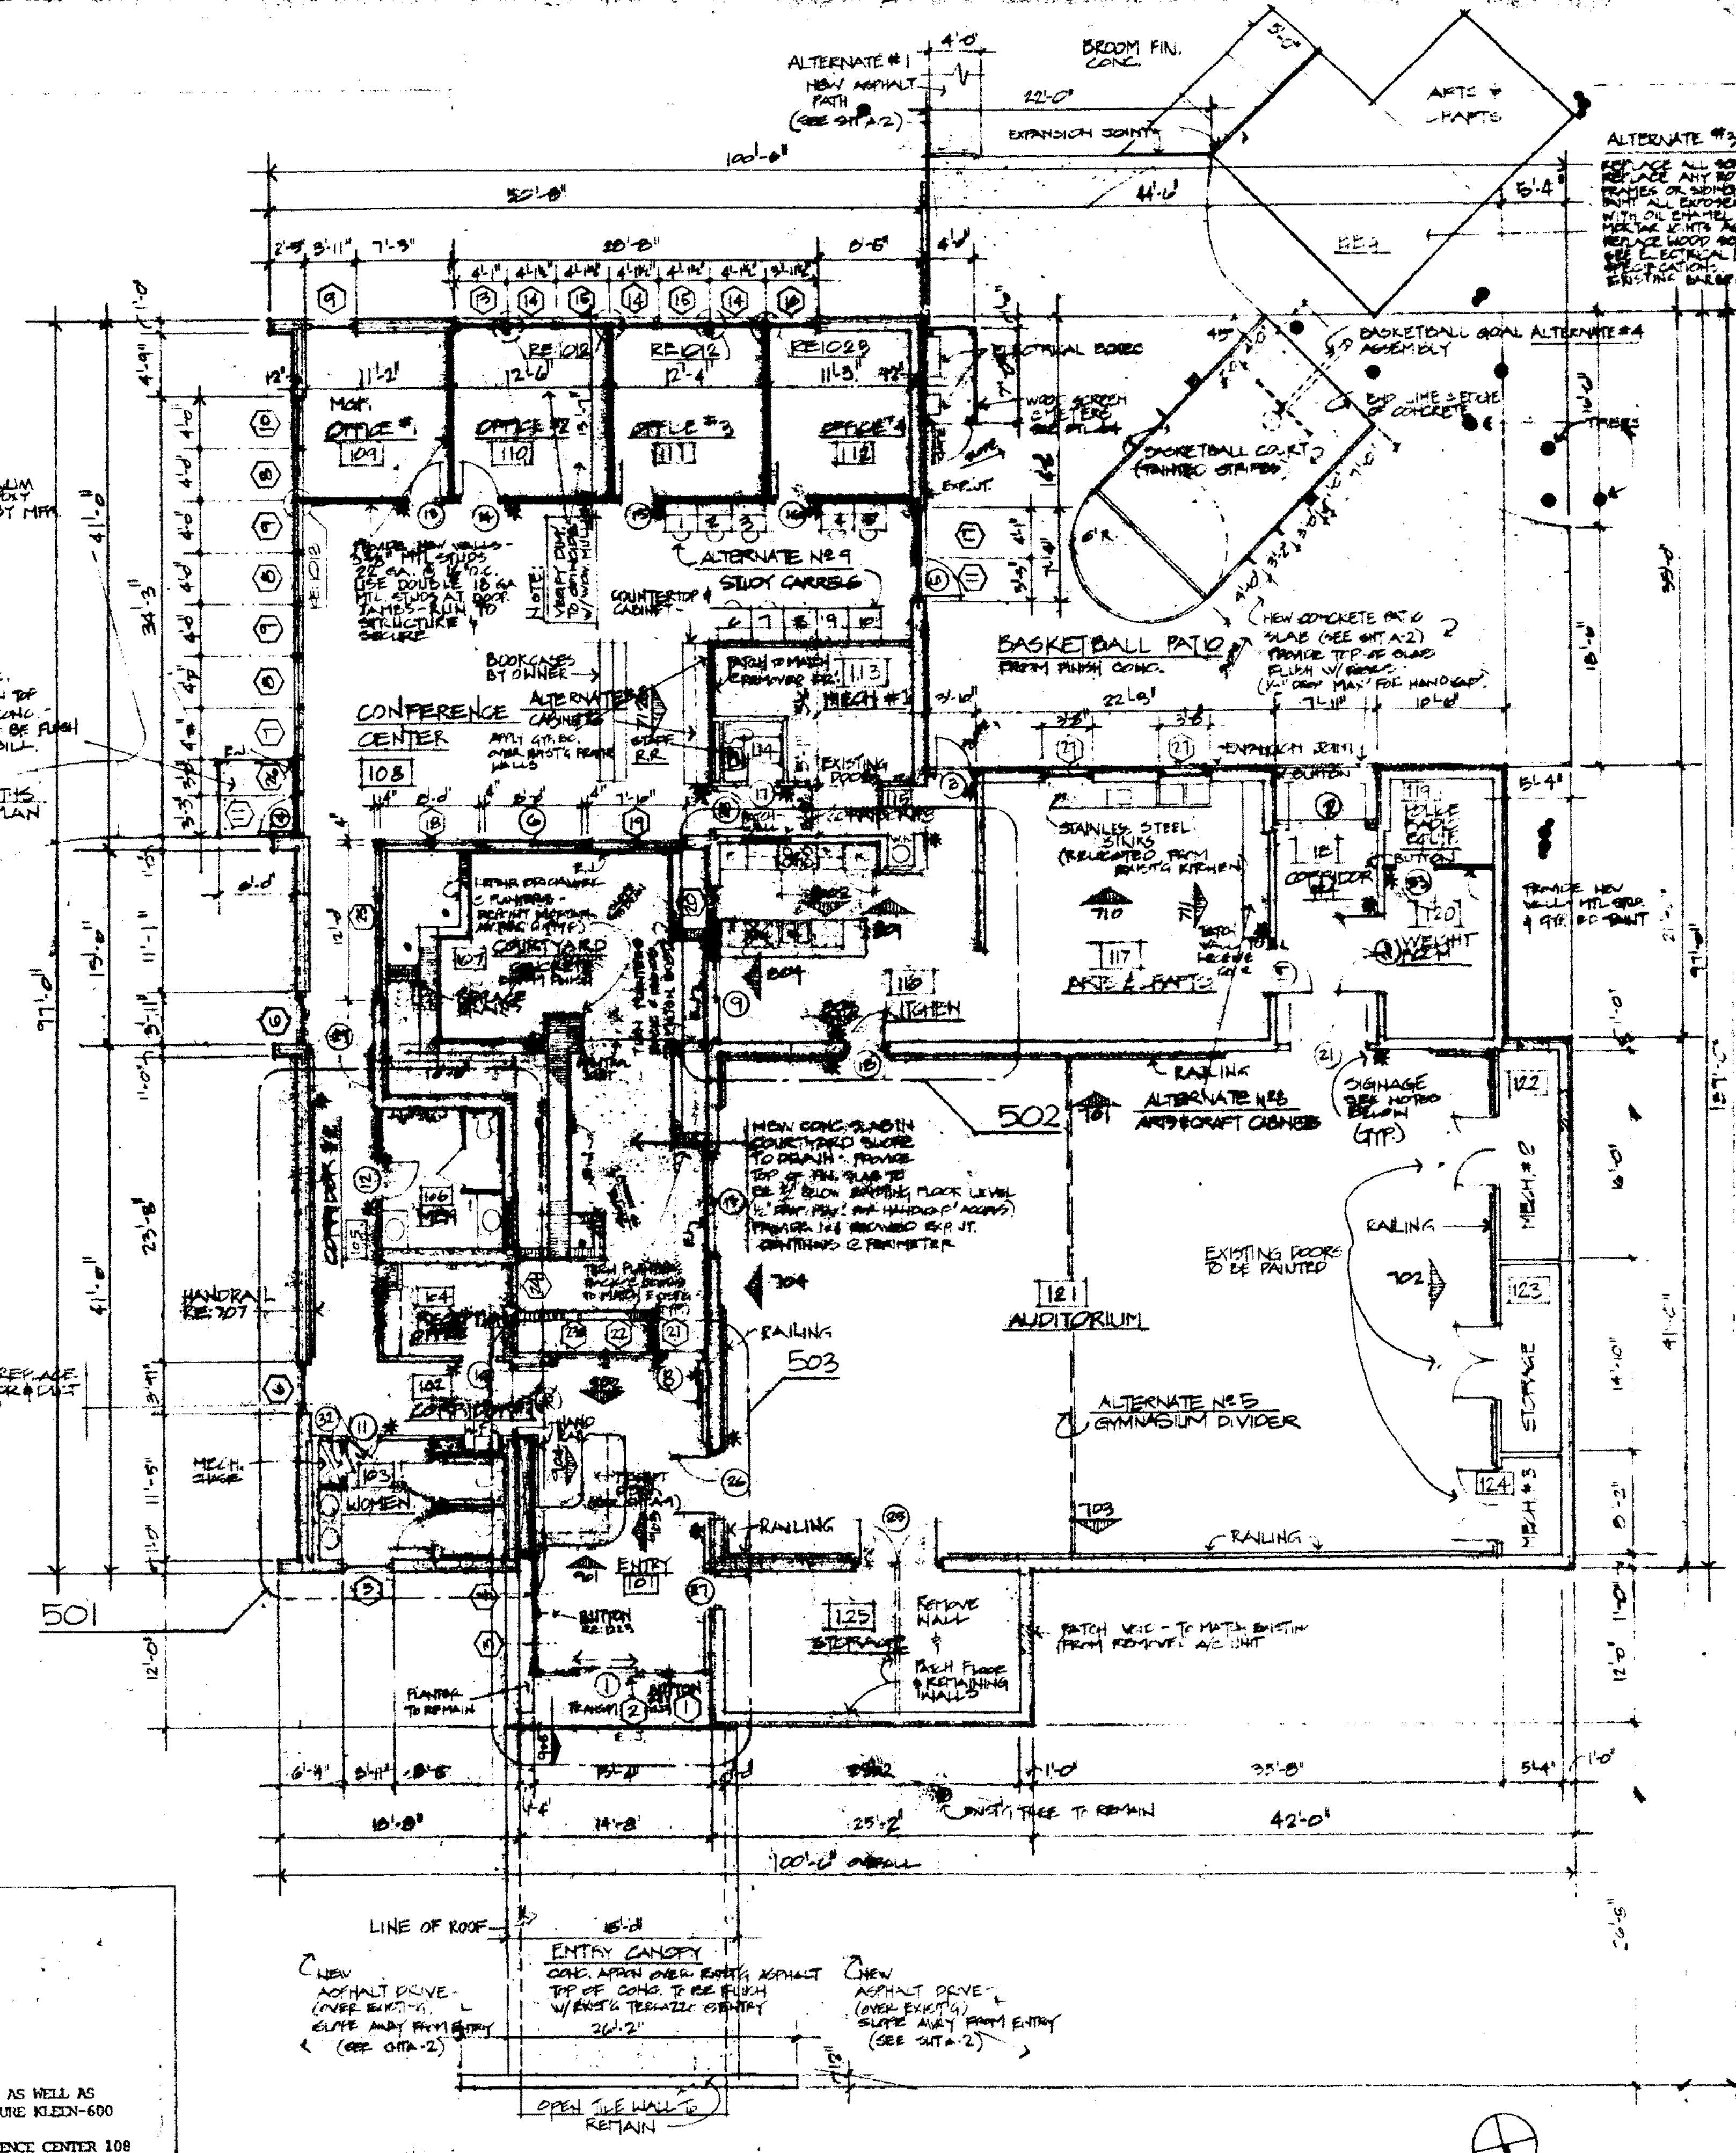
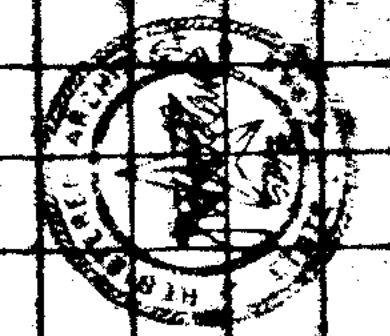
James Holland
Architects, Inc.
2502 COLUMBUS DR.
CITY OF AUSTIN, TEXAS 78721

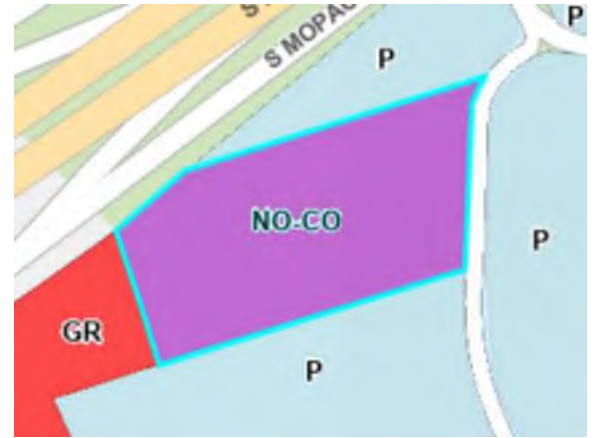
Jurisdiction: **AUSTIN FULL PURPOSE**
 Council District: **8**
 County: **TRAVIS**
 School District: **Eanes ISD, Austin ISD**
 Community Registry: **Austin Lost and Found Pets, Austin Neighborhoods Council, Friends of Austin Neighborhoods, Homeless Neighborhood Association, Neighborhood Empowerment Foundation, Preservation Austin, SELTexas, Save Barton Creek Assn., Save Our Springs Alliance, Sierra Club, Austin Regional Group, South Central Coalition, TNR BCP - Travis County Natural Resources, Zilker Neighborhood Association**

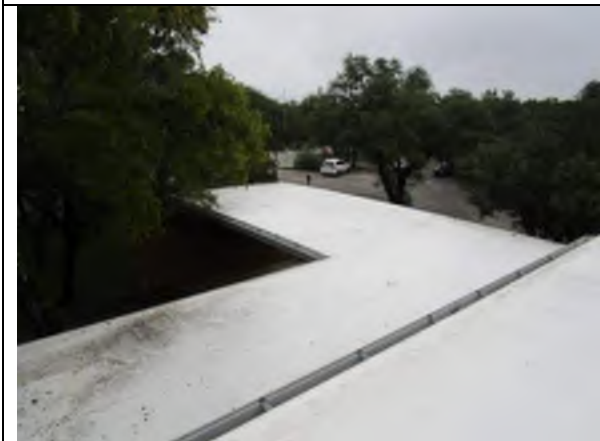
Sealant around hot stack has failed and needs to be replaced.

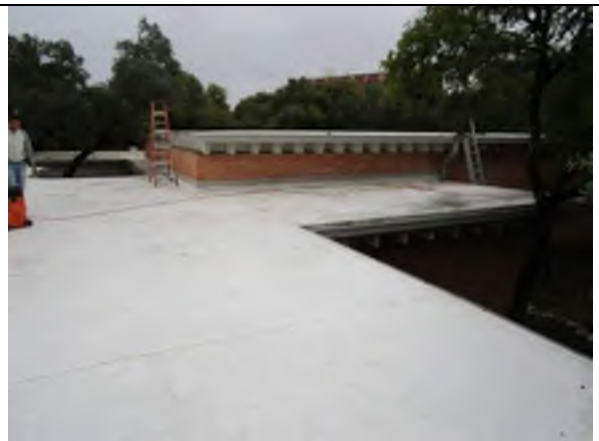
Sealant around pipe boot has failed and needs to be replaced.

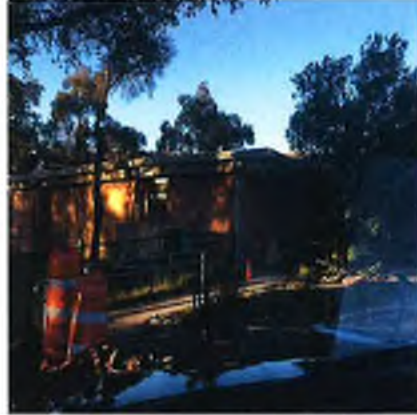
1576697006570593.JPG
WORKORDER:[WO #19370 (ALT#:) (CL#:WO#201810589)]

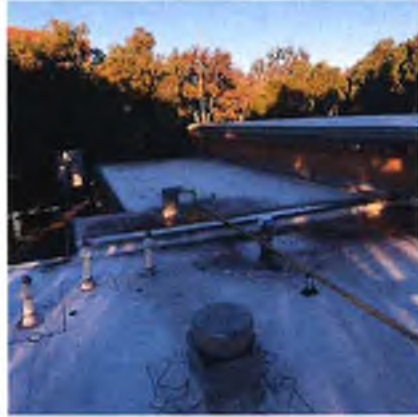
1576697006601997.JPG
WORKORDER:[WO #19370 (ALT#:) (CL#:WO#201810589)]

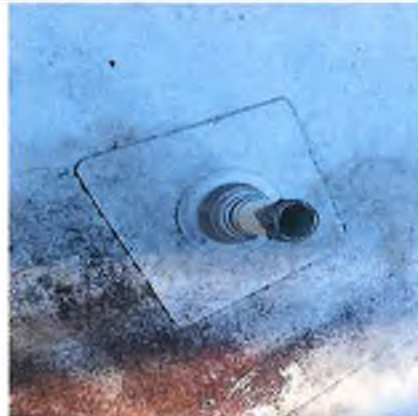
1576697006603522.JPG
WORKORDER:[WO #19370 (ALT#:) (CL#:WO#201810589)]

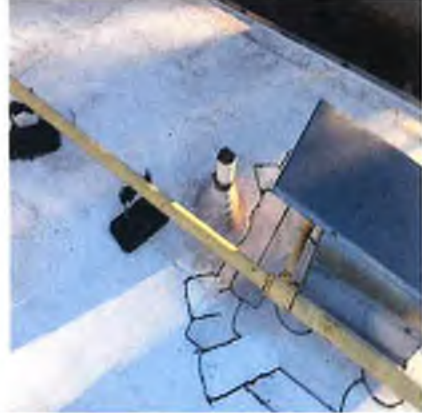
1576697006608458.JPG
WORKORDER:[WO #19370 (ALT#:) (CL#:WO#201810589)]
Improper repair needing properly repaired.

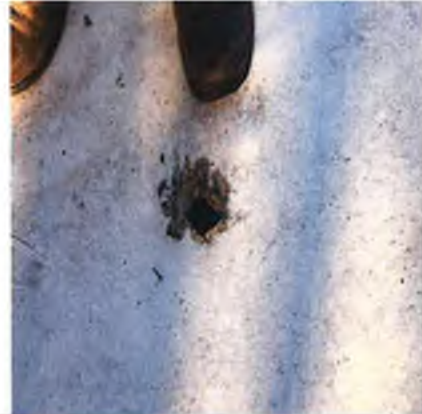
1576697006610164.JPG
WORKORDER:[WO #19370 (ALT#:) (CL#:WO#201810589)]

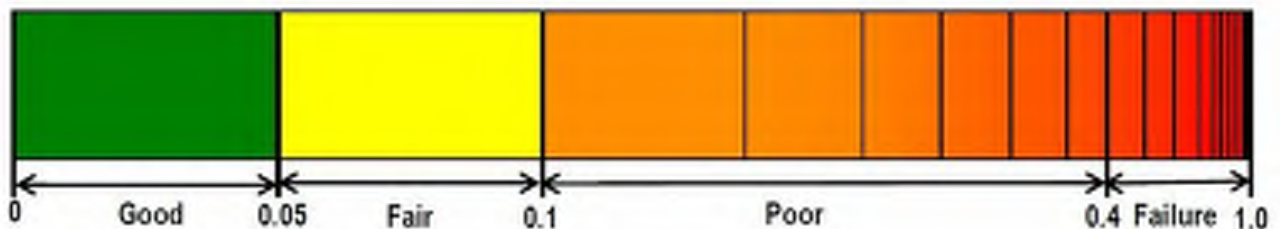
Therefore, the lower the FCI, the lower the need for remedial or renewal funding relative to the facility's value. For example, an FCI of 0.07 signifies a 7% deficiency ratio which is generally considered to be in the fair range. An FCI of 0.7 means that 70% of the building needs extensive repairs or replacement. The FCI is a relative indicator of condition and should be tracked over time to maximize its benefit.

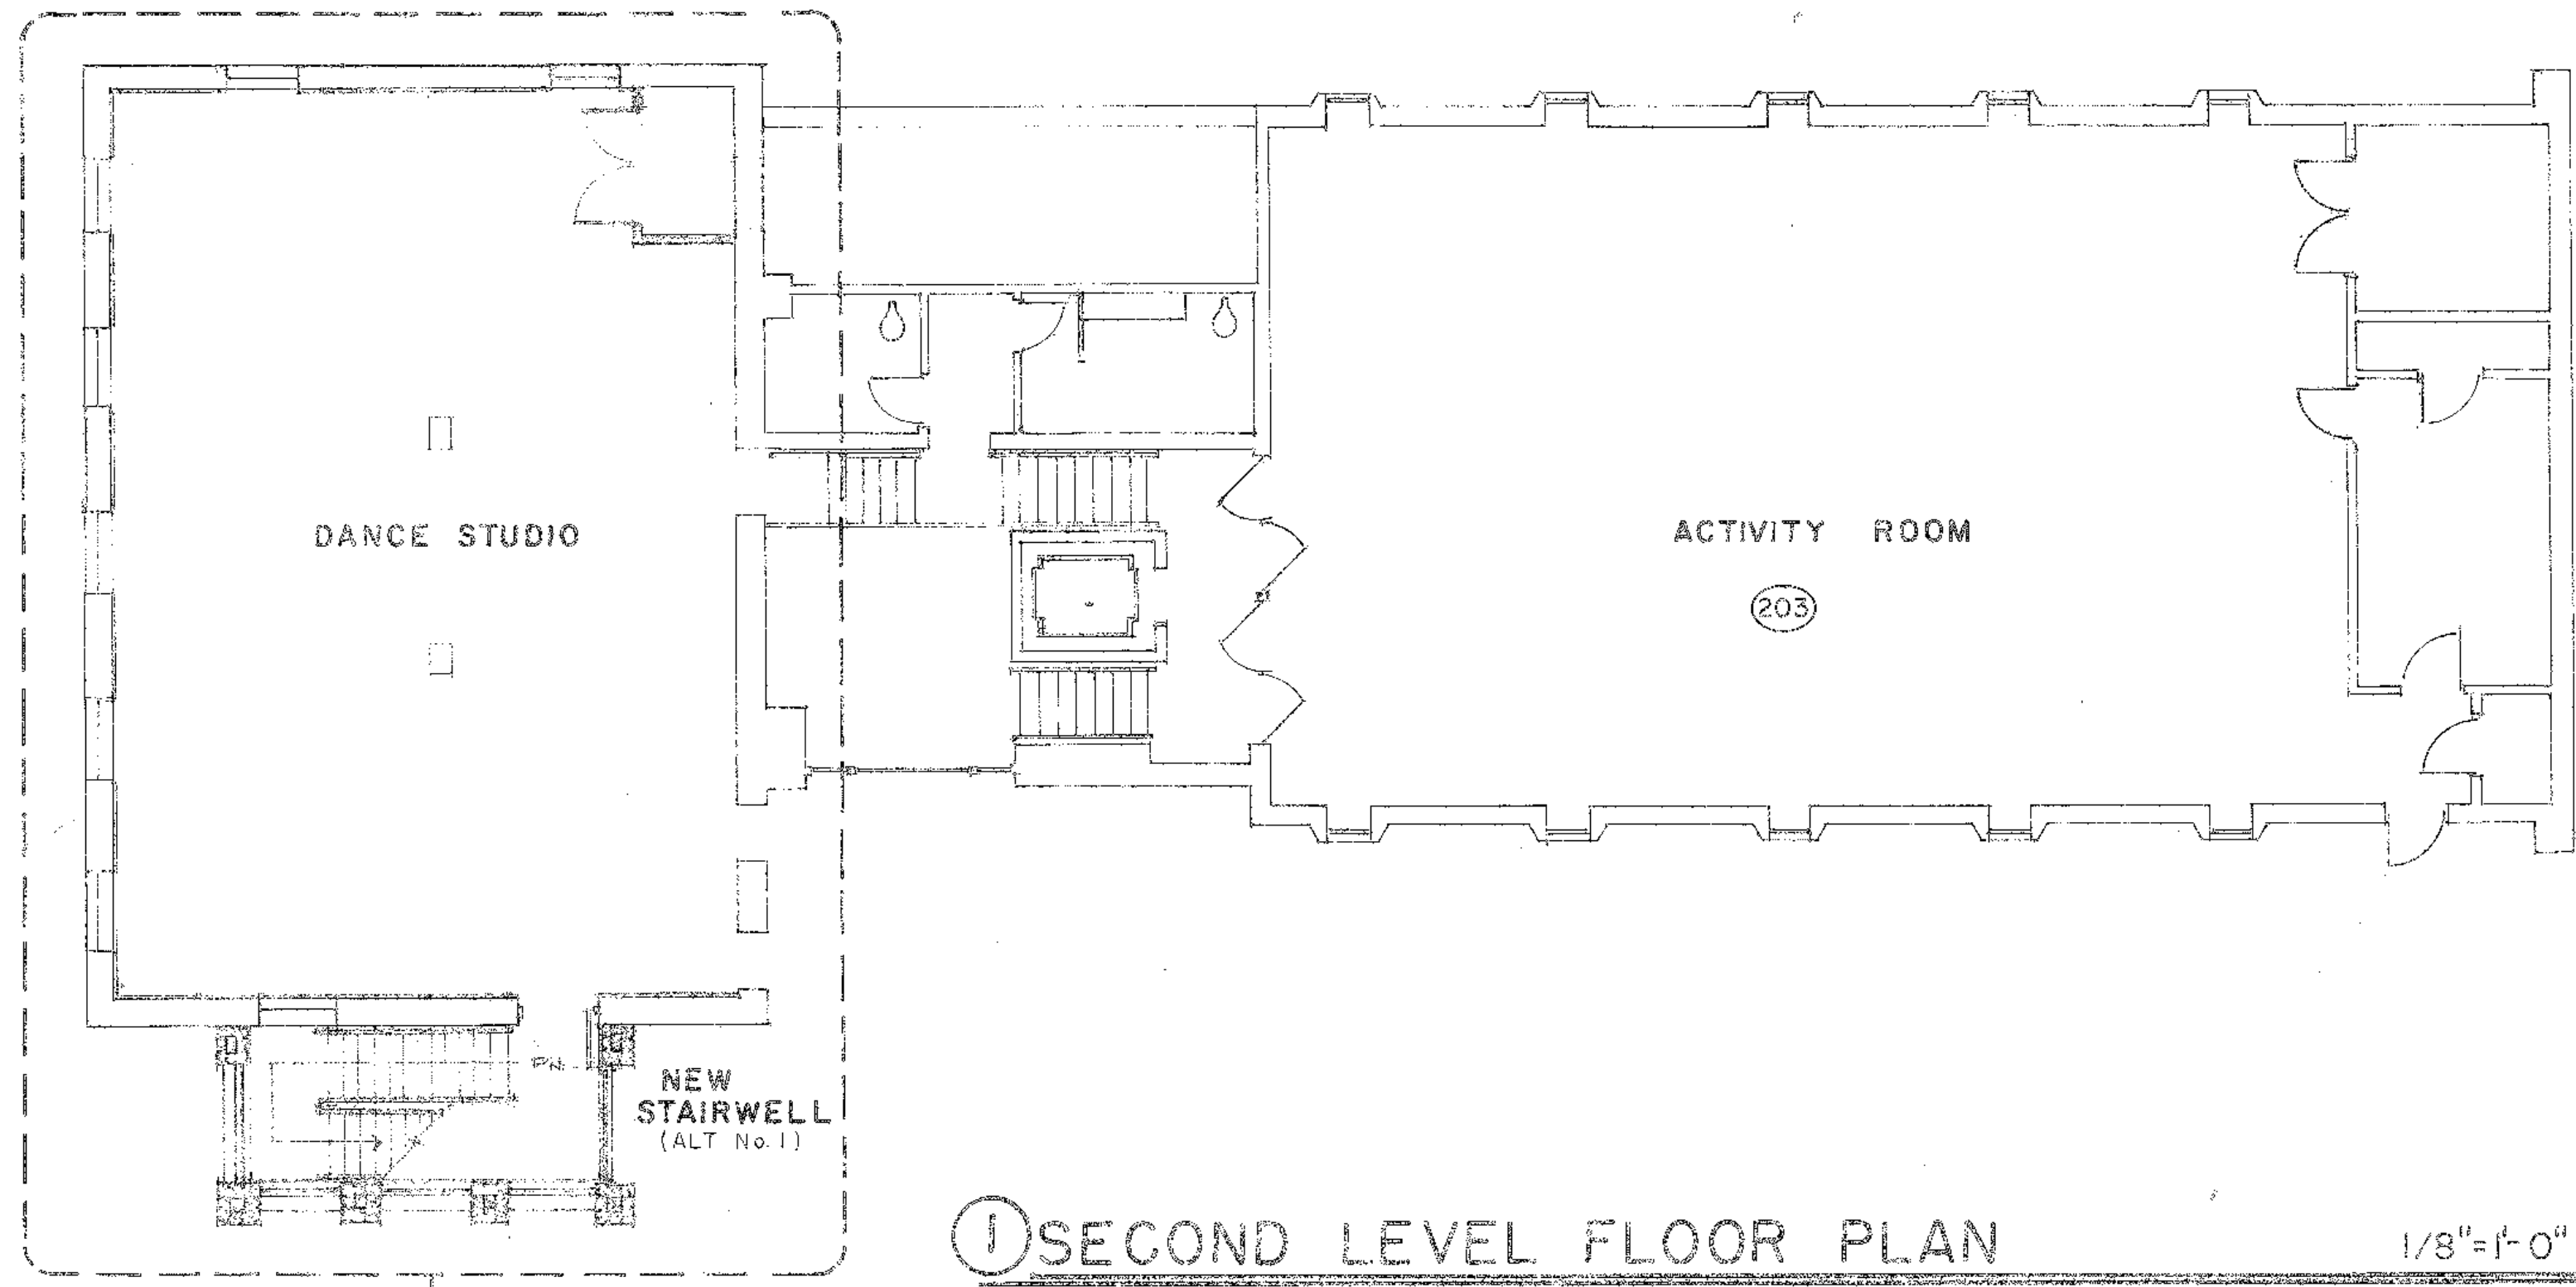
① SECOND LEVEL FLOOR PLAN 1/8"=1'-0"

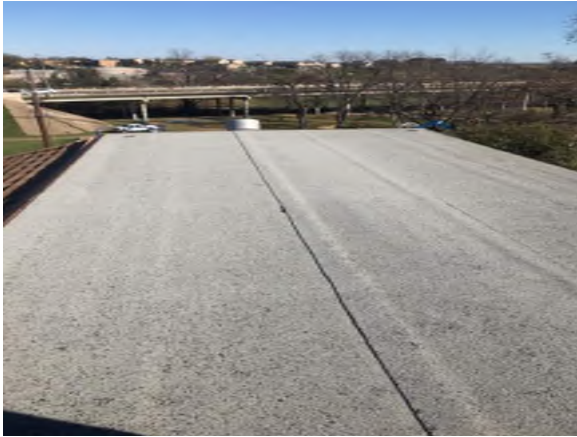
Small Modified roof area. No repairs needed.

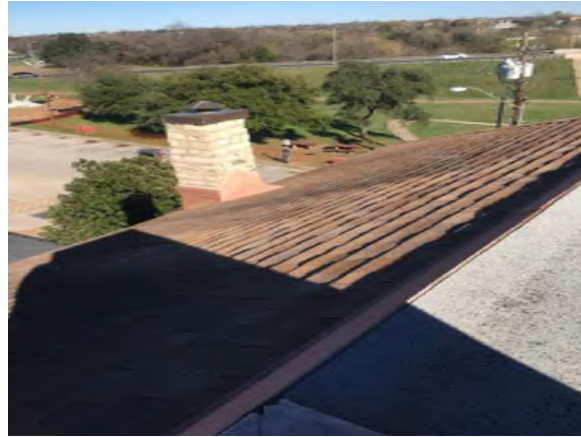
Shingle roof overview.

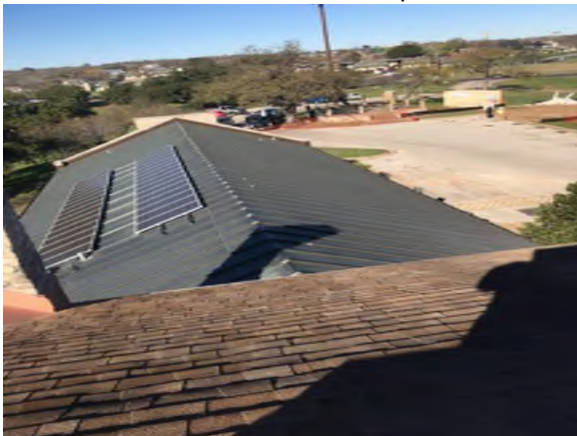
Overview of Metal roof area. Also showing the (3) penetrations needing replaced, one close to solar panels and 2 at the far end on right.

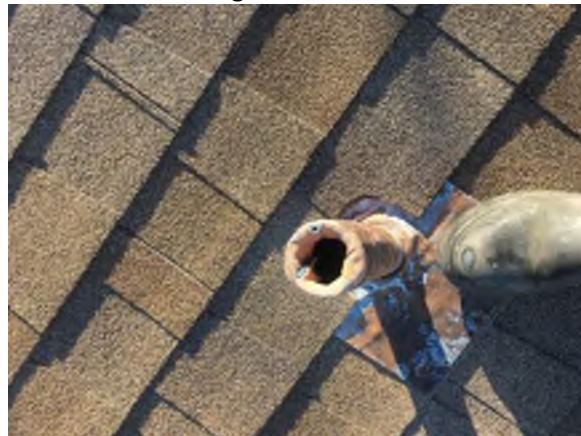
Lead on shingle roof needing replaced.

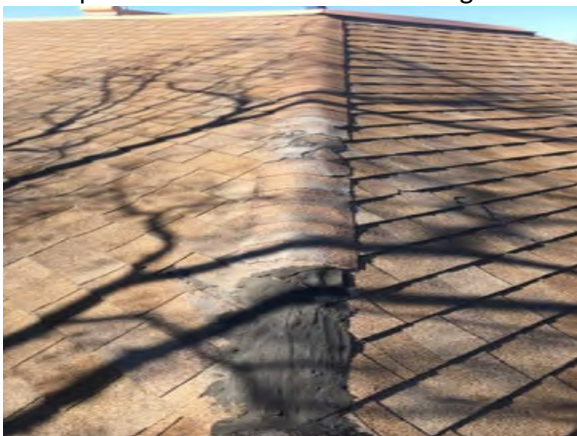
Ridge area needing repairs and ridge row replaced.

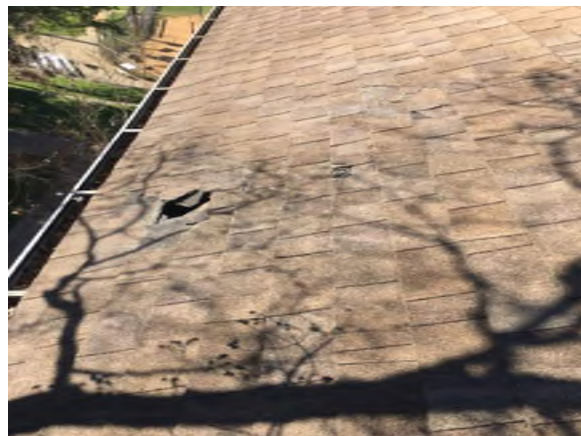
Damaged area needing decking replaced and roof restored to normal condition.

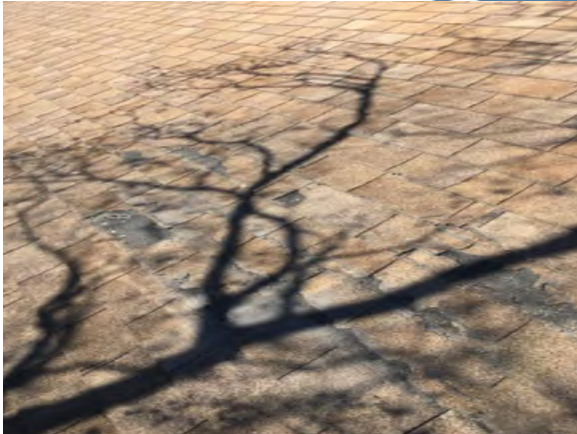
Area of damaged shingles needing replaced.

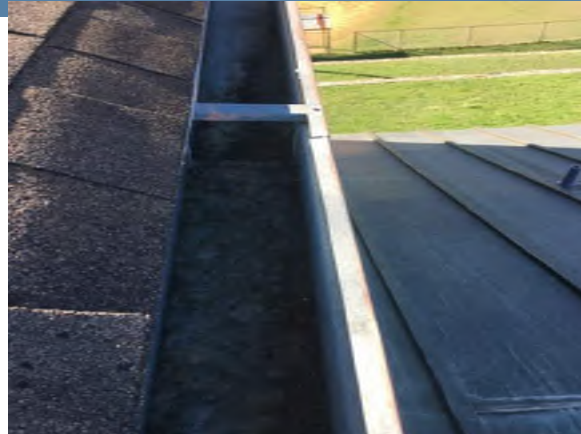
Gutters cleaned. Next picture as well.

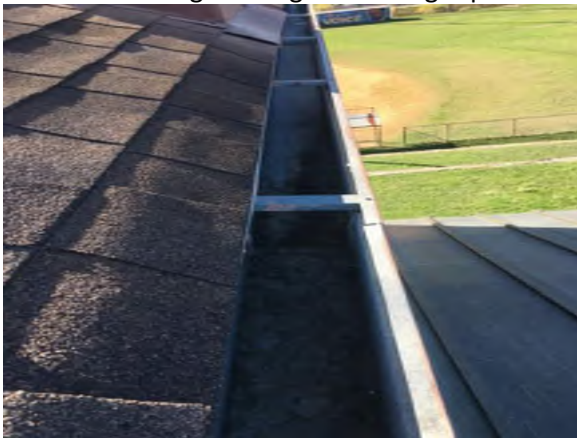
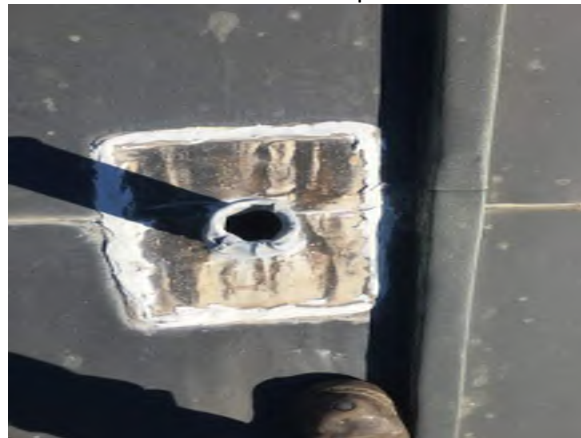
3 Leads needing replaced with new pipe boots.
Next (2) pictures as well.

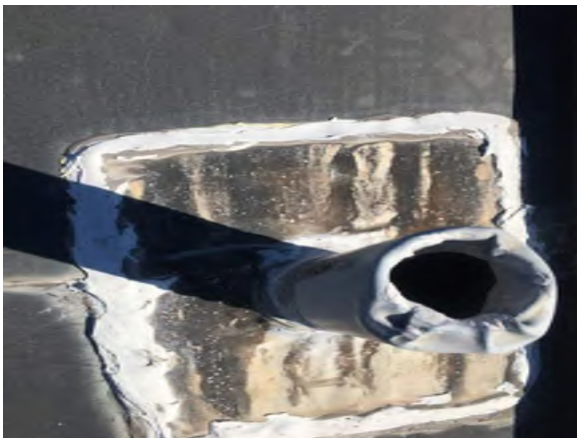
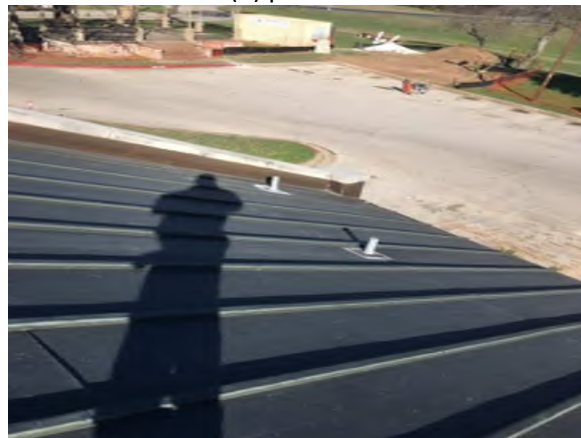
"The Roofing Company by which All Others are Measured."
Thank you for your business!

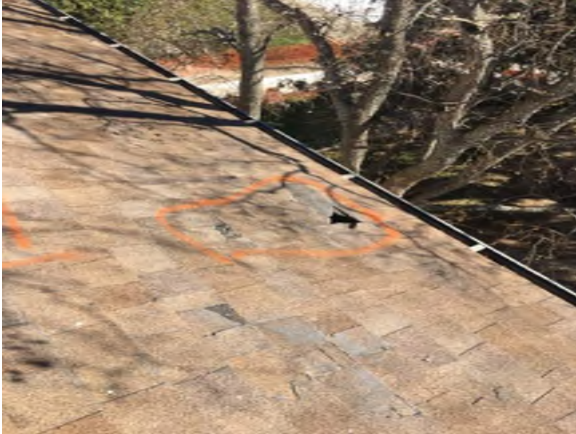
Damaged area marked.

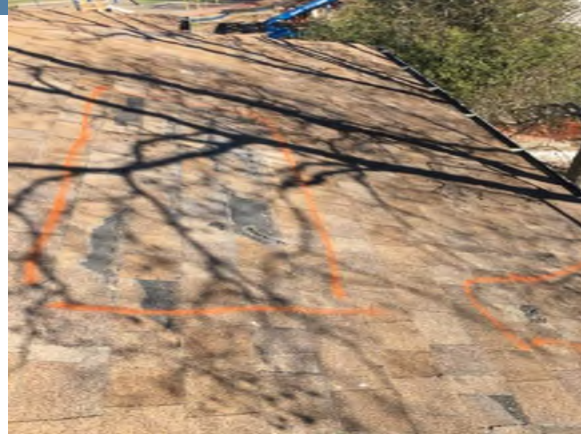
Shingle area marked.

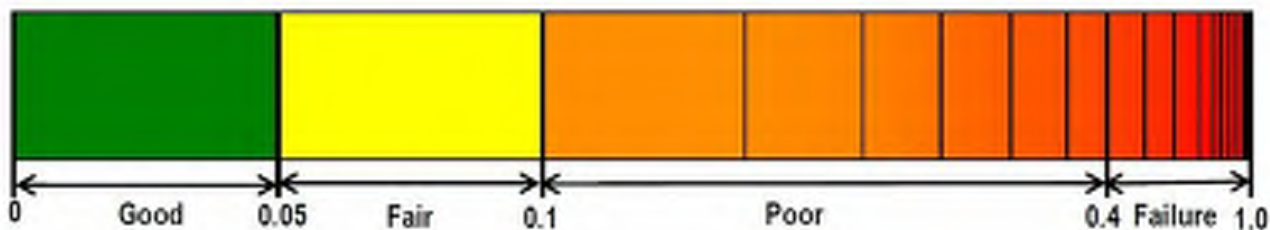
Therefore, the lower the FCI, the lower the need for remedial or renewal funding relative to the facility’s value. For example, an FCI of 0.07 signifies a 7% deficiency ratio which is generally considered to be in the fair range. An FCI of 0.7 means that 70% of the building needs extensive repairs or replacement. The FCI is a relative indicator of condition and should be tracked over time to maximize its benefit.

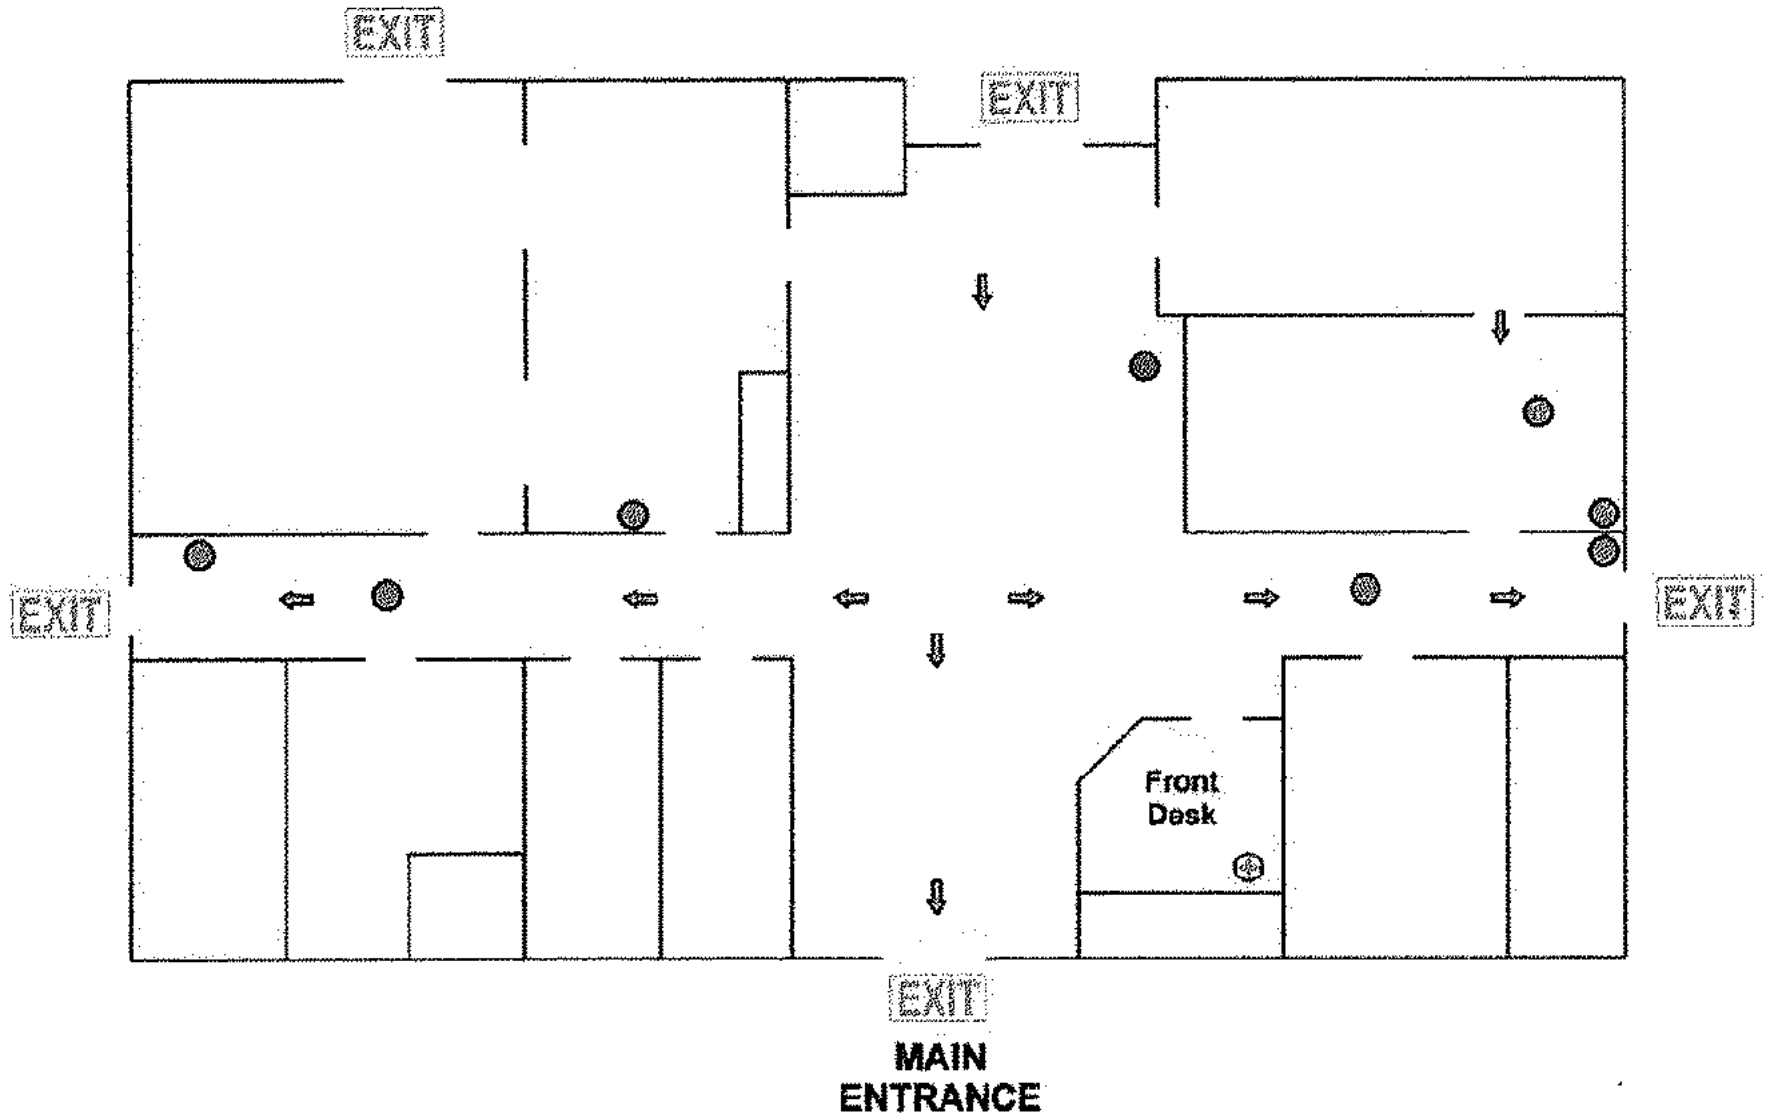
Tippin, Lisa @ Oklahoma City

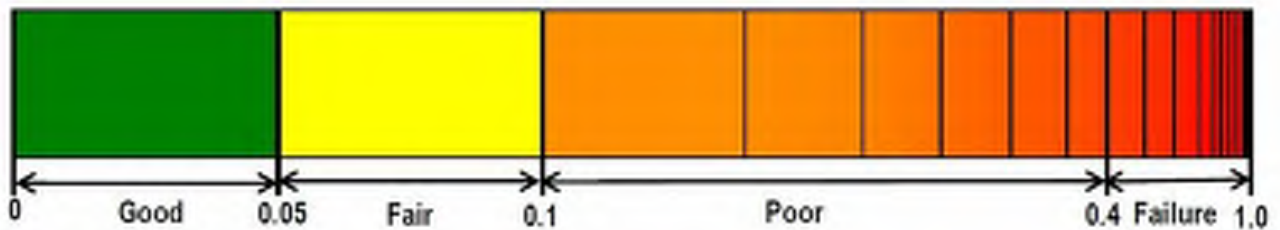
Therefore, the lower the FCI, the lower the need for remedial or renewal funding relative to the facility's value. For example, an FCI of 0.07 signifies a 7% deficiency ratio which is generally considered to be in the fair range. An FCI of 0.7 means that 70% of the building needs extensive repairs or replacement. The FCI is a relative indicator of condition and should be tracked over time to maximize its benefit.

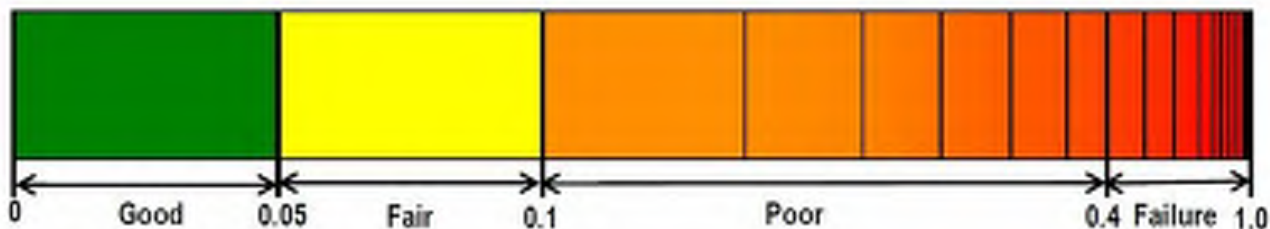
Therefore, the lower the FCI, the lower the need for remedial or renewal funding relative to the facility's value. For example, an FCI of 0.07 signifies a 7% deficiency ratio which is generally considered to be in the fair range. An FCI of 0.7 means that 70% of the building needs extensive repairs or replacement. The FCI is a relative indicator of condition and should be tracked over time to maximize its benefit.

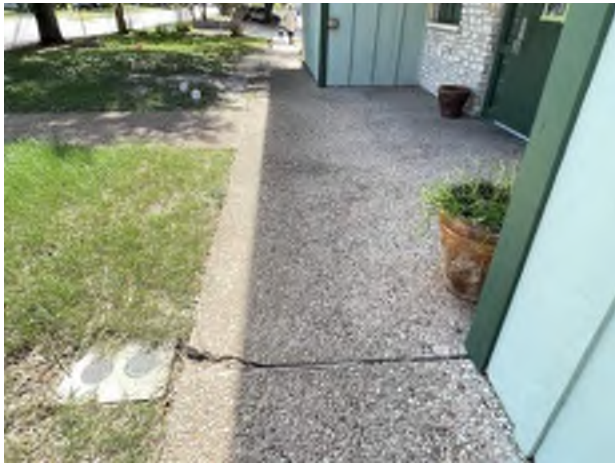
3. Cracked walkway - north side

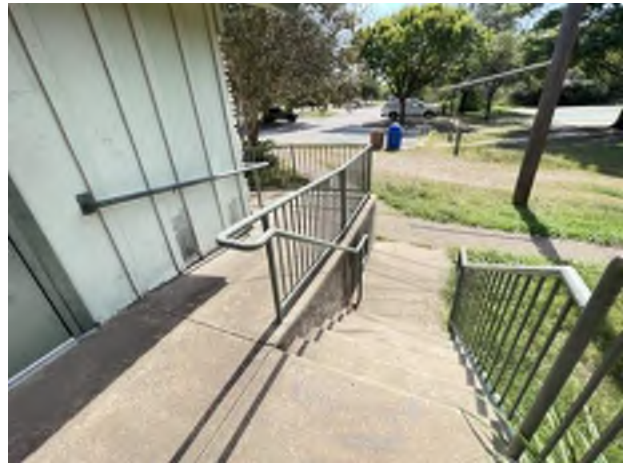
4. Exterior stairs and ramp

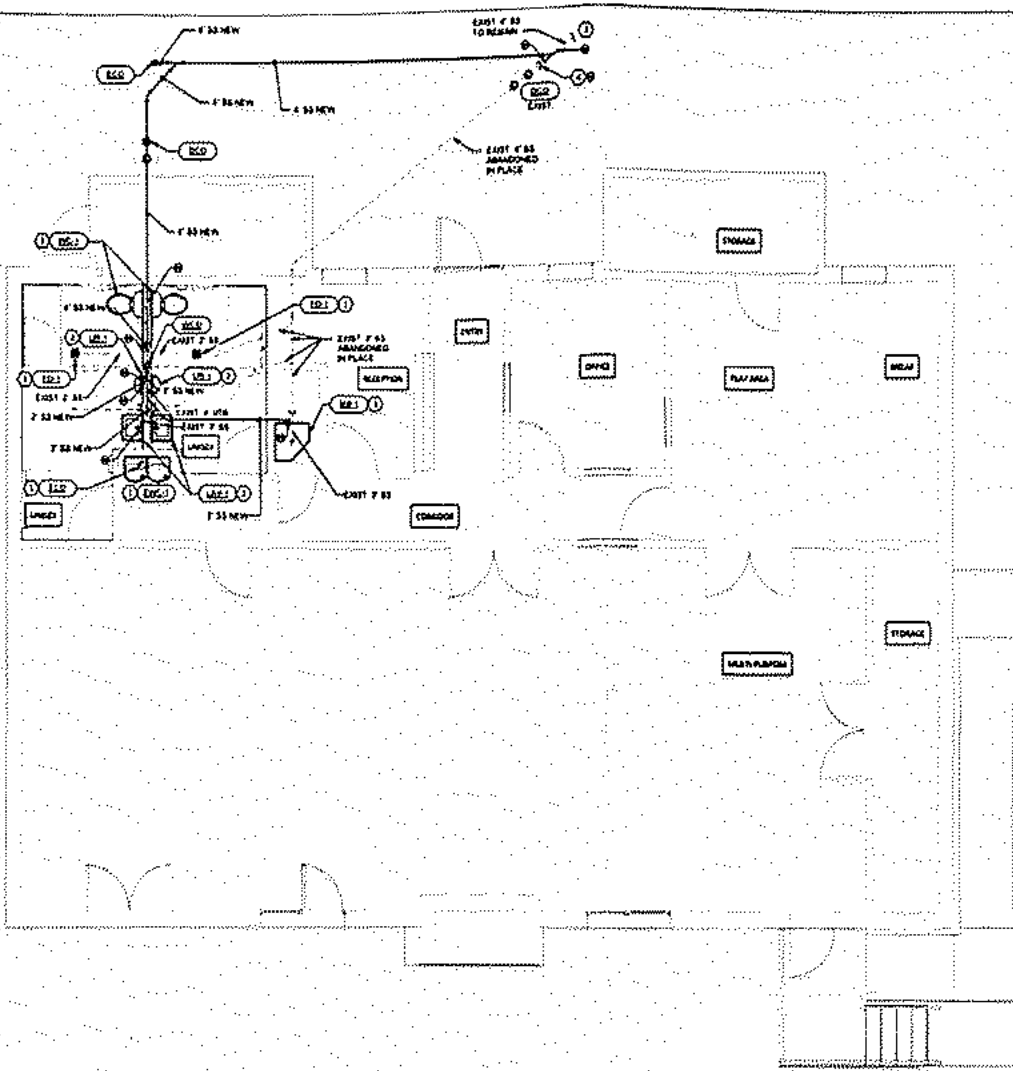
Supplementary Documentation

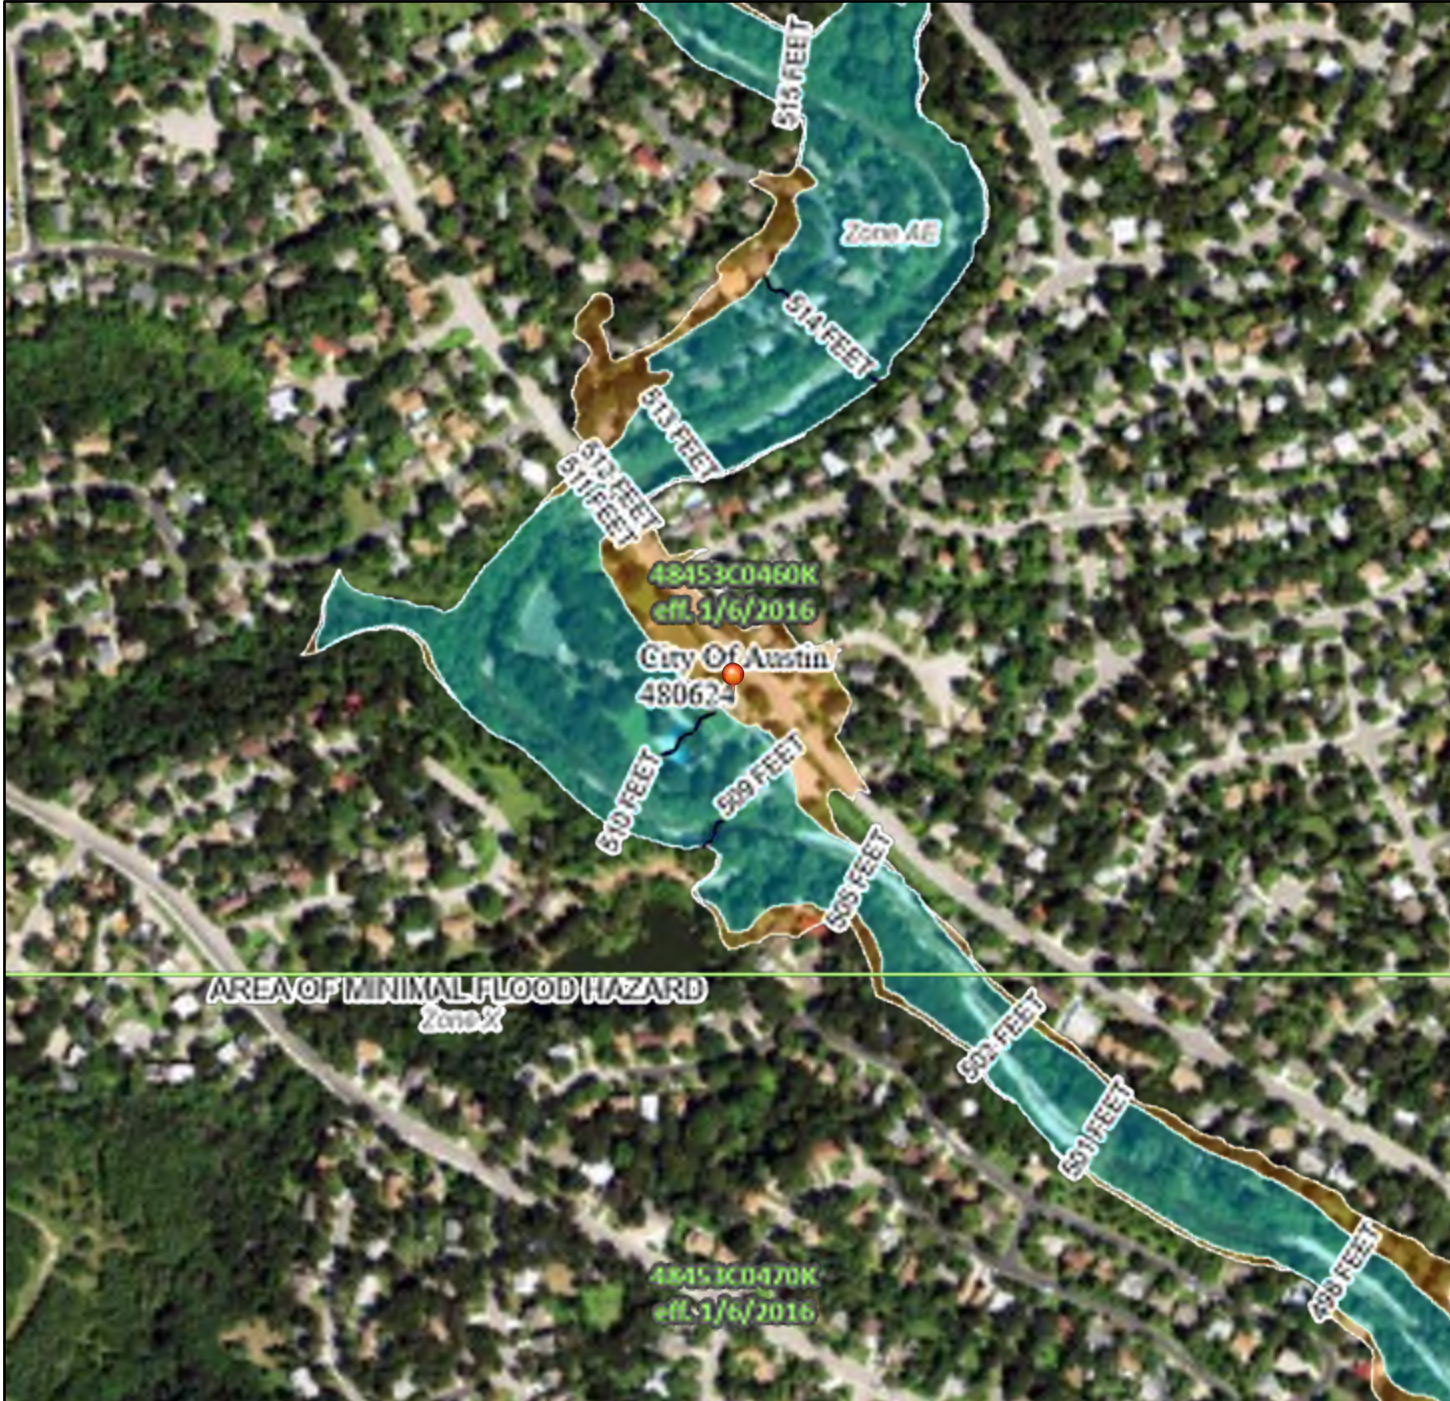
MINIMAL FLOOD HAZARD MAP

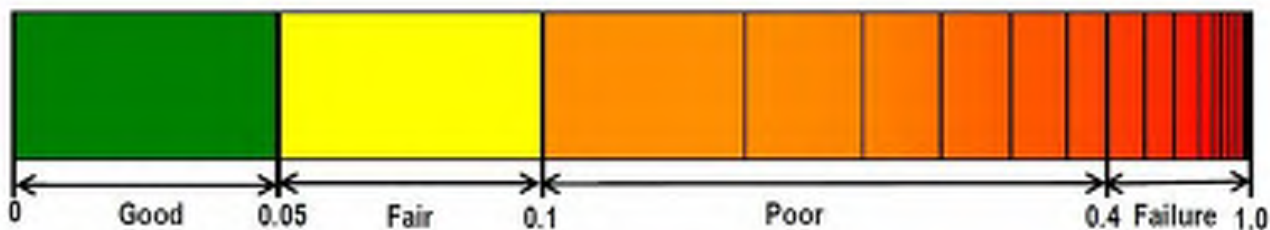
Therefore, the lower the FCI, the lower the need for remedial or renewal funding relative to the facility's value. For example, an FCI of 0.07 signifies a 7% deficiency ratio which is generally considered to be in the fair range. An FCI of 0.7 means that 70% of the building needs extensive repairs or replacement. The FCI is a relative indicator of condition and should be tracked over time to maximize its benefit.
