Appendix C - CBRE Condition Assessments

1. Alamo Recreation Center.....	3
2. Austin Recreation Center.....	83
3. Danny G McBeth Recreation Center.....	156
4. Delores Duffie Recreation Center.....	254

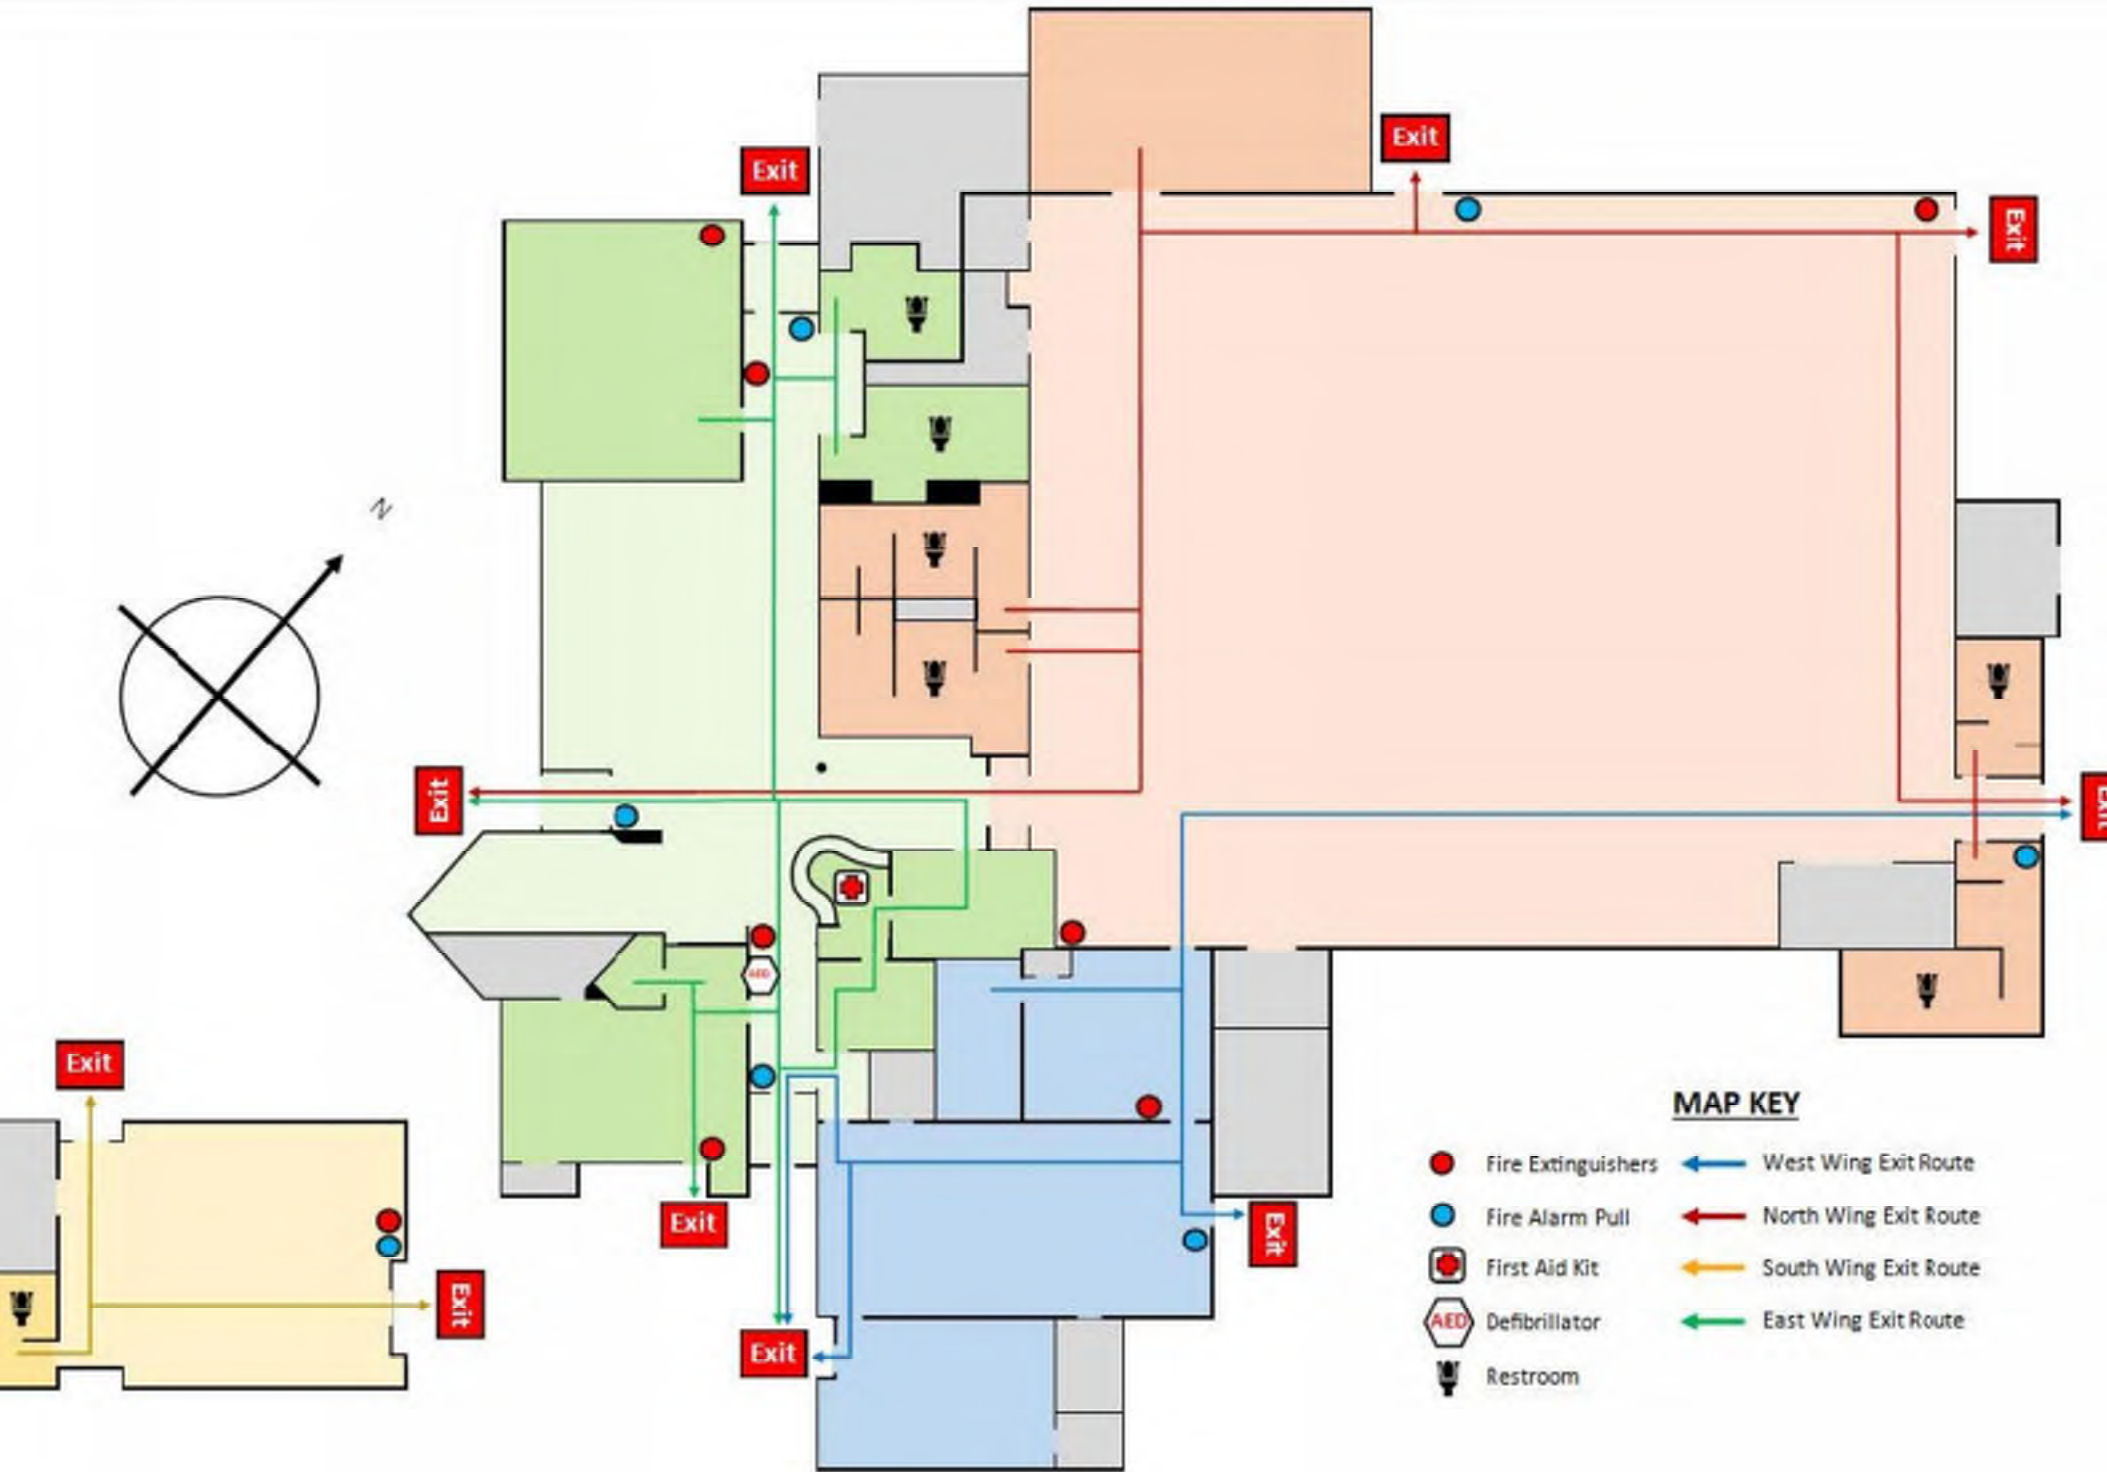
DWLRQD O RRG EPUGDHU) 6VWH

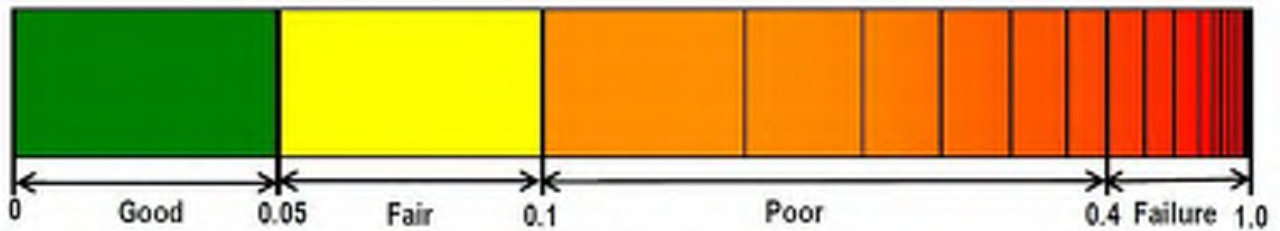
Therefore, the lower the FCI, the lower the need for remedial or renewal funding relative to the facility's value. For example, an FCI of 0.07 signifies a 7% deficiency ratio which is generally considered to be in the fair range. An FCI of 0.7 means that 70% of the building needs extensive repairs or replacement. The FCI is a relative indicator of condition and should be tracked over time to maximize its benefit.

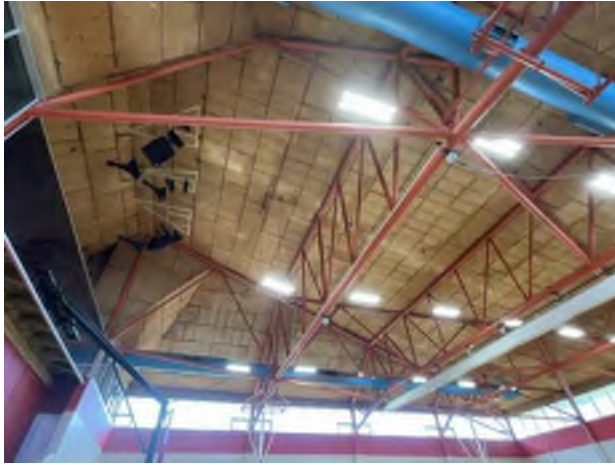
13. Stain Acoustic Panels

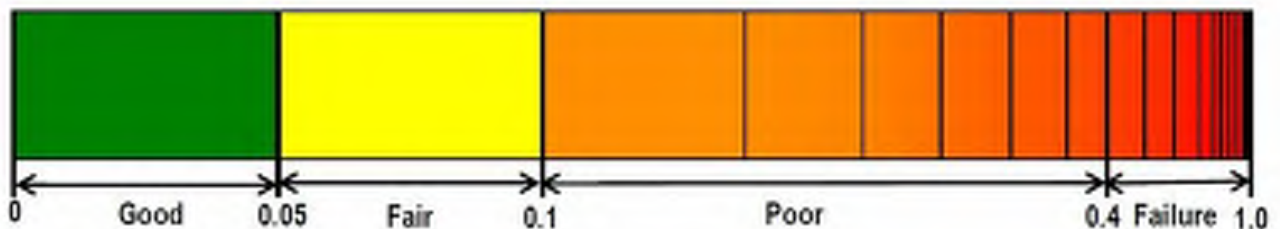
Therefore, the lower the FCI, the lower the need for remedial or renewal funding relative to the facility's value. For example, an FCI of 0.07 signifies a 7% deficiency ratio which is generally considered to be in the fair range. An FCI of 0.7 means that 70% of the building needs extensive repairs or replacement. The FCI is a relative indicator of condition and should be tracked over time to maximize its benefit.

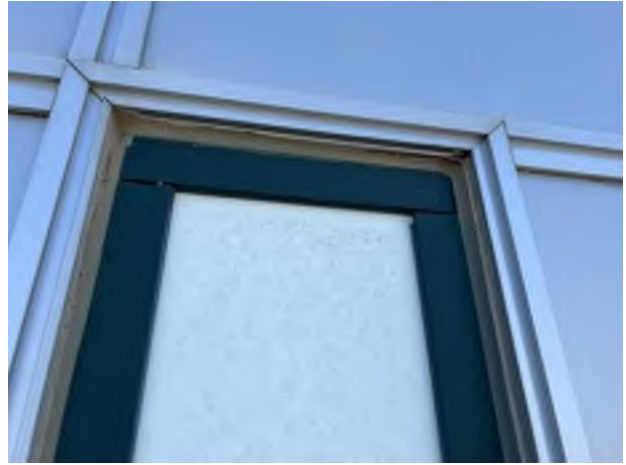
8. Failing Clerestory Window Sealant

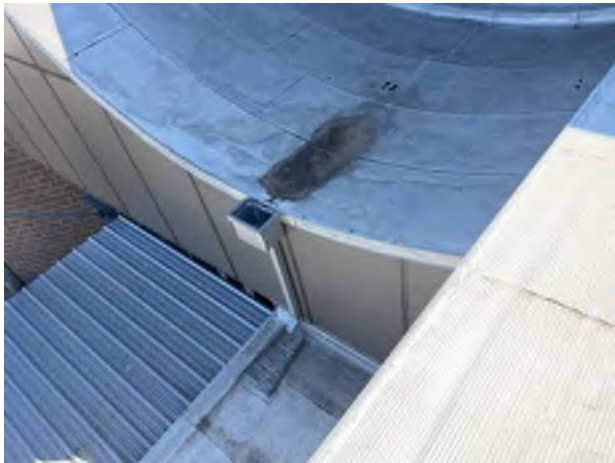
9. Ponding at the Curved Eyebrow Roof

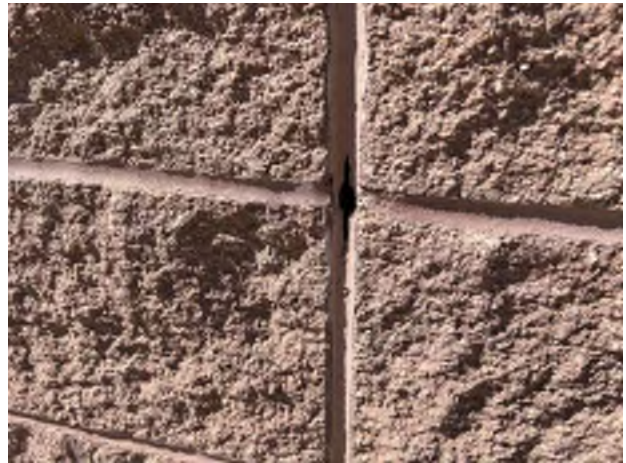
10. Failing Building Expansion Joint

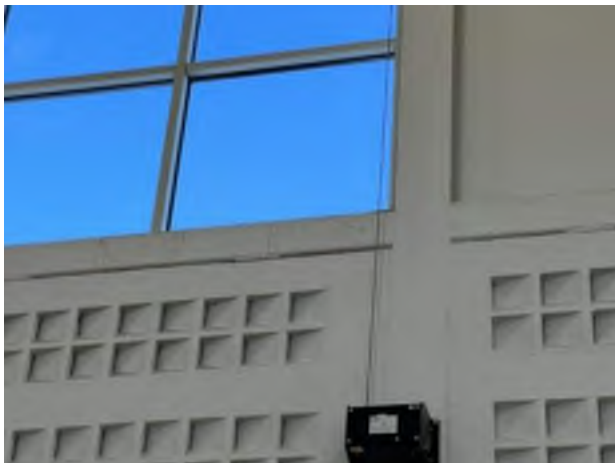
27. Gym Windows-Water Infiltration

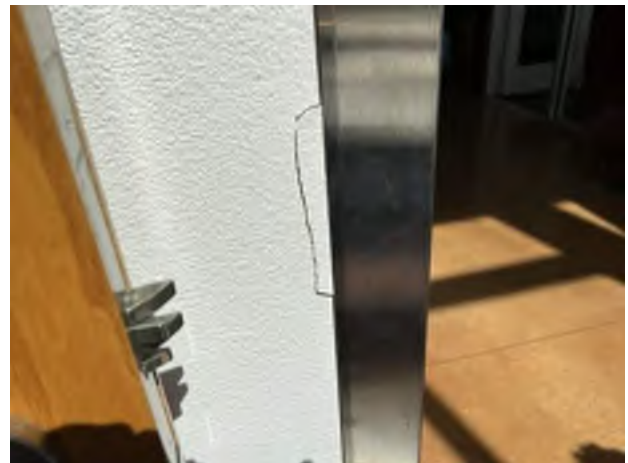
28. Damage at Entry/Exit Door

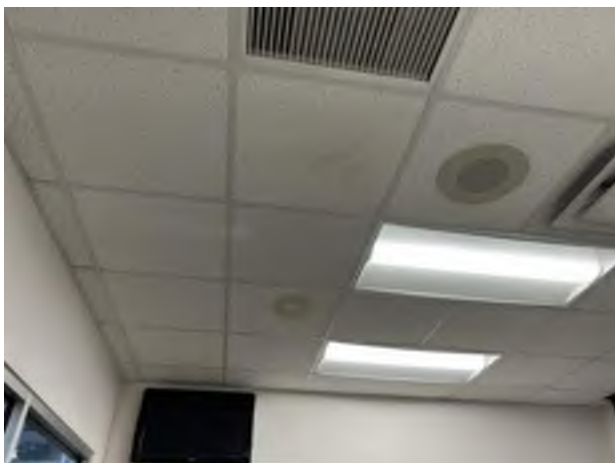
29. Water Staining at ACT in Office 102

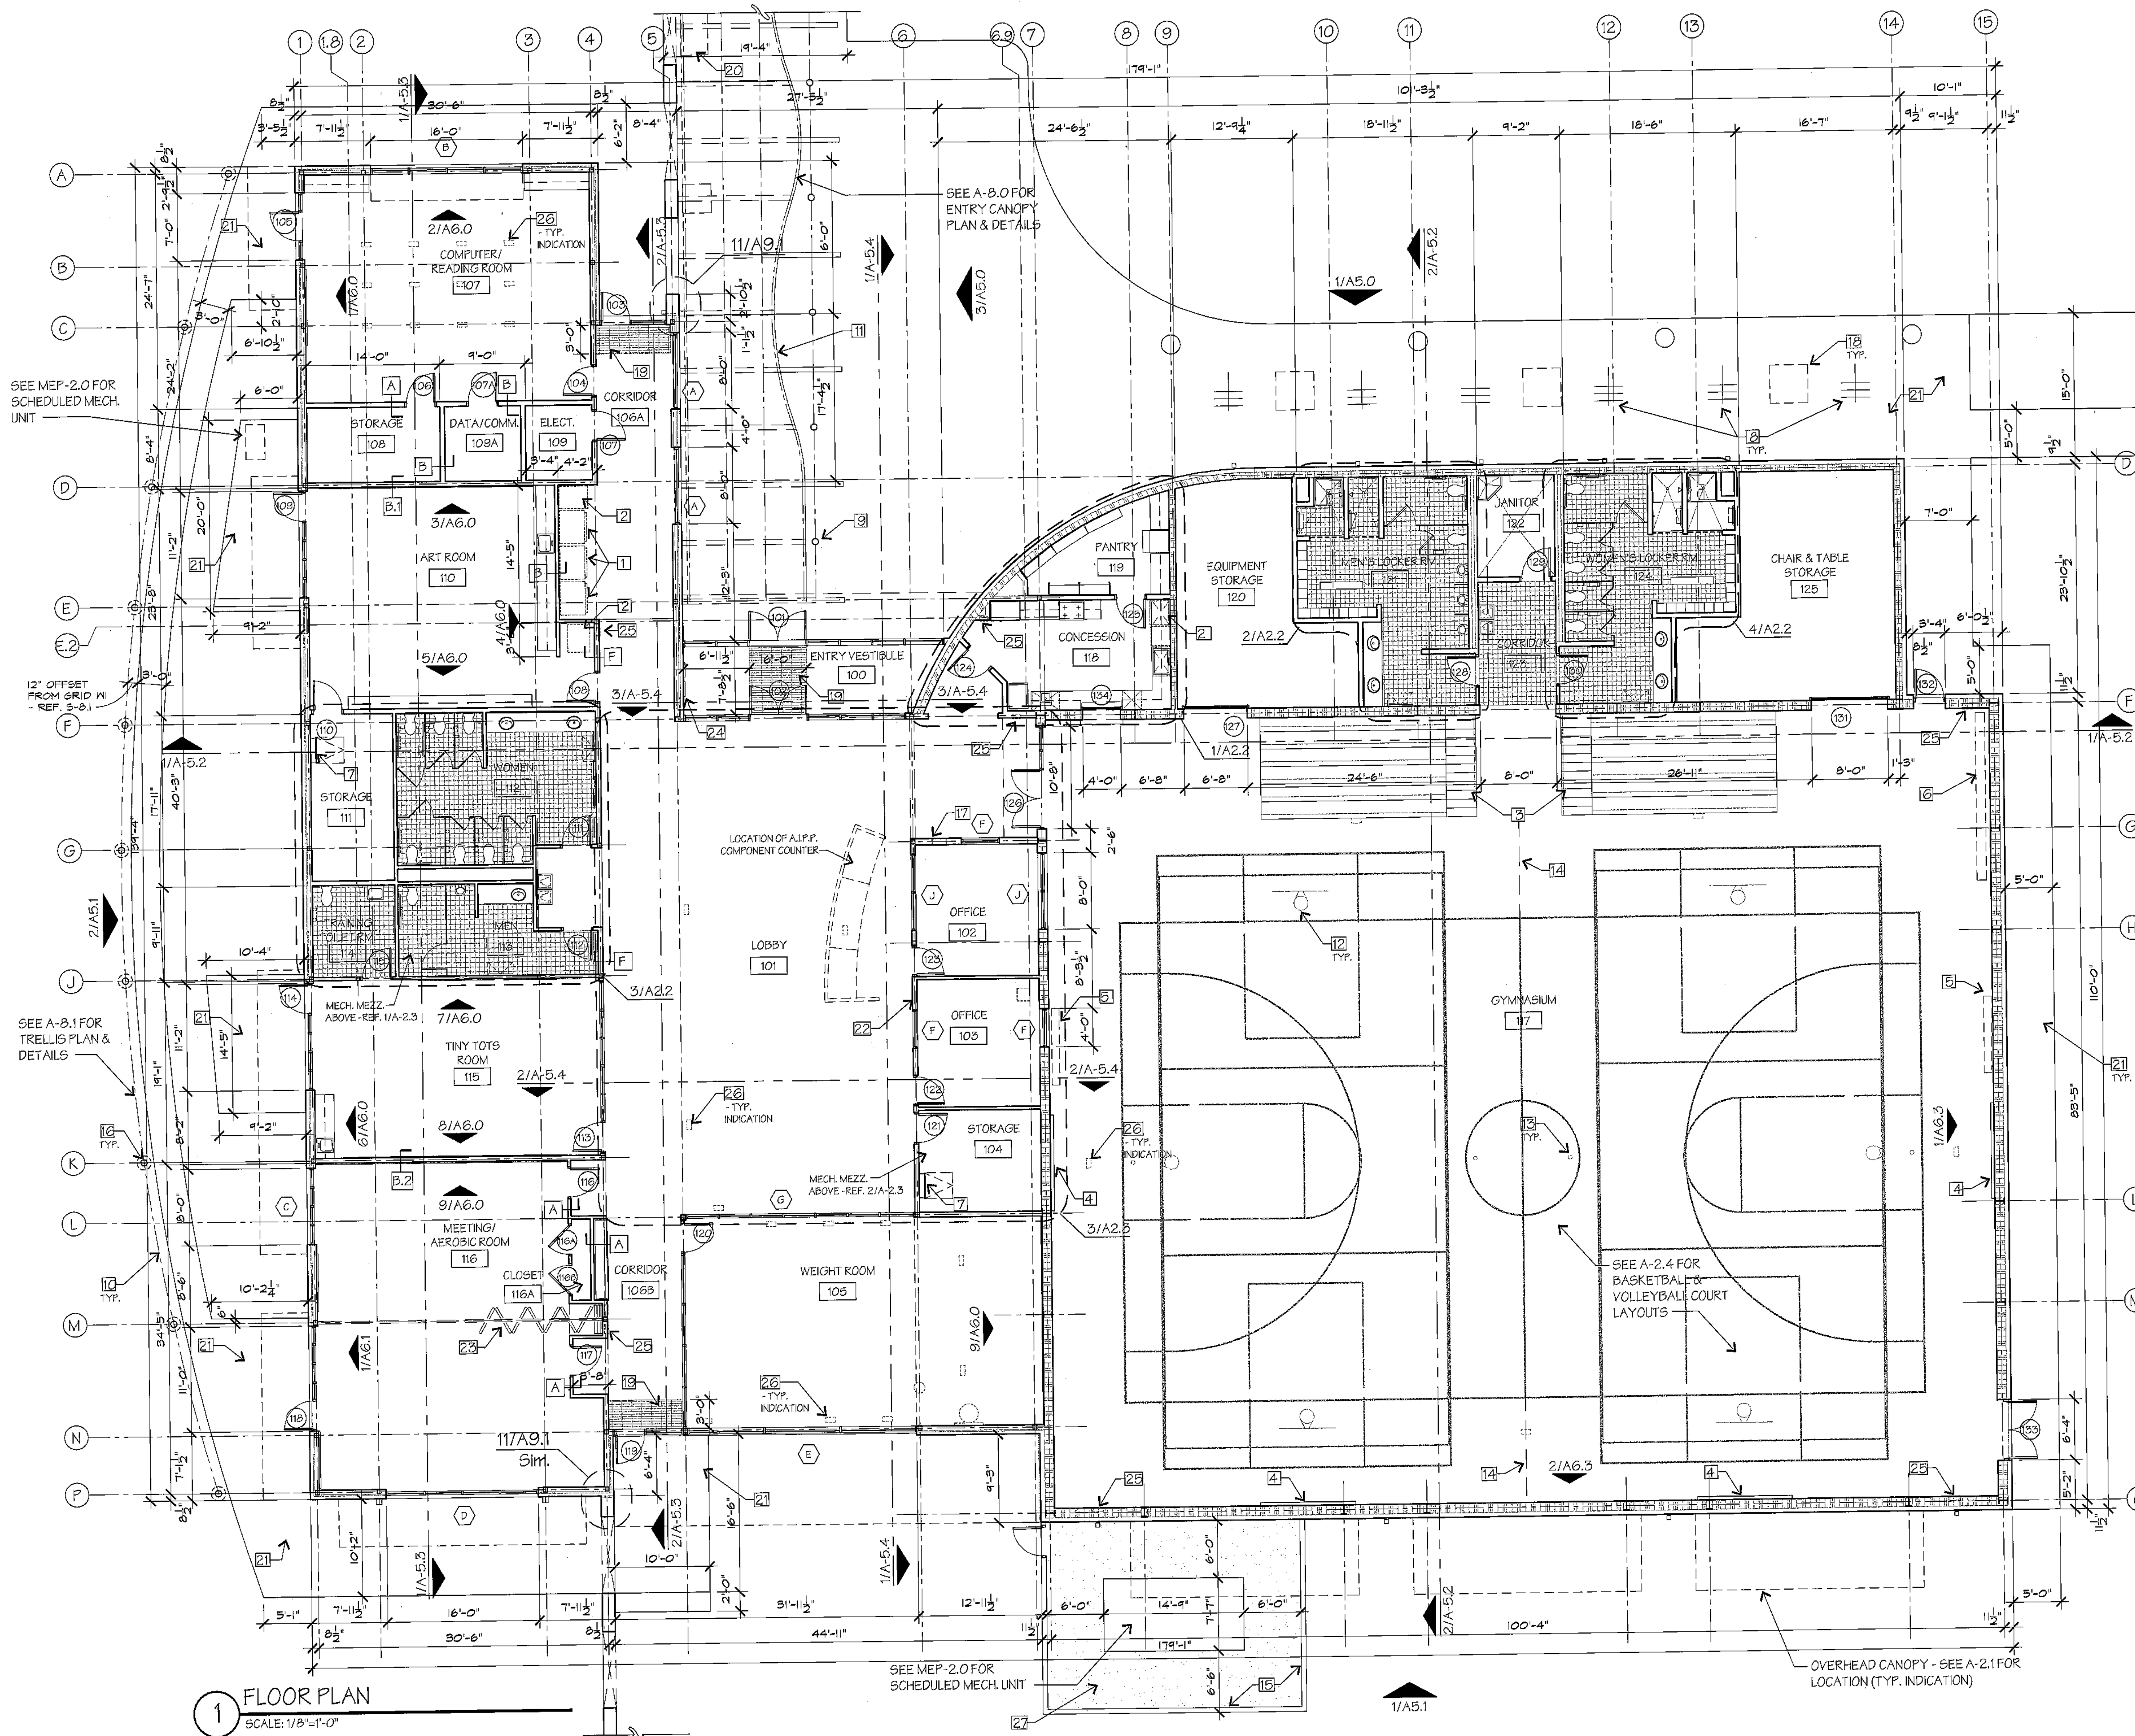
- KEY NOTES:**
- 1 VENDING MACHINES BY OWNER.
 - 2 RECYCLE BINS (1 EACH FOR ALUMINUM, PAPER, AND PLASTIC) BY OWNER.
 - 3 PORTABLE BLEACHERS, 6 ROWS OF SEATS, 13 PEOPLE PER ROW, 78 SEATS PER BLEACHER.

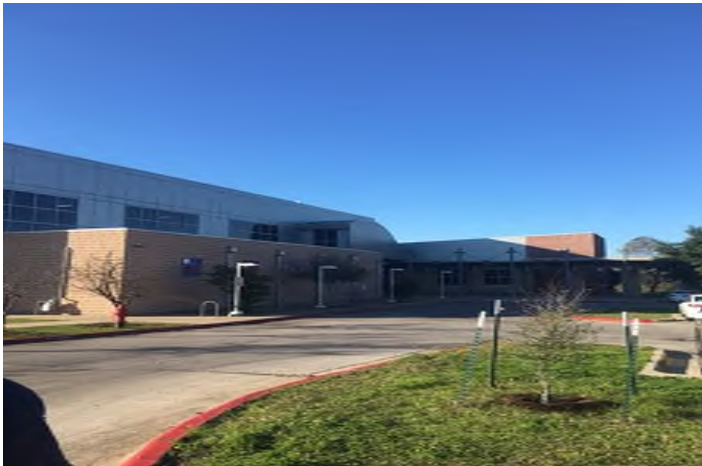
Please make all checks payable to:

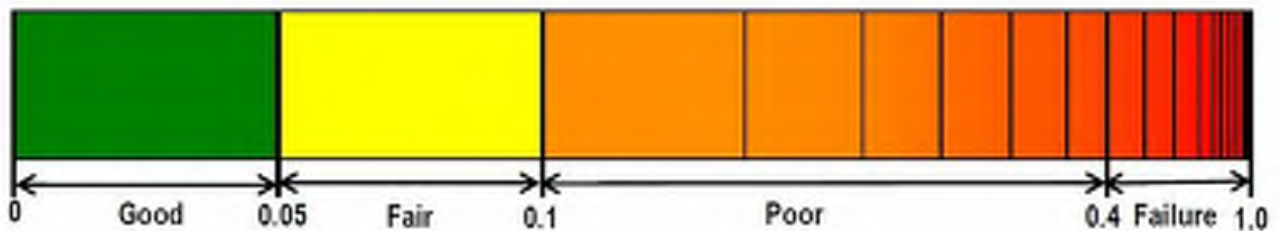
Therefore, the lower the FCI, the lower the need for remedial or renewal funding relative to the facility's value. For example, an FCI of 0.07 signifies a 7% deficiency ratio which is generally considered to be in the fair range. An FCI of 0.7 means that 70% of the building needs extensive repairs or replacement. The FCI is a relative indicator of condition and should be tracked over time to maximize its benefit.

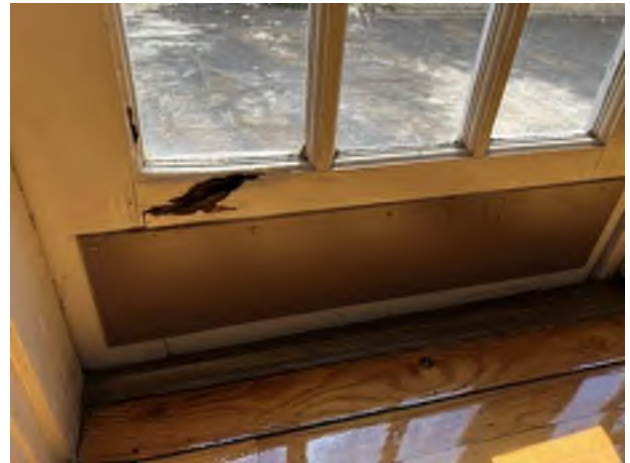
10. Damaged exterior door

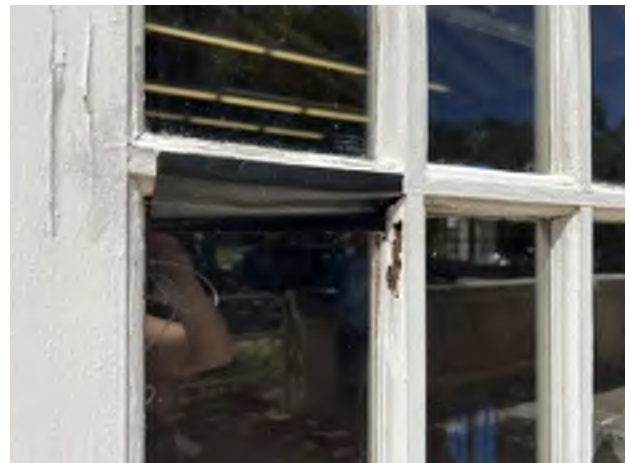
12. Broken glass pane at exterior door

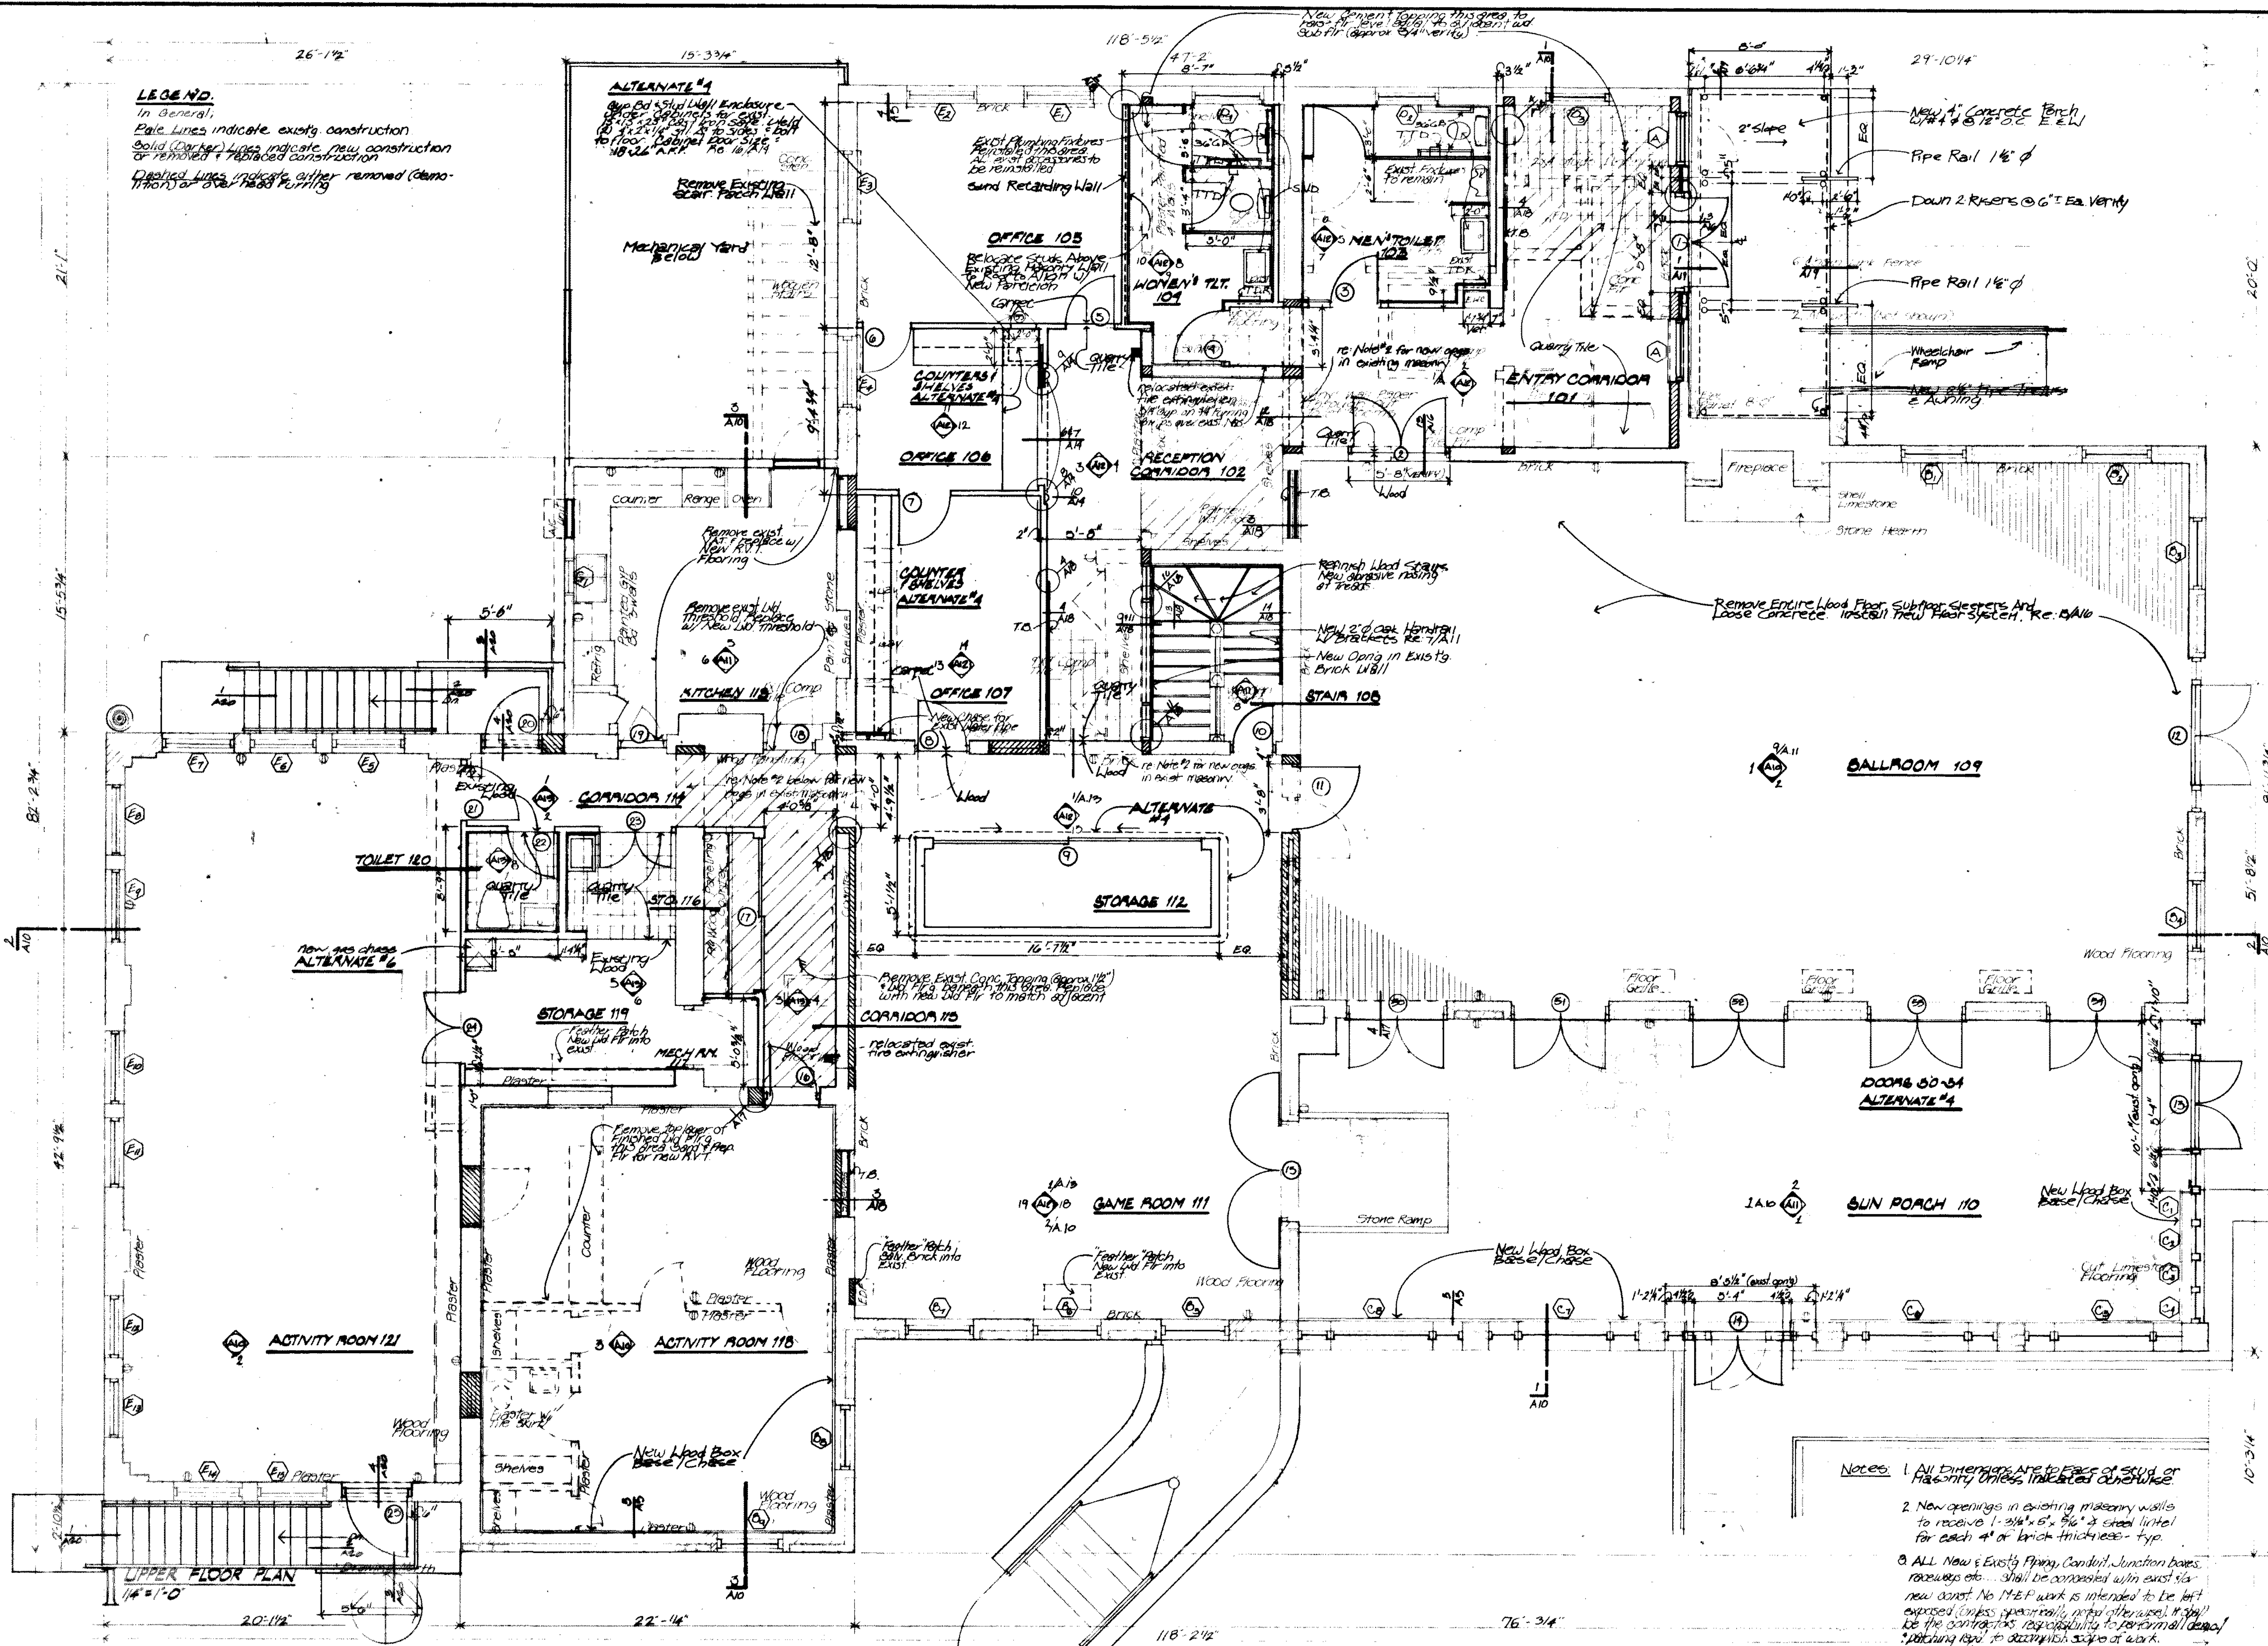
In General:
Pale Lines indicate existing construction
Solid (Darker) Lines indicate new construction
or removed + replaced construction
Dashed lines indicate either removed (demo-
ition) or over head piping

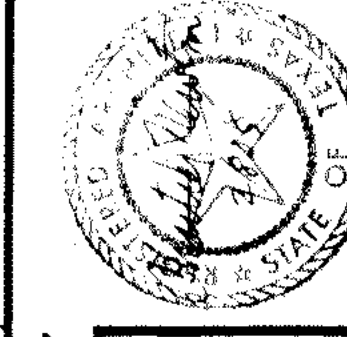
CHARTIER NEWTON & ASSOCIATES · ARCHITECTS · Courtyard at 208 West 4th Street, Austin, Texas 78701 · 512/474-1197
HANCOCK RECREATION CENTER
C.I.P. Project Number 867261
for the City of Austin
811 East 41st Street

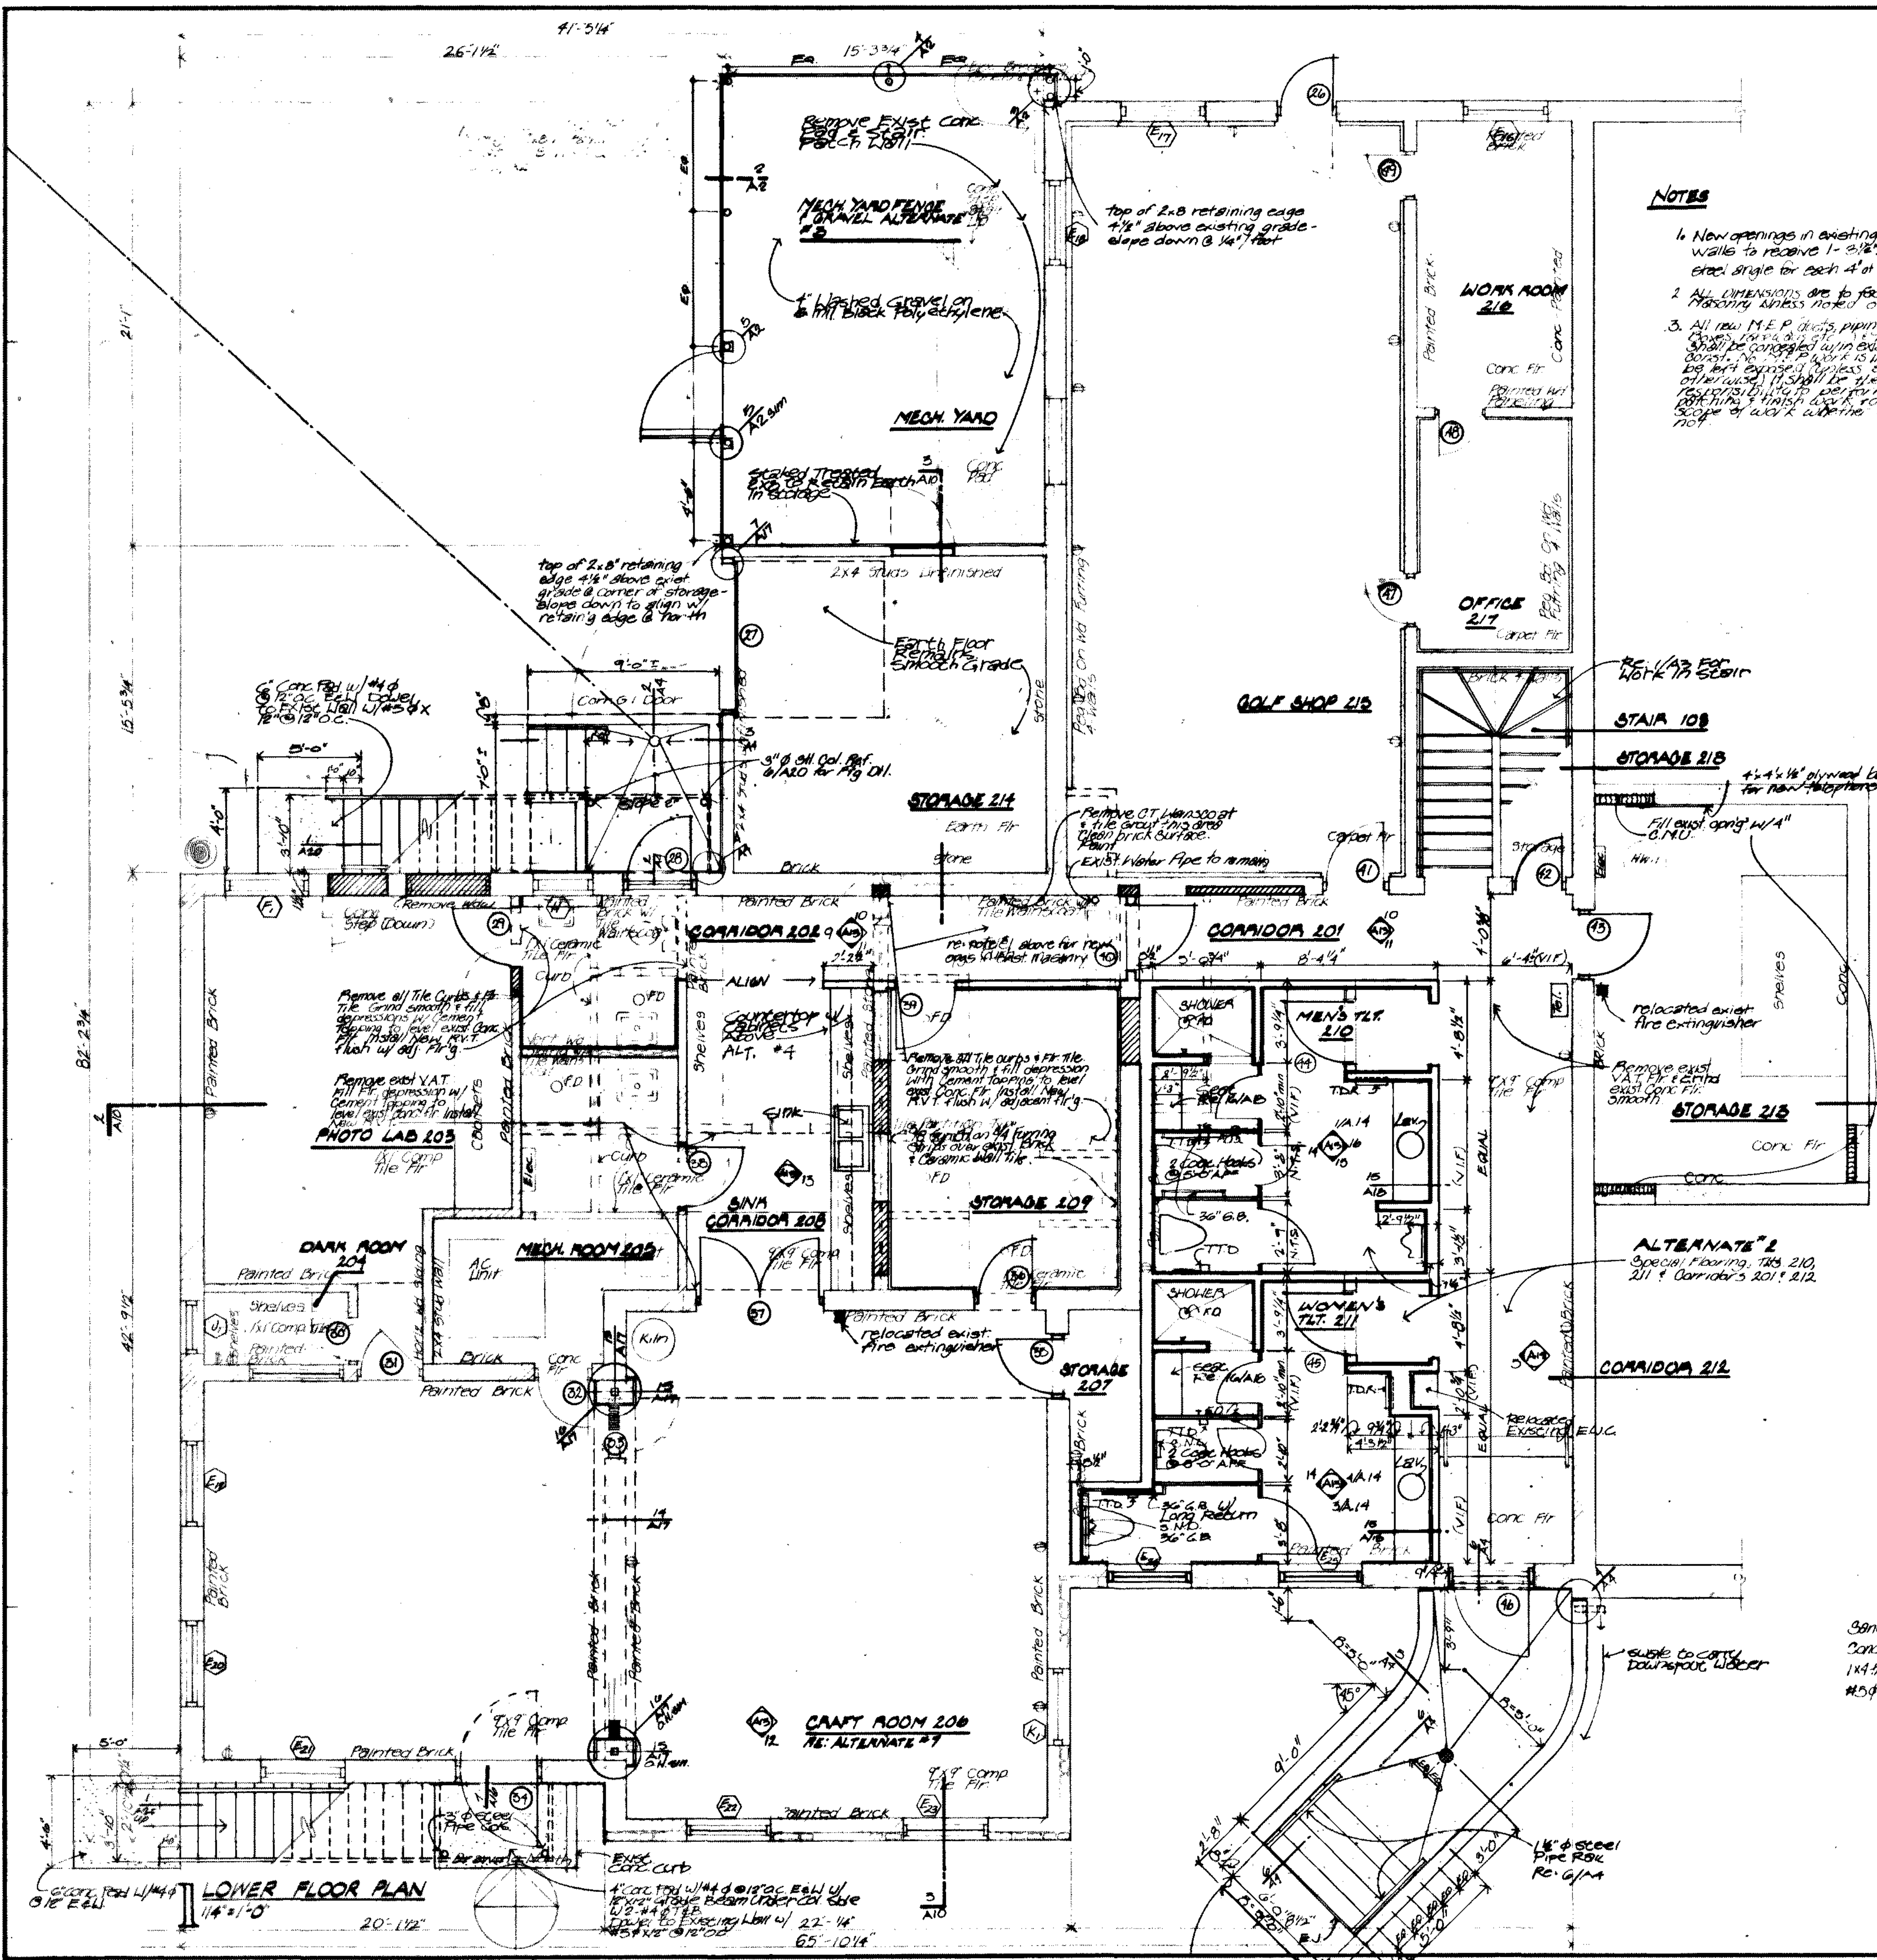
SHEET NO.
A3
OF 20 SHEETS
T-1463
