Appendix C - CBRE Condition Assessments

1. Alamo Recreation Center.....	3
2. Austin Recreation Center.....	83
3. Danny G McBeth Recreation Center.....	156
4. Delores Duffie Recreation Center.....	254

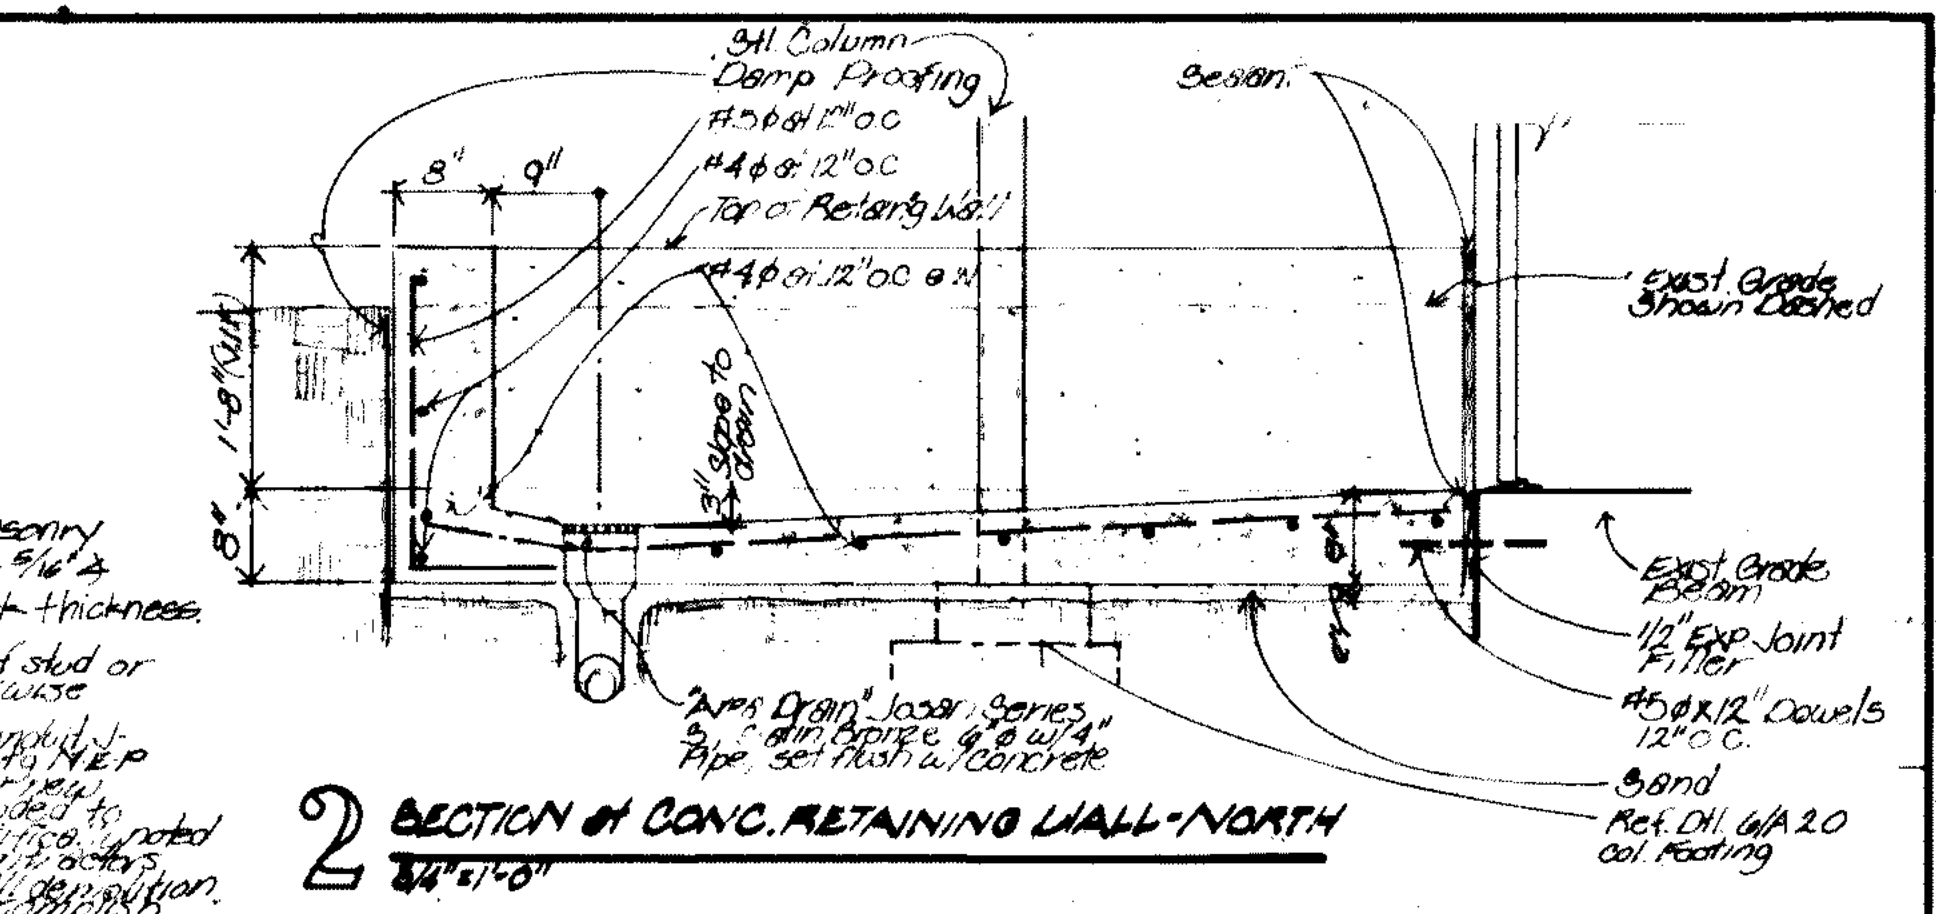
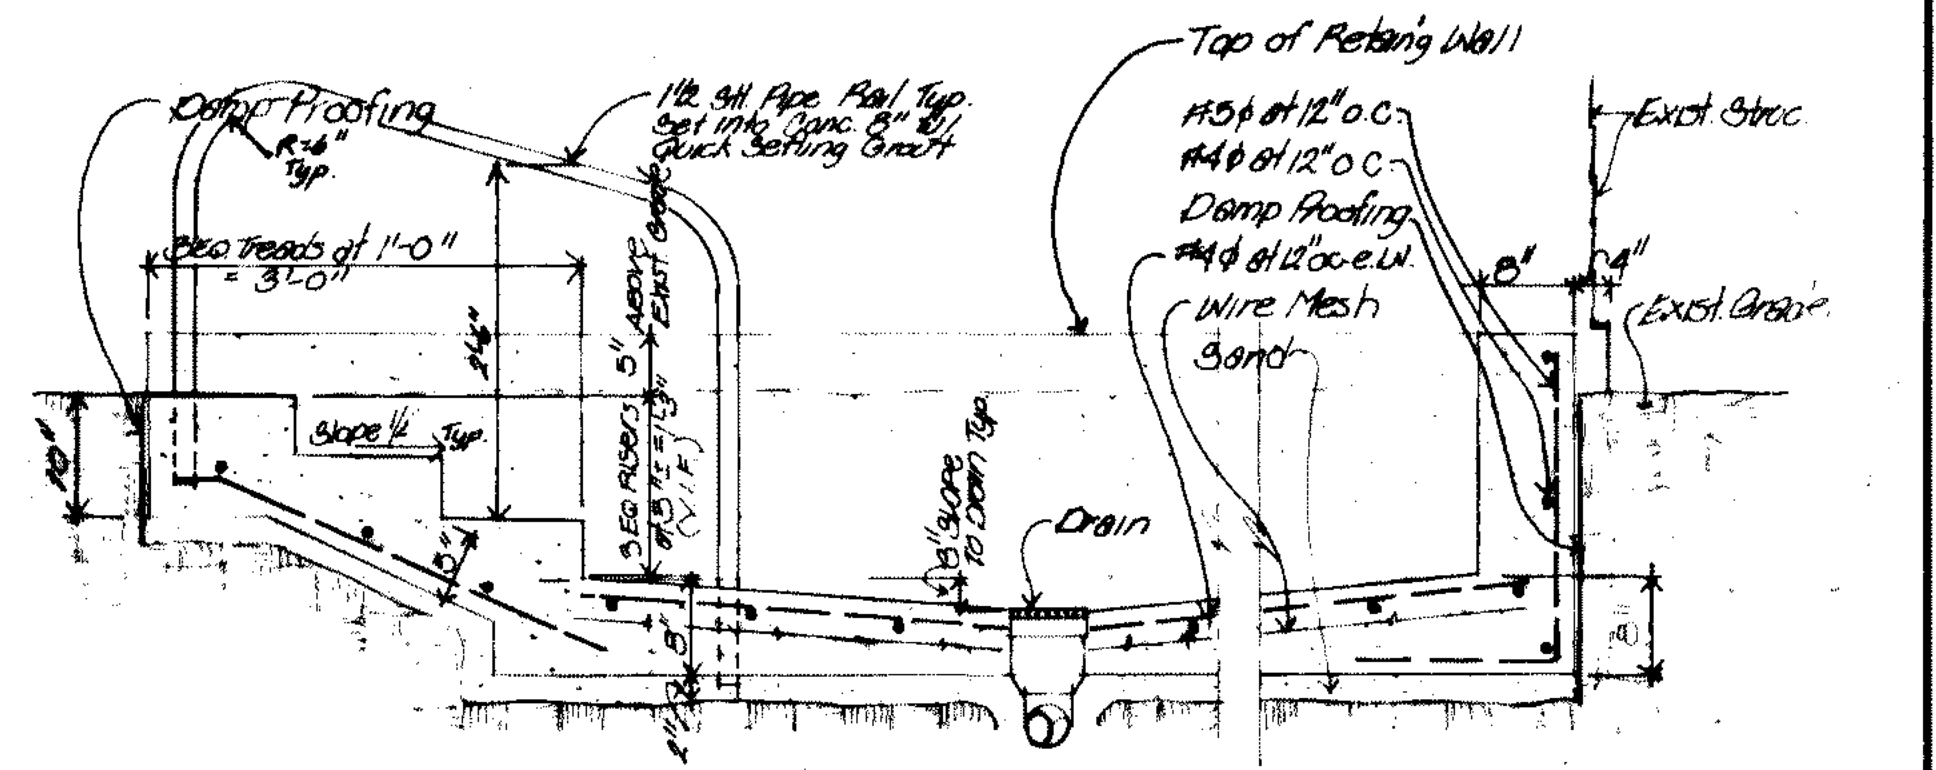
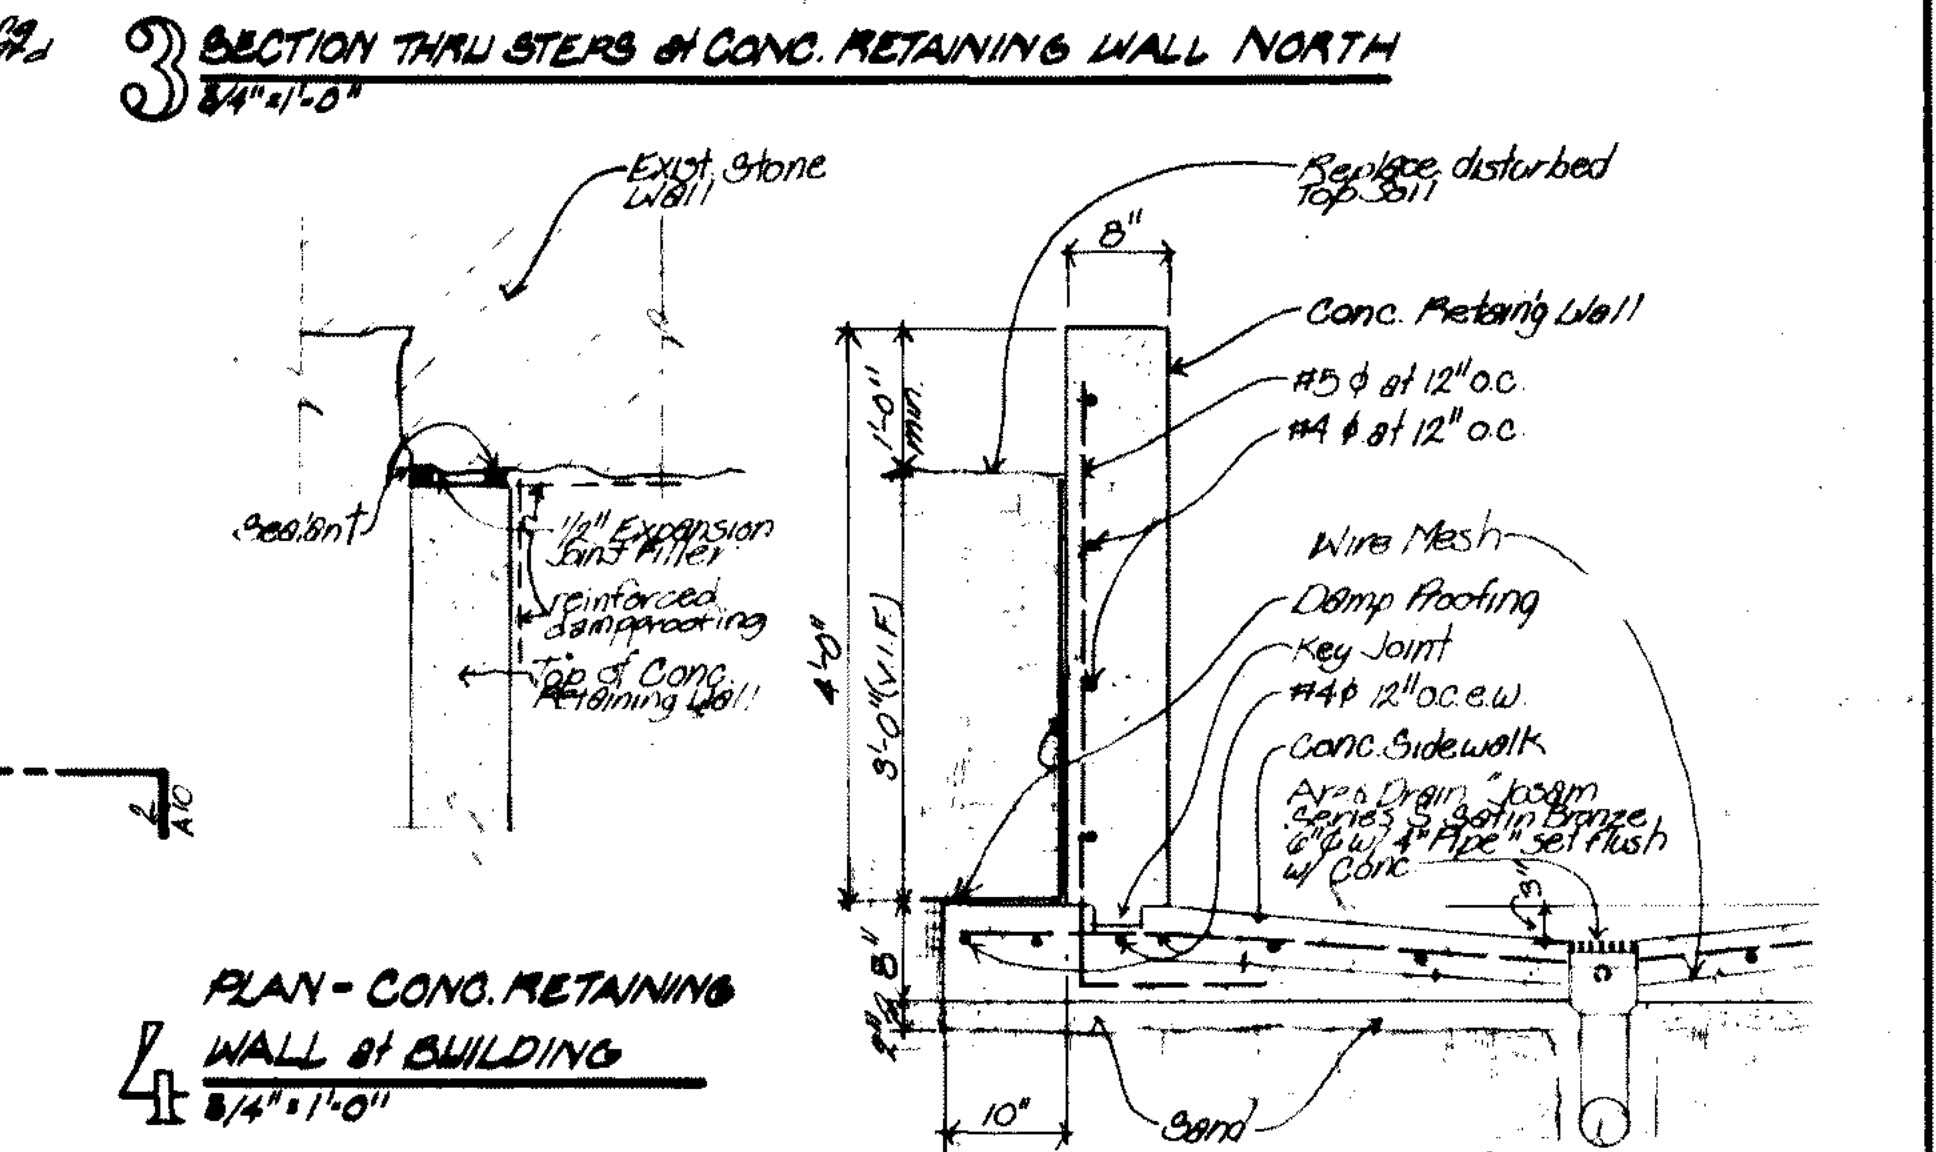
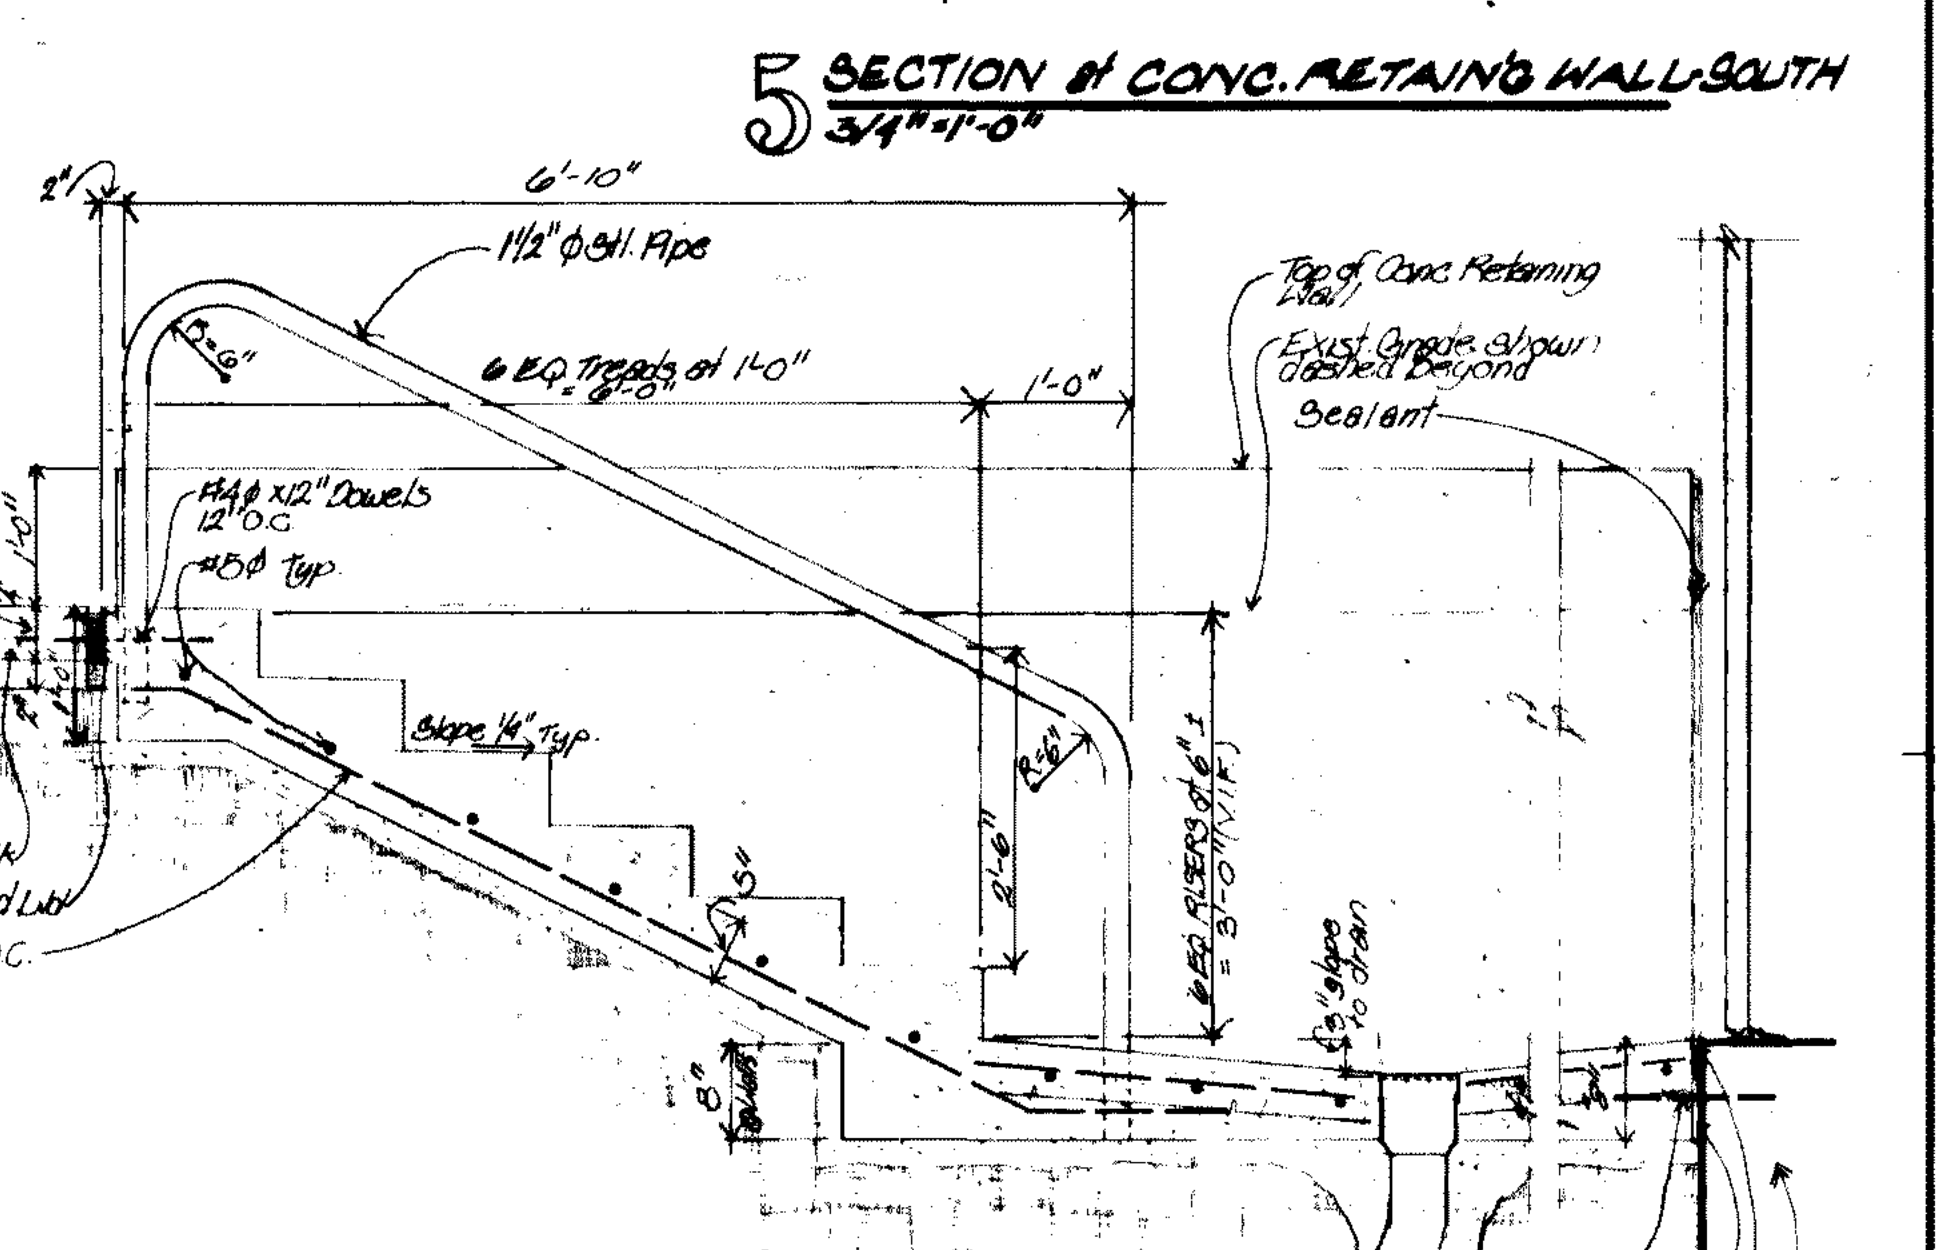
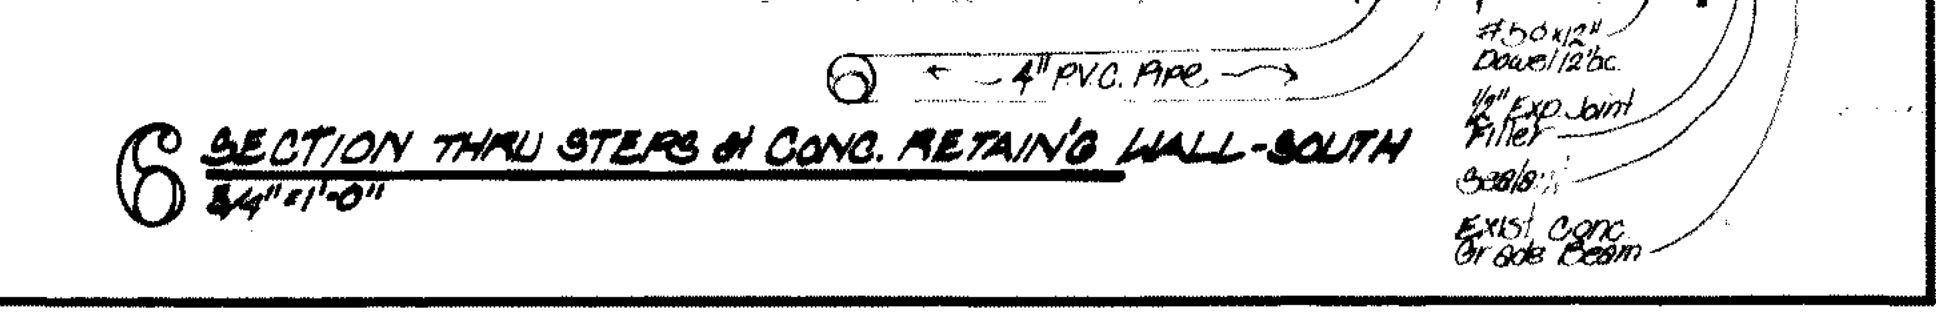
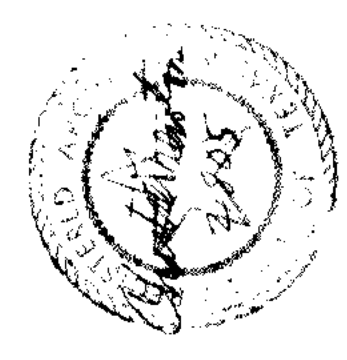
CHARTIER-NEWTON & ASSOCIATES - ARCHITECTS - Courtyard at 208 West 4th Street, Austin, Texas 78701 - 512 474-1197

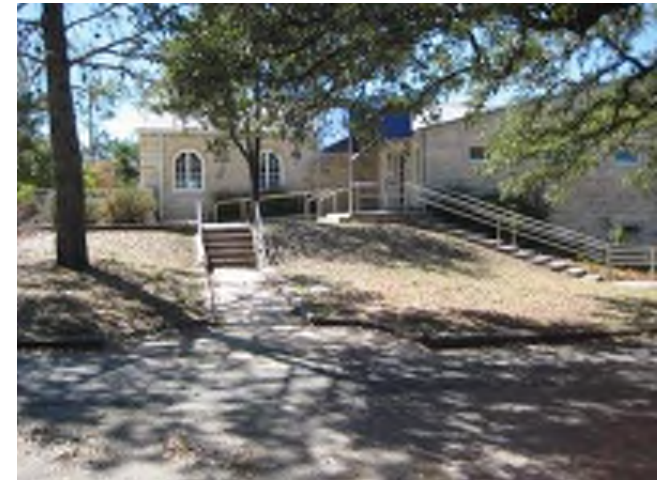
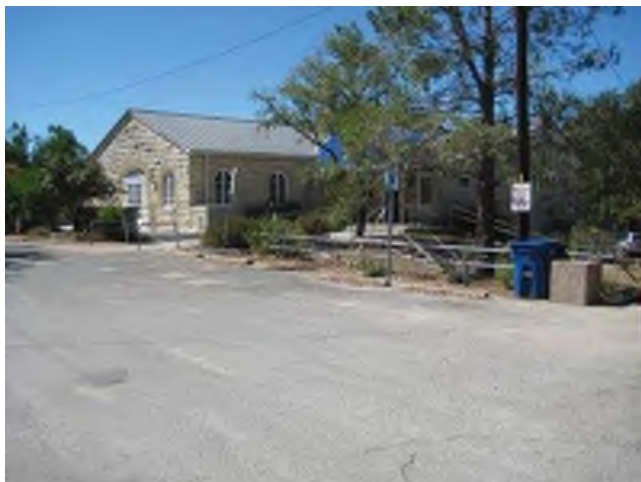
From October 2011 to May 2012 the building and site were visited and analyzed by our Landscape Architect, Civil Engineer, MEP Engineer and Structural Engineer, in addition to our Architectural review. Each discipline observed the existing conditions and gave them a rating based on the conditions listed below.

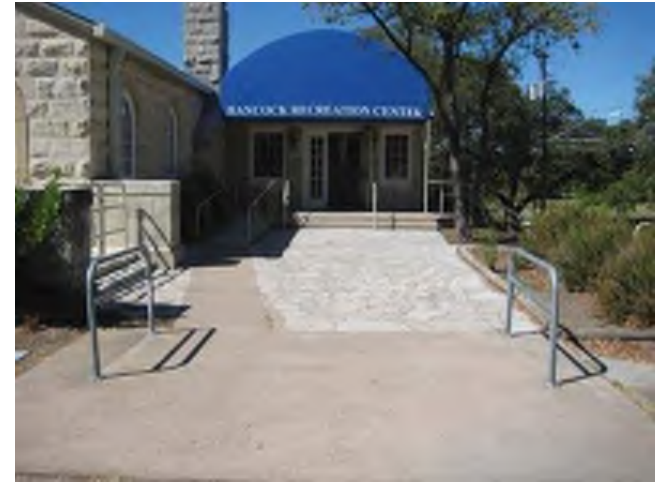
(Condition 4) Does not meet code/does not function properly. These components of the building and site do not meet current building, city, and state codes. These conditions are also hazardous to the facility and its users. Prompt repair is needed for all components within this category.

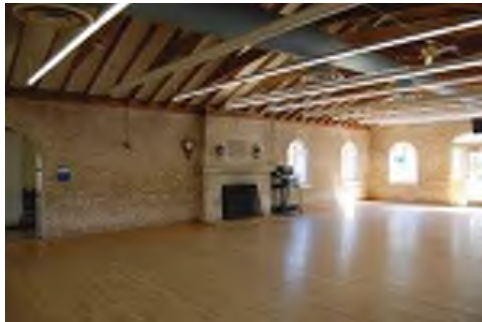
- A1.** The majority of the doors on the interior are not the correct width and do not have ADA compliant hardware. Most do not allow for the correct push and pull clearances that are necessary to comply with the current TAS codes. (Condition 4)
- A2.** The facility does not have TAS compliant drinking fountains. These need to be upgraded. (Condition 4)
- A3.** The lobby on the entrance level could be configured different to be a better use of space. (Condition 2)

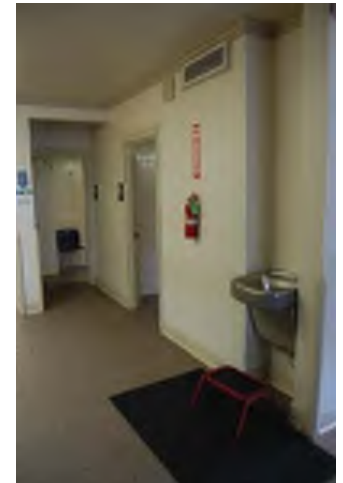
Existing waterfountains.

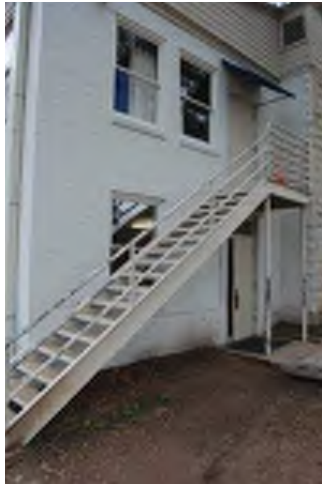
Existing south stair

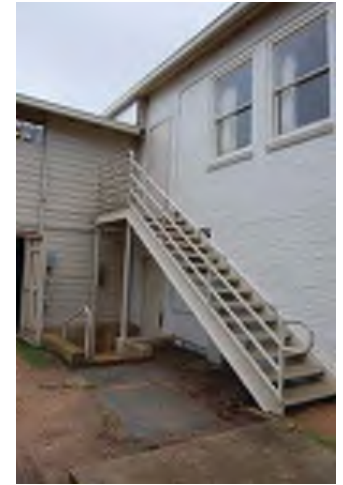
Existing north stair

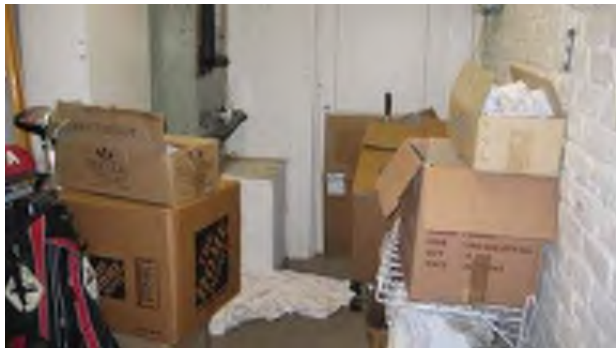
Golf Pro shop office

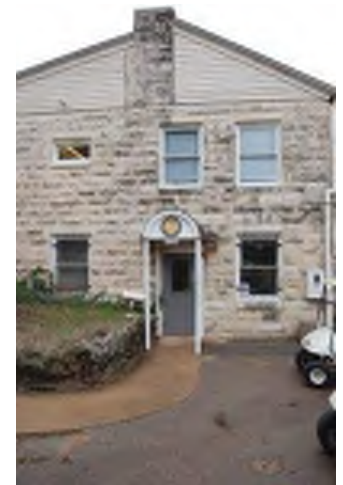
Golf Pro Shop Entrance

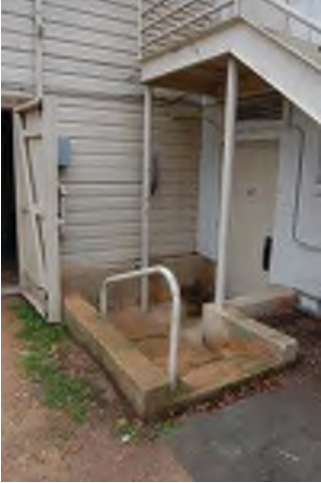
Existing north lower level exit

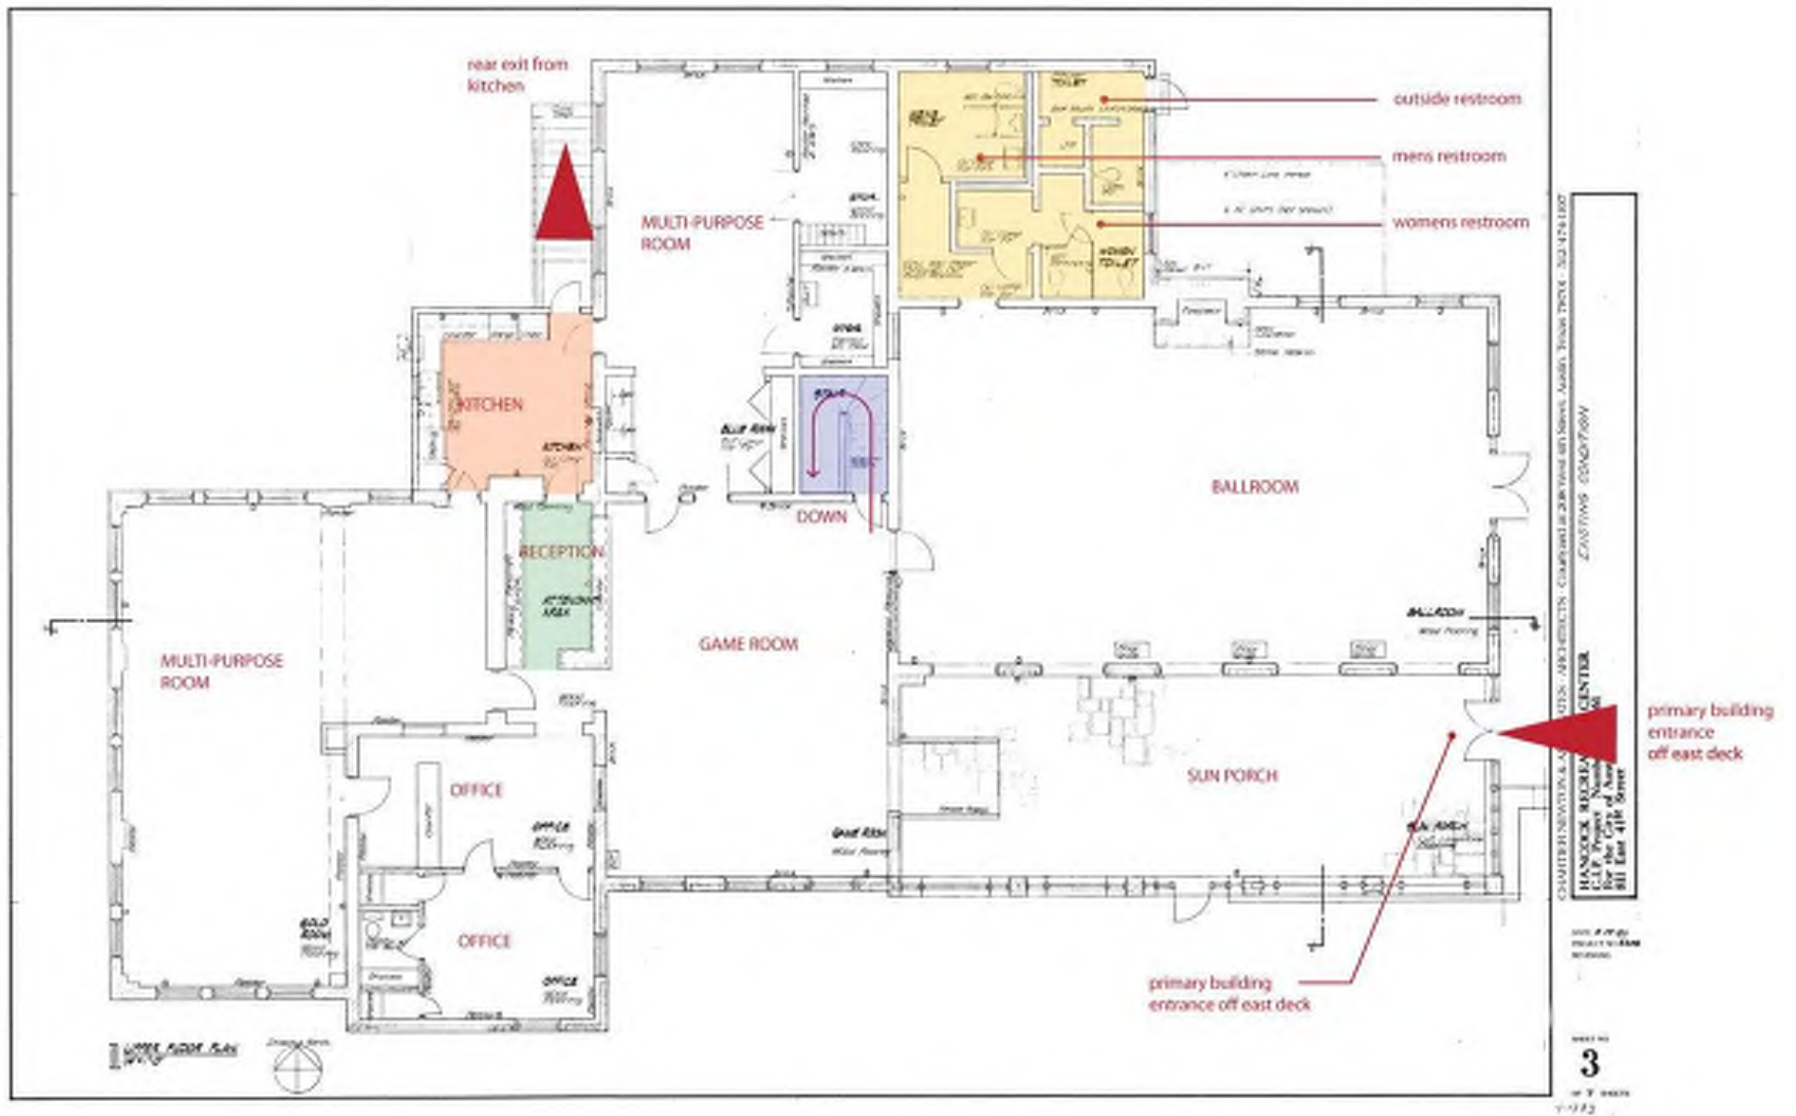
1984 EXISTING CONDITIONS - GROUND LEVEL

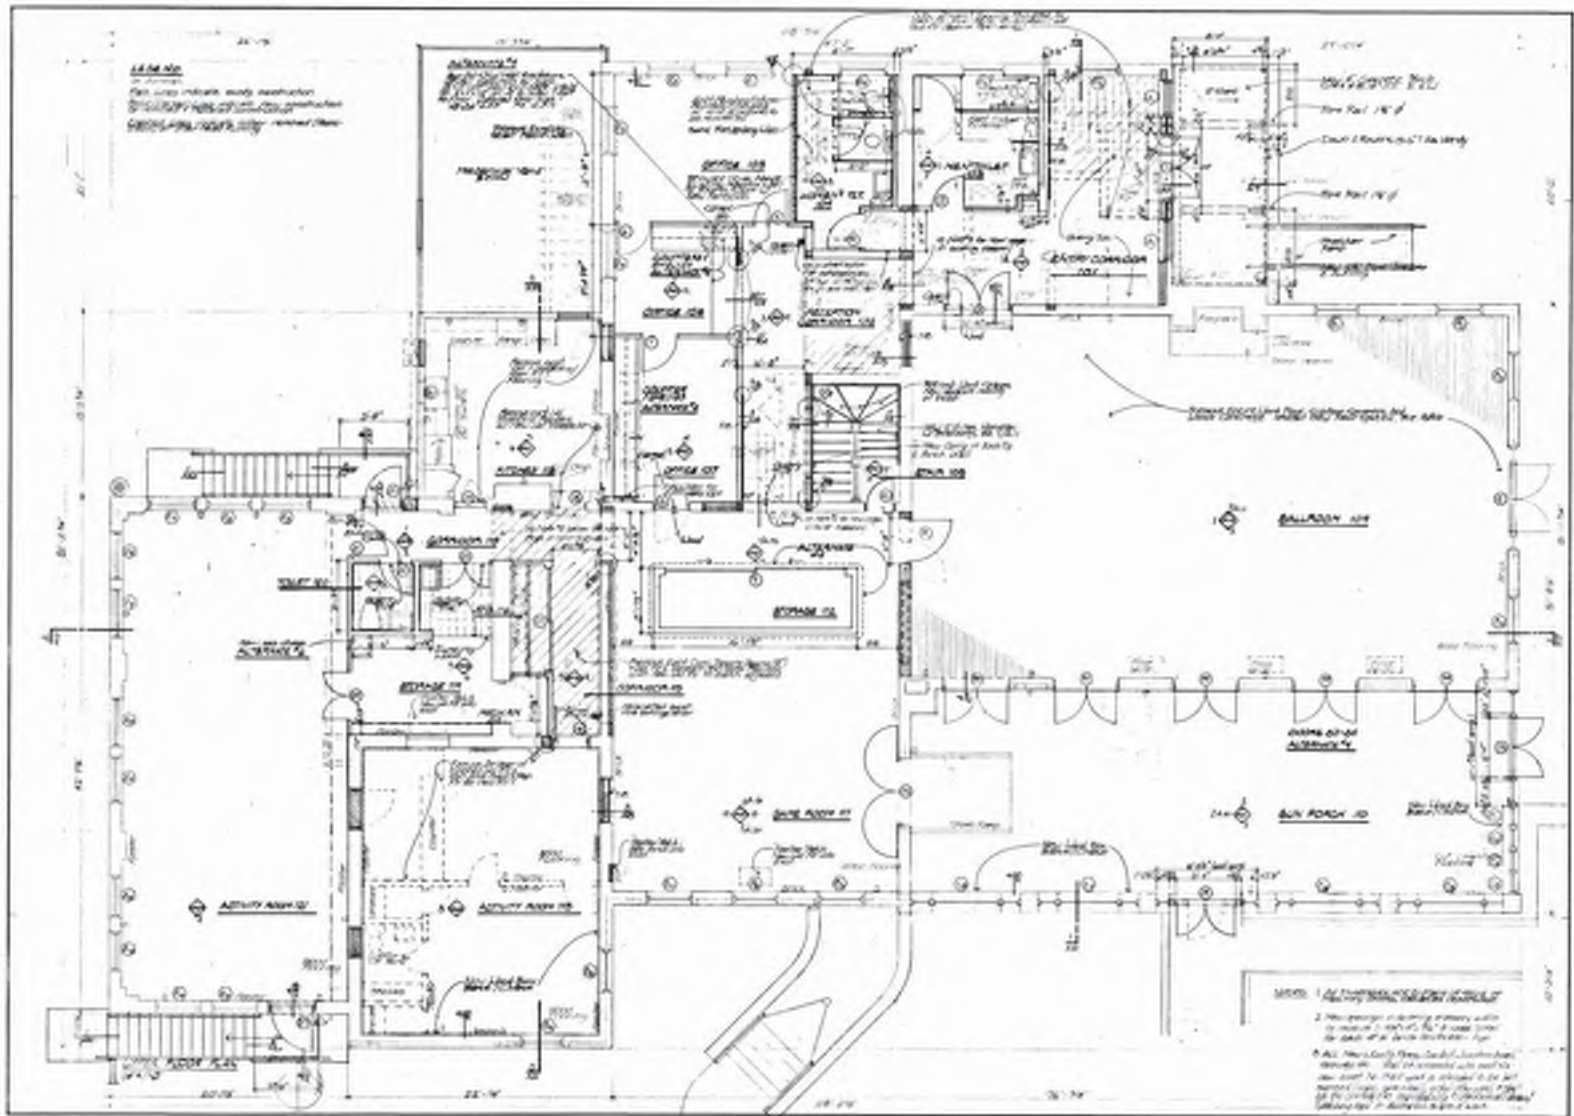
1984 SUGGESTED BUILDING IMPROVEMENTS - GROUND LEVEL

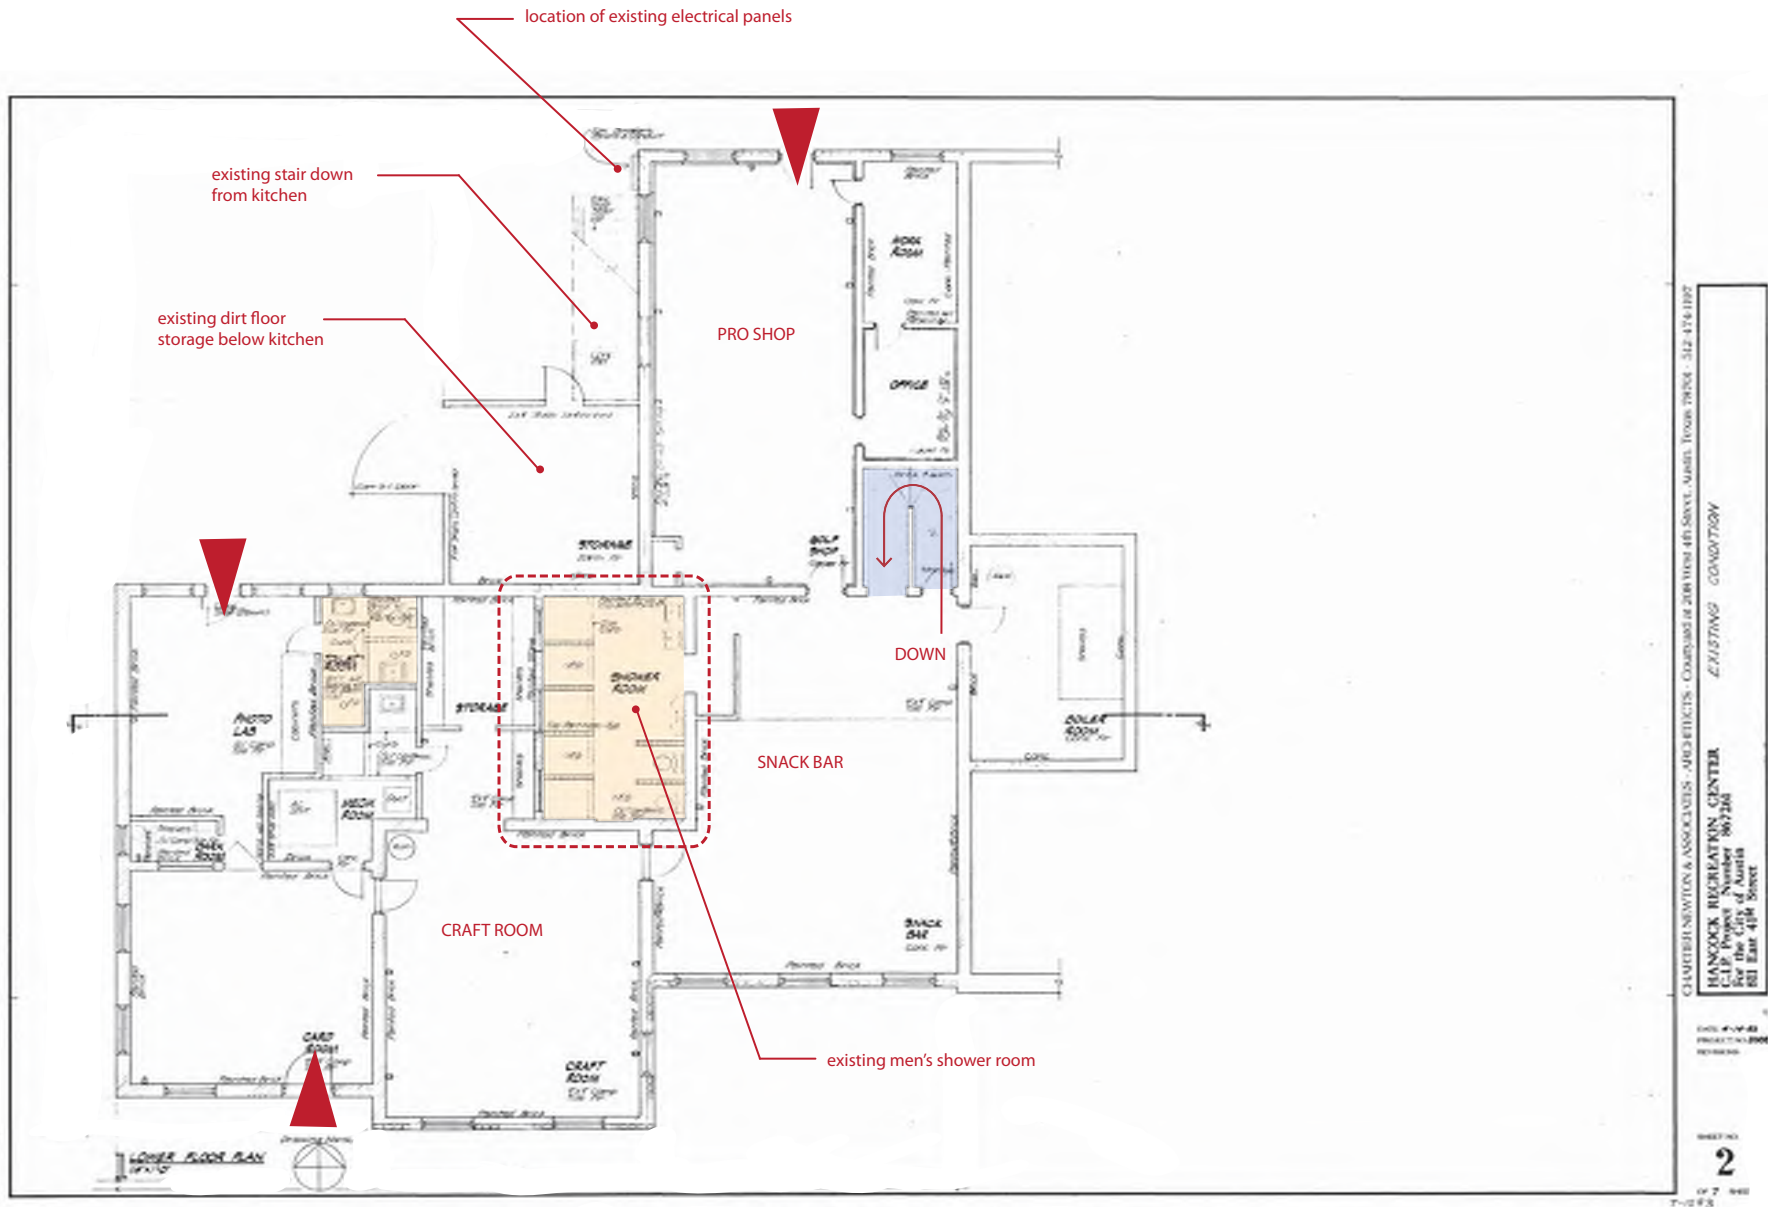
1984 EXISTING CONDITIONS - BASEMENT LEVEL

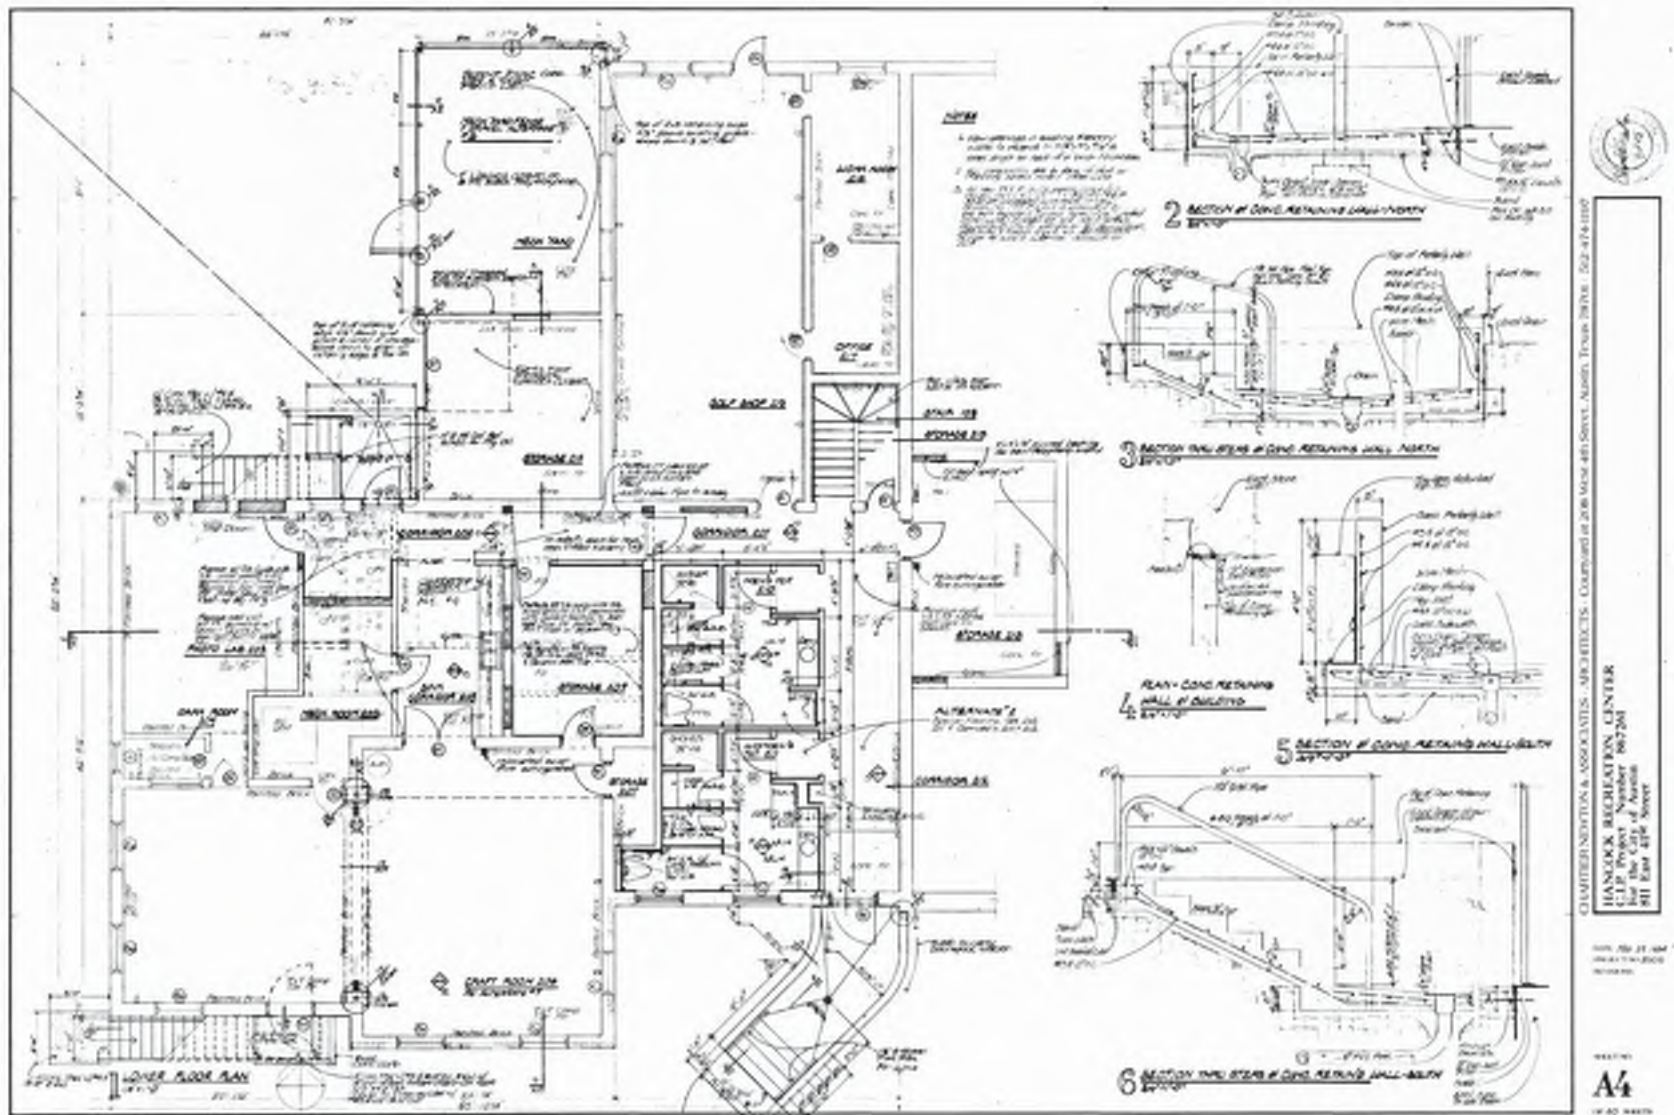
1984 SUGGESTED BUILDING IMPROVEMENTS - BASEMENT LEVEL

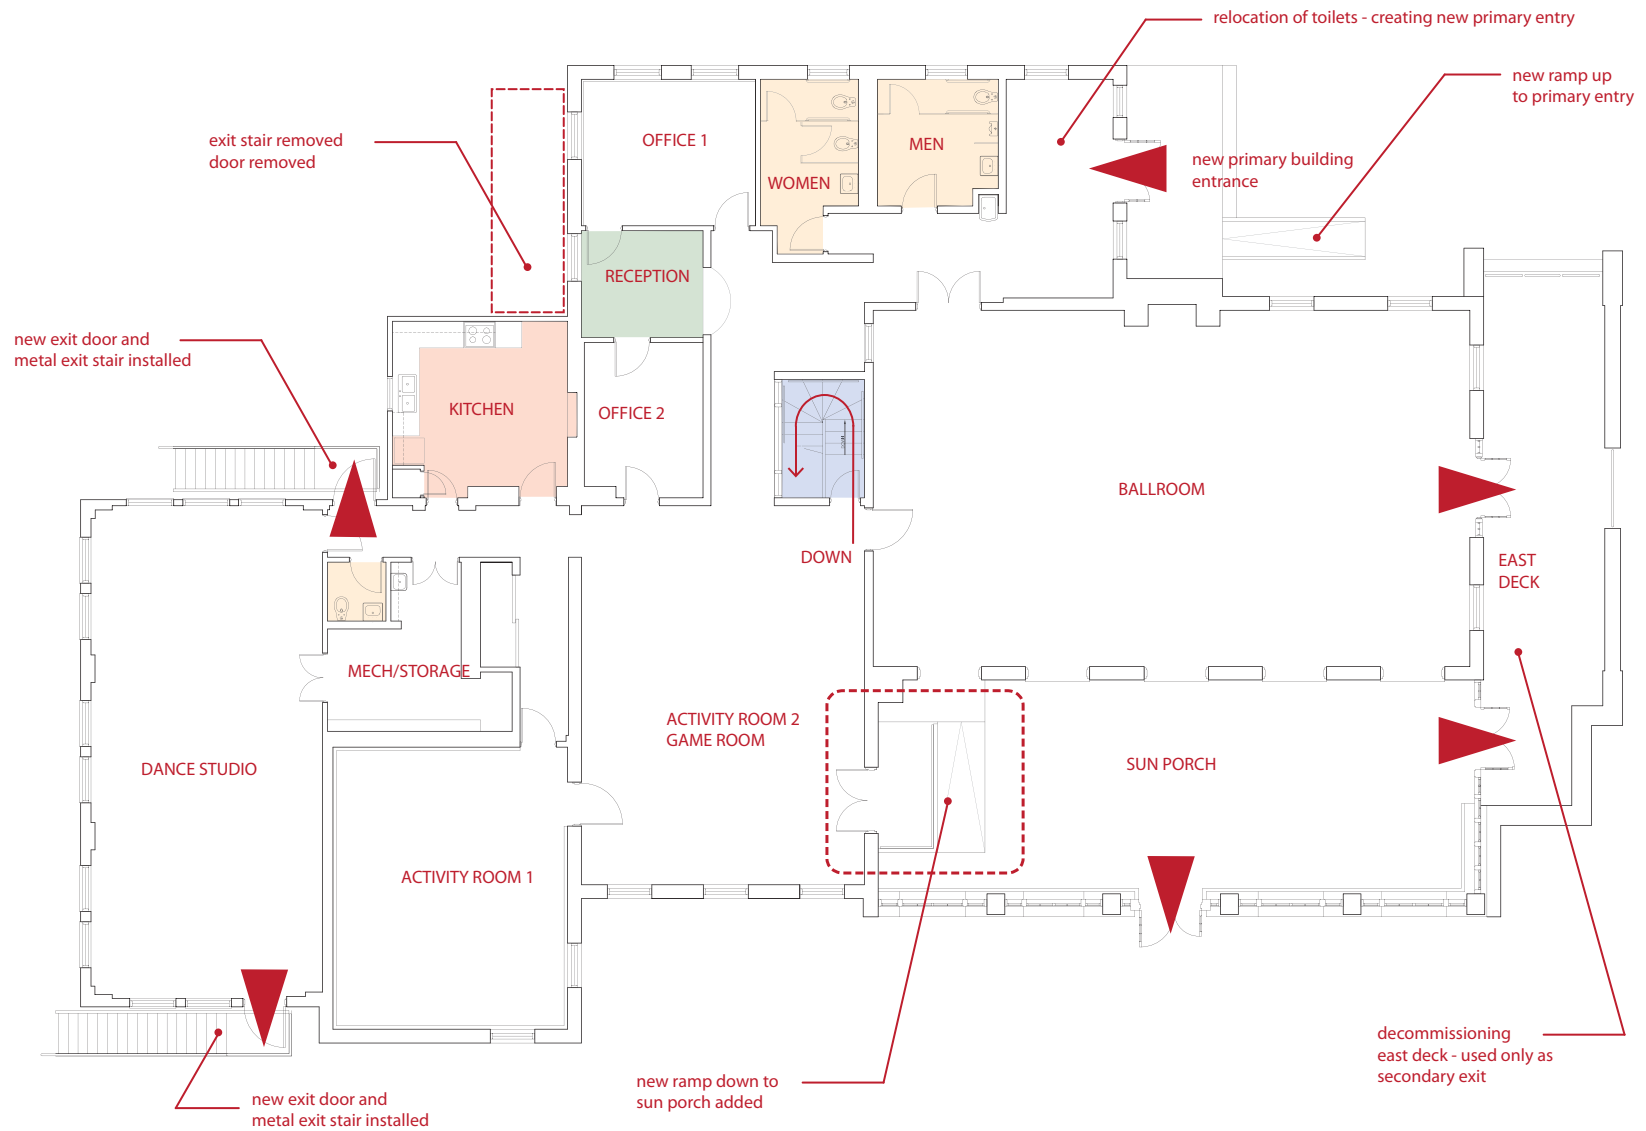
2011 EXISTING CONDITIONS - GROUND LEVEL

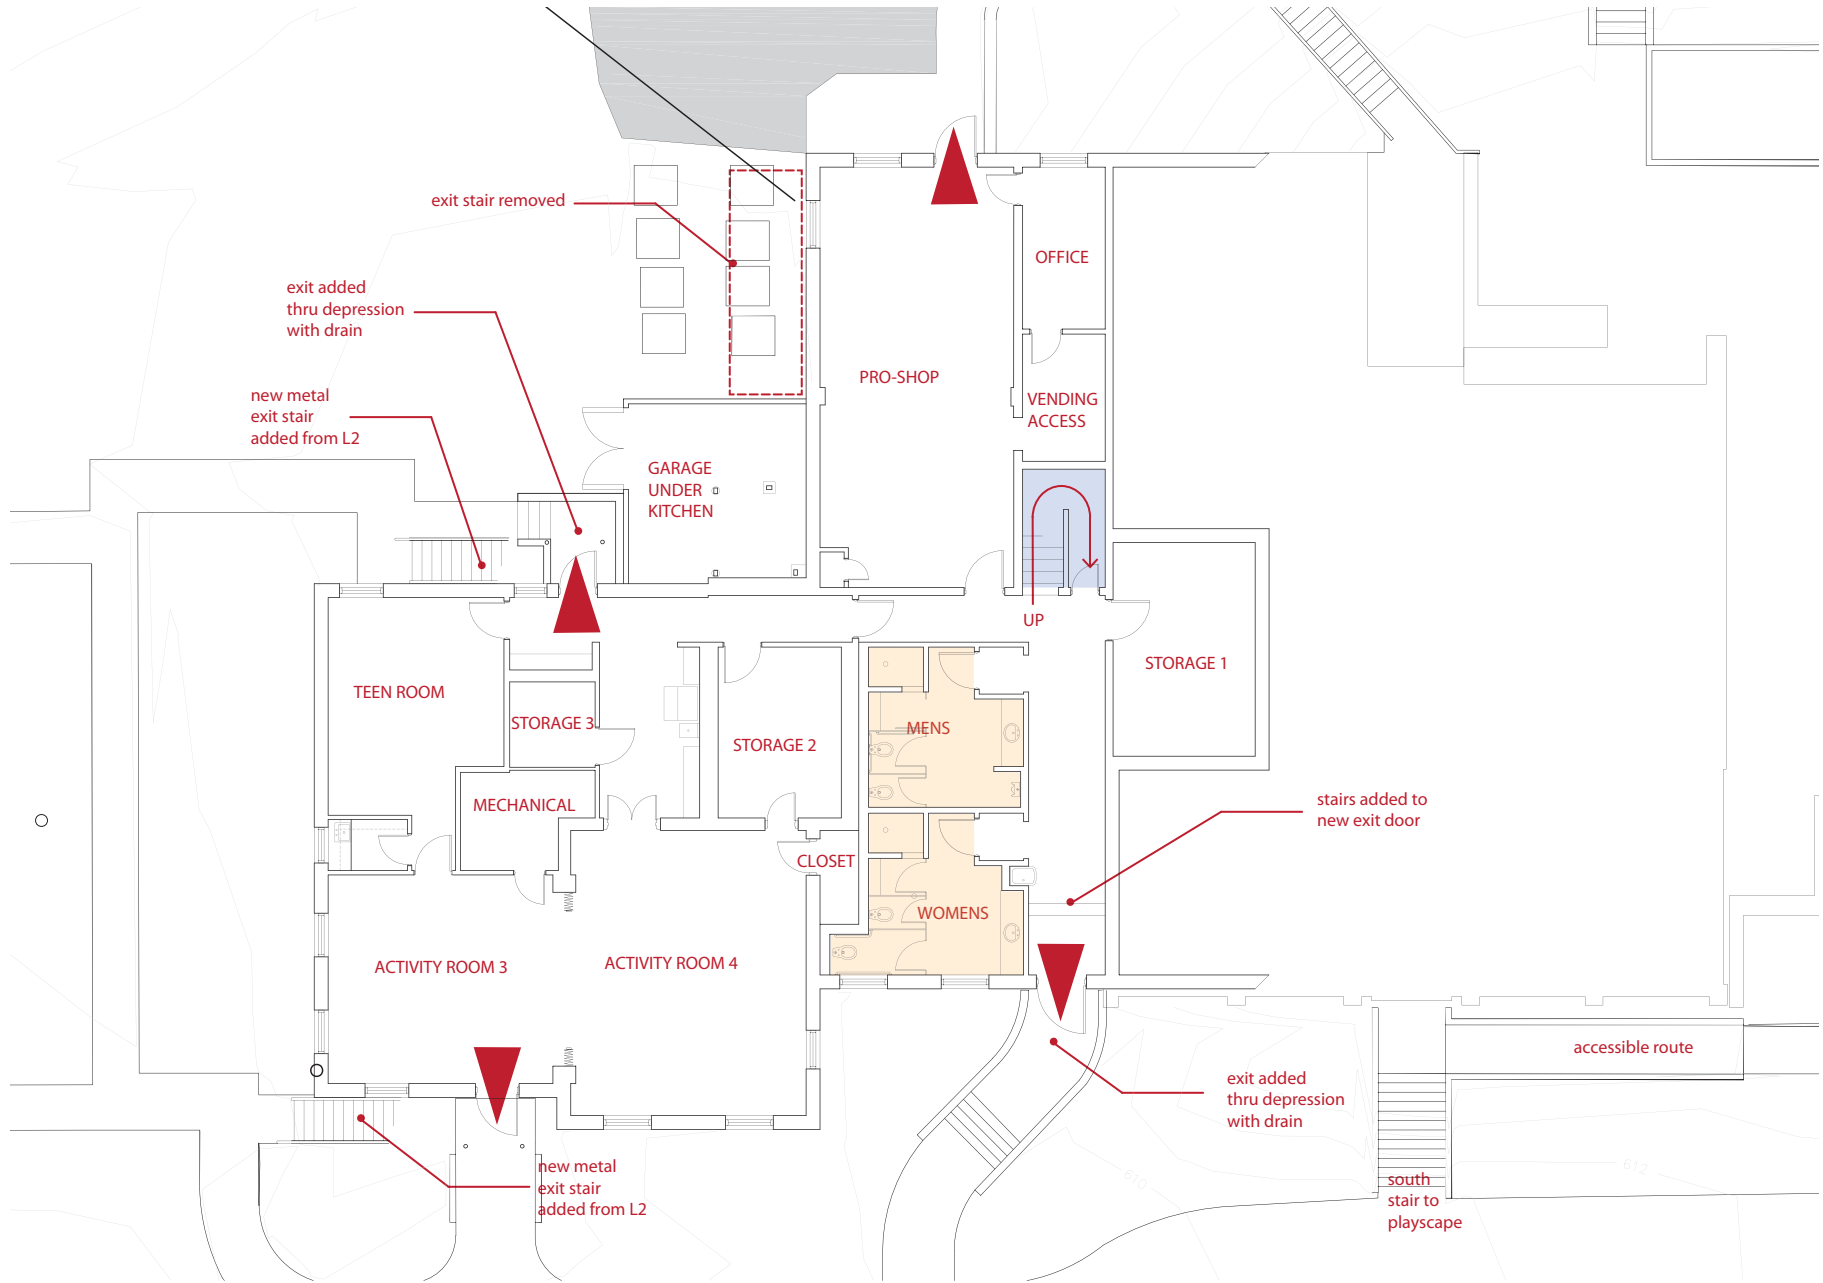
2011 EXISTING CONDITIONS - GROUND LEVEL
