Appendix C - CBRE Condition Assessments

1. Alamo Recreation Center.....	3
2. Austin Recreation Center.....	83
3. Danny G McBeth Recreation Center.....	156
4. Delores Duffie Recreation Center.....	254

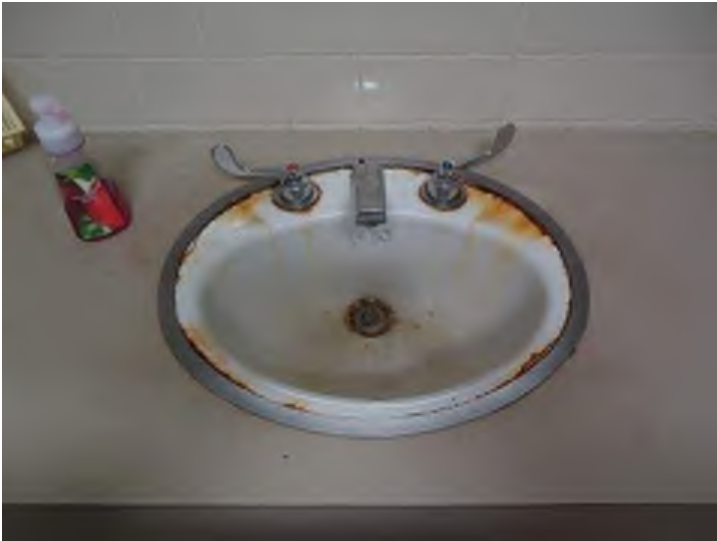
P1. Some plumbing fixtures, such as the lower level restroom lavatories shown in Figure 2-1 below are unsightly and due for replacement. The existing water closets, urinals, and lavatories do not comply with the current Austin Green Building Program (AGBP) Version 2010-2 water reduction basic requirements. Please refer to Table 2-1 below for the water consumption compliance status of the major plumbing fixtures in gallons per flush (gpf) and gallons per minute (gpm). (Condition 4)

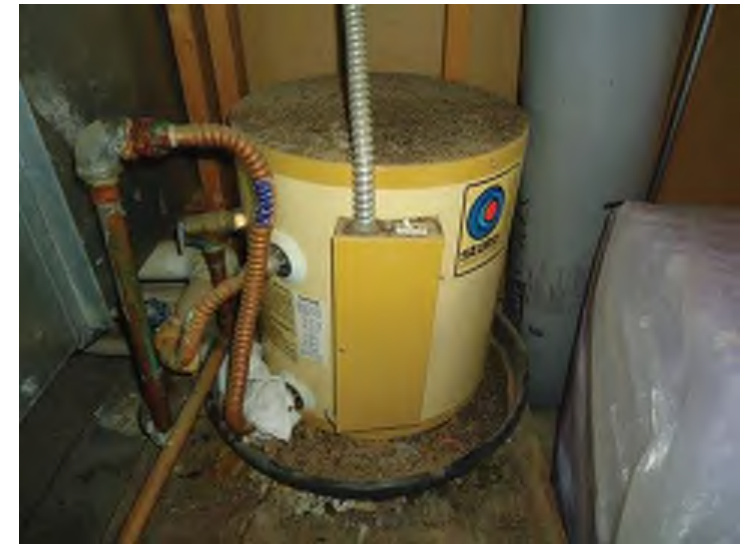
P3. Domestic Hot Water System: The hot water heating system consists of two electric powered hot water heaters. One unit serves the upper level and the other serves the lower level. The building has neither thermal mixing valves at individual fixtures nor a central thermal mixing valve assembly serving a circulating tempered water loop. Thus, the current installation is not compliant with the current plumbing code with regard to the provision of tempered water at showers and lavatories.

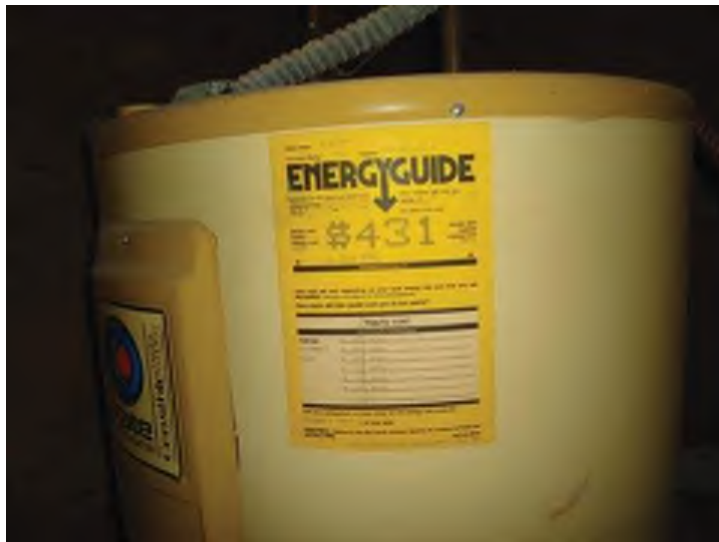
The relatively small unit serving the upper level restrooms has scheduled volume capacity of approximately 6 gallons, heating capacity of 1.65 kW and is located in the attic space. Please refer to Figure 2-3. The unit piping connections are in poor conditions due to galvanic corrosion at the piping joints resulting from the connection of incompatible metals without proper use of dielectric fittings. This unit seems relatively aged and may have a calcified build-up tank and elements that would reduce its efficiency. Furthermore, the conditions of the piping connections warrant overall replacement.

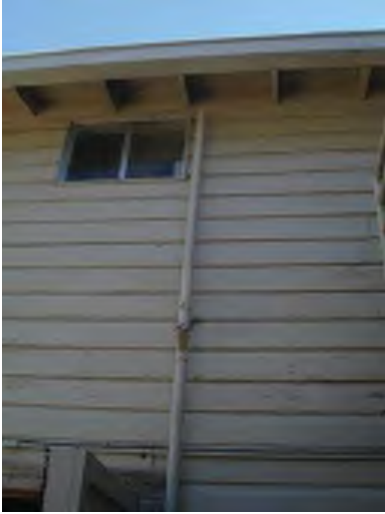
The building is served by a four-inch main waste line. There are four plumbing vents through the roof. However, there is also an additional vent that is not through the roof. Please refer to

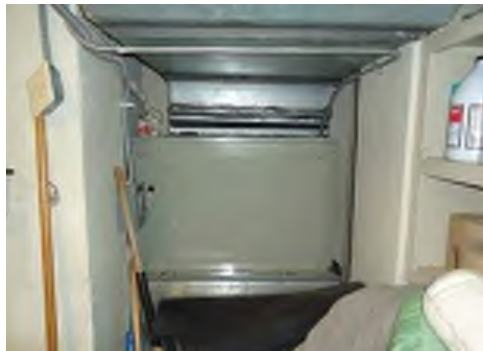
* Manufacturer nameplate of AHU-1 is obstructed and therefore data could not be gathered.

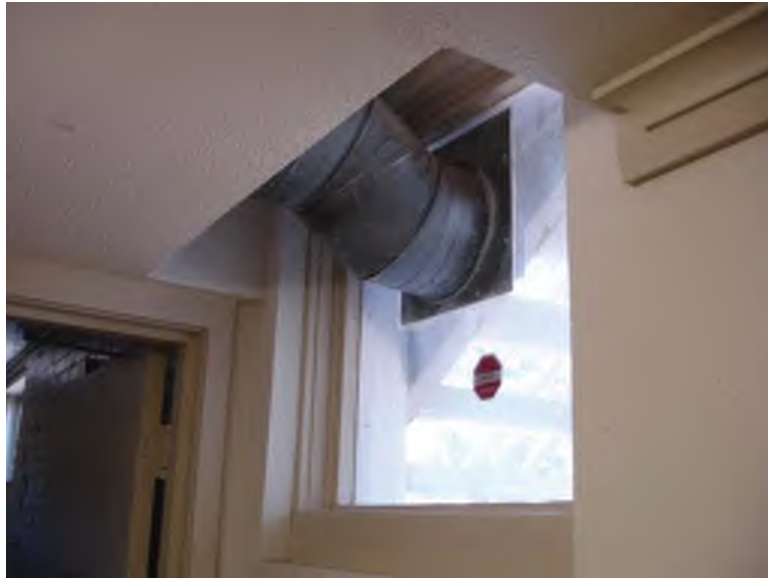
M2. Air Distribution Ductwork: The majority of the ductwork is galvanized steel sheet metal, predominantly rectangular with exception of some round rigid ductwork and some round flexible ductwork. The age of all the ductwork is not fully known. However, the dates of the record drawings imply the majority of the existing ductwork was renovated as part of the 1984 renovations. Some of the ductwork however could be part of the renovations in 1976.

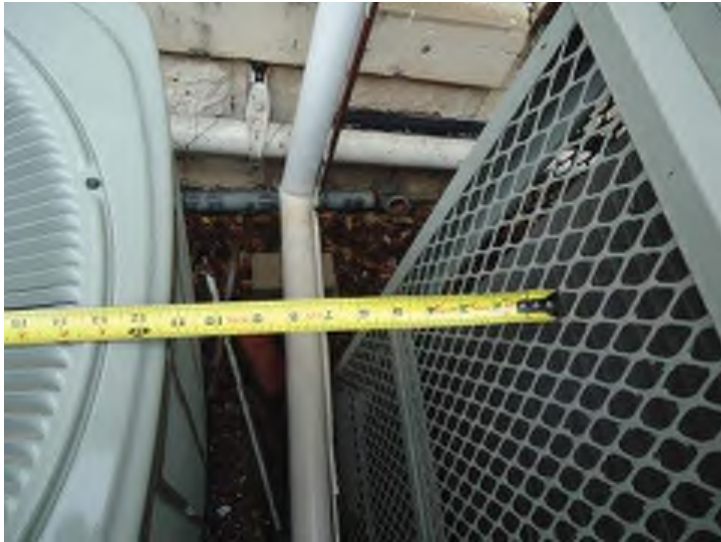
All eight of the existing split systems use HCFC-22(R-22), a refrigerant that is being phased out per the Montreal Protocol due to its ozone depleting and

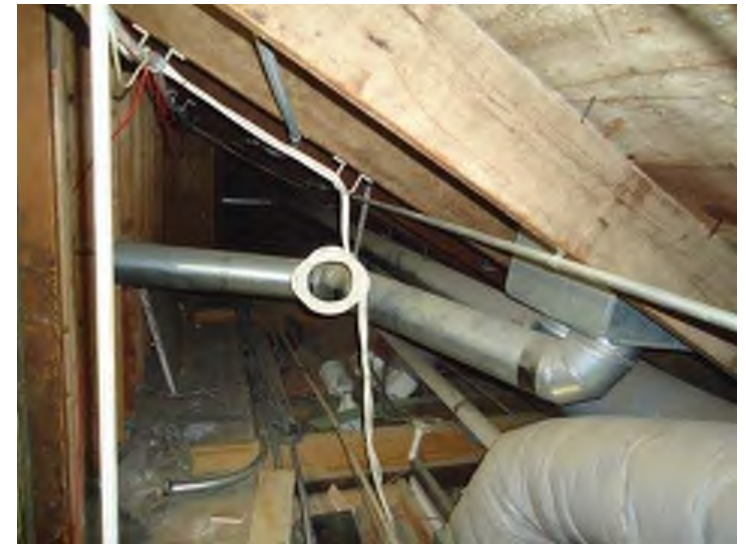
installed, and balanced to provide the fresh air. However, because there is a lack of balancing dampers on the attic return plenum air grilles, the existing installation could not have been balanced to induce the entry of fresh air. Therefore, there may be little ventilation entering the space.

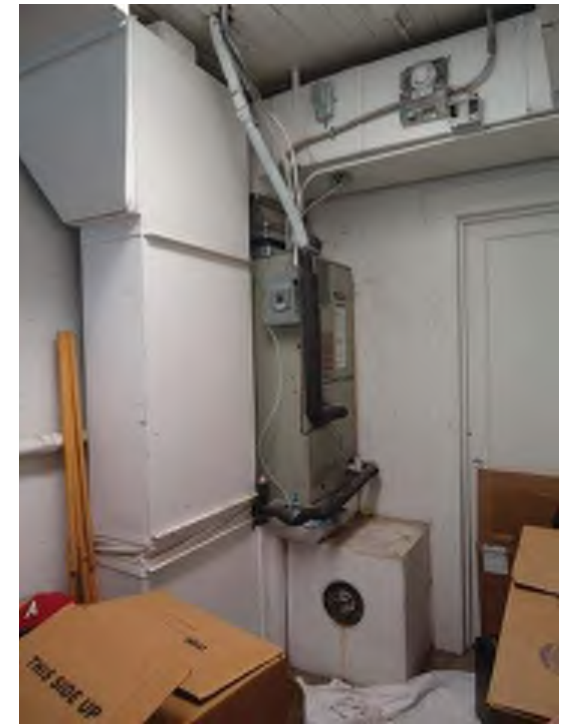
Although ventilation is required by code, the codes allow various methods of control to achieve the ventilation requirements. Thus, the lack of the mentioned, though recommended, controls is not necessarily mandatory and could be accomplished through more antiquated and less efficient mechanical methods. Nonetheless, although the installed sensors appear to be in excellent overall condition, without having further direct commissioning knowledge of the control system and the observed lack of control components with regard to ventilation, we grant the building HVAC control system a rating of fair/moderate condition. (Condition 2)

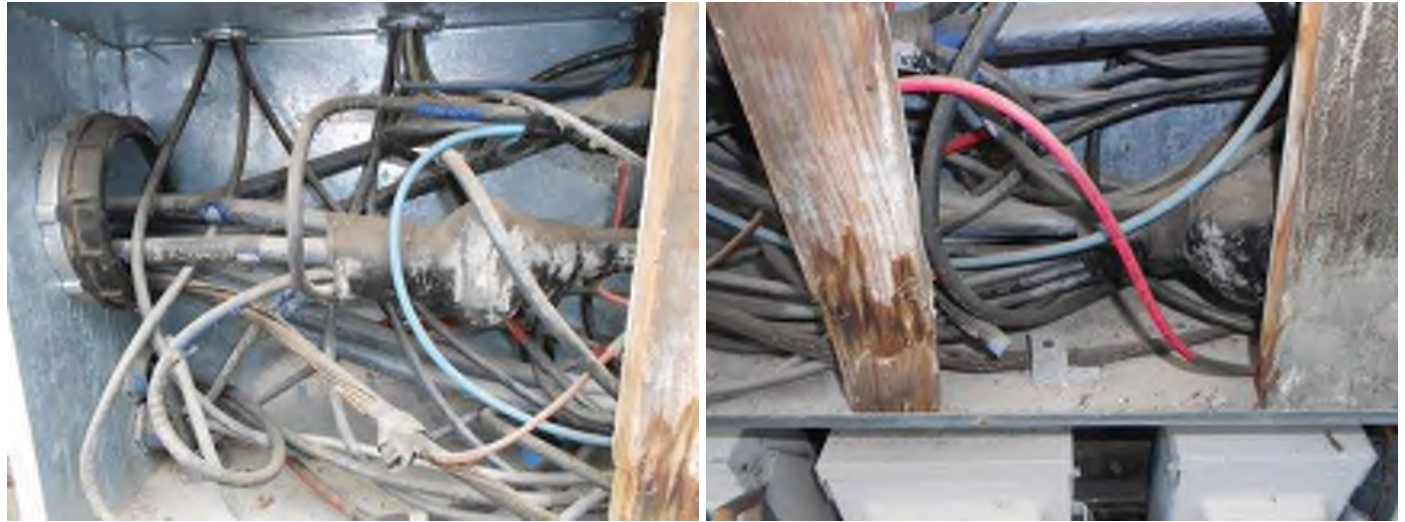
conductor serving as the main grounding electrode conductor is tapped between the point of attachment to the copper water pipe in the Garage and the point where it bonds with the system neutral conductor in the main disconnecting means enclosure to provide equipment grounding of the Mechanical yard wire gutter and the panelboard located in the Golf Shop. Please refer to Figure 4-9. The NEC requirements state that the electrode grounding conductor shall be used solely to connect the grounded (or neutral) conductor of the service or derived system to the grounding electrode. All grounding conductors to equipment, raceways, and enclosures shall be connected to the equipment grounding terminal located in the main disconnecting means enclosure.

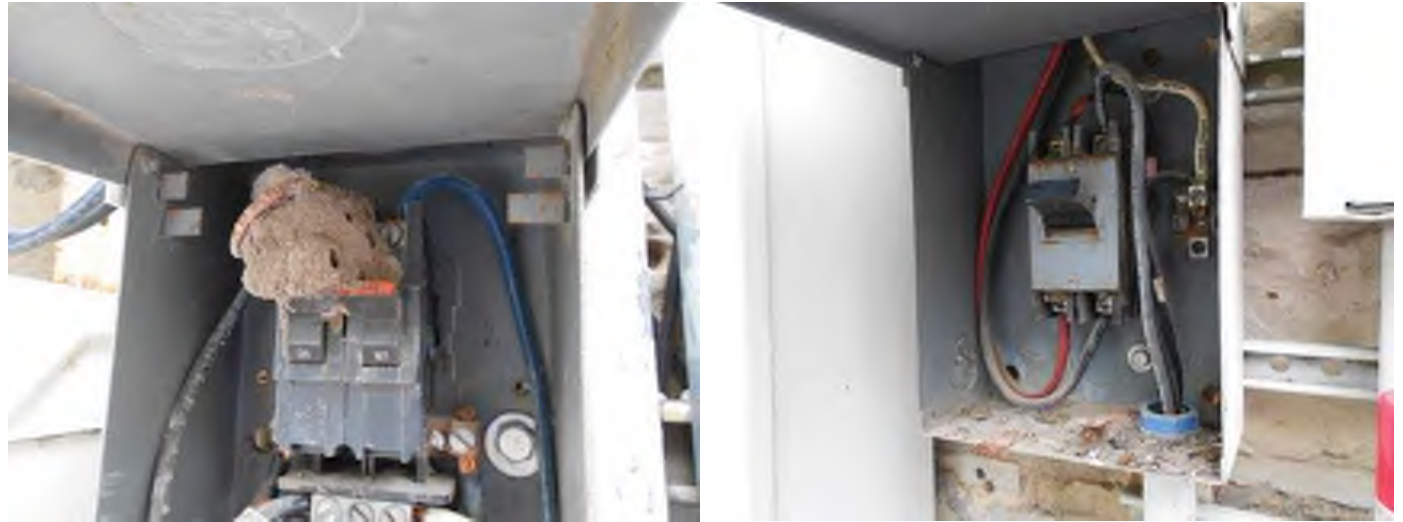
Disconnect switches located at feeder taps are required by the NEC to contain overcurrent protective devices (fuses or circuit breakers). This requirement is not applicable to the local disconnect switches installed at the equipment, however, the large majority of the local disconnect switches installed are of the fusible type. While this is an acceptable installation, it also can lead to additional maintenance to replace blown fuses.

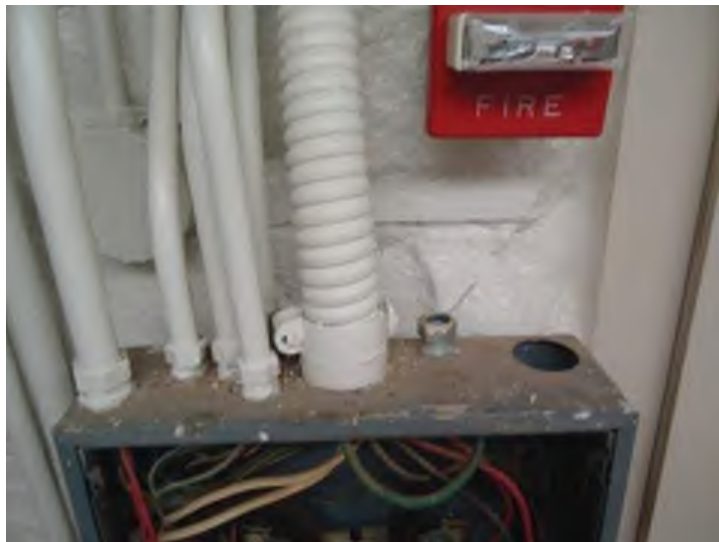
the above described issues or present a personnel safety issue should an object inadvertently pass through the opening into the exposed live parts within the enclosure. The NEC states that unused openings, other than those intended for the operation of equipment or for mounting purposes, shall be closed to afford protection substantially equivalent to the wall of the equipment.

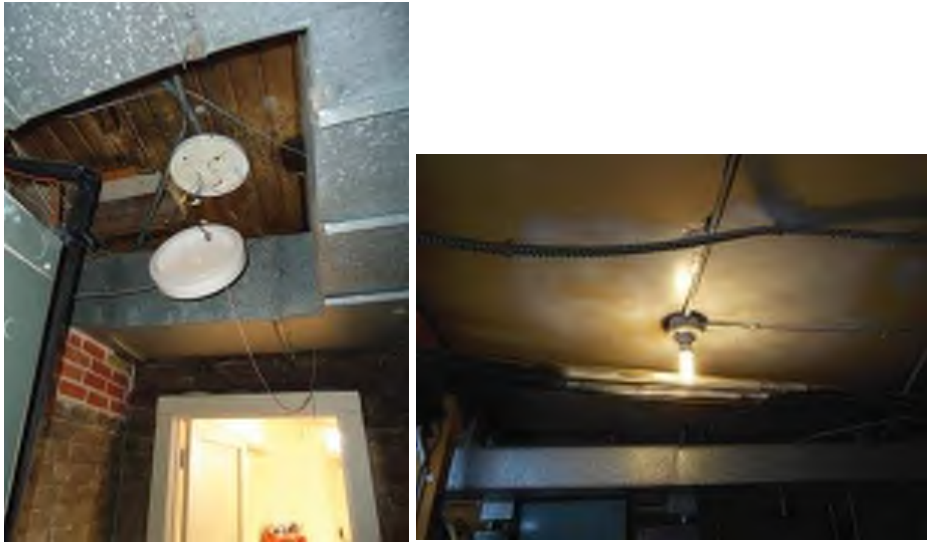
E4. Lighting and Wiring Devices: Lighting compliance for minimum illuminance levels and energy levels for both the interior and exterior of the facility were not evaluated as part of this report. Such evaluations require specialty equipment to measure existing illumination levels. Interior and exterior lighting fixtures were visually observed for condition assessment and operational status.

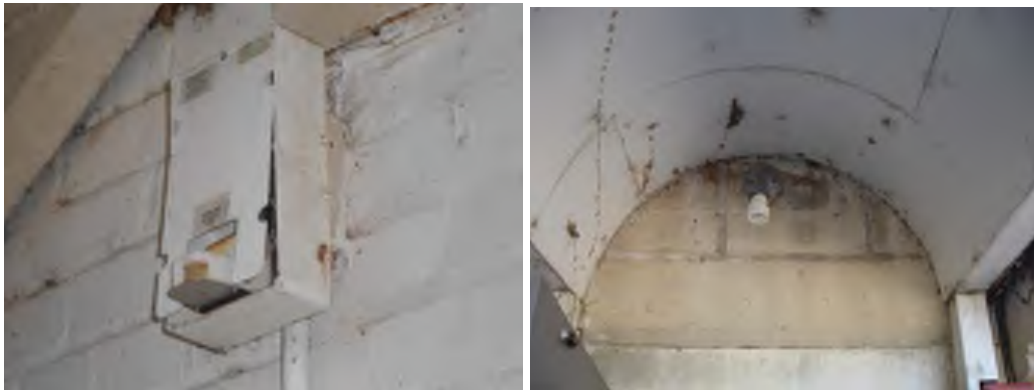
The exterior lighting fixtures at the west entrance to the facility have been maintained and appear to be in good operating condition. However, exterior fixtures located at the lower level north and south entrances were observed to be in poor condition or missing components and completely inoperable. Please refer to Figure 4-15.

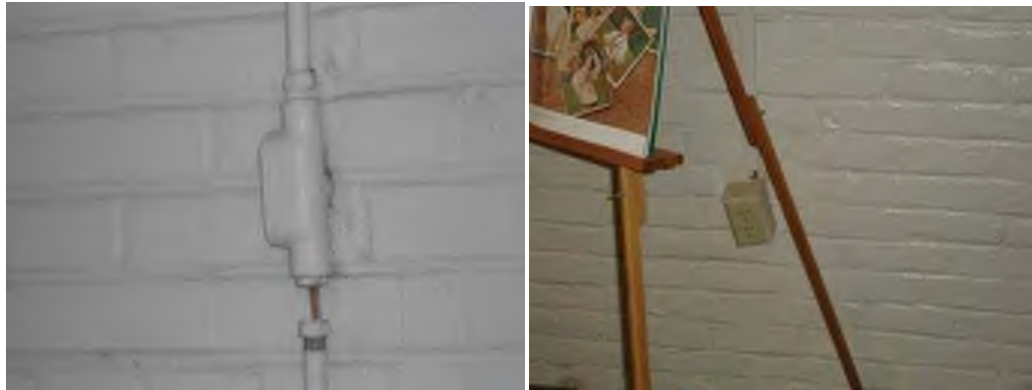
In summary, the lighting system is functional but as with other components of the facility's electrical system it is aged. While parts are readily available for many of the fixtures, some consideration should be given to replacing the fixtures with newer more energy efficient luminaries. Additionally, there are maintenance issues in some areas with lighting fixtures that are in disrepair. The wiring devices do not meet the standards set forth by regulating authorities for accessibility to handicapped persons and in several areas, receptacles do not comply with NEC requirements established for protection of personnel. As a result, the lighting and wiring devices receives a does not meet code/does not function properly condition rating. (Condition 4)

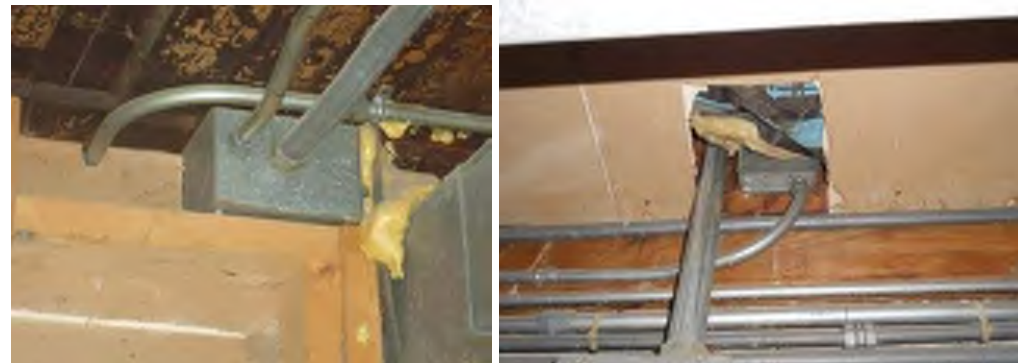
Existing pull boxes and junction boxes were not evaluated with

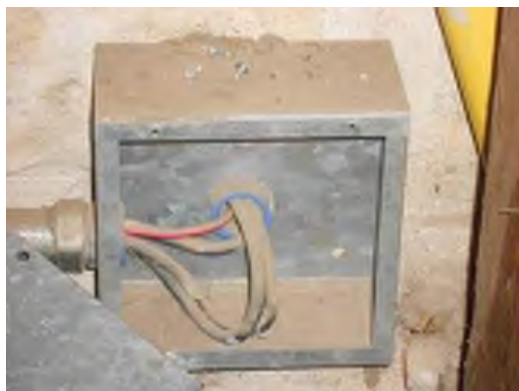
inside raceway systems. Insulation types vary in concert with the ages of the conductors. Where accessible in boxes and equipment, wiring insulation appeared to be intact. All conductor material observed appeared to be copper with no aluminum wiring readily visible.

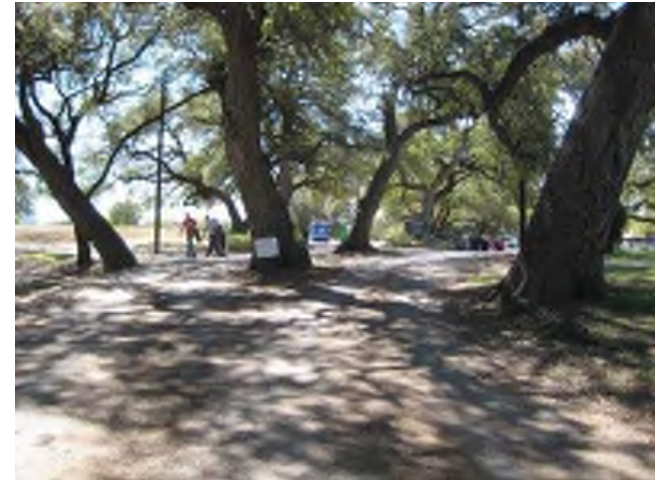
Heritage trees at entrance drive

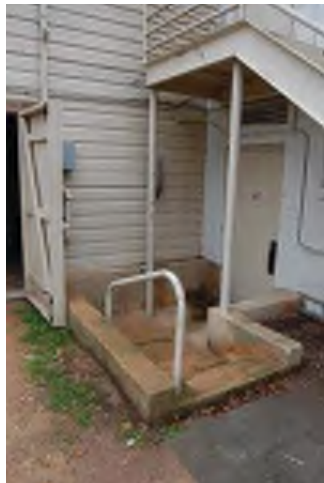
Northwest depressed entrance

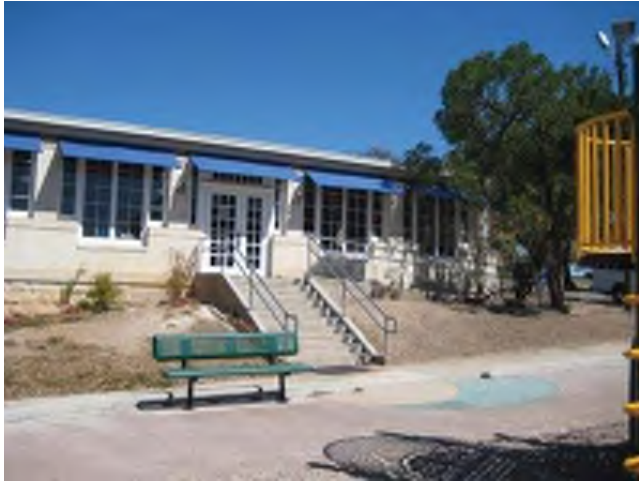
South entrance stair

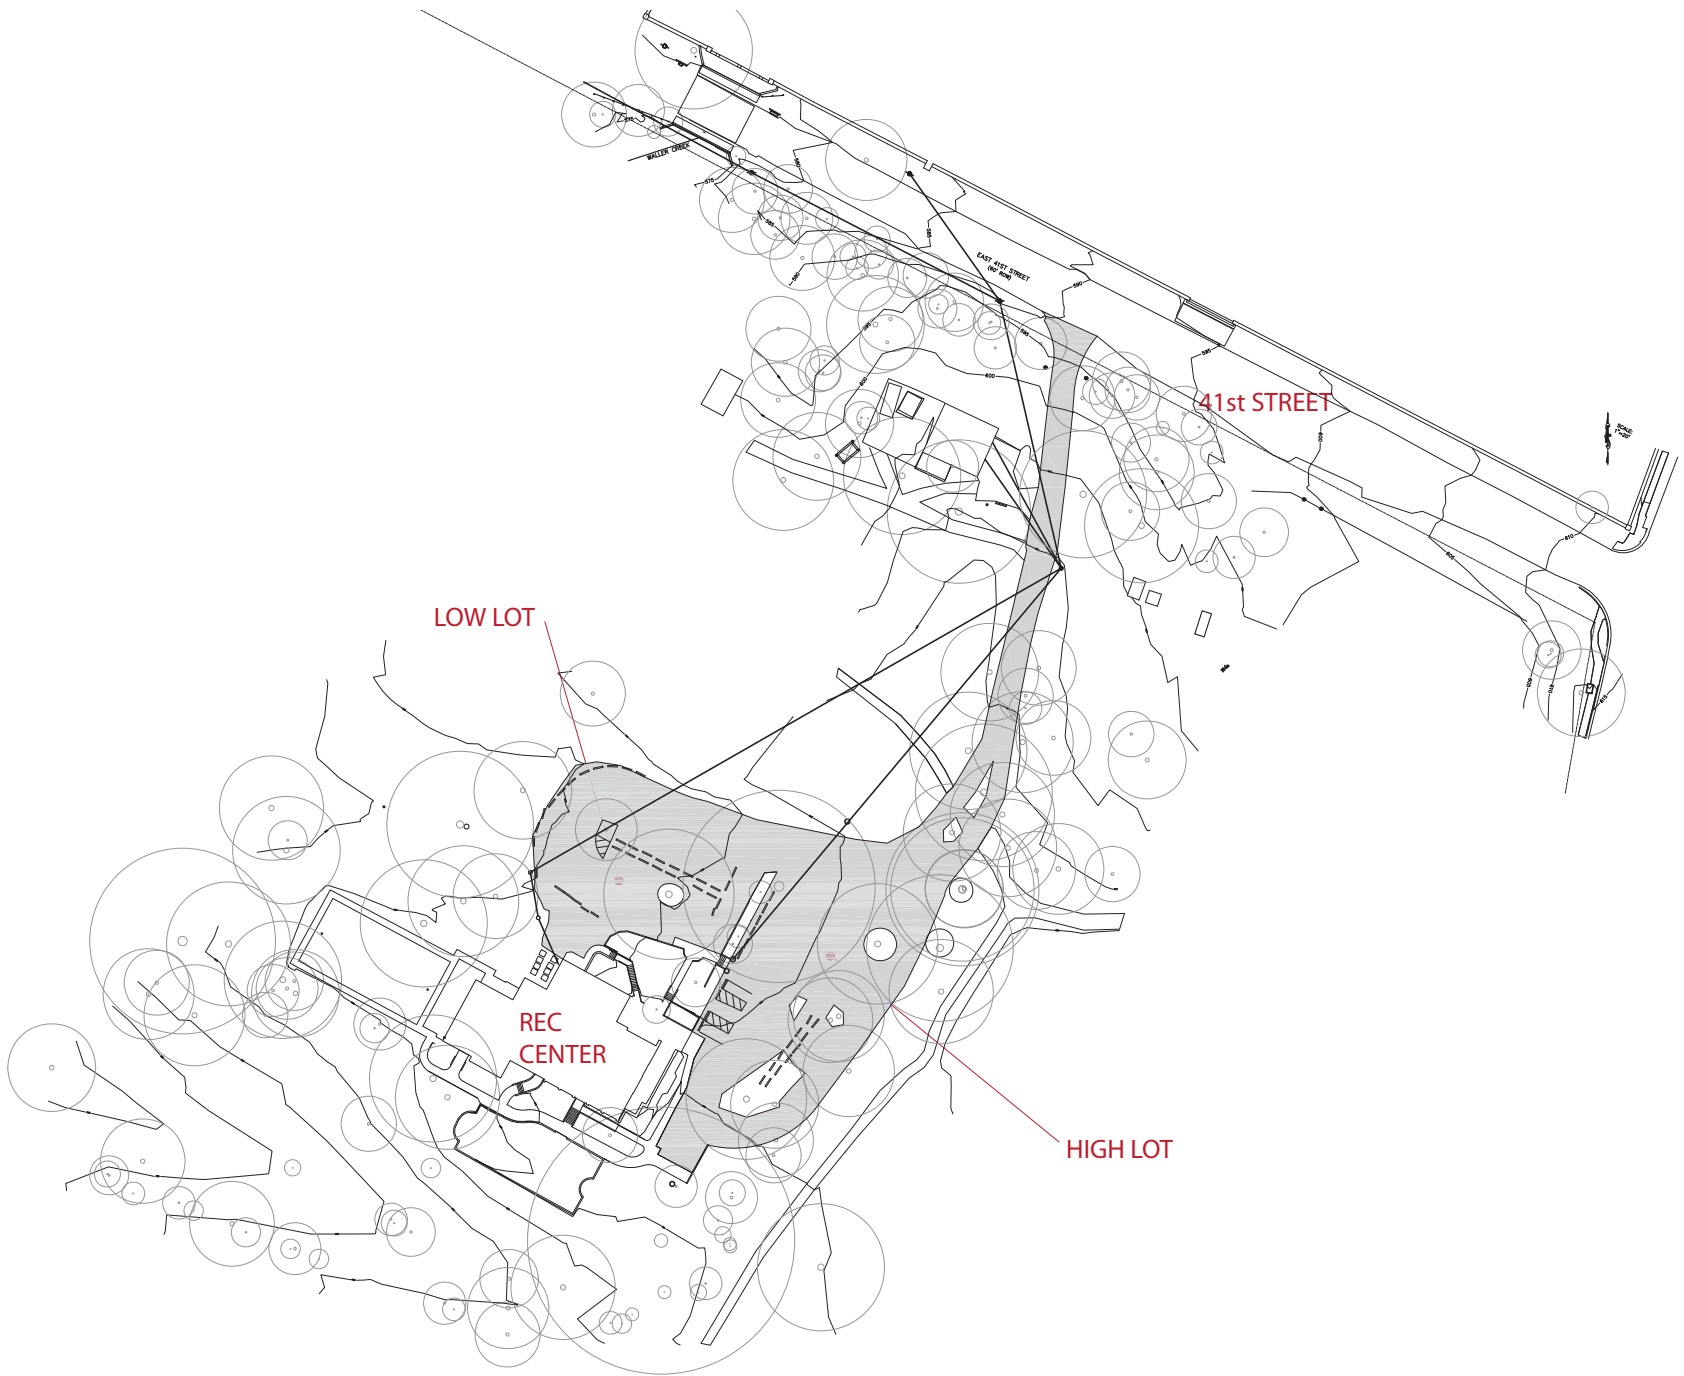
SURVEY OF EXISTING SITE 2011

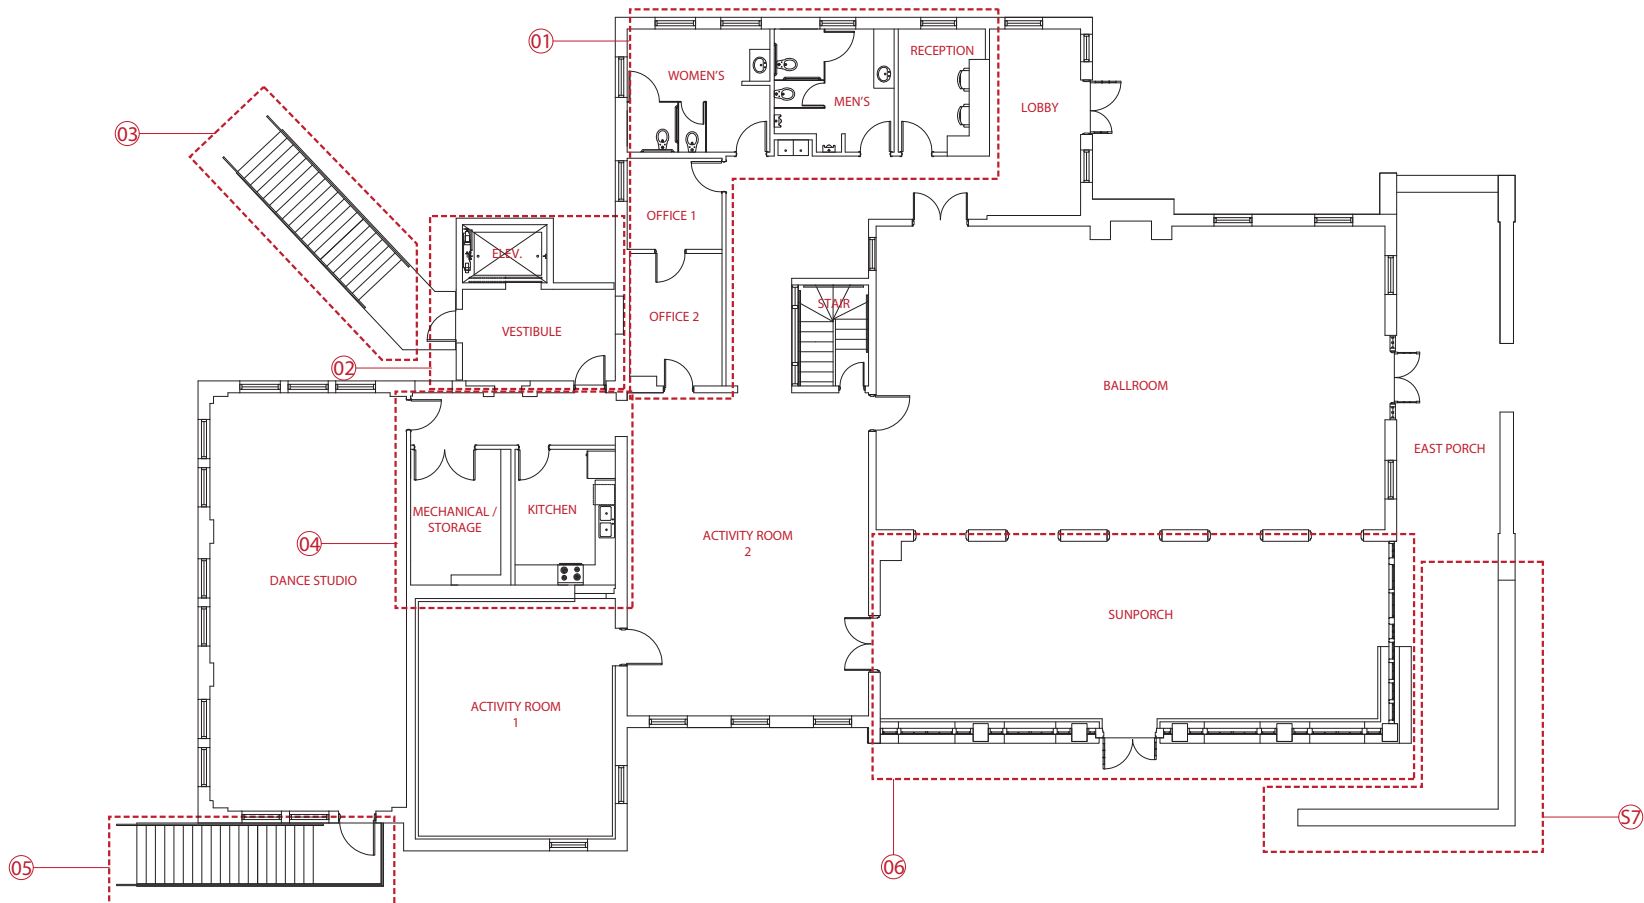
RECOMMENDED BUILDING RENOVATIONS 2012 - GROUND LEVEL

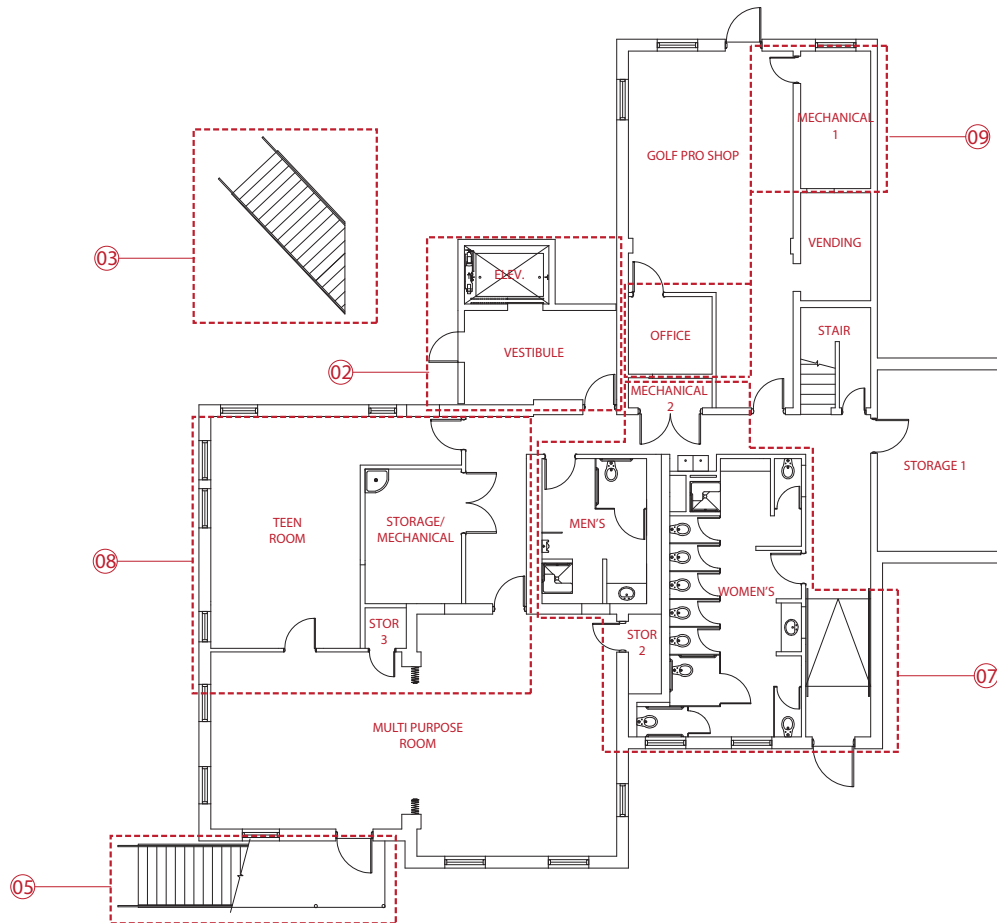
RECOMMENDED BUILDING RENOVATIONS 2012 - BASEMENT LEVEL

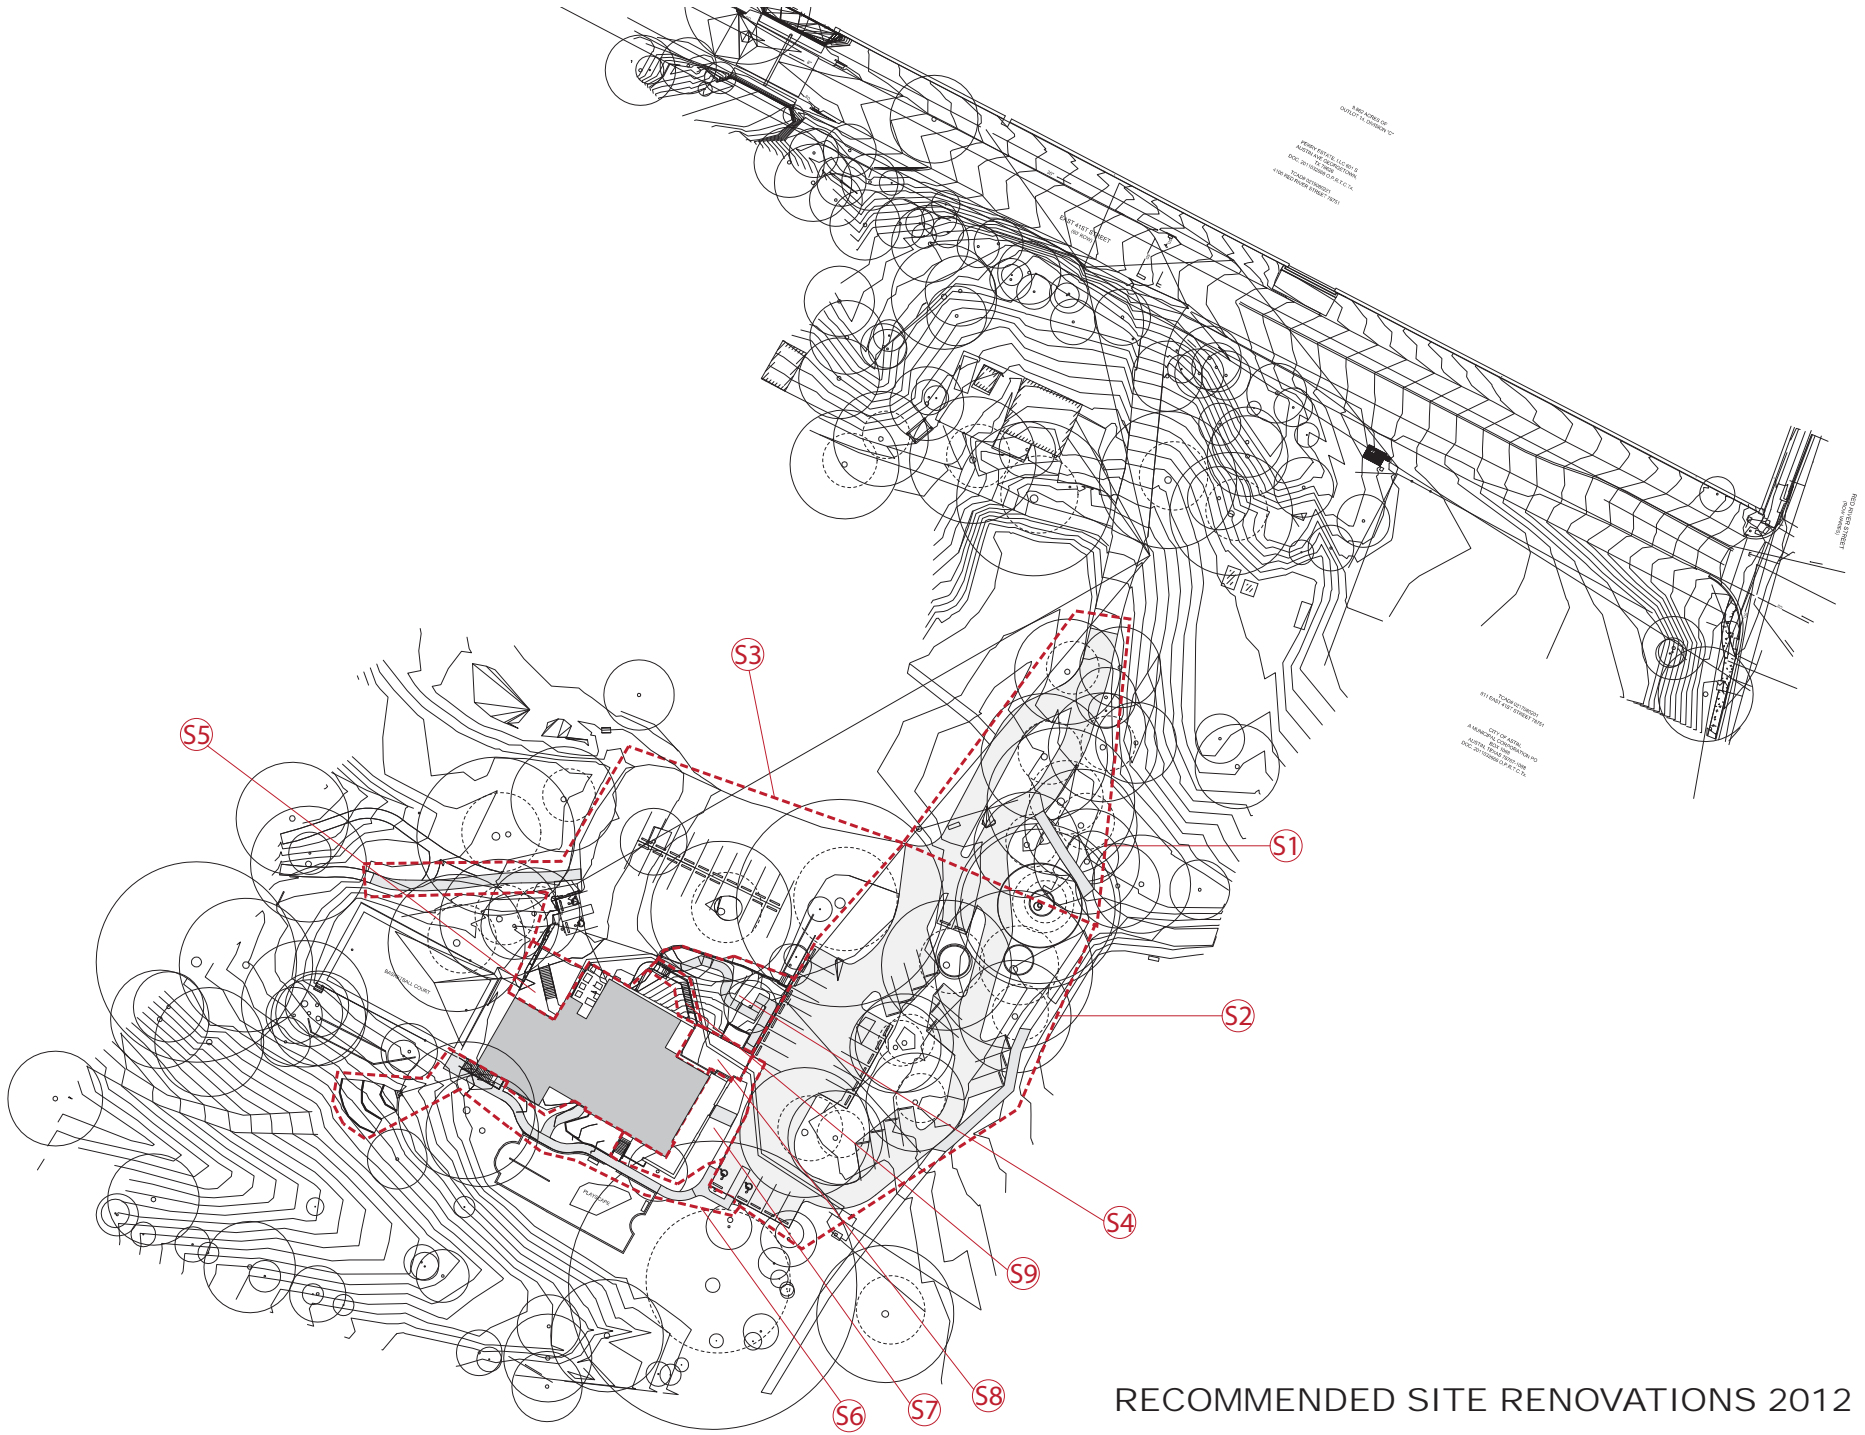
RECOMMENDED SITE RENOVATIONS 2012

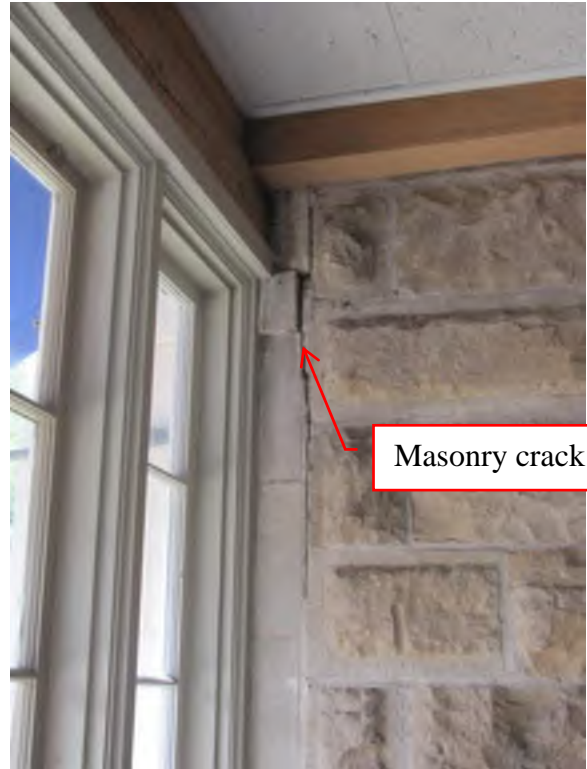
Figure 4. Masonry crack at Sun Porch southwest corner

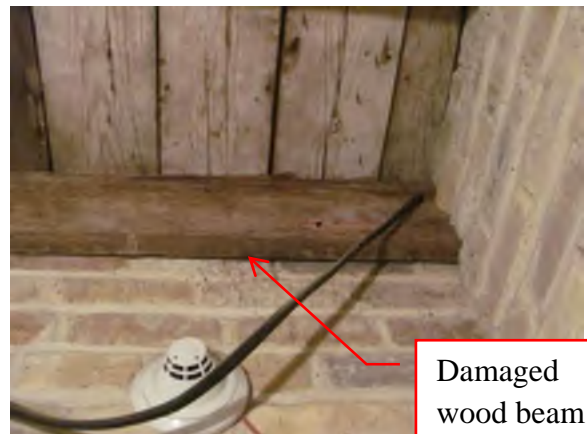
Figure 5. Beam damage under stair

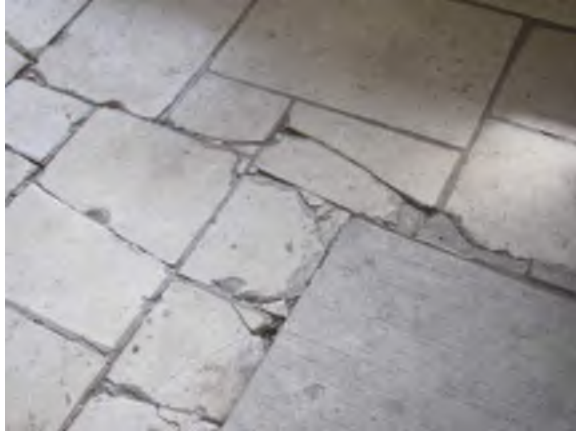
Figure 6. Sun Porch Floor damage

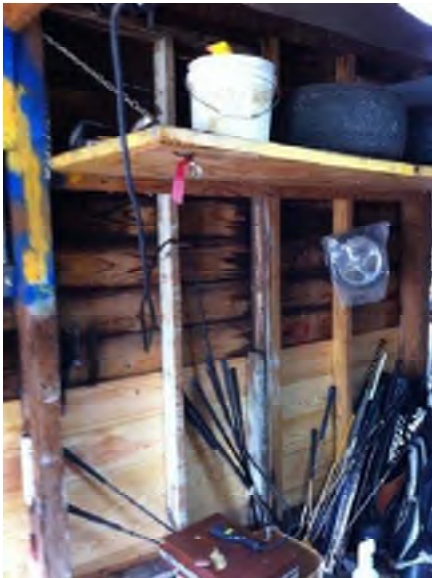
Figure 7. Cart Barn North Wall

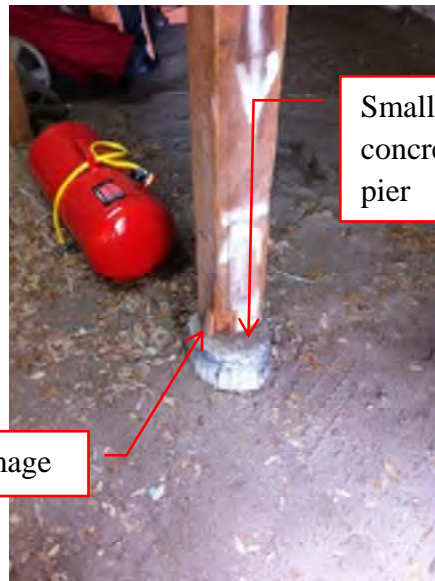
Figure 9. Cart Barn Center Post

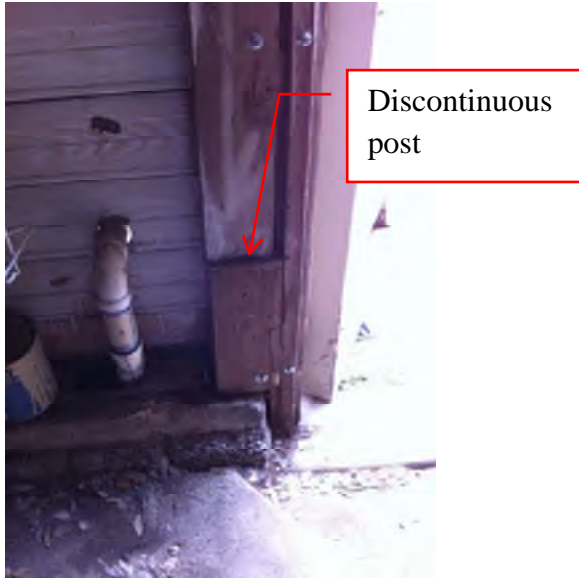
Figure 11. Cart Barn Post at Door

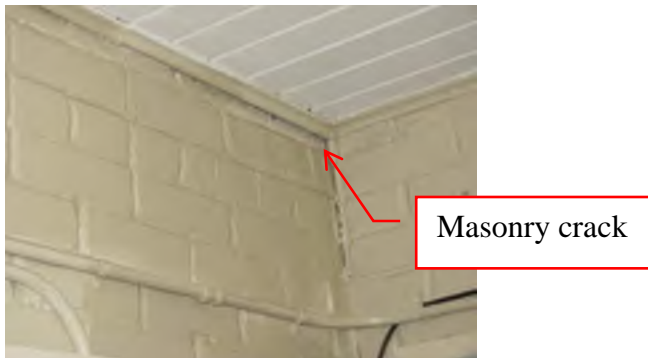
Figure 12. Masonry crack at ceiling in Teen Room

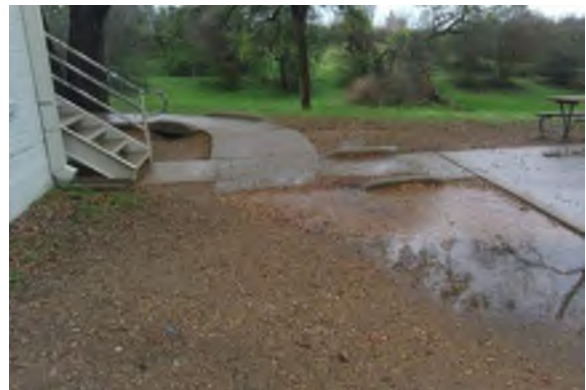
Figure 15. Poor drainage at west end of building

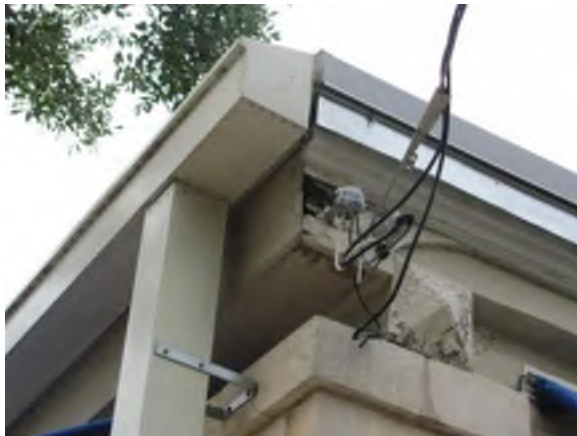
Figure 13. Eave damage at the southeast building corner

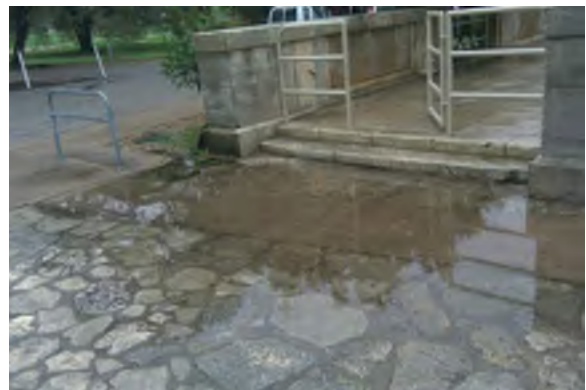
Figure 16. Poor drainage at northeast corner of the building

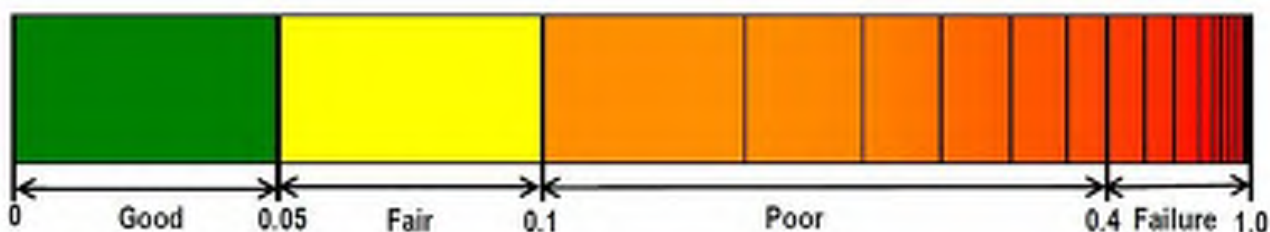
Therefore, the lower the FCI, the lower the need for remedial or renewal funding relative to the facility’s value. For example, an FCI of 0.07 signifies a 7% deficiency ratio which is generally considered to be in the fair range. An FCI of 0.7 means that 70% of the building needs extensive repairs or replacement. The FCI is a relative indicator of condition and should be tracked over time to maximize its benefit.

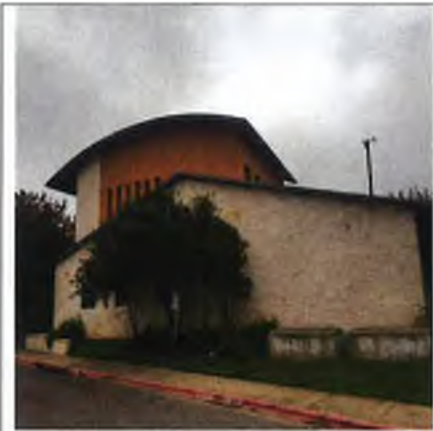
35 Robert Martinez Jr. St. Roof is in Good Condition.

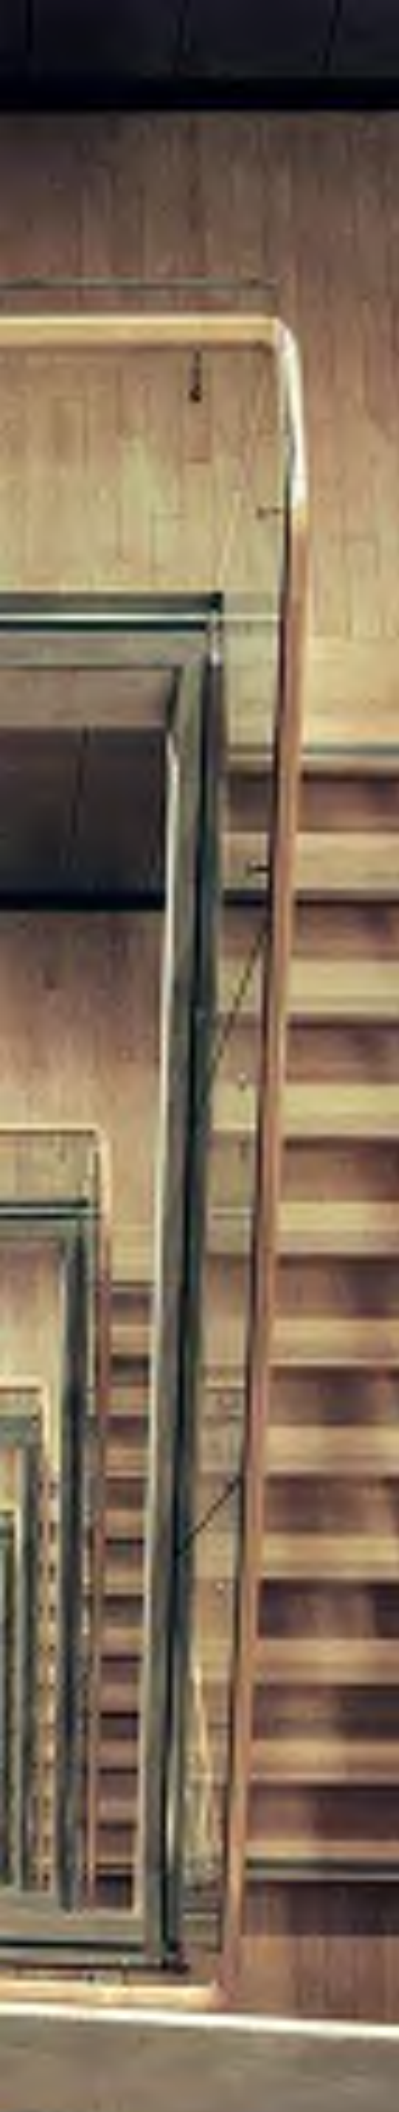
Facility Condition Assessment

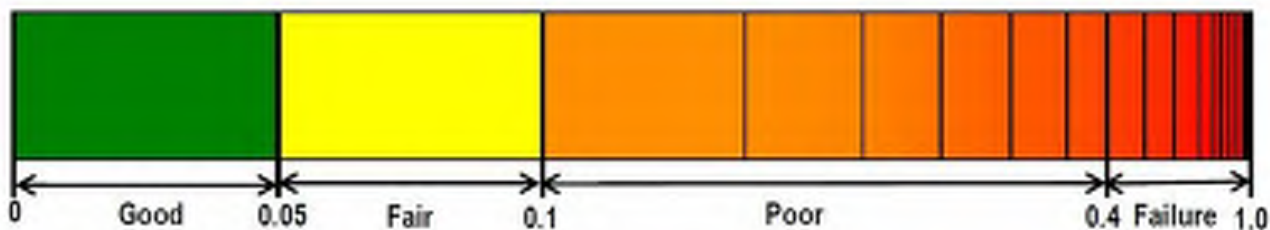
Therefore, the lower the FCI, the lower the need for remedial or renewal funding relative to the facility’s value. For example, an FCI of 0.07 signifies a 7% deficiency ratio which is generally considered to be in the fair range. An FCI of 0.7 means that 70% of the building needs extensive repairs or replacement. The FCI is a relative indicator of condition and should be tracked over time to maximize its benefit.

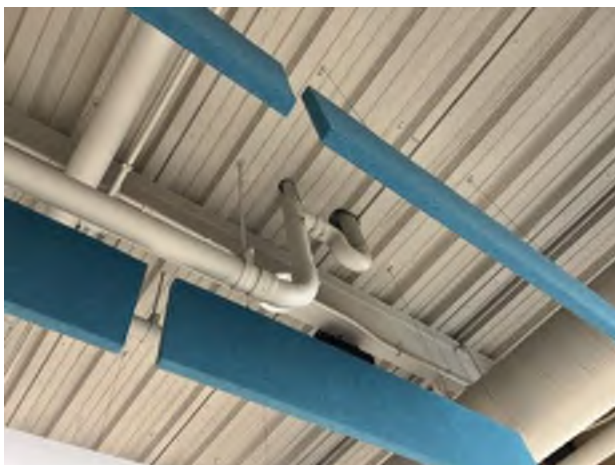
41. Leaking pipe at the ground floor ceiling.

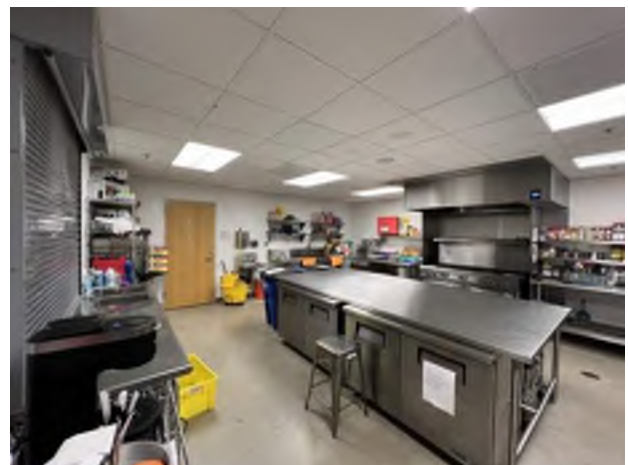
42. Kitchen interior finishes.

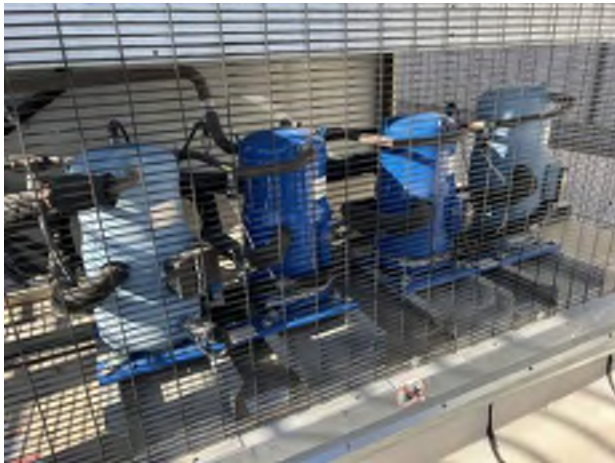
51. Replaced condenser at RTU-2.

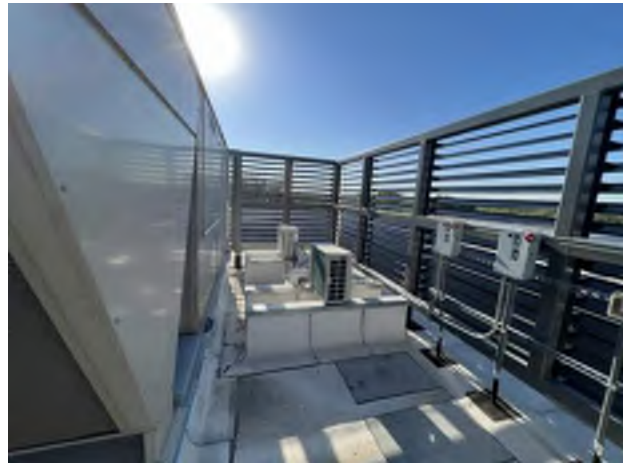
52. Mini split system condenser units.
