Appendix C - CBRE Condition Assessments

1. Alamo Recreation Center.....	3
2. Austin Recreation Center.....	83
3. Danny G McBeth Recreation Center.....	156
4. Delores Duffie Recreation Center.....	254

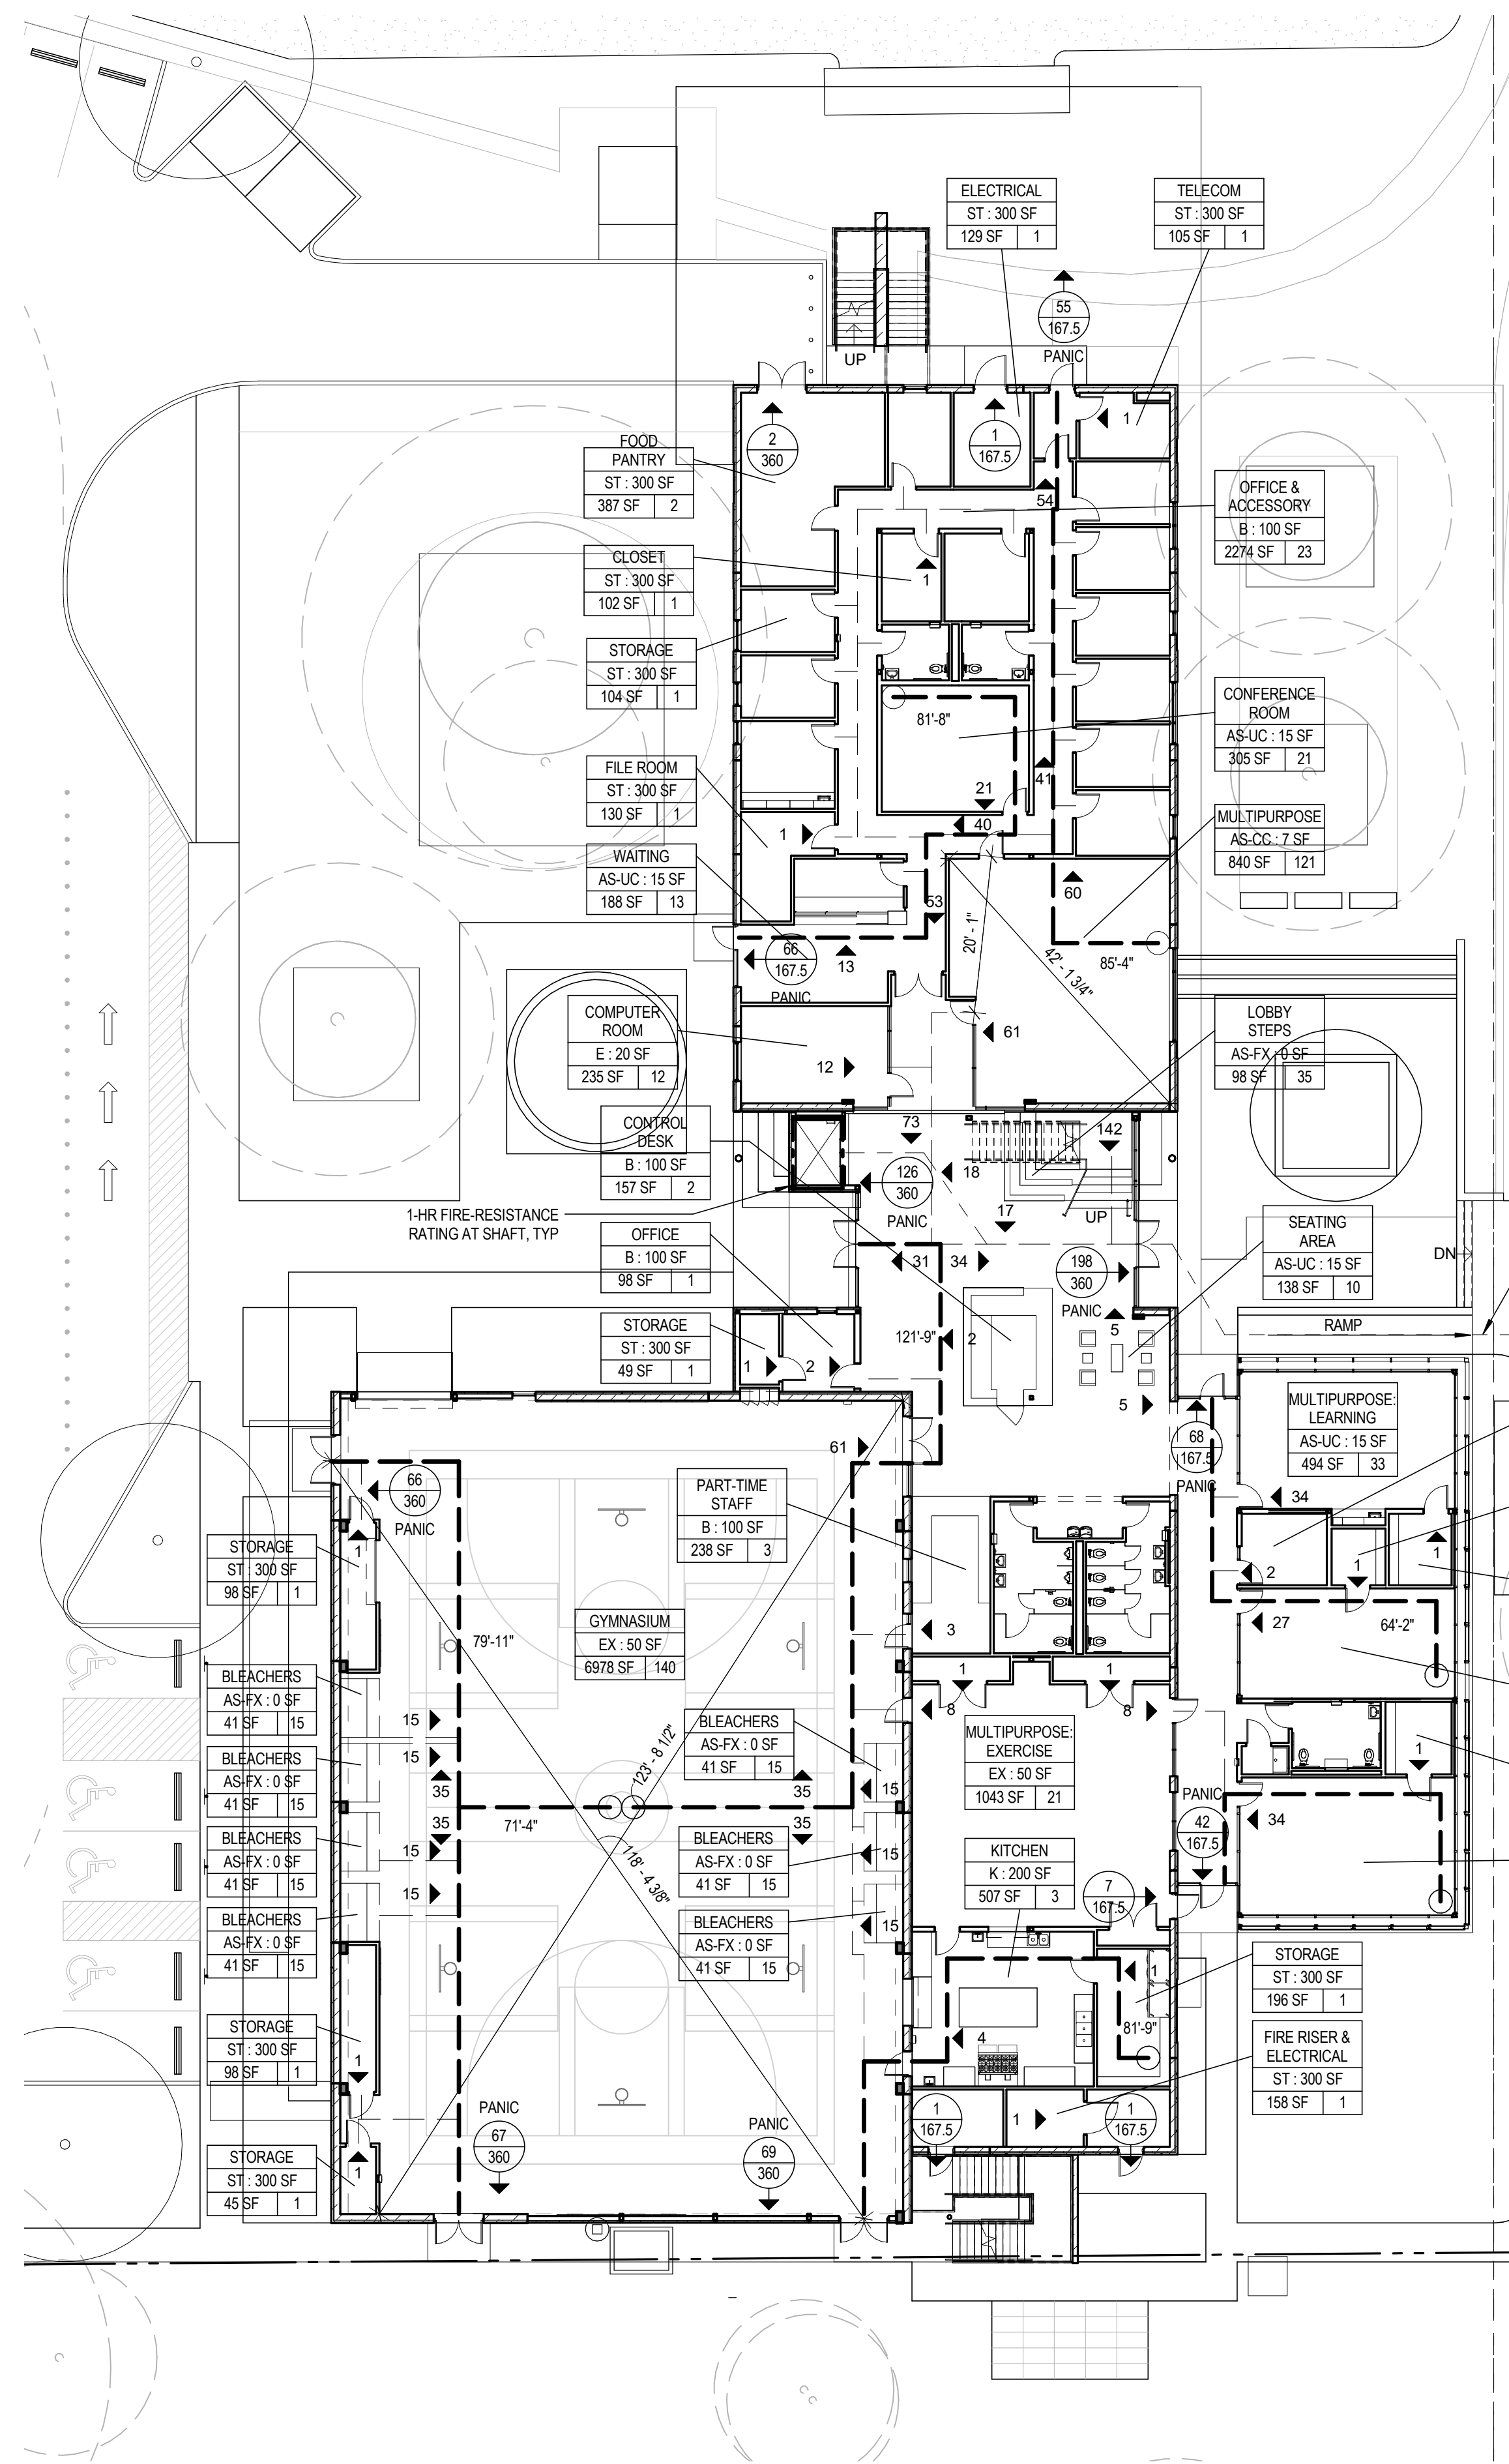
FIRE SAFETY AND EVACUATION PLAN - LEVEL 1 1
SCALE: 1/16" = 1'-0" | A022

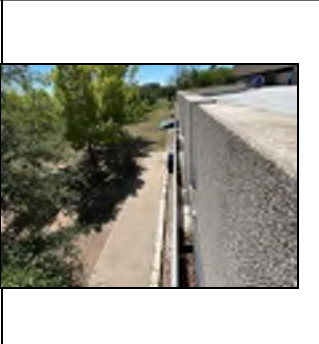
No.	Deficiency	Description	Unit	Unit Cost	Qty	Total	Deficiency Photo
10	Investigate Roof Leaks	On-site staff reported current roof leaks. Recommendation to engage a licensed professional to investigate the issue and complete repairs as needed.	Allow	\$3,000	1	\$3,000

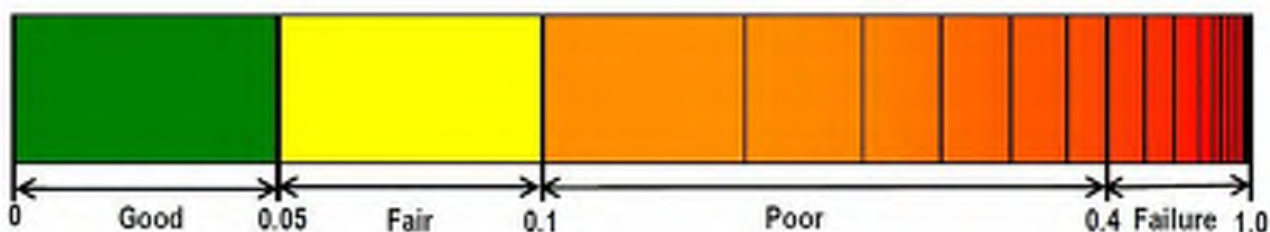
Therefore, the lower the FCI, the lower the need for remedial or renewal funding relative to the facility’s value. For example, an FCI of 0.07 signifies a 7% deficiency ratio which is generally considered to be in the fair range. An FCI of 0.7 means that 70% of the building needs extensive repairs or replacement. The FCI is a relative indicator of condition and should be tracked over time to maximize its benefit.

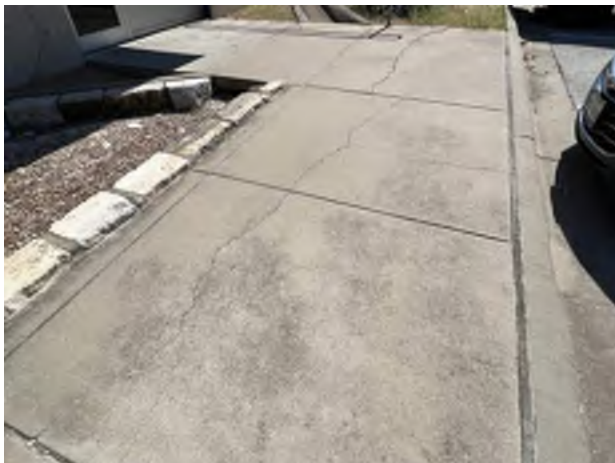
5. Cracked concrete walkway

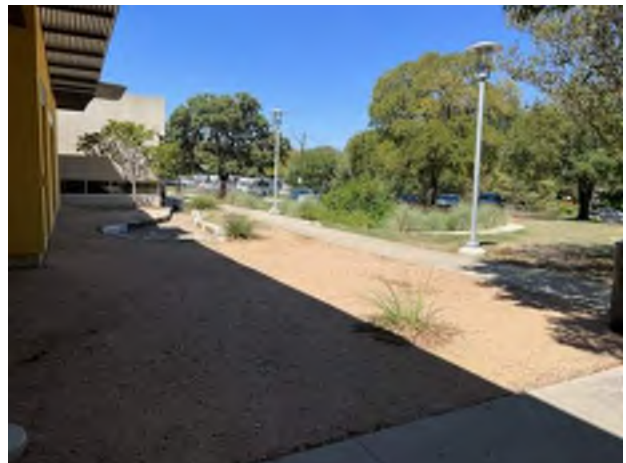
6. Landscaping at north side of building

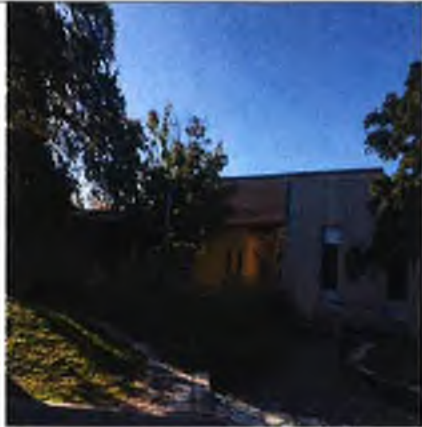
2913 Nrothland Dr. Modified roof installed in 2011. Good Condition.

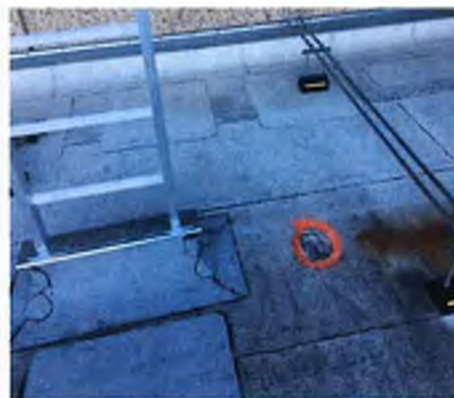
Old Patch needing properly repaired.

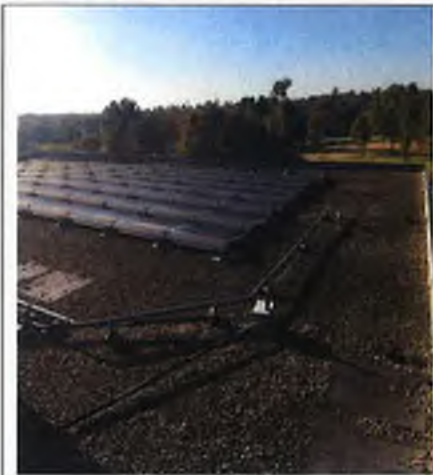
Gravel Built Up roof in Poor condition.
Solar Panels installed in 2012.

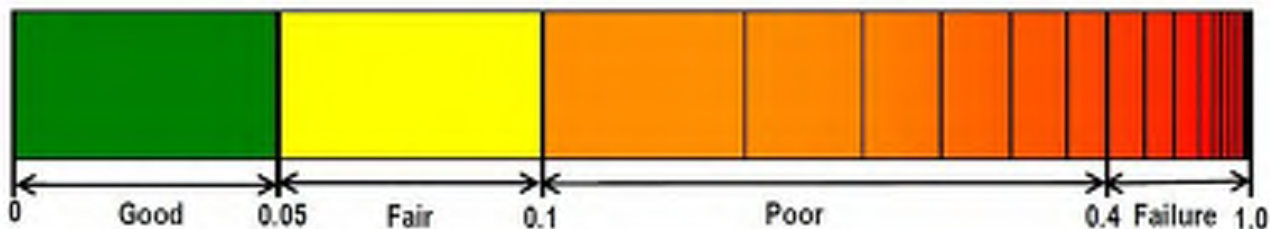
Therefore, the lower the FCI, the lower the need for remedial or renewal funding relative to the facility's value. For example, an FCI of 0.07 signifies a 7% deficiency ratio which is generally considered to be in the fair range. An FCI of 0.7 means that 70% of the building needs extensive repairs or replacement. The FCI is a relative indicator of condition and should be tracked over time to maximize its benefit.

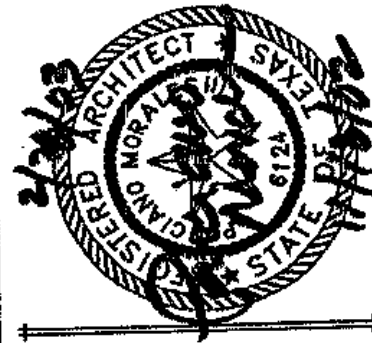
CONSULTANTS
 CIVIL:
 STRUCTURAL: P.E. STRUCTURAL
 MECHANICAL: JOSE I. GUERRA, INC.

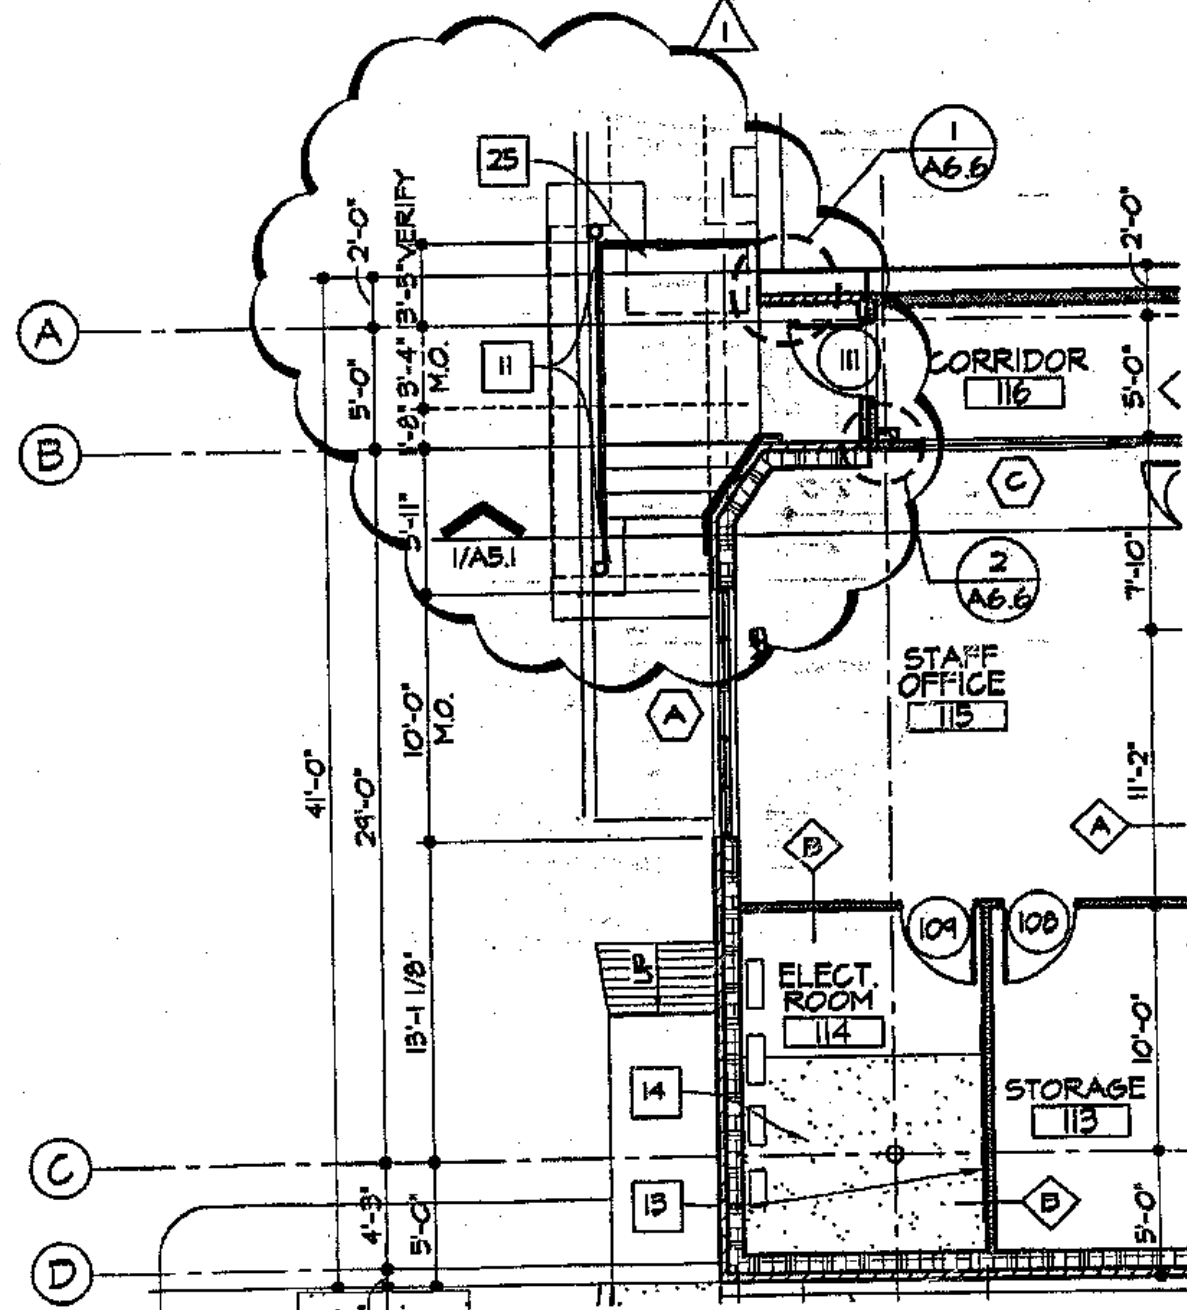
NEW FIRST FLOOR PLAN A2.2
 SCALE: 1/8" = 1'-0"
 A2.2-1A

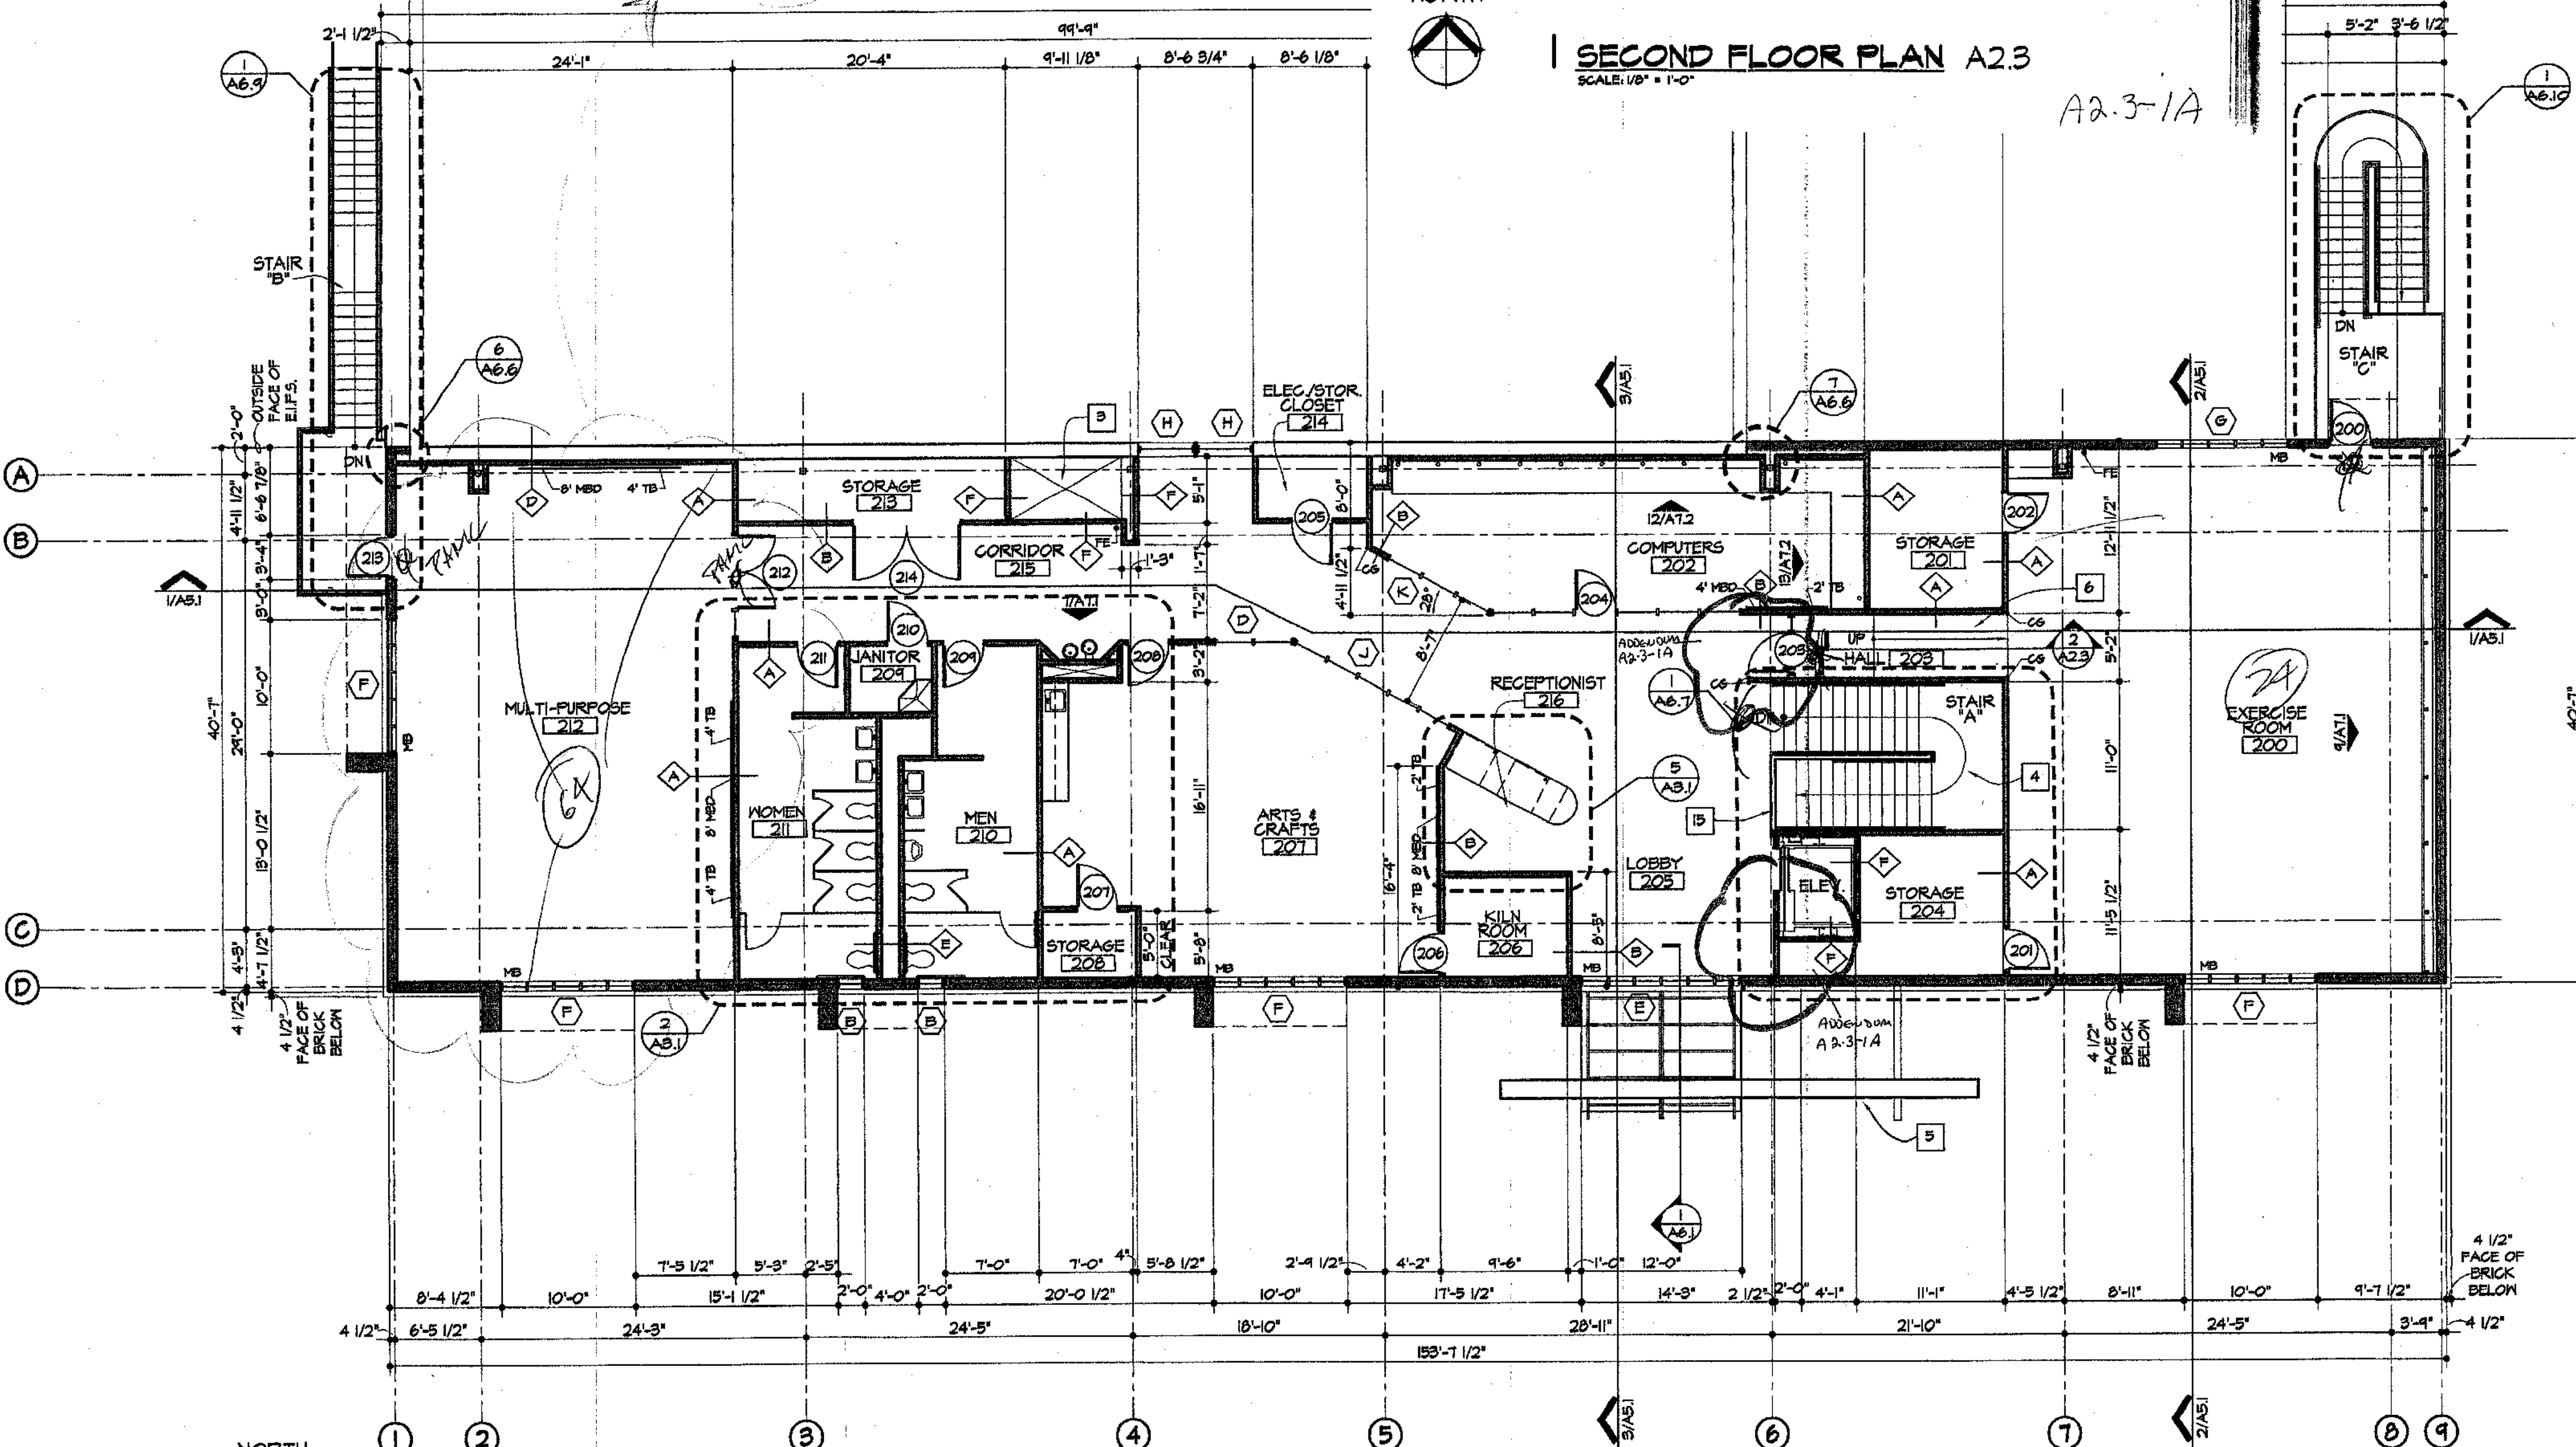
SECOND FLOOR PLAN
SCALE: 1/8" = 1'-0"

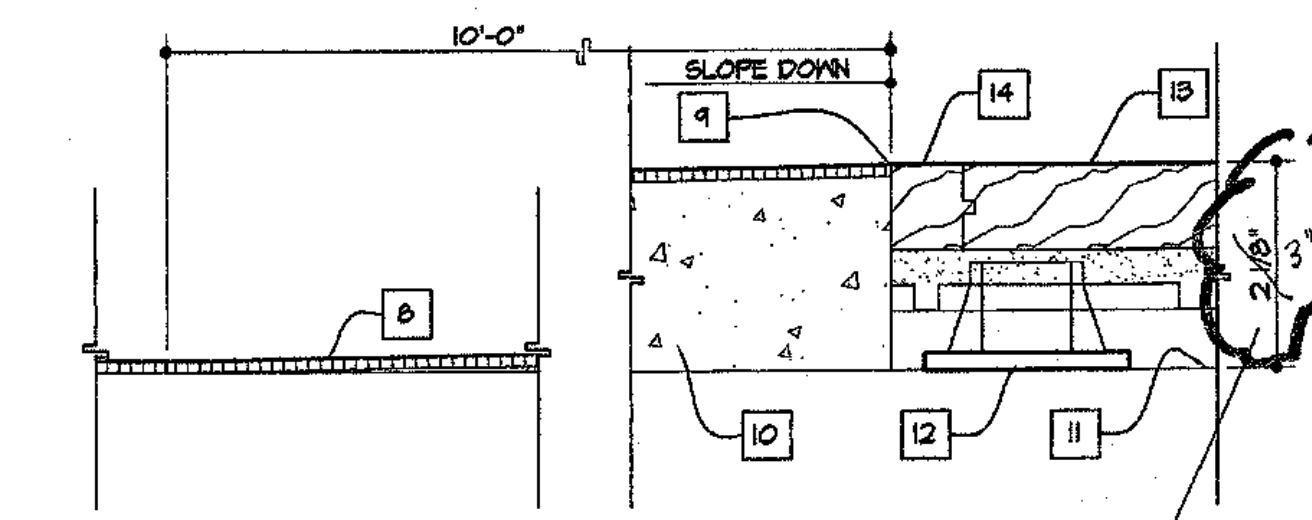
SECTION THROUGH RAMP
SCALE: 6" = 1'-0"

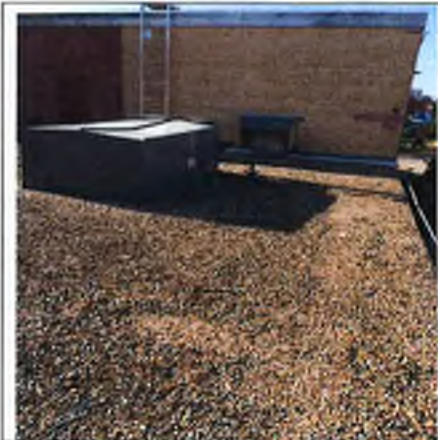
2100 E 3rd St. Gravel Built Up/Poor Condition, Metal/Fair Condition.

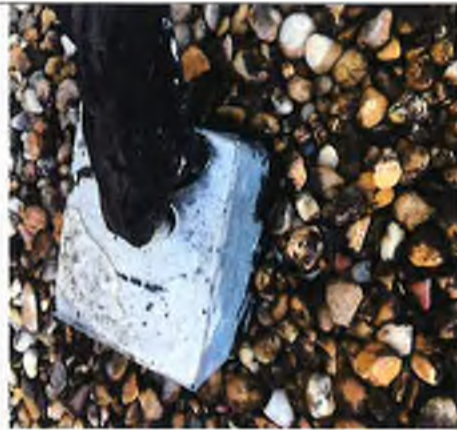
1 pitch pan needing resealed/filled. Next (2) pictures.

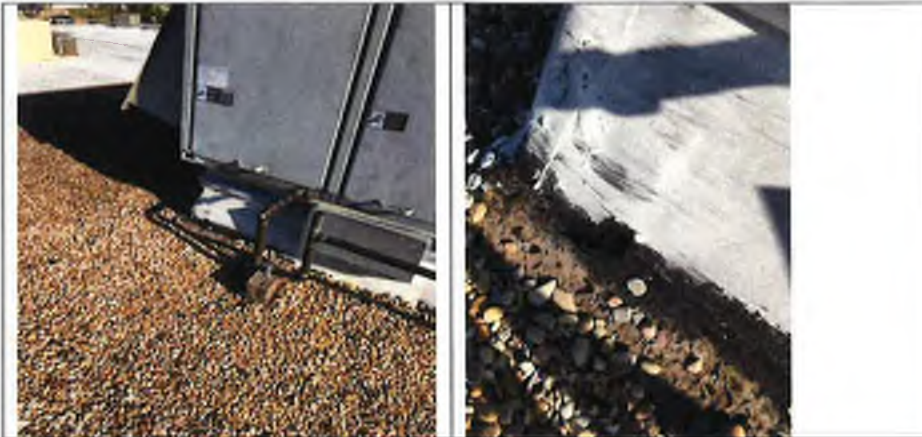
4 Holes/damaged flashing at RTUs
needing coated. Next (3) pictures.

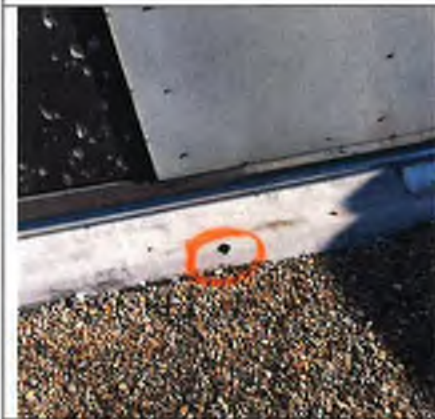
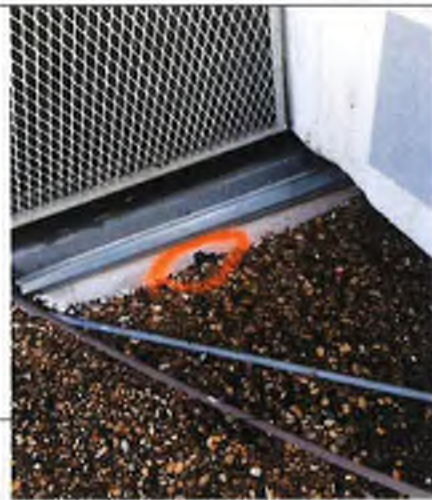
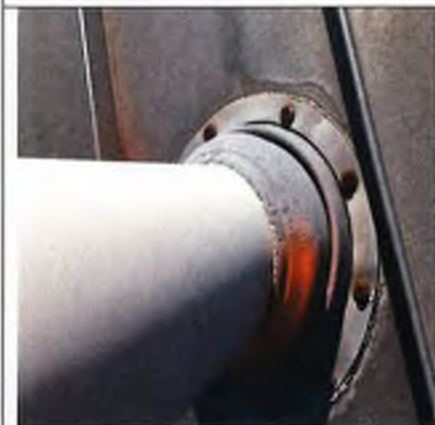
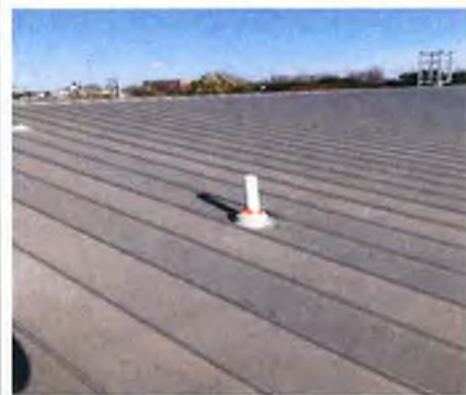
4 pipe boots needing resealed. Next 2
pictures.

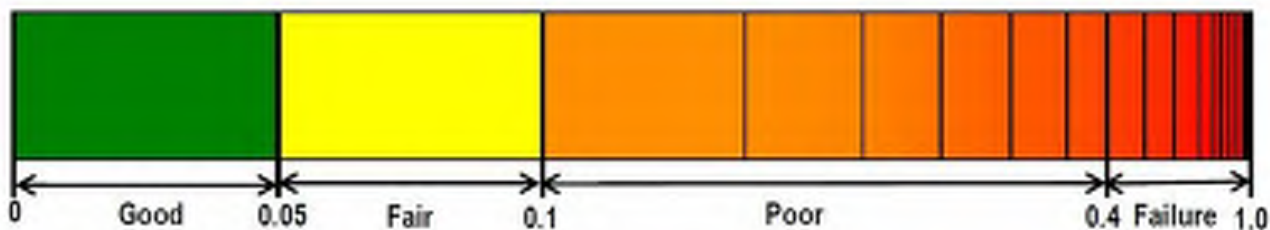
Therefore, the lower the FCI, the lower the need for remedial or renewal funding relative to the facility's value. For example, an FCI of 0.07 signifies a 7% deficiency ratio which is generally considered to be in the fair range. An FCI of 0.7 means that 70% of the building needs extensive repairs or replacement. The FCI is a relative indicator of condition and should be tracked over time to maximize its benefit.

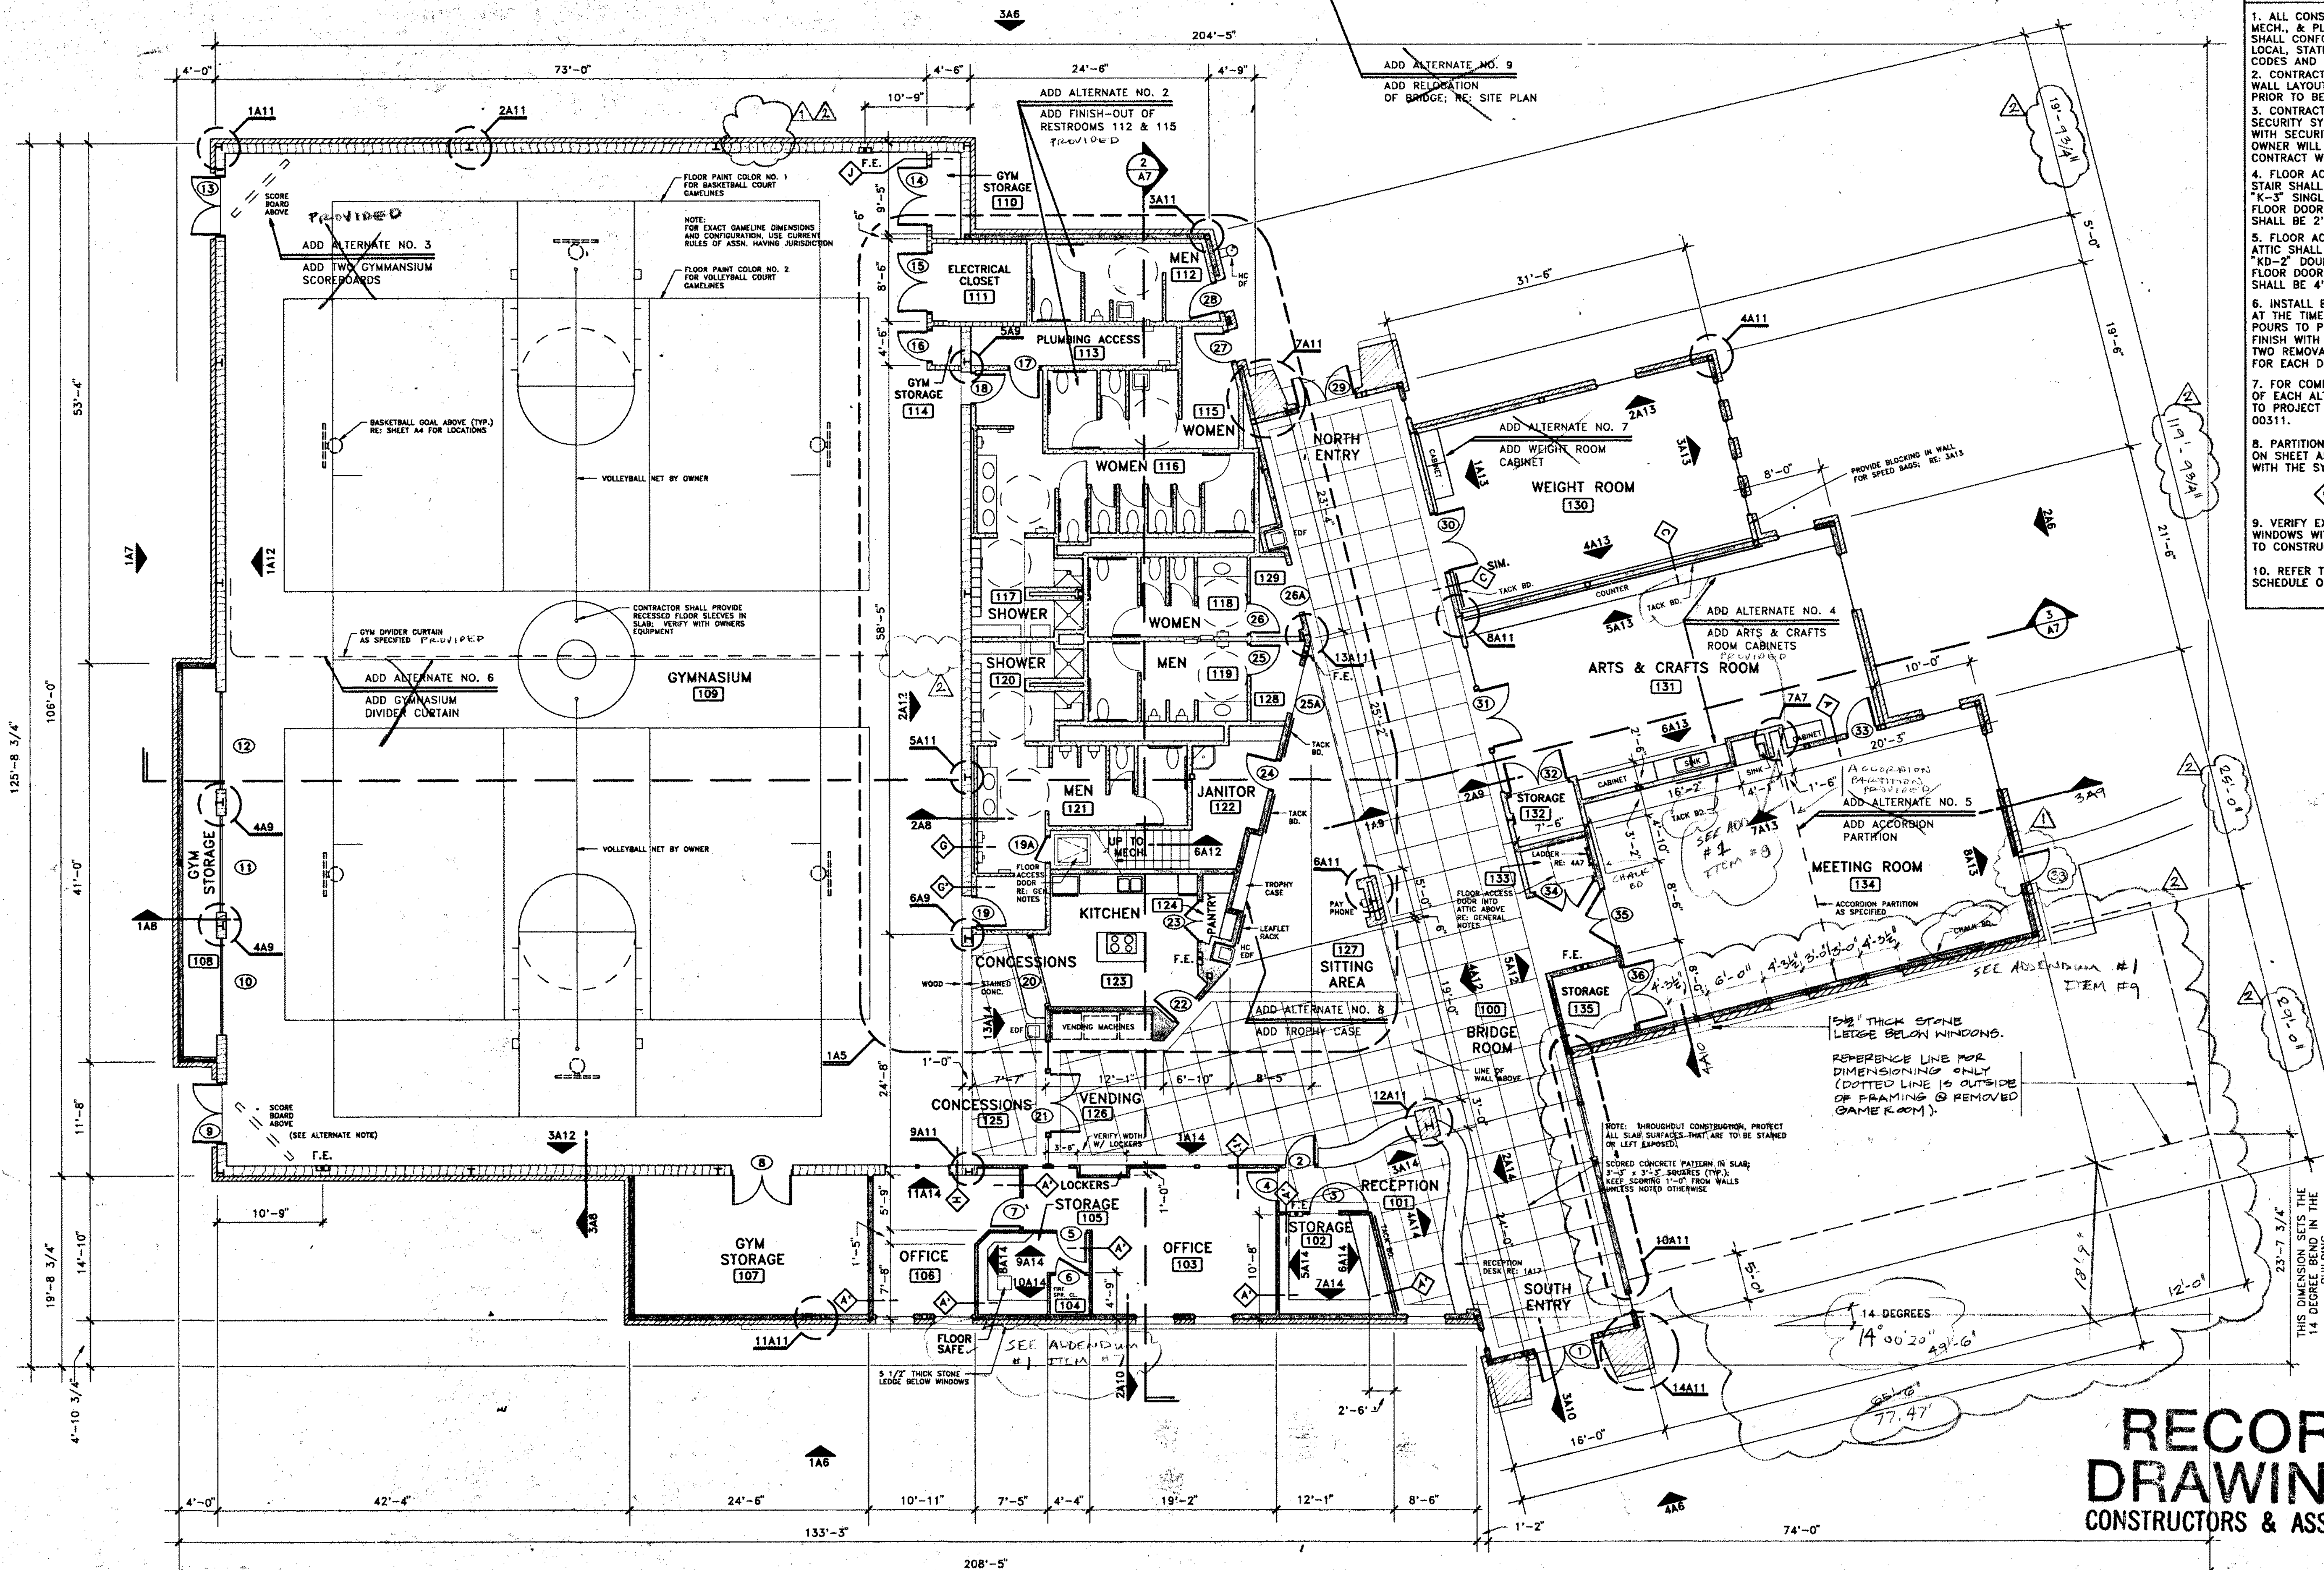
- GENERAL NOTES**
1. ALL CONSTRUCTION, ELECT., MECH., & PLUMBING WORK SHALL CONFORM TO APPLICABLE LOCAL STATE AND NATIONAL CODES AND ORDINANCES.
 2. CONTRACTOR SHALL VERIFY WALL LAYOUT WITH ARCHITECT PRIOR TO BEGINNING CONST.

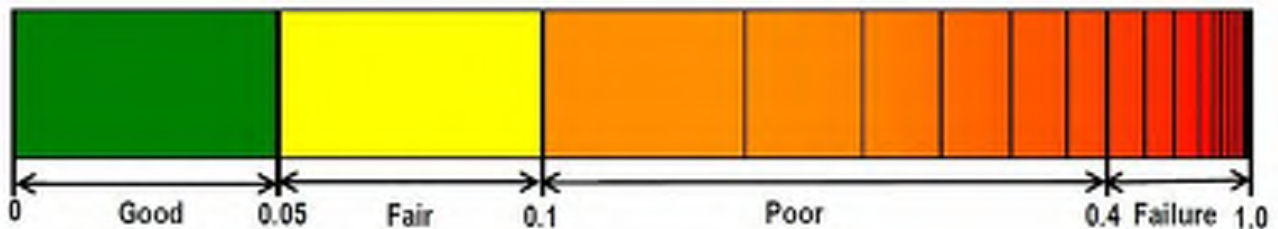
Therefore, the lower the FCI, the lower the need for remedial or renewal funding relative to the facility’s value. For example, an FCI of 0.07 signifies a 7% deficiency ratio which is generally considered to be in the fair range. An FCI of 0.7 means that 70% of the building needs extensive repairs or replacement. The FCI is a relative indicator of condition and should be tracked over time to maximize its benefit.

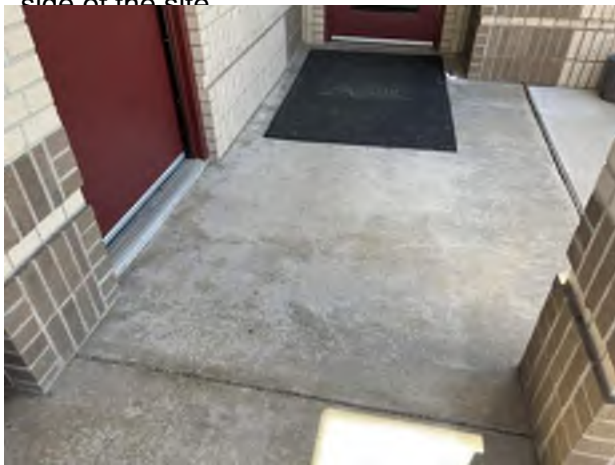
3. Isolated cracking at the concrete entryway.

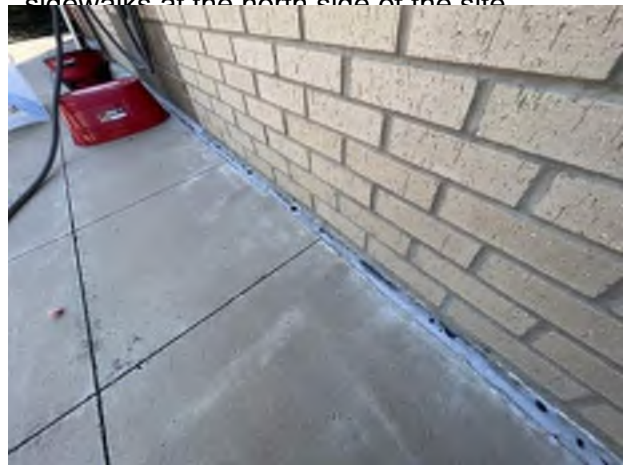
4. Failing expansion joint along the east building perimeter

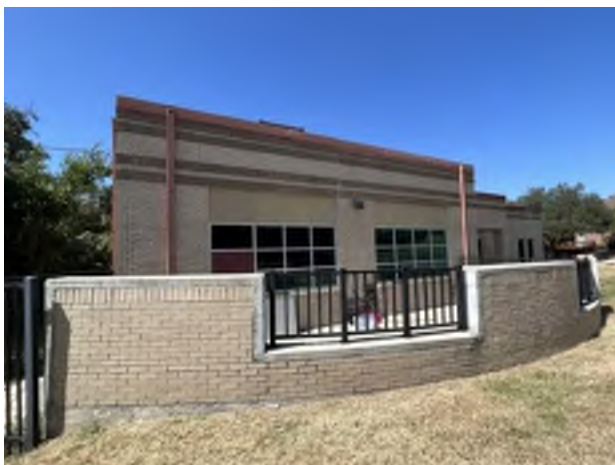
5. Brick site wall with painted metal fencing along the east side of the building

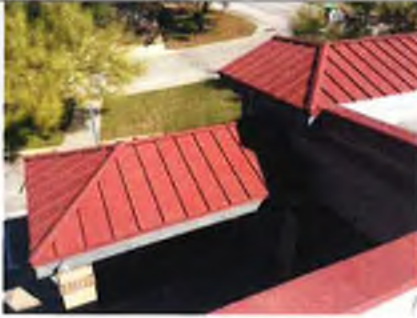
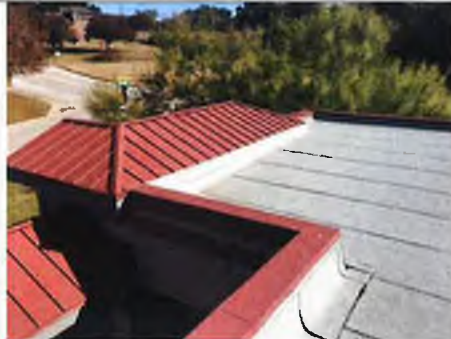
<p>200 S Lamer Blvd. Both Roof areas are in Good Condition.</p>	<p>Overview.</p>

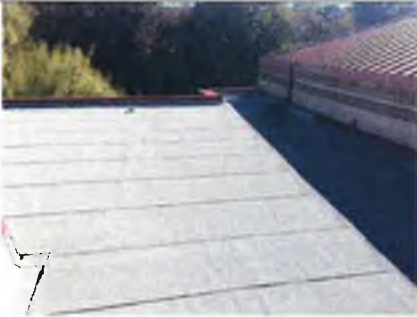
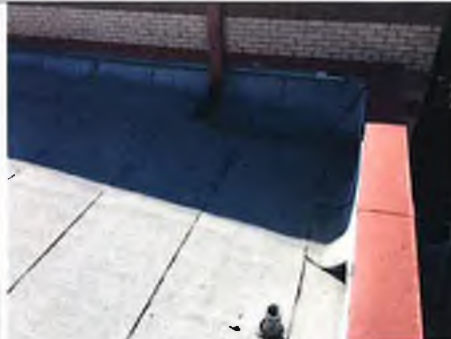
<p>Overview.</p>	<p>Overview.</p>

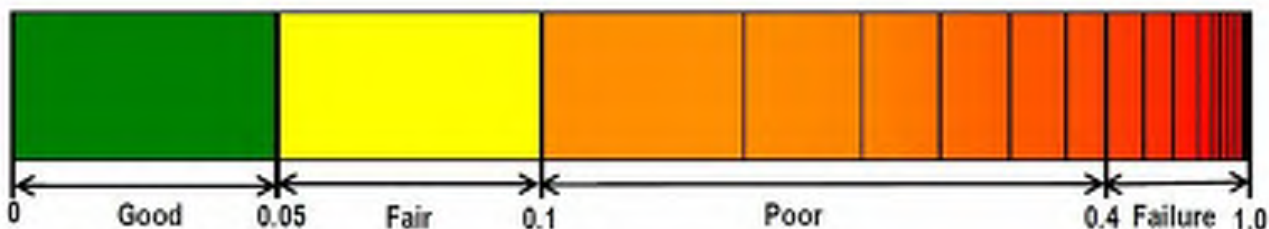
Therefore, the lower the FCI, the lower the need for remedial or renewal funding relative to the facility’s value. For example, an FCI of 0.07 signifies a 7% deficiency ratio which is generally considered to be in the fair range. An FCI of 0.7 means that 70% of the building needs extensive repairs or replacement. The FCI is a relative indicator of condition and should be tracked over time to maximize its benefit.

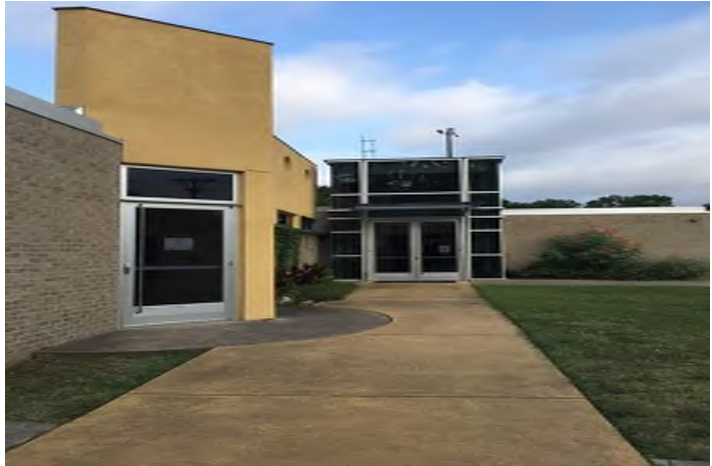
Please make all checks payable to:
Empire Roofing Companies, Inc.
16311 Central Commerce Drive
Pflugerville, TX 78660

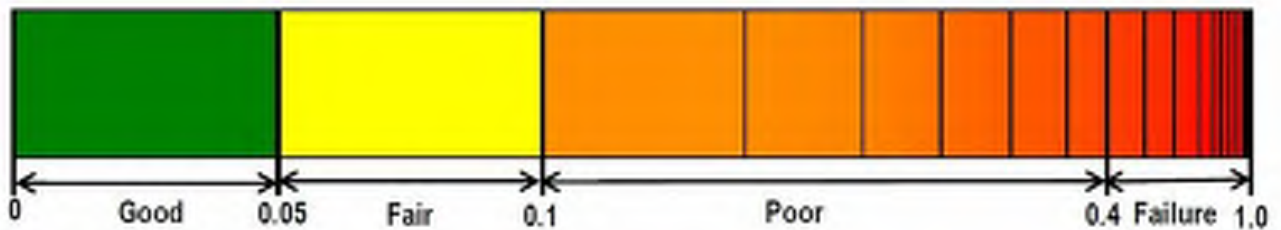
Therefore, the lower the FCI, the lower the need for remedial or renewal funding relative to the facility’s value. For example, an FCI of 0.07 signifies a 7% deficiency ratio which is generally considered to be in the fair range. An FCI of 0.7 means that 70% of the building needs extensive repairs or replacement. The FCI is a relative indicator of condition and should be tracked over time to maximize its benefit.

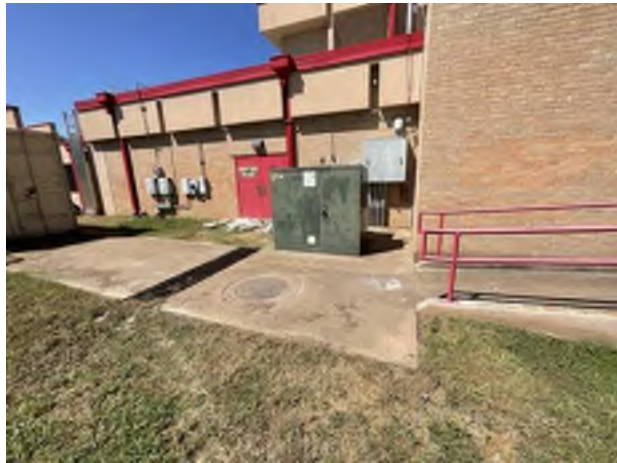
15. Transformer Pad and Worn Metal Door Paint
