Appendix C - CBRE Condition Assessments

1. Alamo Recreation Center.....	3
2. Austin Recreation Center.....	83
3. Danny G McBeth Recreation Center.....	156
4. Delores Duffie Recreation Center.....	254

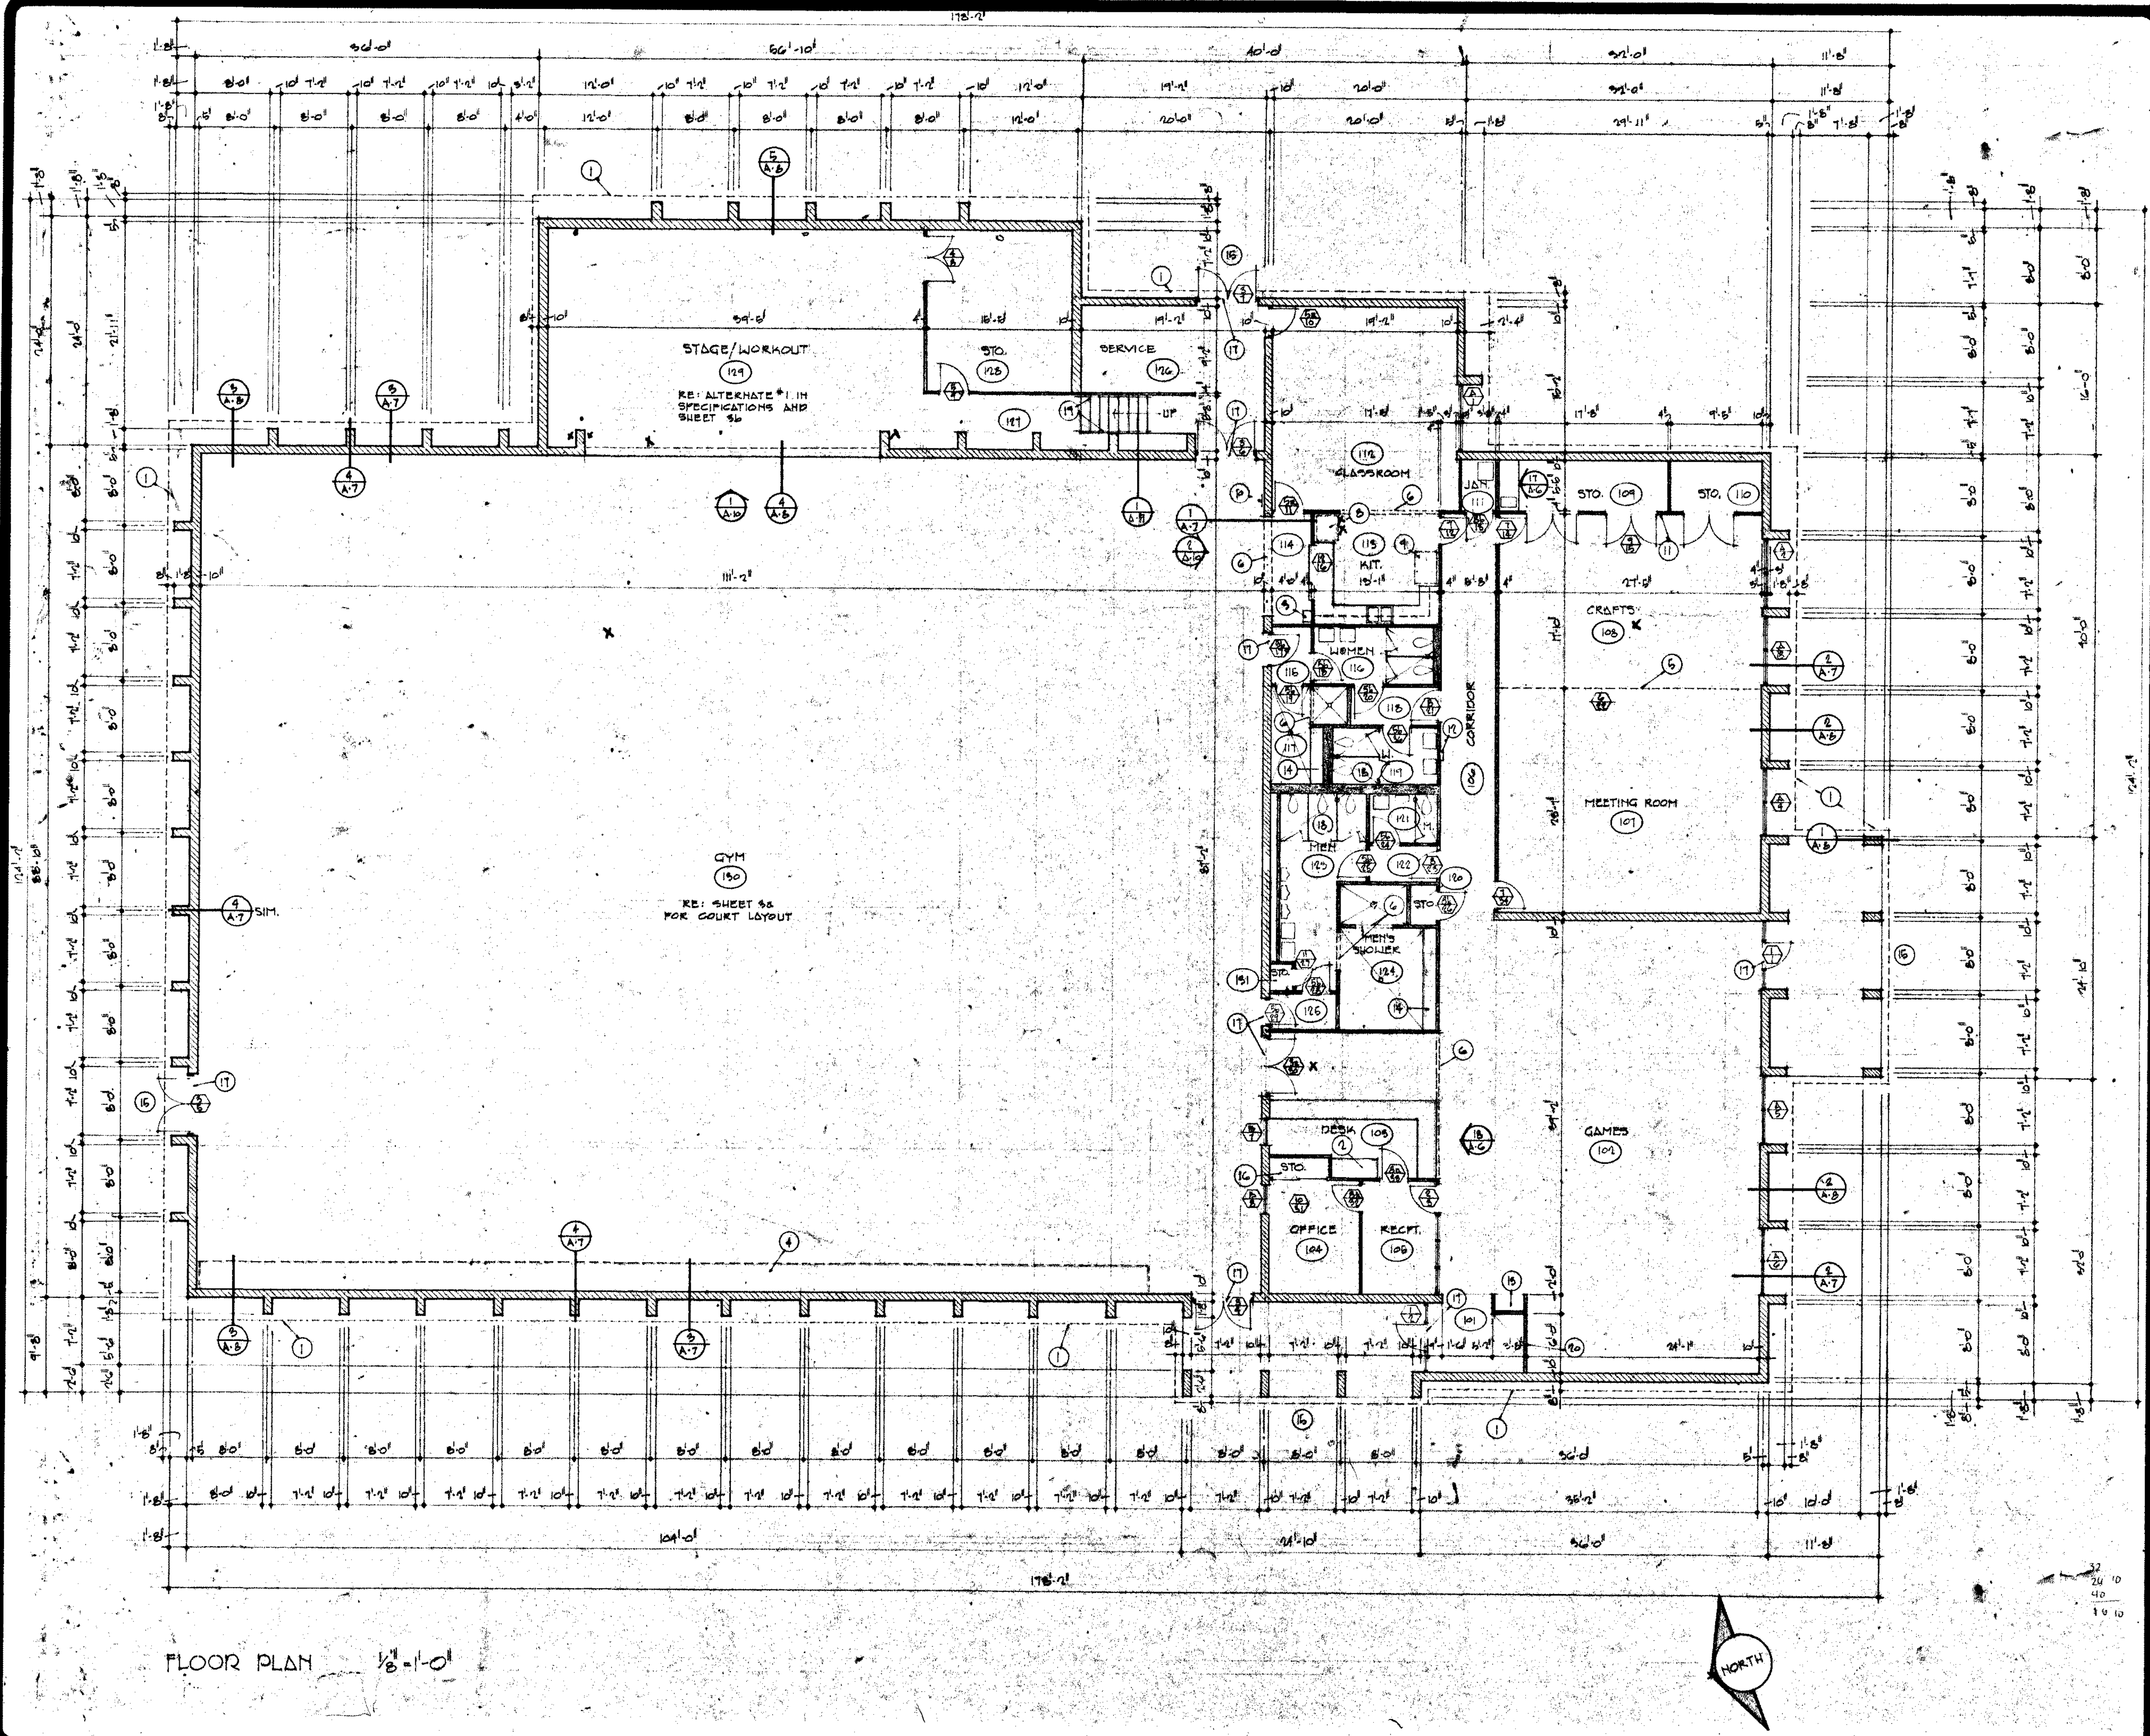
FLOOR PLAN 1/8" = 1'-0"

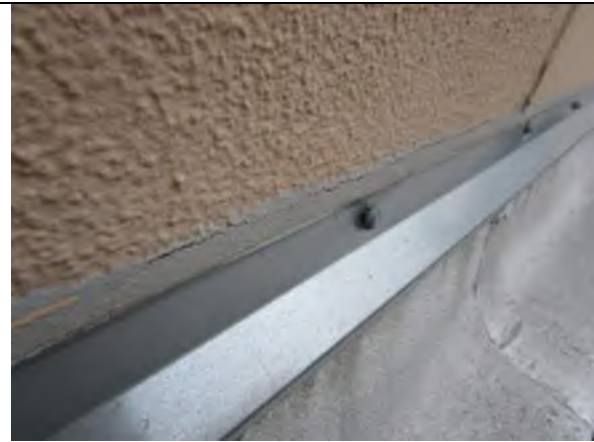
Caulking along existing counter flashing has failed and should be replaced with new sealant.

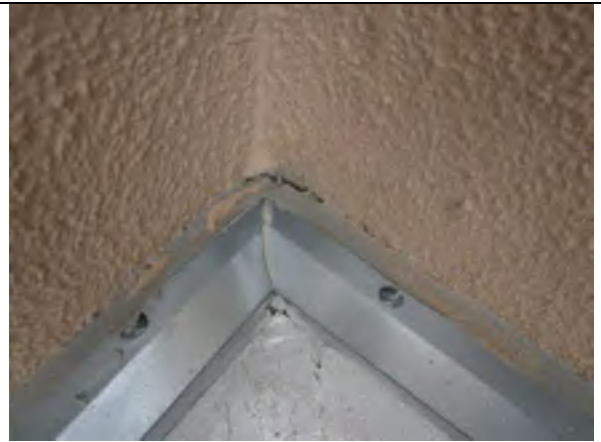
Caulking along existing counter flashing has failed and should be replaced with new sealant.

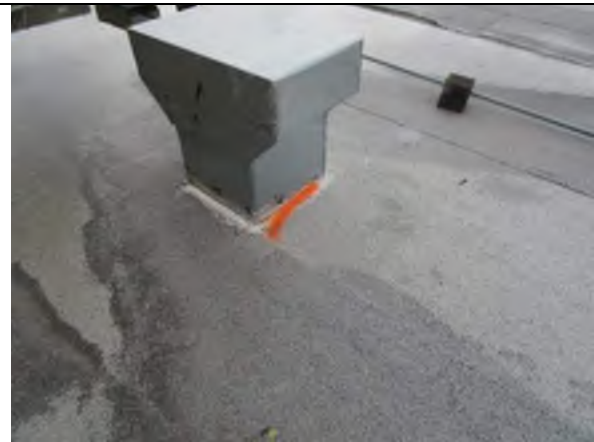
Abandoned T-top should be removed and roof brought back to original condition.

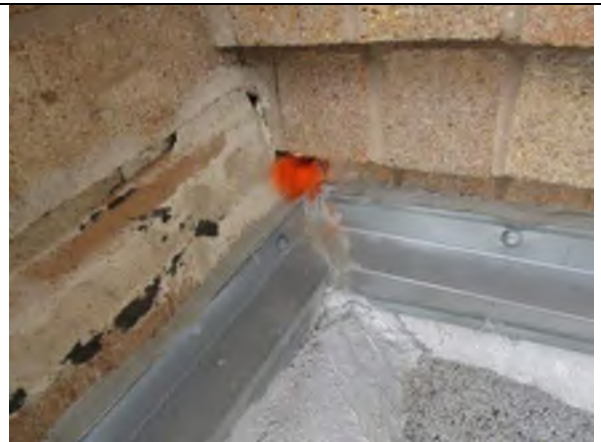
Mortar joint has opened. Sealant should be installed to prevent water intrusion.

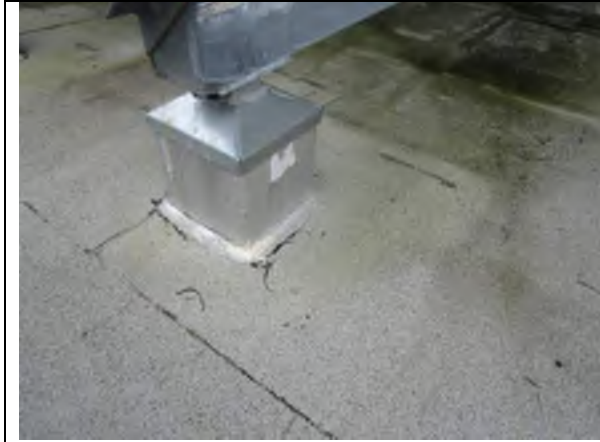
Sealant at the base of the pitch pan has failed and should be repaired with liquid applied membrane.

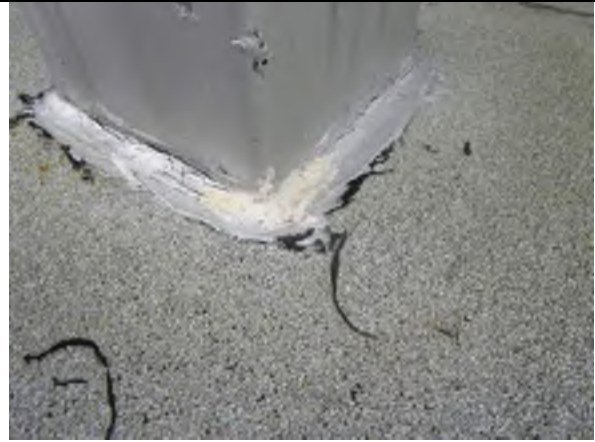
Sealant at the base of the pitch pan has failed and should be repaired with liquid applied membrane.

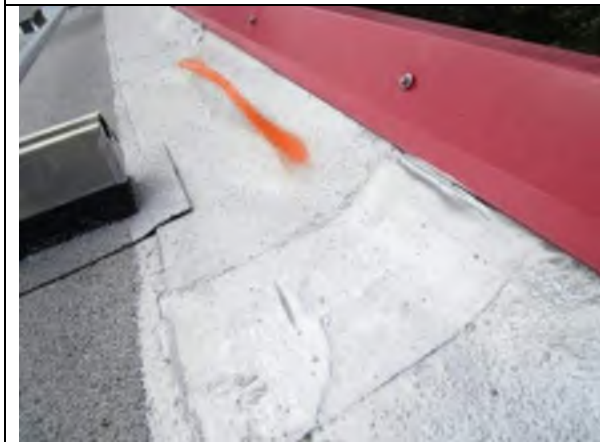
Blister in the existing base flashing. Blister should be cut out and roof repaired using modified bitumen.

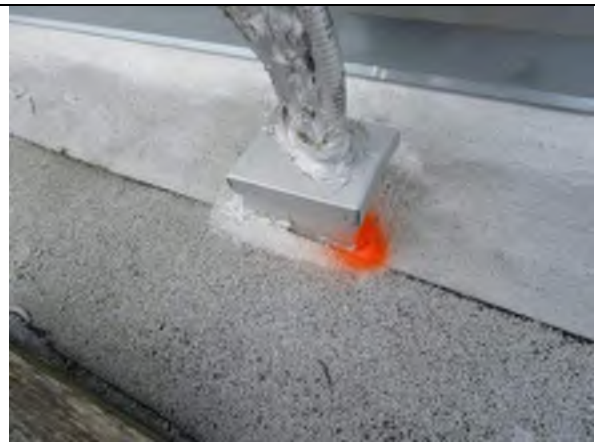
Pitch pan has failed and should be replaced.

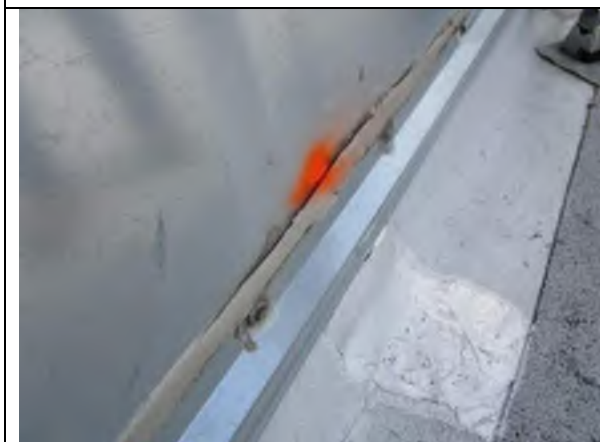
Sealant along the HVAC unit's counter flashing has failed and should be replaced with new sealant.

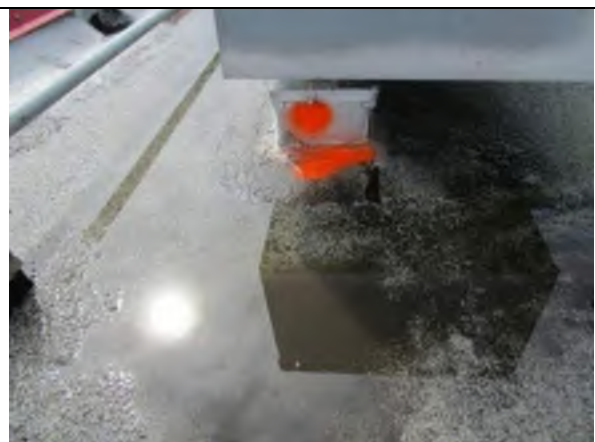
Sealant at base of existing pitch pan has failed and should be repaired using liquid applied membrane.

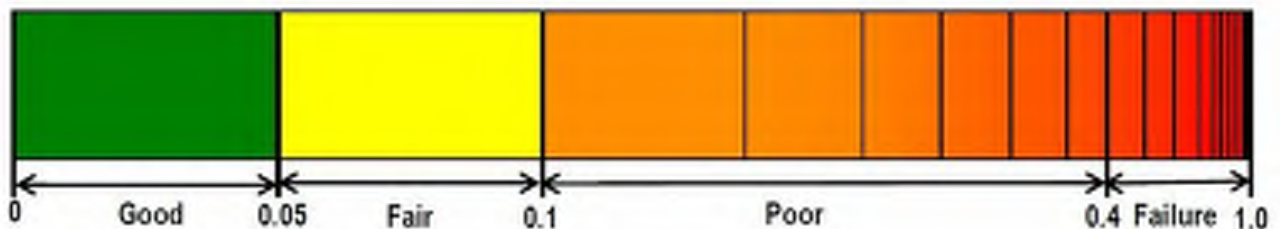
Therefore, the lower the FCI, the lower the need for remedial or renewal funding relative to the facility's value. For example, an FCI of 0.07 signifies a 7% deficiency ratio which is generally considered to be in the fair range. An FCI of 0.7 means that 70% of the building needs extensive repairs or replacement. The FCI is a relative indicator of condition and should be tracked over time to maximize its benefit.

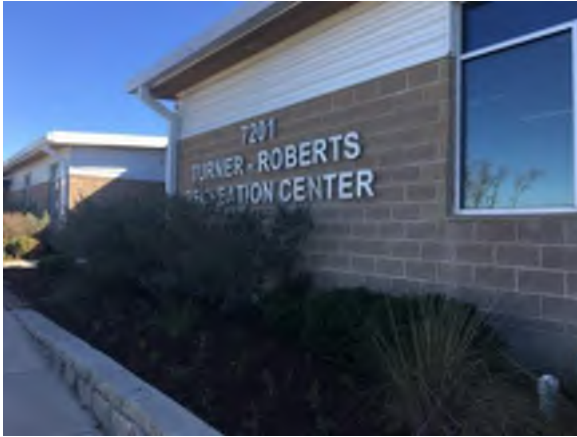
Area #1 Modified needing repairs to be completed at multiple areas of improper repairs approximately 30LF. Next (15) pictures.

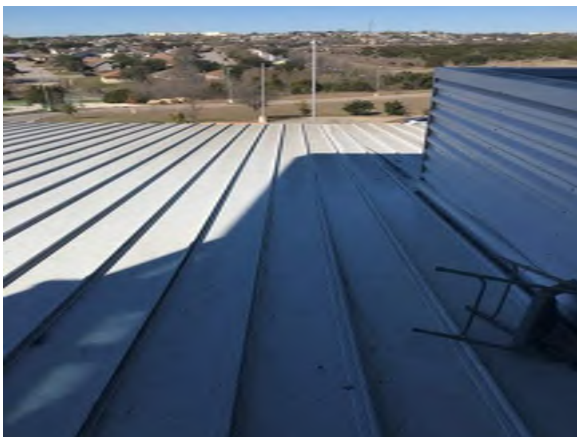
Area #2 No repairs needed. Next (7) pictures.

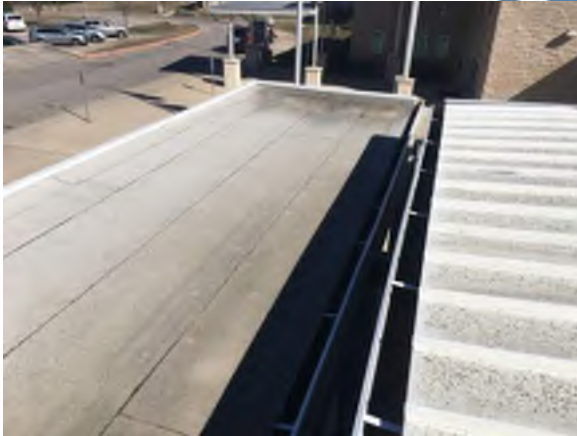
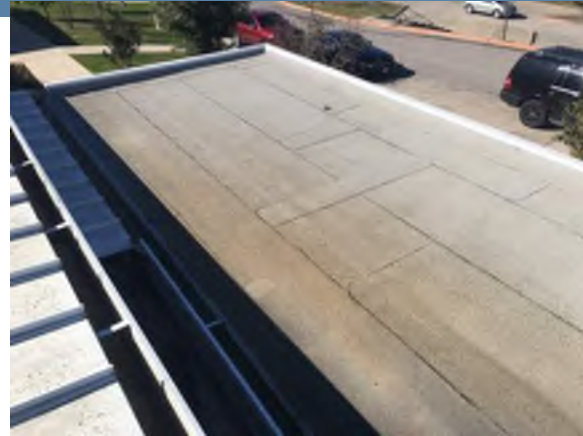
Area #3 No repairs needed. Next picture.

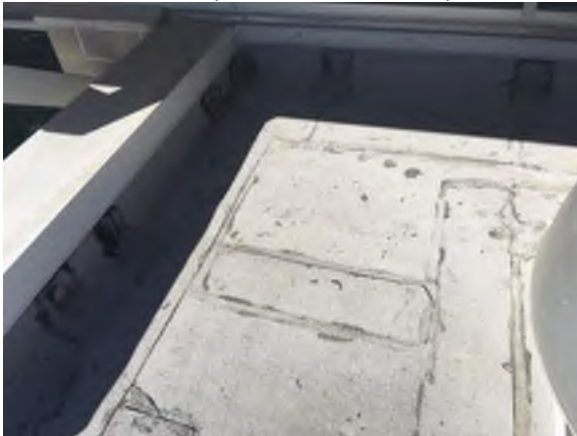
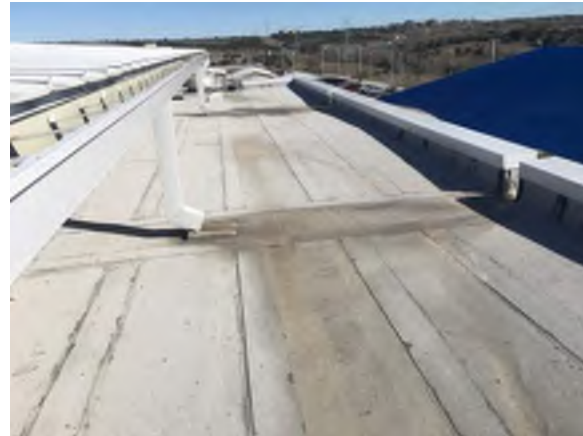
Area #4 needing (1) pipe resealed. Next 4 pictures of area #4.

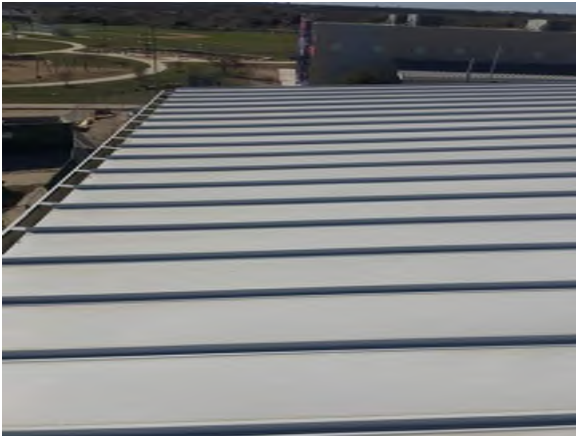
Area #5 No repairs needed. Next (7) pictures.

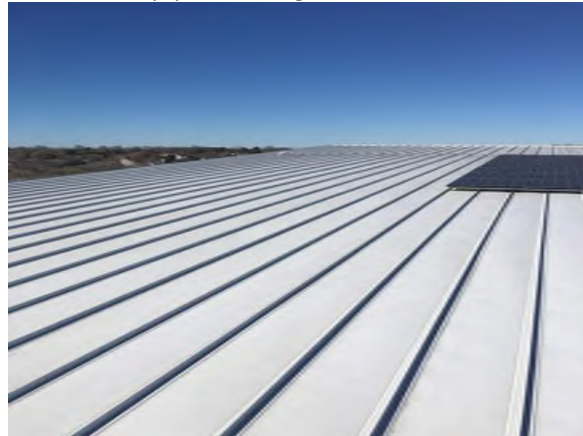
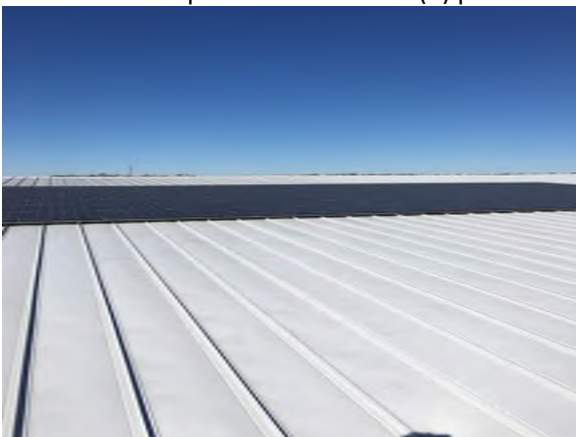
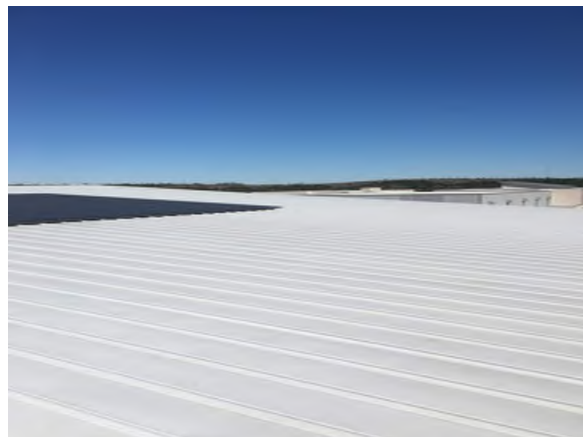
“The Roofing Company by which All Others are Measured.”
Thank you for your business!

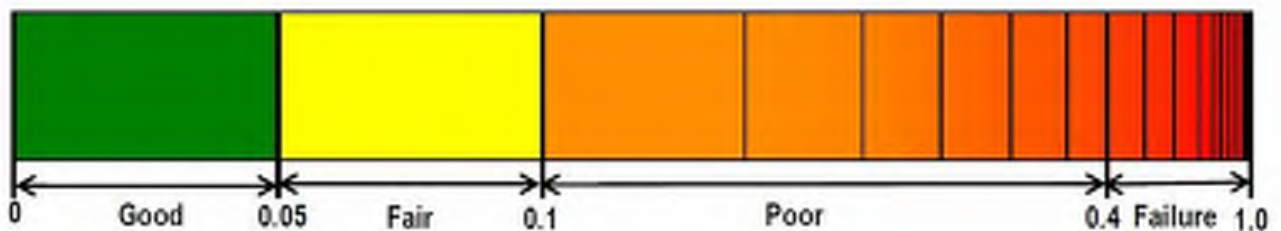
Therefore, the lower the FCI, the lower the need for remedial or renewal funding relative to the facility’s value. For example, an FCI of 0.07 signifies a 7% deficiency ratio which is generally considered to be in the fair range. An FCI of 0.7 means that 70% of the building needs extensive repairs or replacement. The FCI is a relative indicator of condition and should be tracked over time to maximize its benefit.

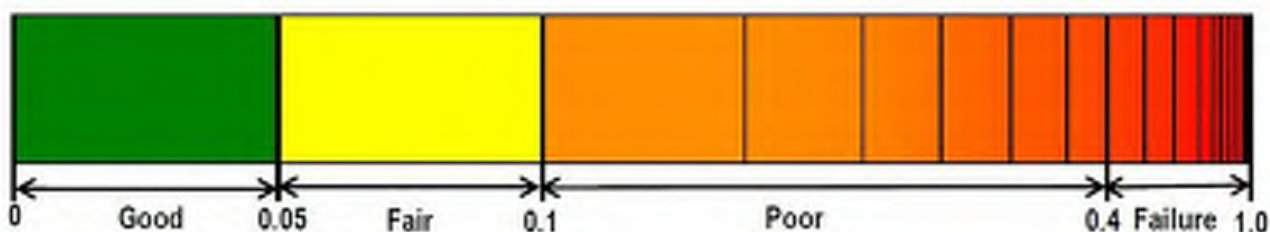
Therefore, the lower the FCI, the lower the need for remedial or renewal funding relative to the facility’s value. For example, an FCI of 0.07 signifies a 7% deficiency ratio which is generally considered to be in the fair range. An FCI of 0.7 means that 70% of the building needs extensive repairs or replacement. The FCI is a relative indicator of condition and should be tracked over time to maximize its benefit.

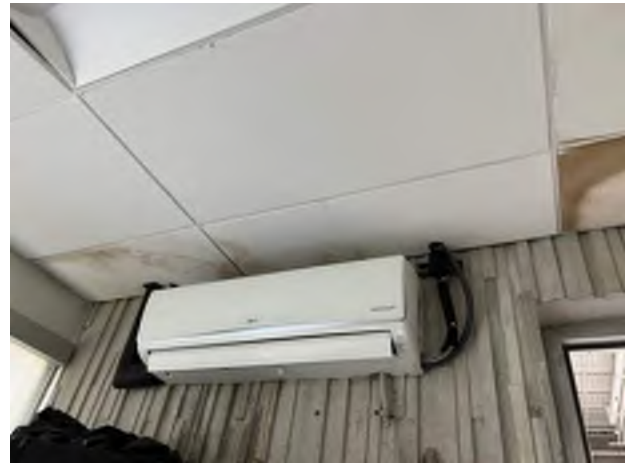
34. Split system air conditioner

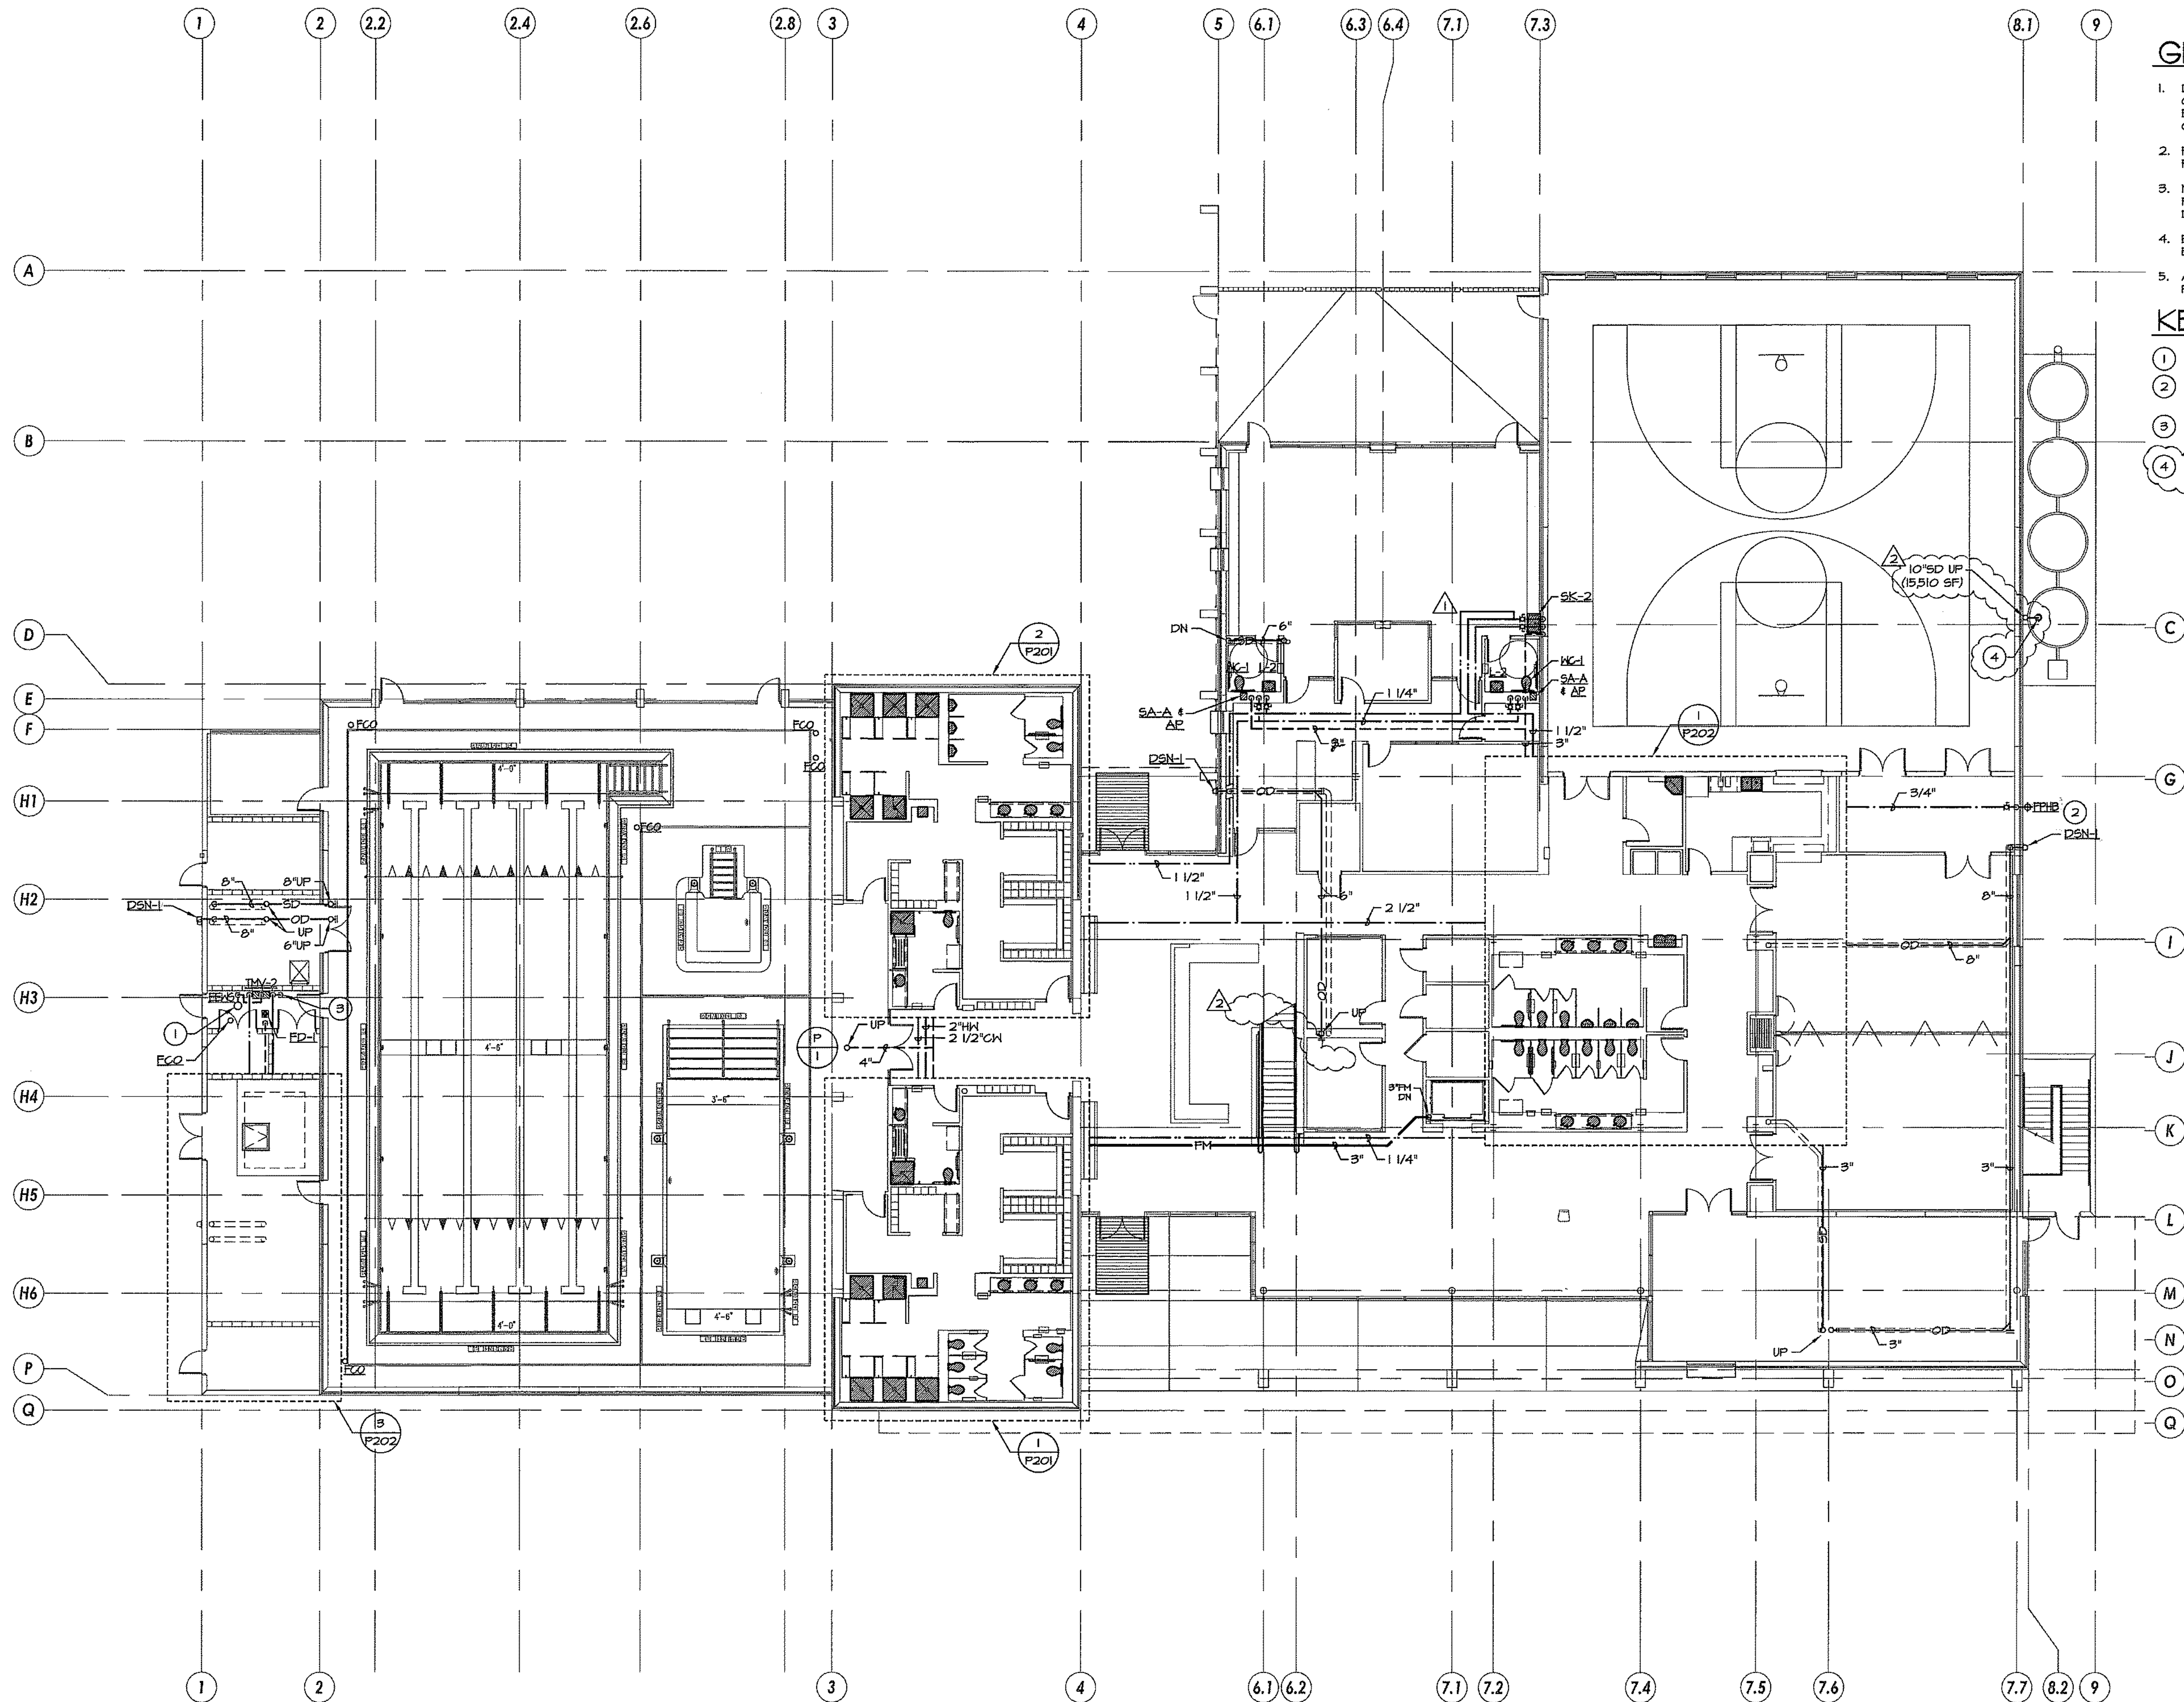
Supplementary Documentation

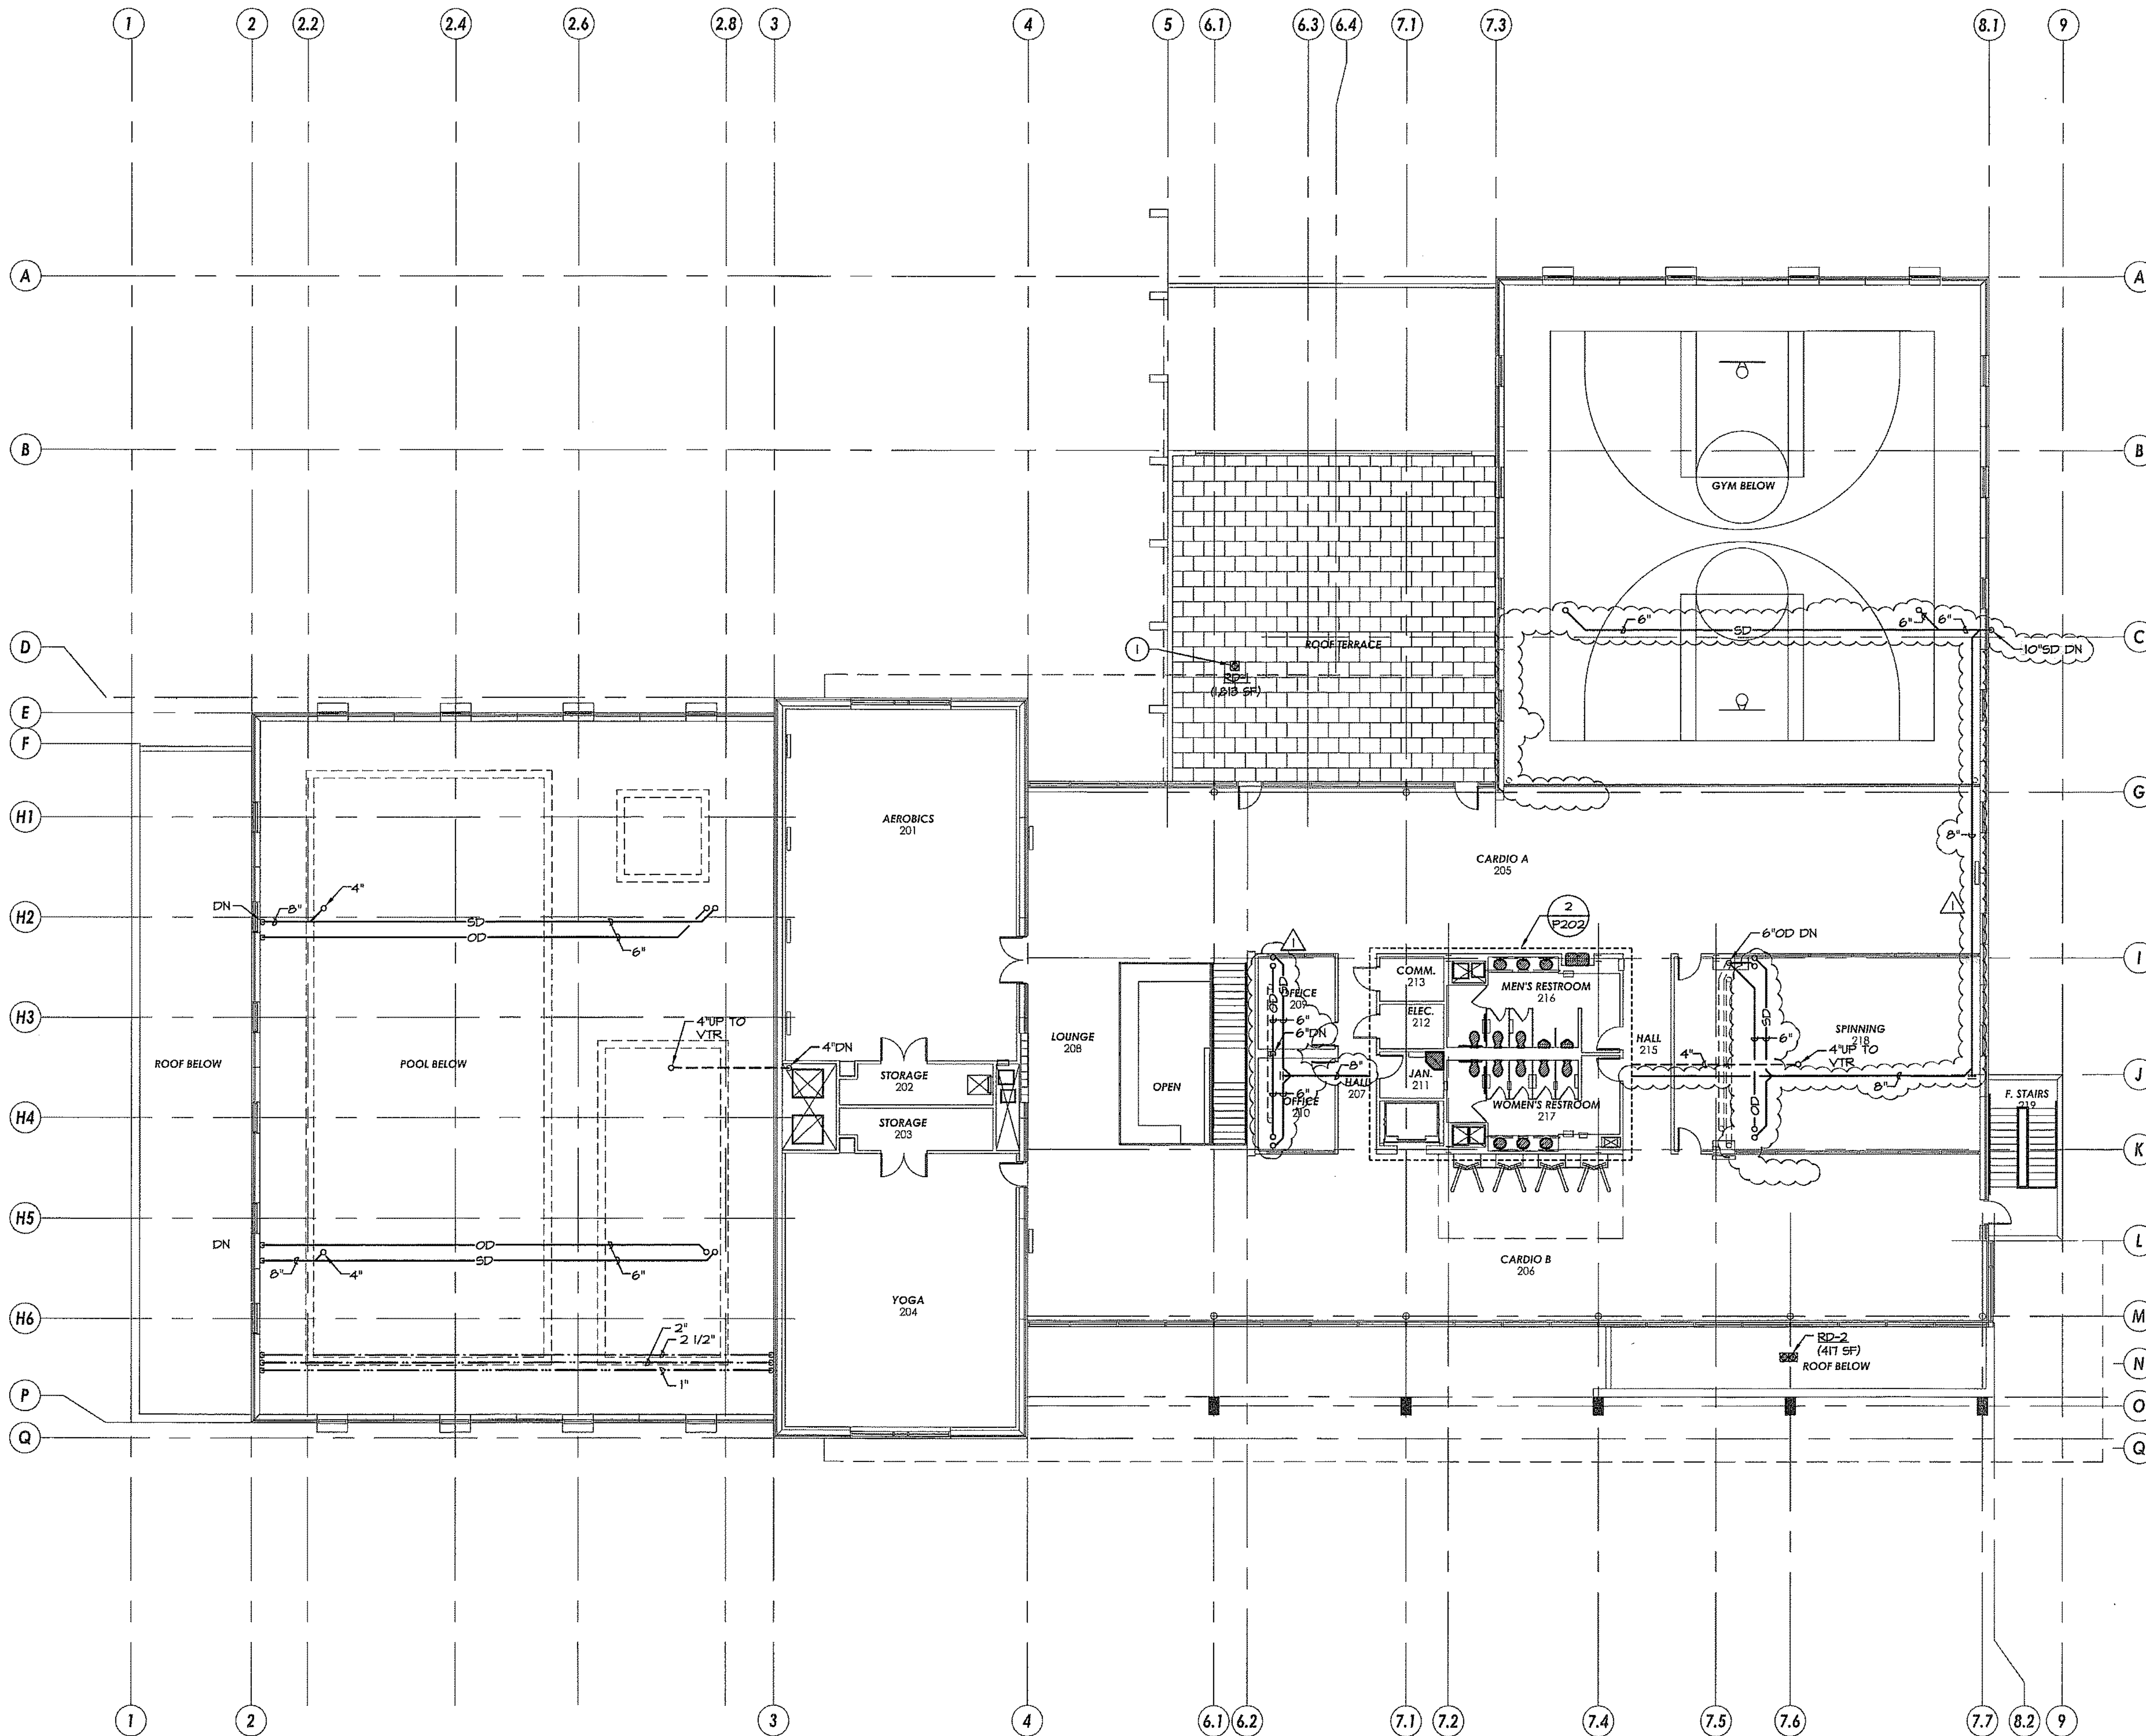
CADFILE: F:\10048\CADFILES\10048_P102 Second Floor Plumbing Plan.dwg Plotted: Mon., Dec. 05, 2011 @ 10:59 AM By: jjeangalo Scale: 1:128

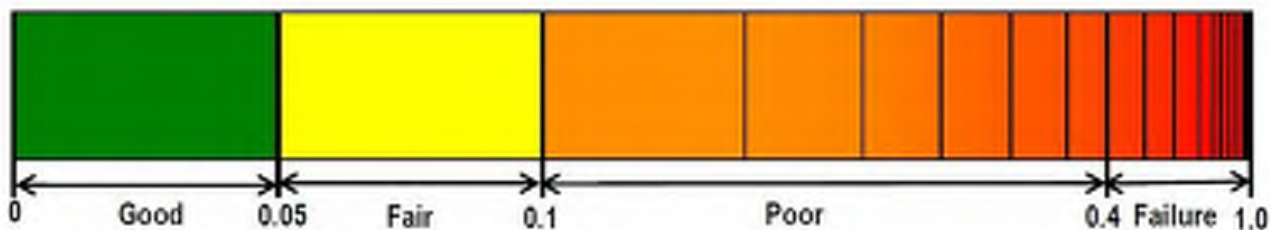
Therefore, the lower the FCI, the lower the need for remedial or renewal funding relative to the facility’s value. For example, an FCI of 0.07 signifies a 7% deficiency ratio which is generally considered to be in the fair range. An FCI of 0.7 means that 70% of the building needs extensive repairs or replacement. The FCI is a relative indicator of condition and should be tracked over time to maximize its benefit.

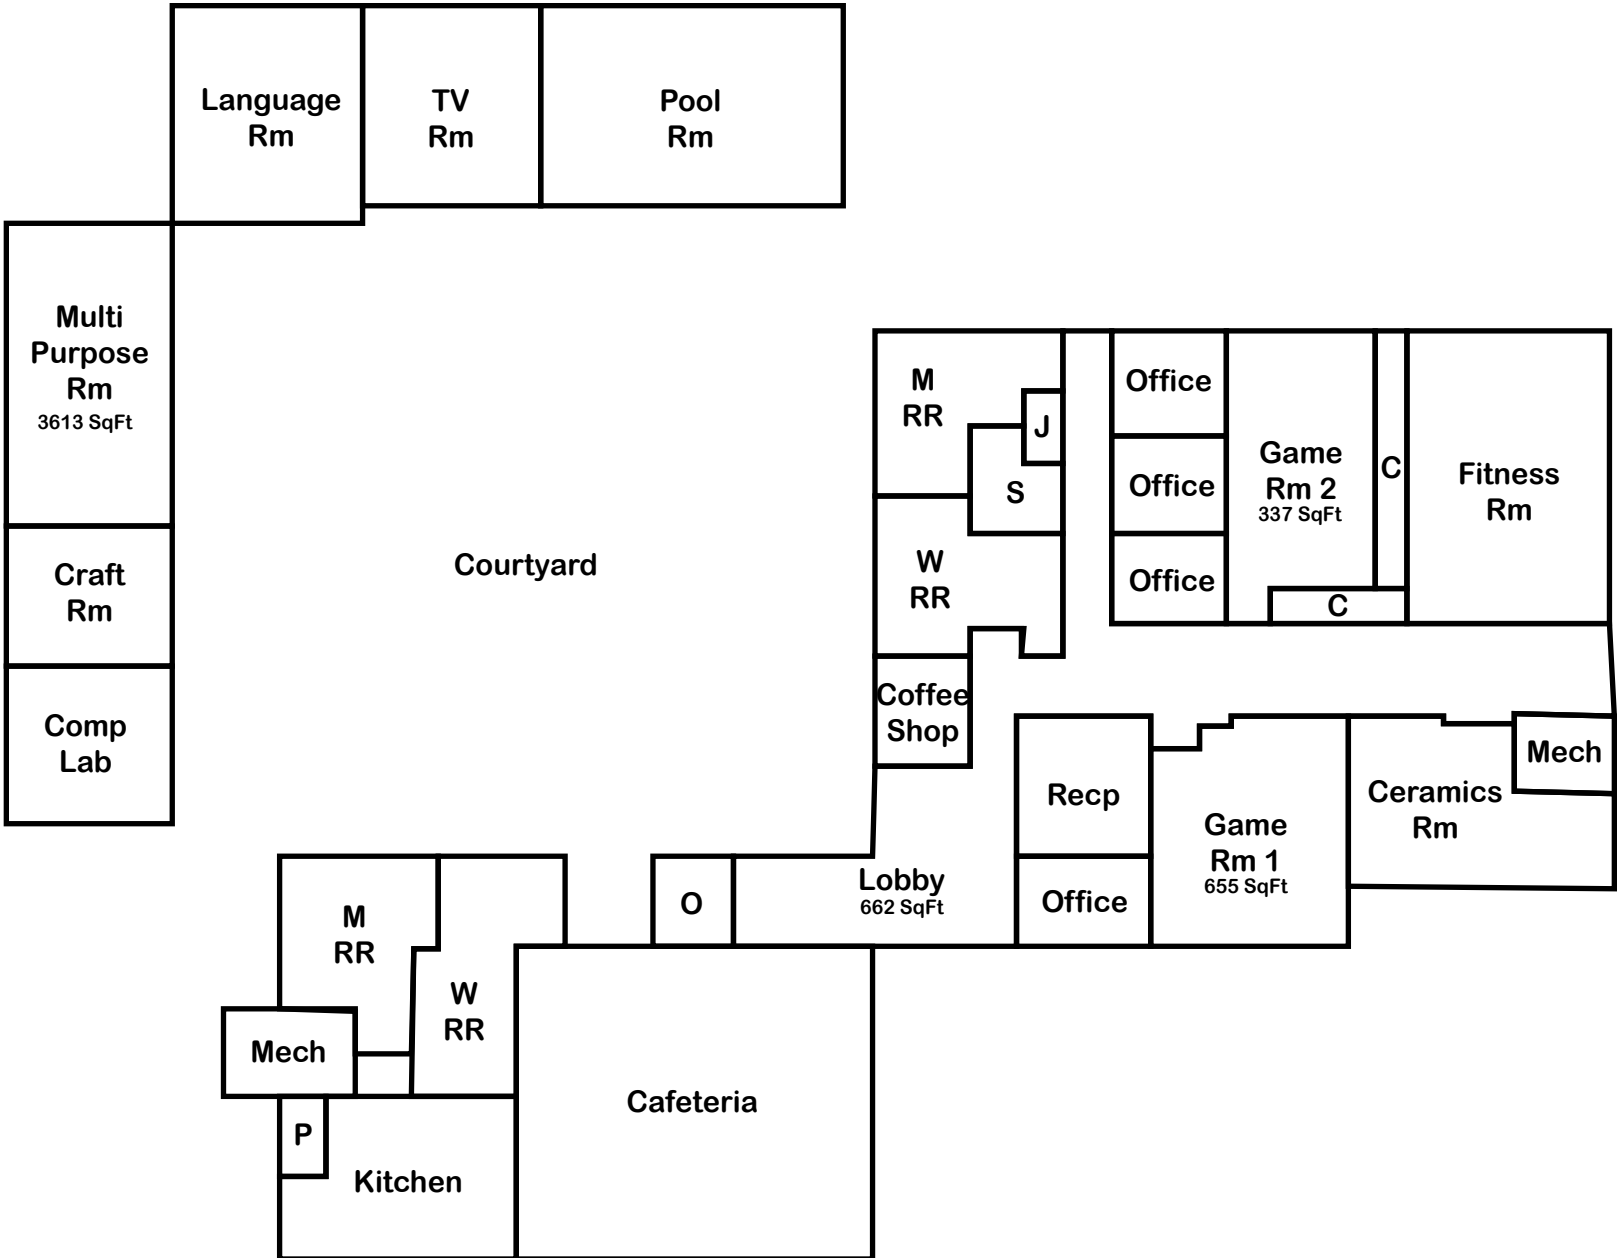
National Flood Hazard Layer FIRMette

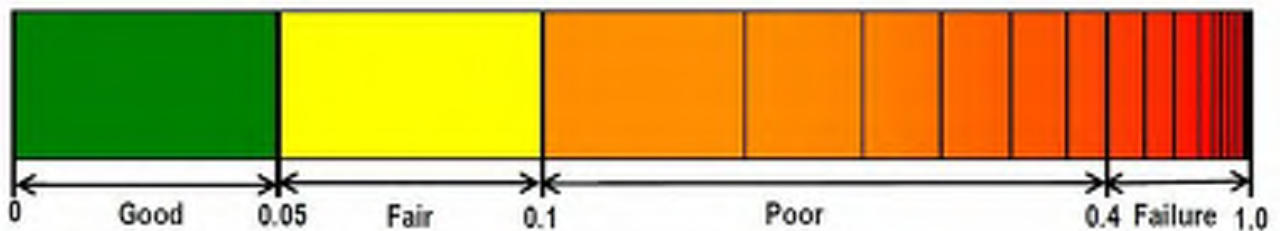
Therefore, the lower the FCI, the lower the need for remedial or renewal funding relative to the facility's value. For example, an FCI of 0.07 signifies a 7% deficiency ratio which is generally considered to be in the fair range. An FCI of 0.7 means that 70% of the building needs extensive repairs or replacement. The FCI is a relative indicator of condition and should be tracked over time to maximize its benefit.

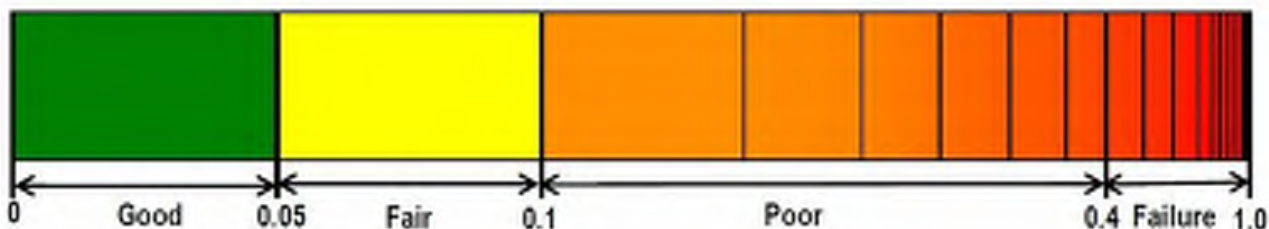
Therefore, the lower the FCI, the lower the need for remedial or renewal funding relative to the facility’s value. For example, an FCI of 0.07 signifies a 7% deficiency ratio which is generally considered to be in the fair range. An FCI of 0.7 means that 70% of the building needs extensive repairs or replacement. The FCI is a relative indicator of condition and should be tracked over time to maximize its benefit.
