May 11, 2018

Re: Documentation of Slope Failure Along Shoal Creek at Pease Park

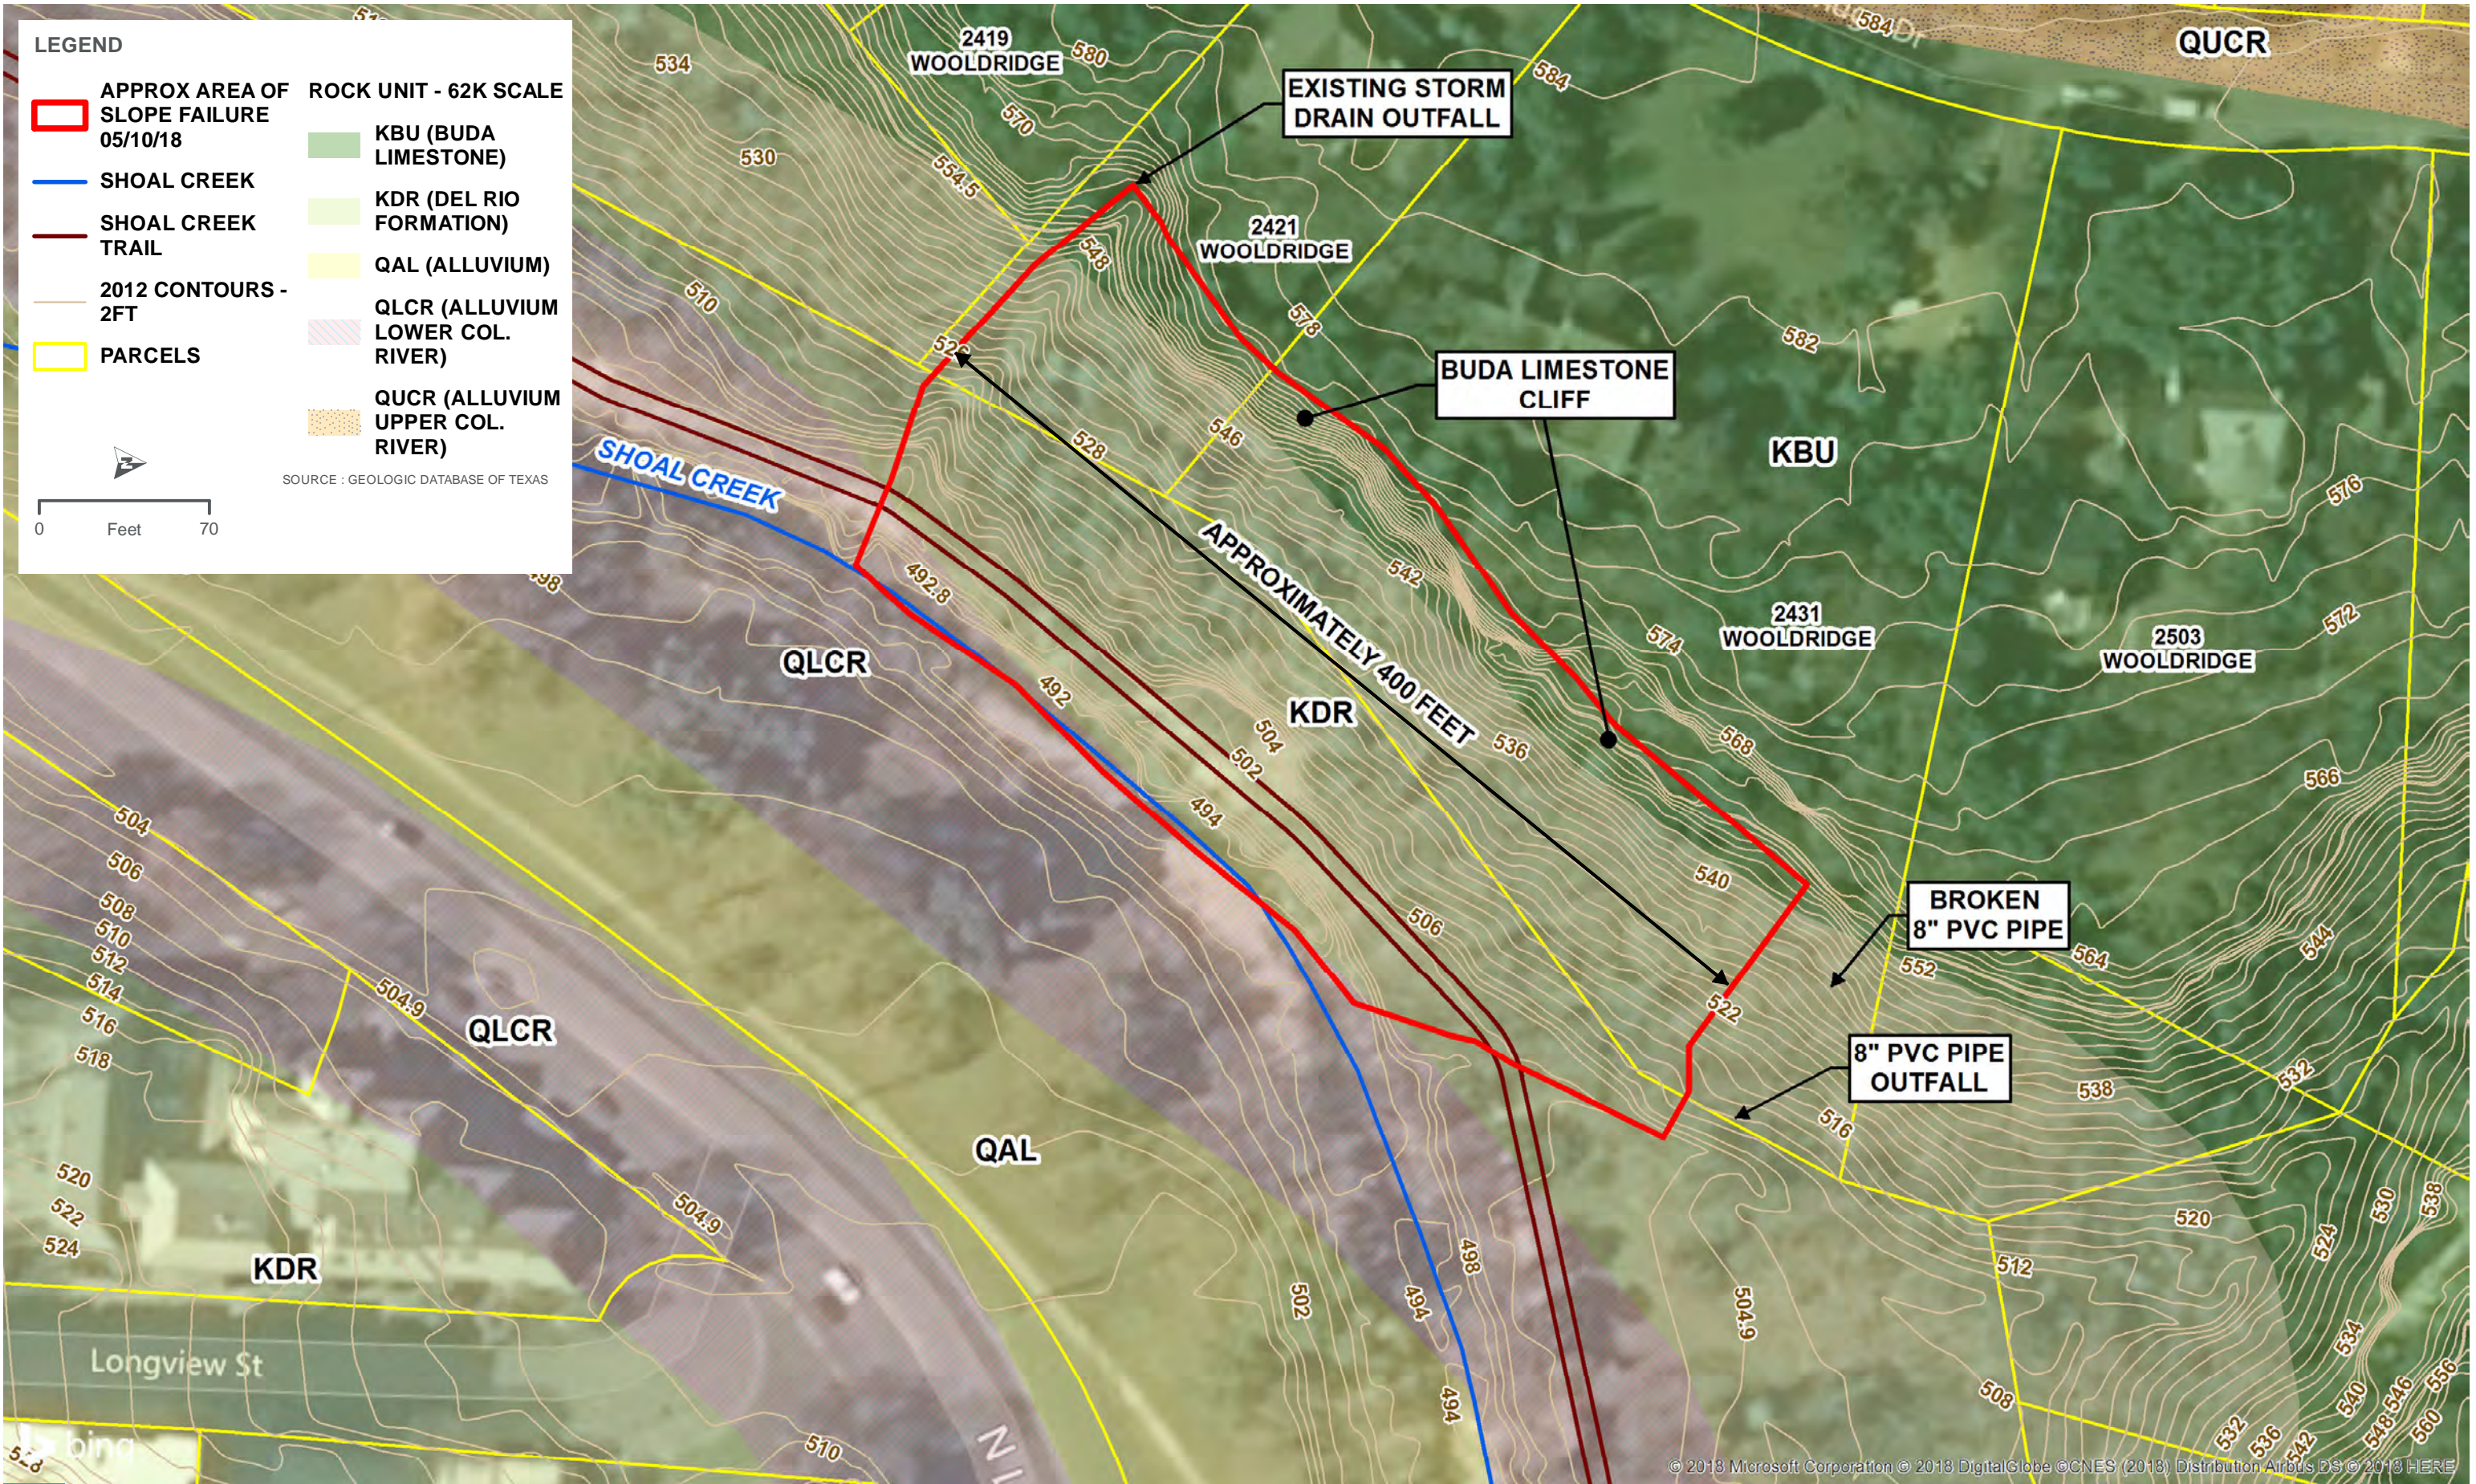
SHOAL CREEK AT PEASE PARK
FIGURE - 1

After heavy rains on May 4, 2018, a slope failure occurred along the existing hill on the west side of Shoal Creek just downstream of the Shoal Creek Boulevard bridge. The associated slip surface initiated on private properties located on top of the hill and extended into Shoal Creek. Figure 1 provides an aerial view of the site with the approximate limits of the failure identified.

The approximated limits of the failure were determined from a drone video provided by the City and site reconnaissance with a geolocation enabled device (Figure 1). Based on the scaled aerial, the width of the slope failure is approximately 400 feet, as measured along Shoal Creek. The length of the slope failure, as measured from Shoal Creek to the hill top, ranges from approximately 150 to 200 feet.

Based on the 2-foot topographic contours from the City (Figure 1), the elevations along the crest (pre-failure) generally range from El. 552 feet to El. 574 feet (msl). The bottom elevation along Shoal Creek (within the impacted area) is approximately El. 492 feet (+/-). The total slope heights, as measured between Shoal Creek and the pre-failure crest, range from approximately 60 to 80 feet.

The surface grade prior to failure averaged approximately 42% to 46%, which equates to a slope angle of approximately 24 degrees. The average incorporates the surface elevations within the upper reaches (near the crest), where pre-failure slopes in excess of 65 degrees were measured from the topographic data provided on Figure 1.

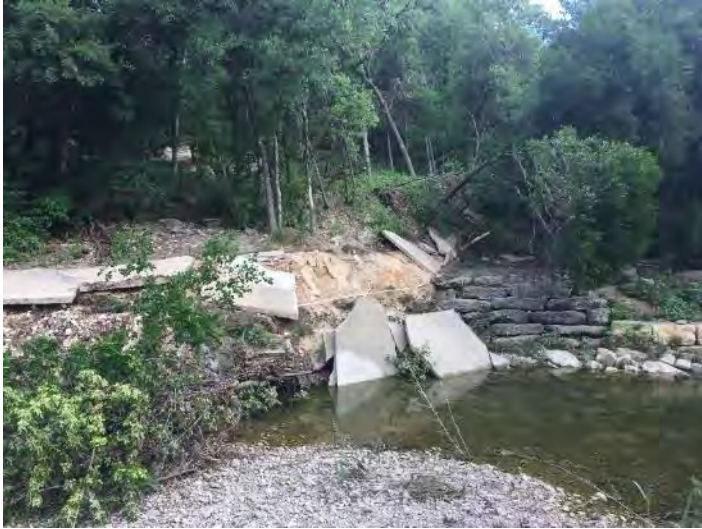
Northern terminus of slide at Shoal Creek
Existing dry stack wall pushed horizontally into creek

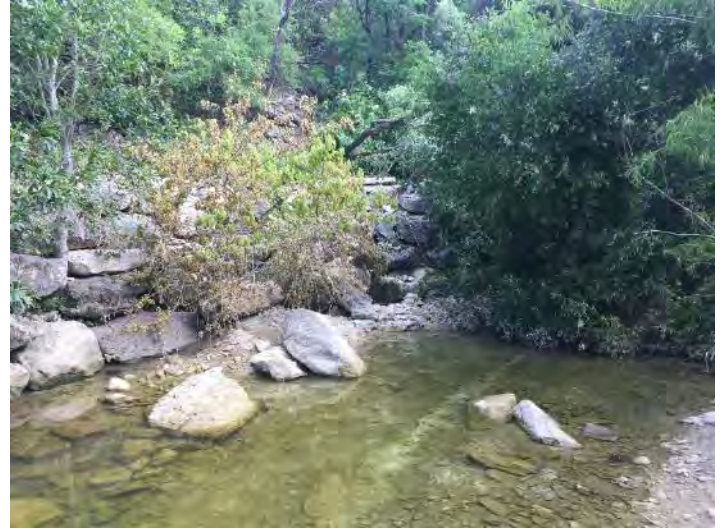
Southern terminus of slide at Shoal Creek
Existing dry stack wall pushed horizontally into creek

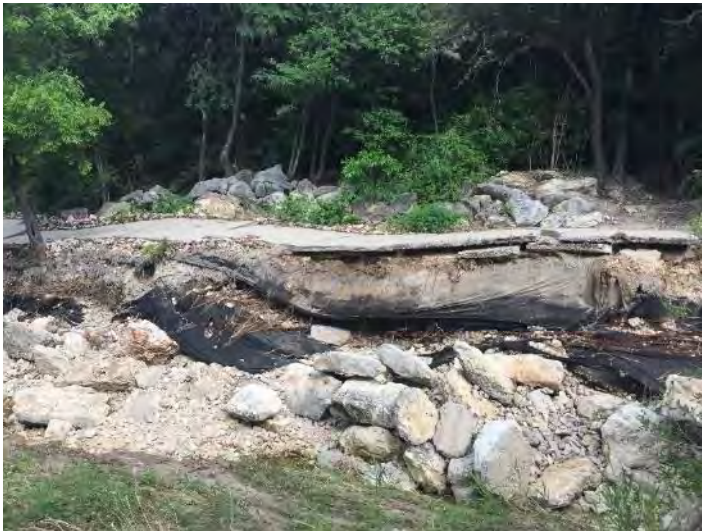
D/S half of horiz. trail wall displacement at Shoal Creek
Creek bed material pushed up into pile in front of slide
Displacement greater in downstream (d/s) half compared to upstream (u/s) half

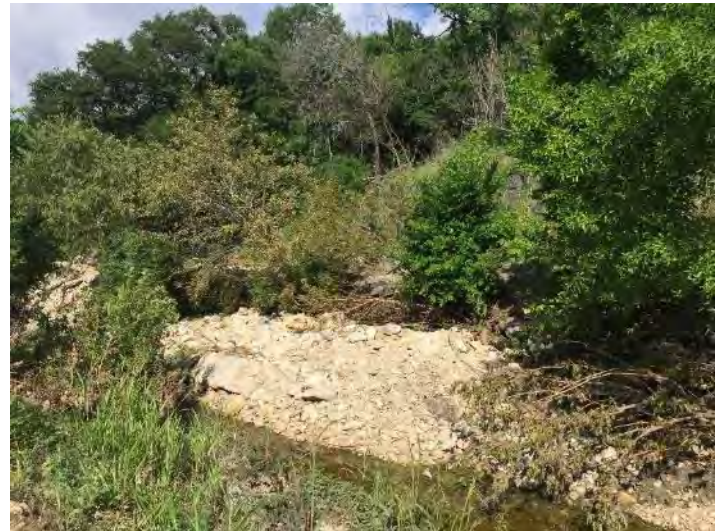
D/S half of horiz. trail wall displacement at Shoal Creek
Creek bed material pushed up into pile in front of slide
Displacement greater in d/s half compared to u/s half

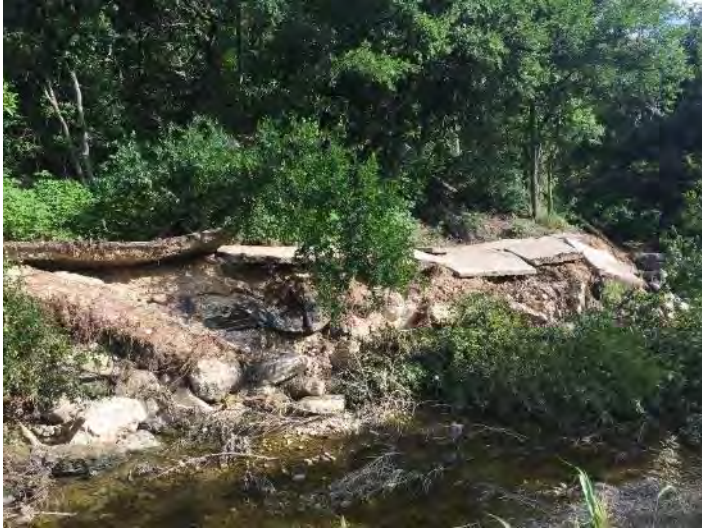
Upstream (u/s) half of horiz. trail wall displacement at Shoal Creek
Displacement of bed material not as significant

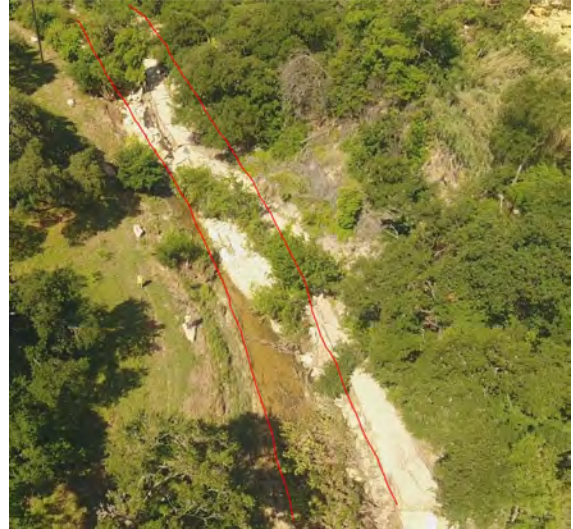
Top view of trail at creek, along toe of slide looking d/s
Rough approximation of pre-event creek bottom width (shown by red line)

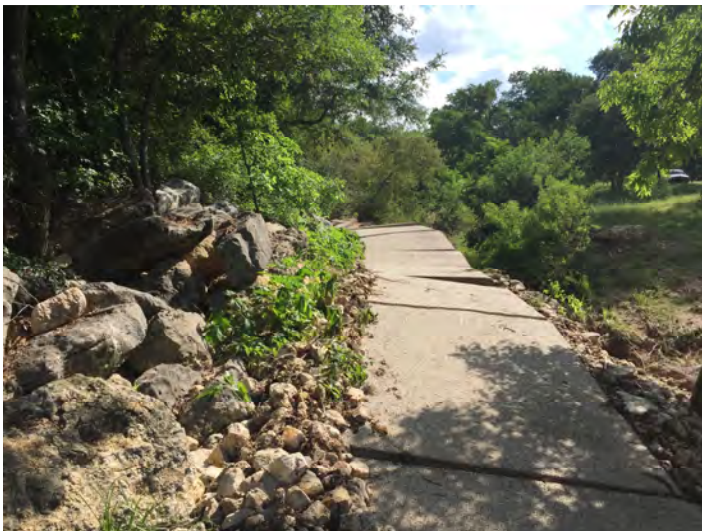
Along trail south of existing gabion wall
Some vertical displacement of pavement, mostly horizontal

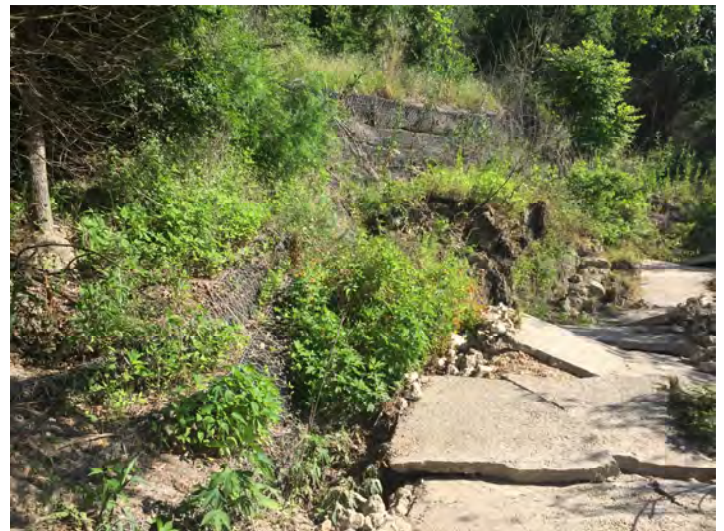
Existing gabion wall
Note bulging displaced gabion toe at south end and heaving/thrusting of material at front face

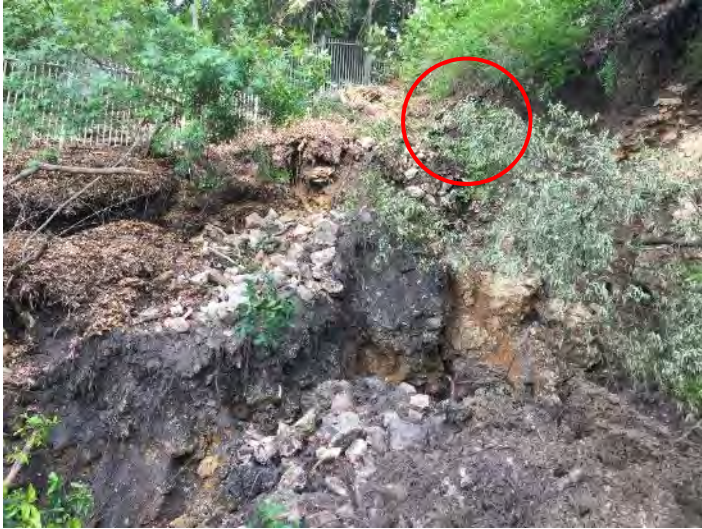
Southern edge of slope failure along fence line at 2419
Wooldridge Drive
*Deep crevasse and separation along fence line.
Upper right hand corner – existing storm drain*

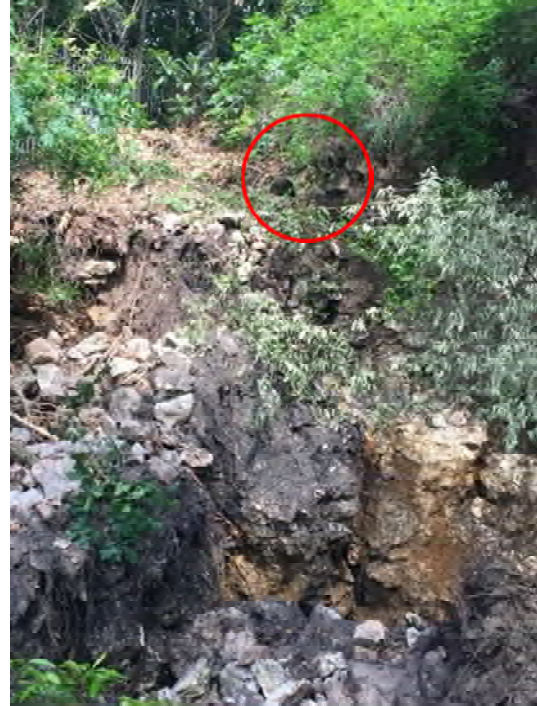
Southern edge of slope failure along fence line
Upper right hand corner – existing storm drain

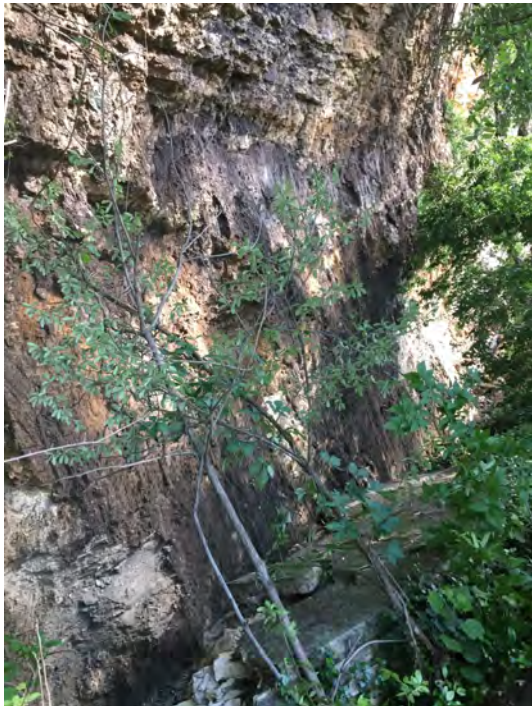
Buda Formation at upslope edge of failure
Along 2421 Wooldridge Drive

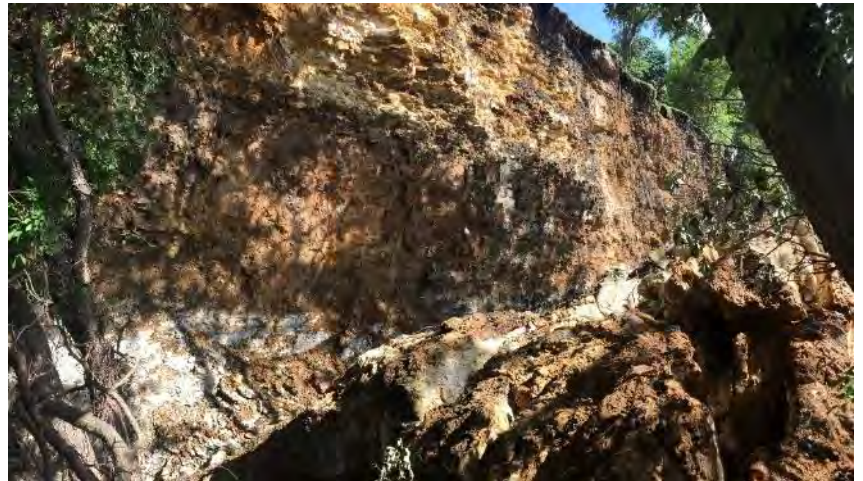
Upslope edge of failure at between 2421 and 2431 Wooldridge Drive
*Buda Formation (above) Del Rio (below) – contact location
Thickness of Buda approx. 20ft. Unstable slope.ft*

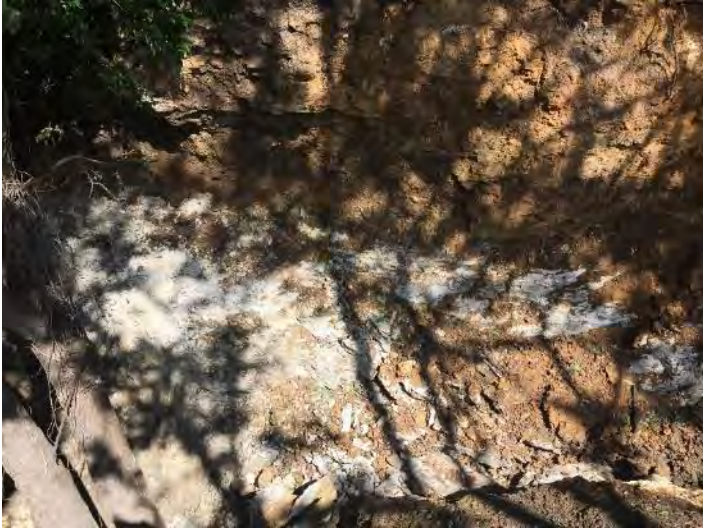
Close up of Buda/Del Rio contact location
Along south end of 2431 Wooldridge Drive

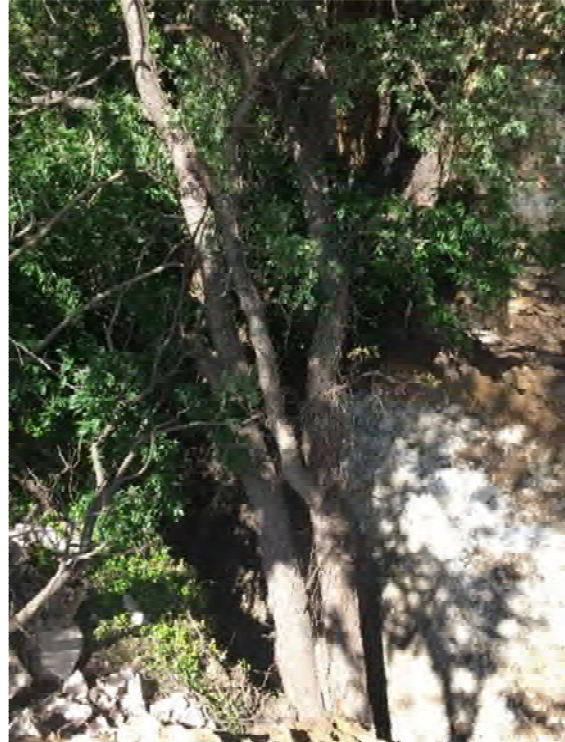
Upslope edge of failure at between 2421 and
2431 Wooldridge Drive
Buda Formation (above) Del Rio (below) – contact
Note deep separation crevasse behind tree at
bottom of pic

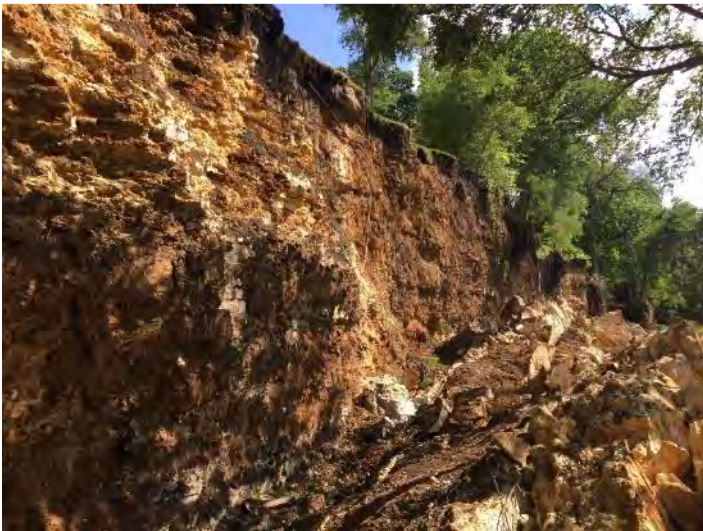
Upslope edge of failure at 2431 Wooldridge Drive
Looking north. Unstable slope.

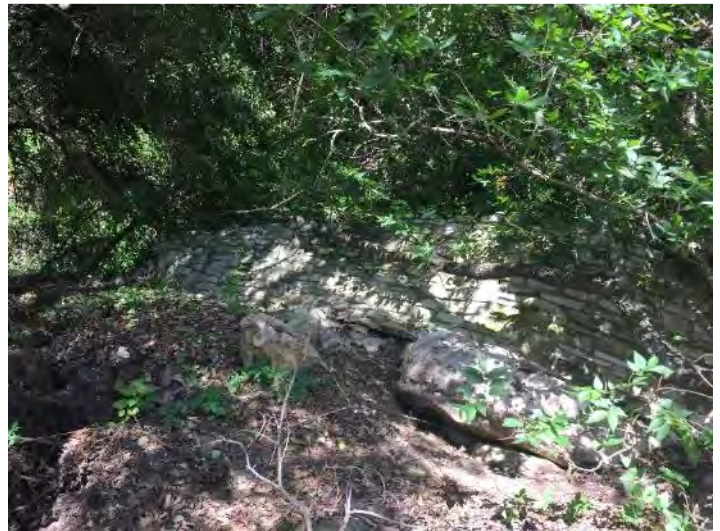
At base of upslope edge of failure at 2431 Wooldridge
Drive
Landscape wall fallen from yard above

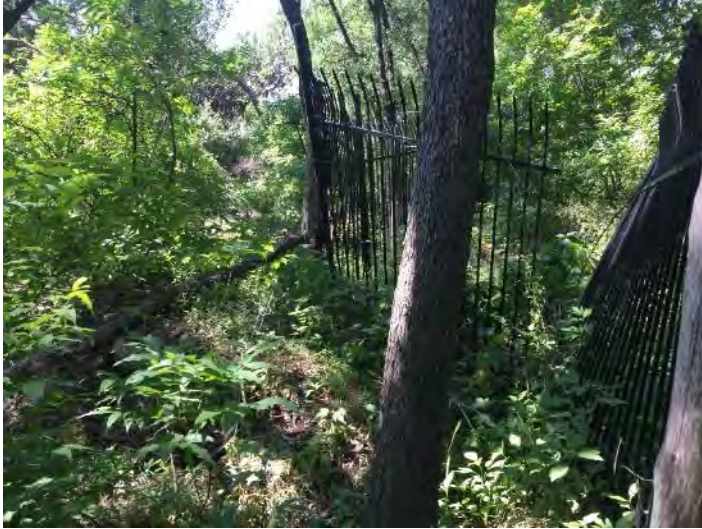
NW corner of fence for 2431 Wooldridge Drive locally displaced
Near downslope and northern edge of slide

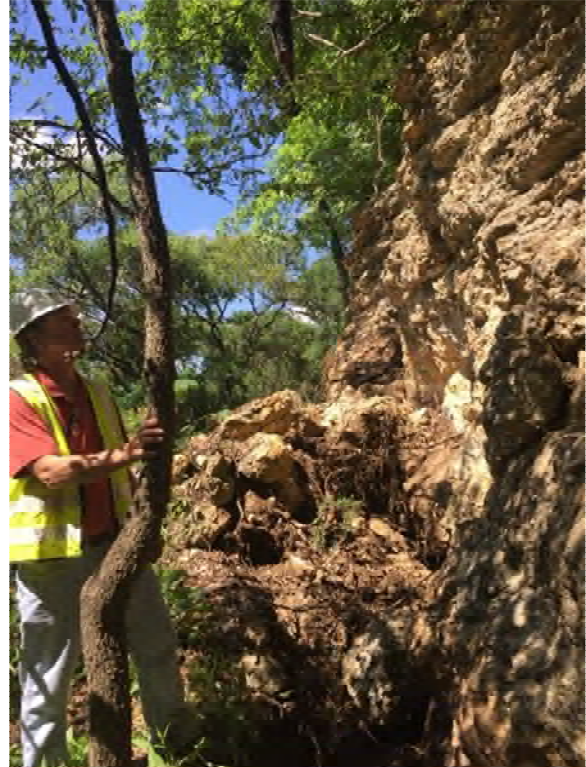
North end of upslope edge of failure at 2431 Wooldridge Drive
Buda formation above

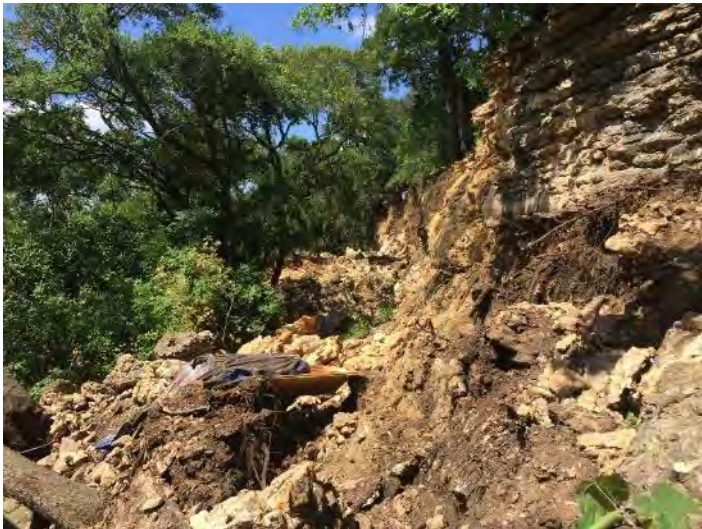
Upslope edge of failure at 2431 Wooldridge Drive
Looking south near north end of failure. Unstable slope.
Mortared natural ledge stone landscape wall at upper right corner

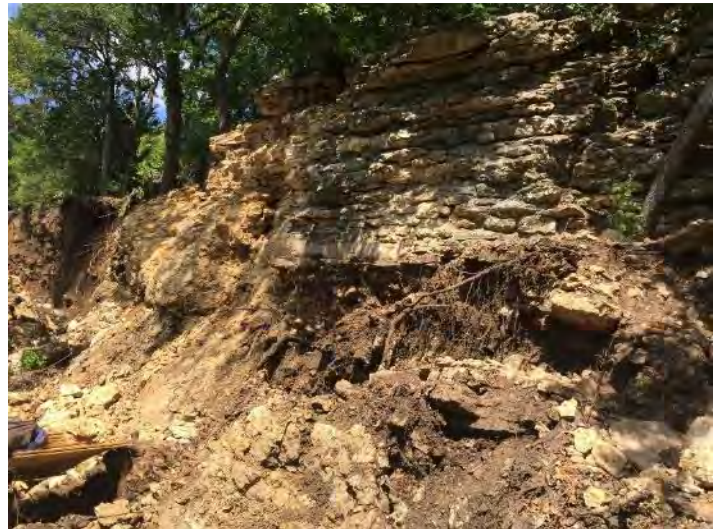
Upslope edge of failure at 2431 Wooldridge Drive
Mortared natural ledge stone landscape wall

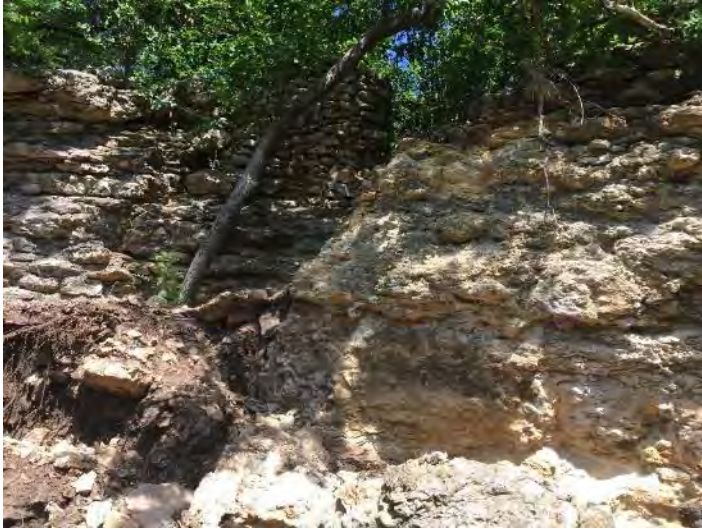
Upslope edge of failure at 2431 Wooldridge Drive
*Mortared natural ledge stone landscape wall
 Looking west near north end of failure*

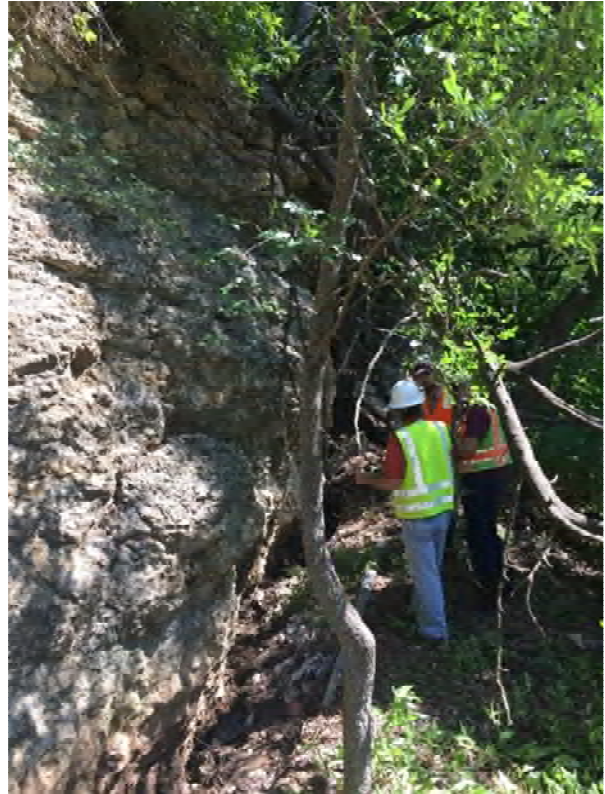
Older failure along north edge of 2431 Wooldridge Drive
Soil on right and Buda rock face on left (looking north). Note slight separation at base parallel to new failure

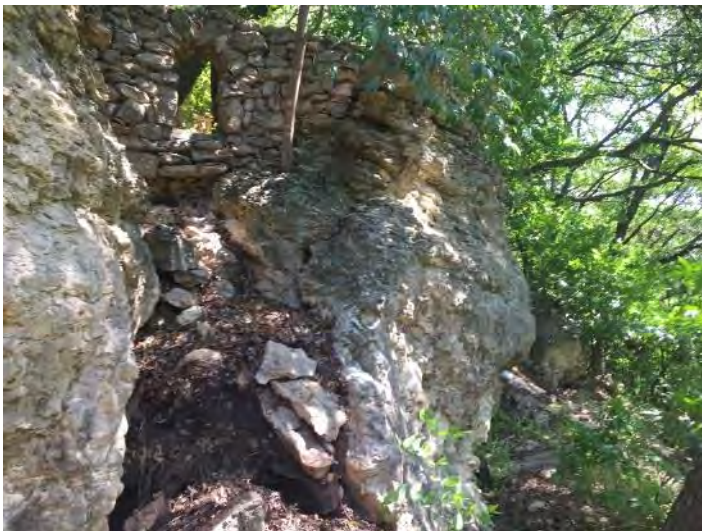
North edge 2431 Wooldridge Drive
*Potential older failure - parallel to new failure
 Location of misc. natural ledge stone walls
 Looking north*

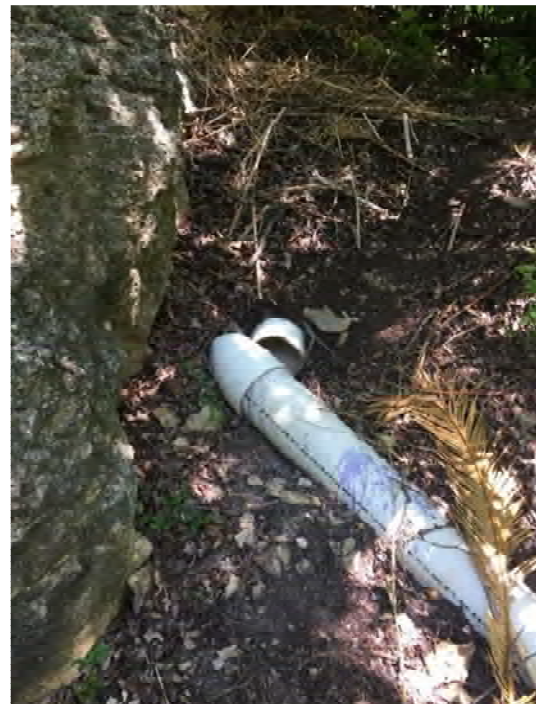
8" PVC at north edge of 2431 Wooldridge Drive

Break in pipe does not appear to be new

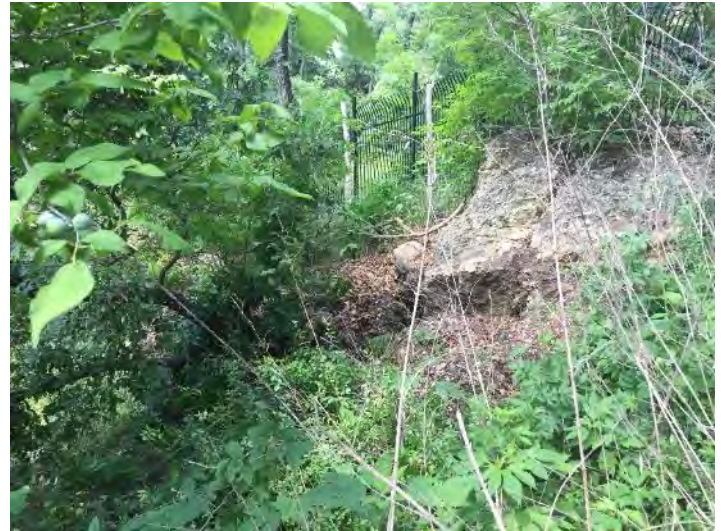
Near NW corner of fence for 2431 Wooldridge Drive
locally displaced
Near downslope and northern edge of slide
