Zilker Park Bathhouse Zone Feasibility Study

Draft for City of Austin Parks + Recreation Department

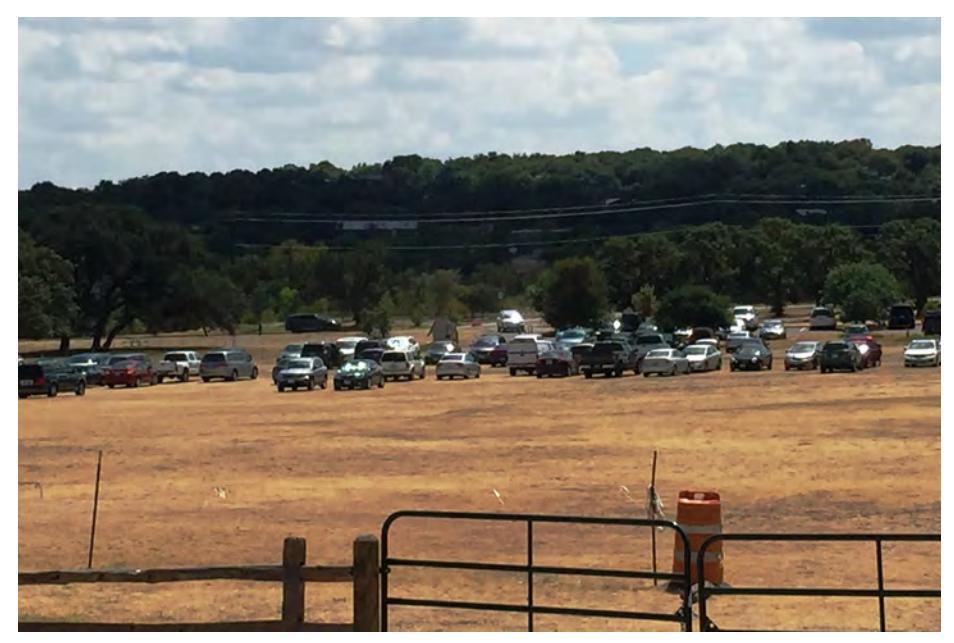
Site Circulation: The use of landscape areas of the park for parking and pedestrian circulation has resulted in extensive environmental degradation, most specifically within the critical root zones of trees in the park.

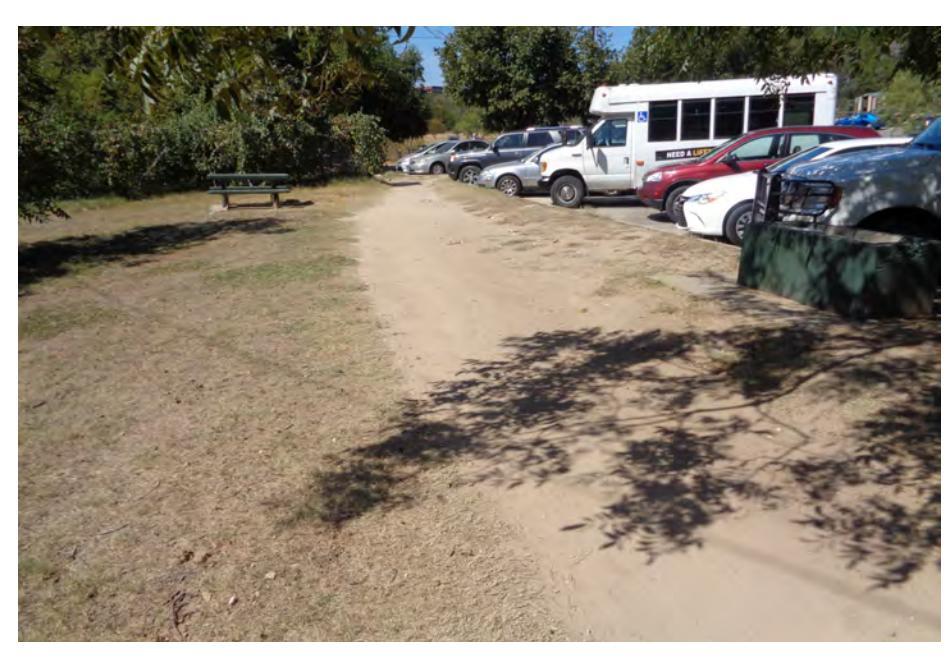
Site Circulation: Pathways such as this bare-earth trail to the north of the Violet Crown Trailhead do not well serve existing demand.

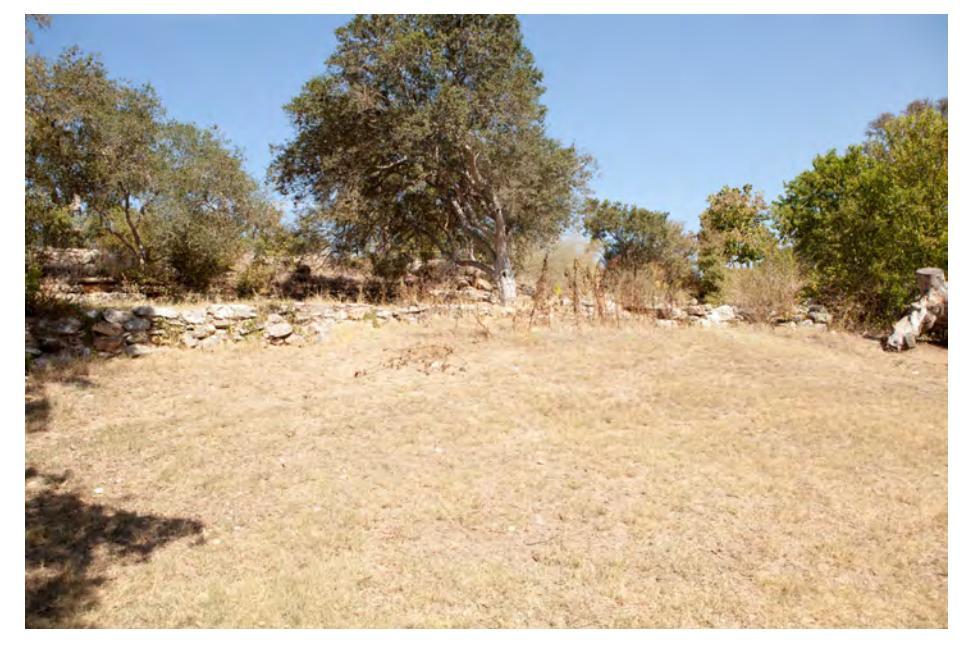
Site Circulation: The lack of coordination between pedestrian and vehicular amenities within the park has resulted in the development of ad-hoc trails across vegetated areas. Rationalization of trails and other pedestrian amenities will concentrate pedestrian traffic in designated corridors, mitigating damage to lawns and trees within the park and allowing for effective provision of amenities such as trash receptacles and drinking fountains.

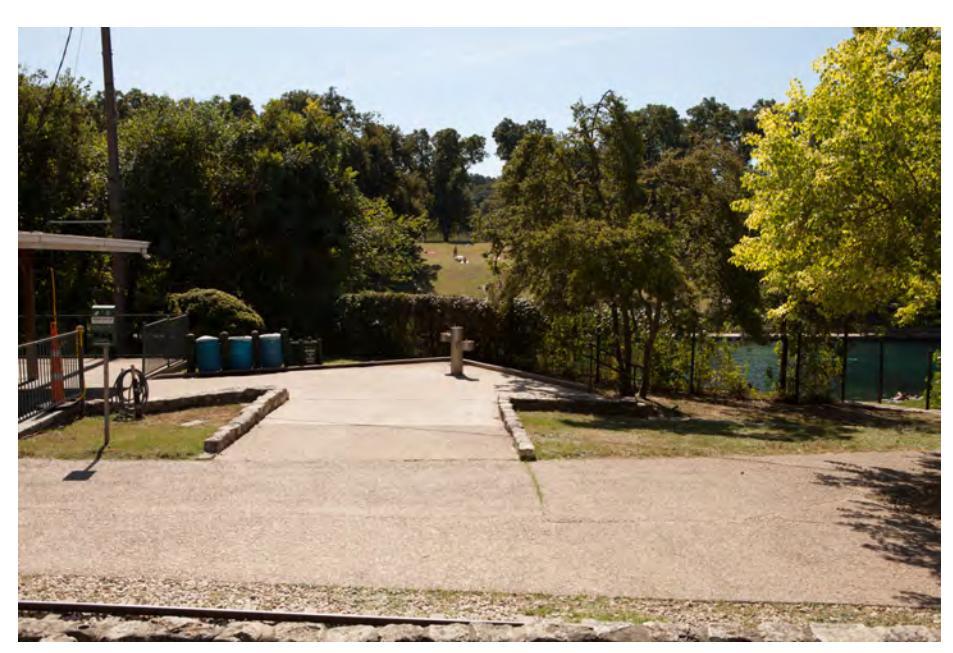
Picnic Pavilion: The Picnic Pavilion and its infrastructure (such as pedestrian connections, waste receptacles, and drinking fountain) are generally serviceable.

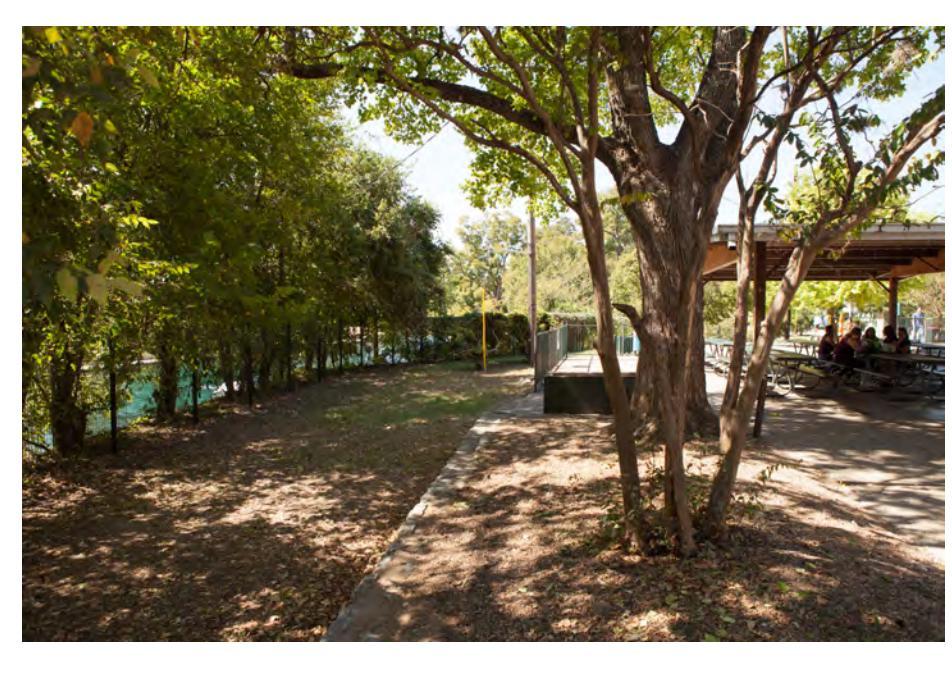
The existing picnic pavilion is objectively suitable for its intended function. Nevertheless the number of picnic tables presently occupying the shelter suggests that it is smaller than present demand would dictate, with a corresponding reduction in the level of service, insofar as picnic tables closer to the edges of the pavilion will not enjoy the same level of weather protection as those in the interior. Likewise details of the pavilion, such as the configuration of the downspouts from the roof and the deficient slope of the concrete pad result in inadequate drainage from the picnic area.

Picnic Pavilion: The Pavilion itself is too small for the number of tables it contains, many of which are poorly protected from sun and rain.

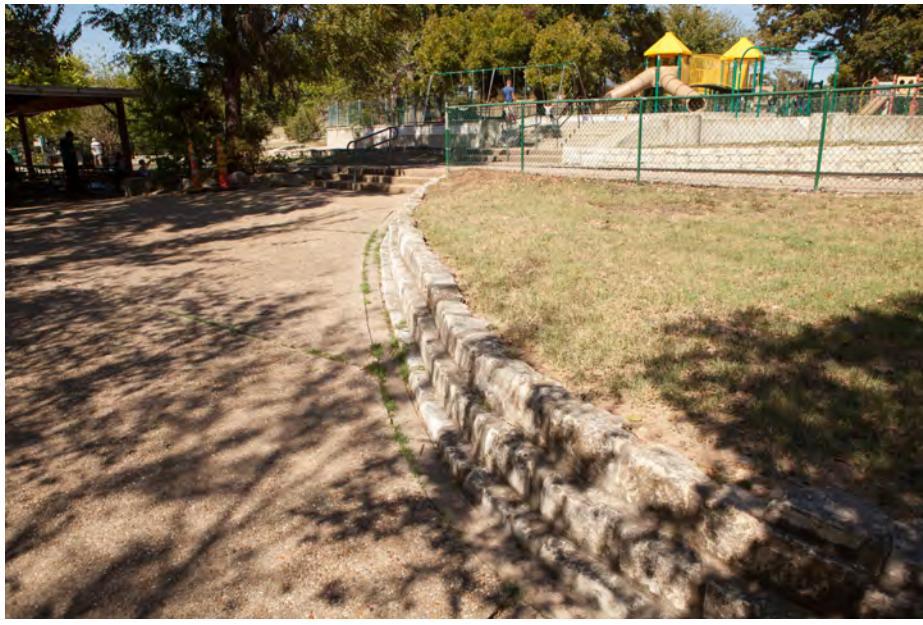
Picnic Pavilion: The Pavilion is well-located adjacent to the Playscape, although changes in grade, and the intervening Zilker Zephyr trackway, compromise this adjacency.

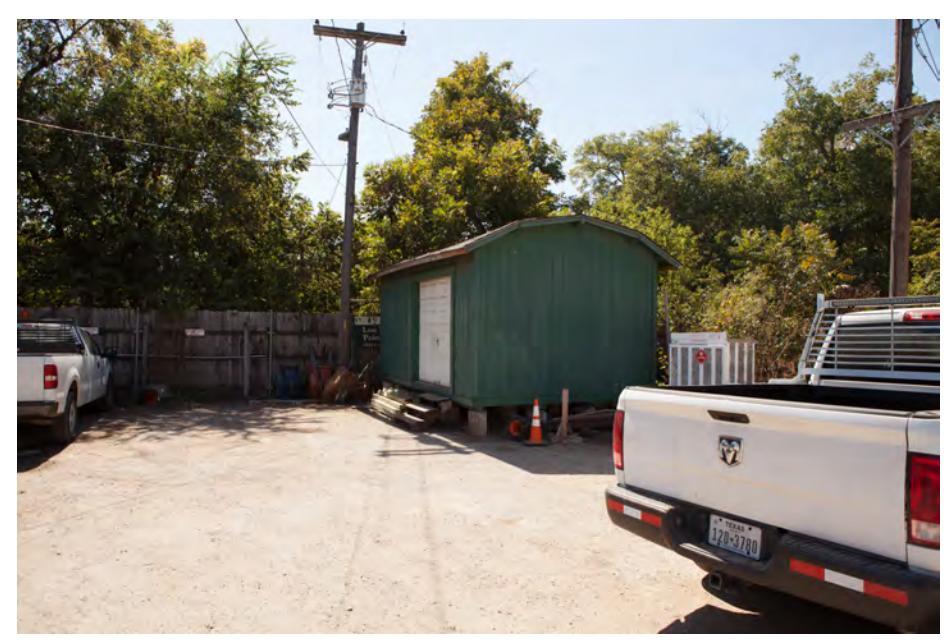
Maintenance Yard: Improvised storage, as in the form of this portable building, is a problem throughout the Bathhouse Zone. The quantity of equipment stored in the open-air at the Maintenance Yard indicates that even improvised storage is at a premium.

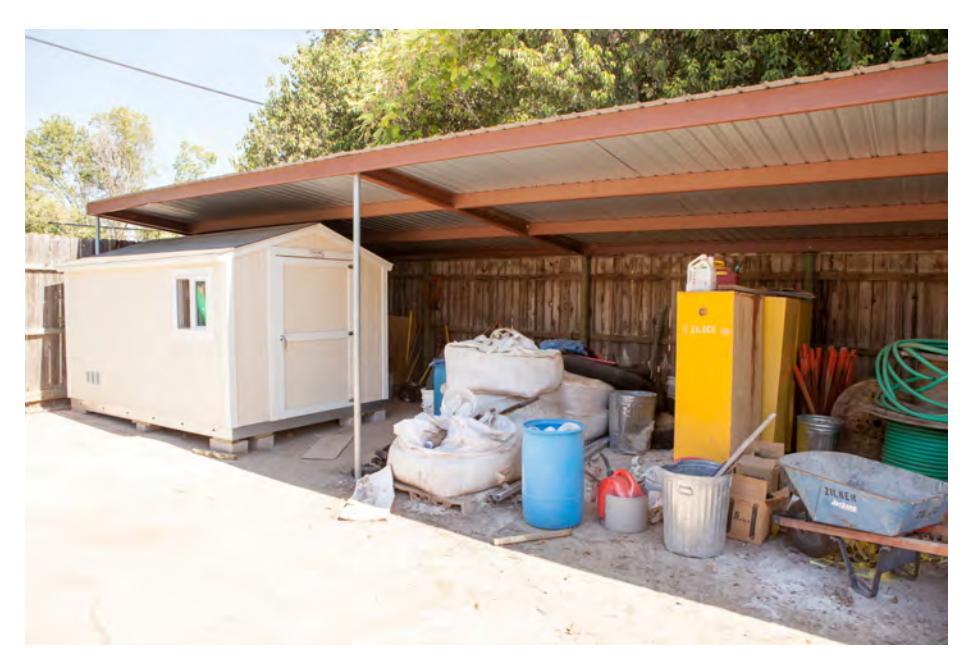
Maintenance Yard: Ad-hoc storage is characteristic of the current Maintenance Yard. The storage of fuels and other chemicals within the yard over the decades raises concerns over the viability of any potential repurposing of this facility.

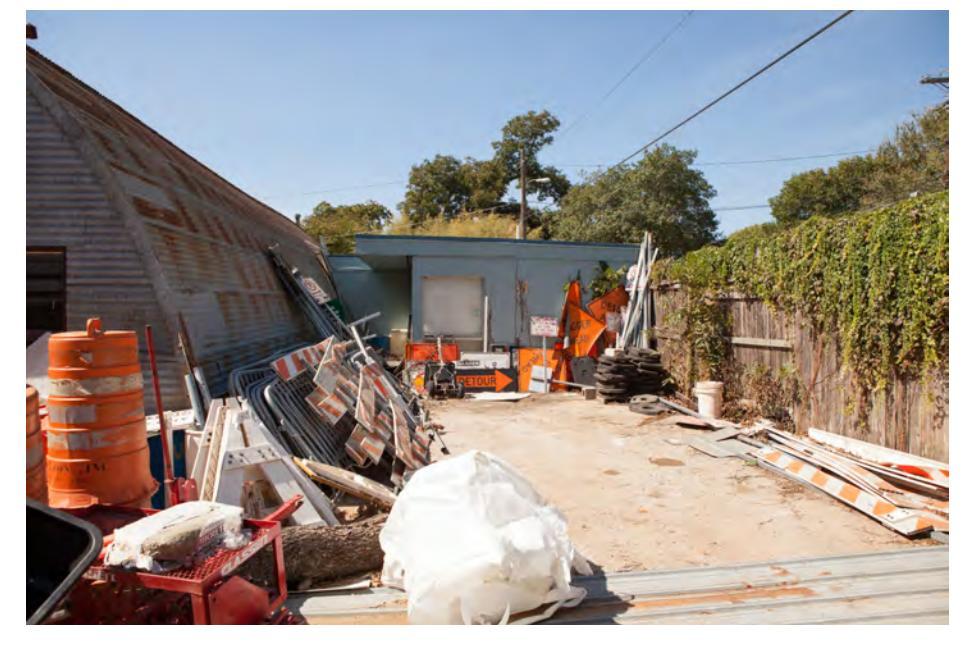
The existing maintenance facility consists of a 1940s era steel Quonset hut with a small, conditioned office addition, various auxiliary structures (sheds) of more recent construction and a fuel point. The qounset structure and attached office are in poor physical condition and would require major structural and envelope rehabilitation for any use other than unconditioned storage. The auxiliary facilities are mostly in better condition. The condition and limited degree of enclosure of the existing buildings in the maintenance facility and the lack of modern air conditioning would limit the viability of their repurposing for any programmatic function currently existing within the Bathhouse Zone. It is understood that this facility has already been deemed unserviceable by PARD, and is scheduled for replacement.

Maintenance Yard: The Quonset storage building, although an interesting structure, has reached a serviceability limit state. The extent of rust visible on the exterior of the building, and the number of open holes visible from the interior, indicate a building past economic rehabilitation. It would be less expensive to replace this building than it would to repair it for a different use.

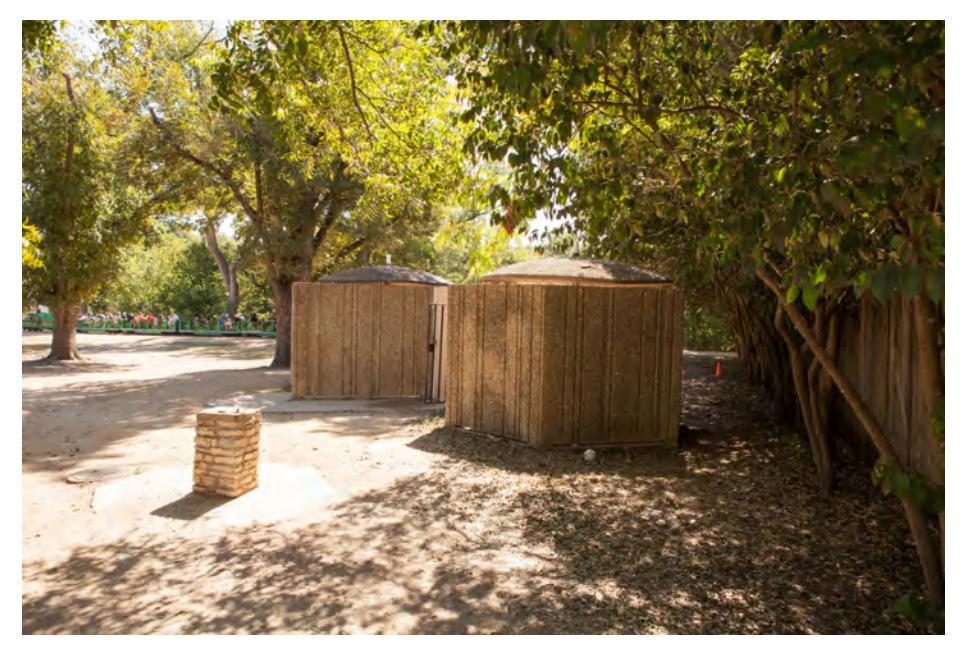
Pecan Grove Picnic Area: The existing restrooms at the Pecan Grove Picnic Area are in poor physical condition.

• Existing restrooms serving the Pecan Grove should be replaced

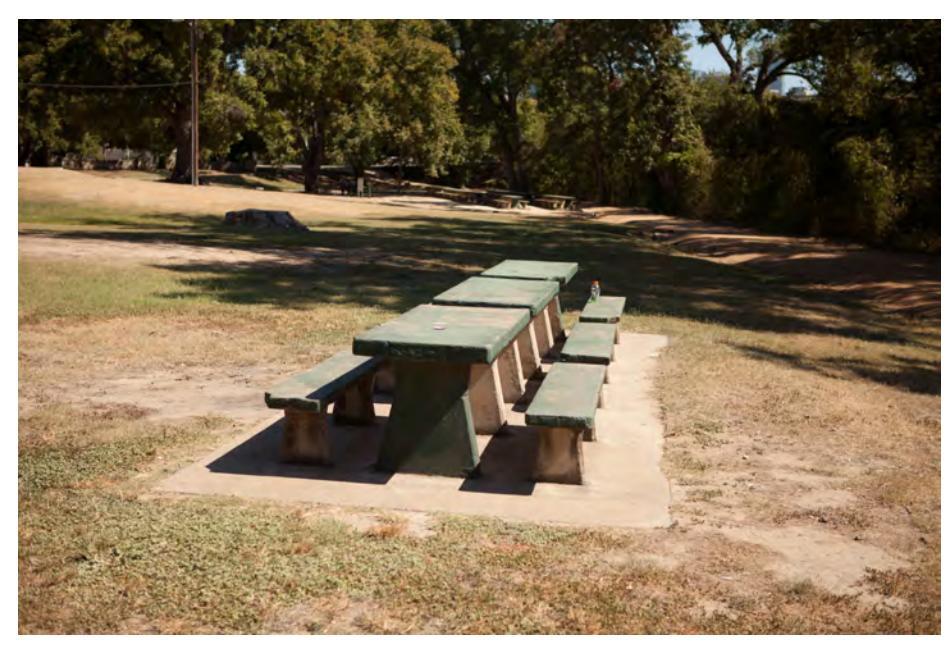
Pecan Grove Picnic Area: As the existing trees in the grove continue to die off, more picnic areas will be left unshaded. The Grove warrants action both to protect and preserve existing trees, and to incorporate replacement trees for future generations.

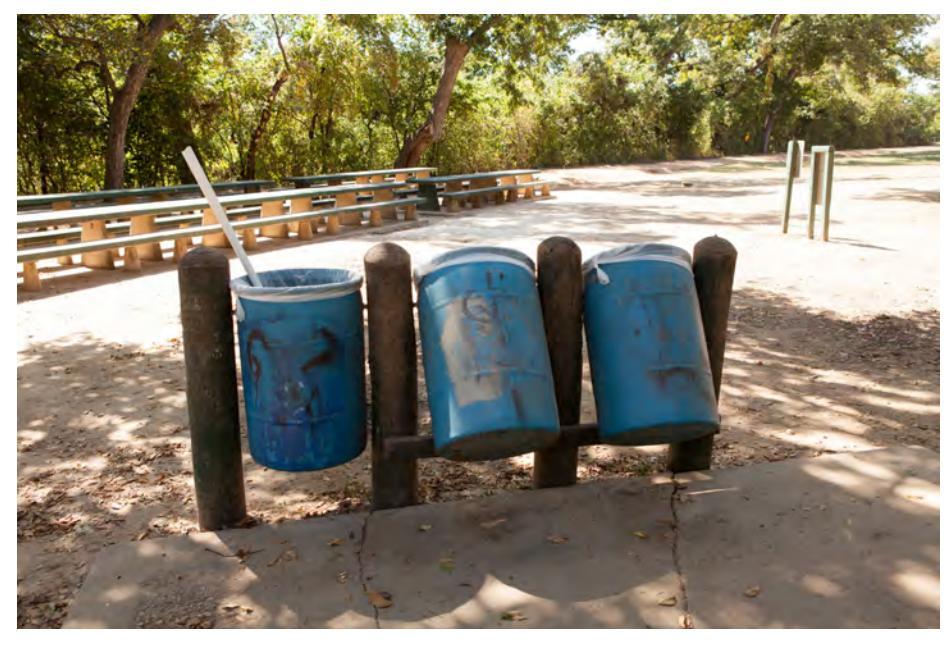
Pecan Grove Picnic Area: The Pecan Grove is not a particularly welcoming amenity, being poorly shaded and unprotected from the weather and incorporating significant areas of bare earth.

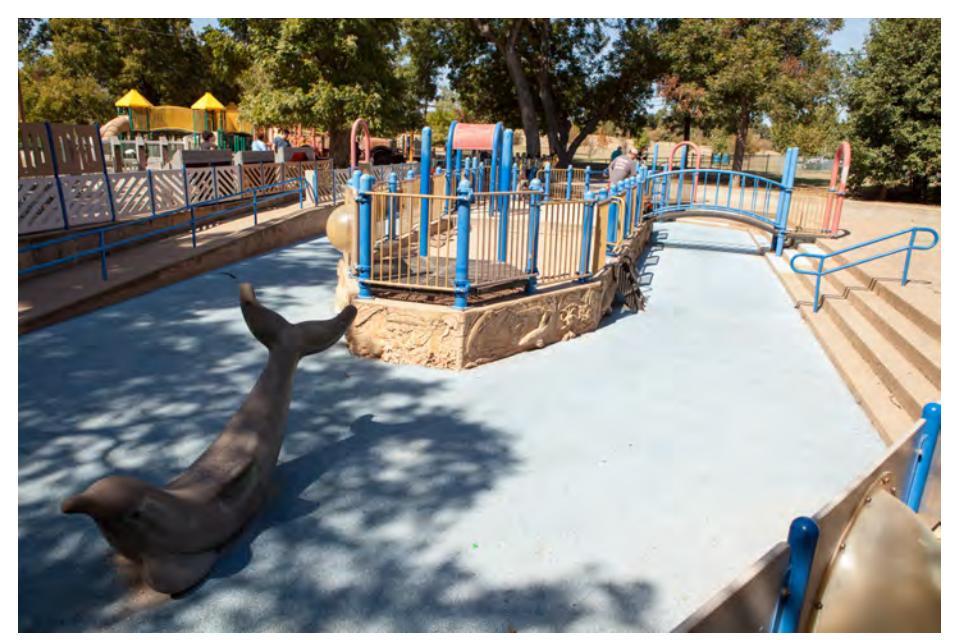
Zilker Playscape: Initial impressions, from the vantage point of a grade school child, is of fences and rails rather than play equipment.

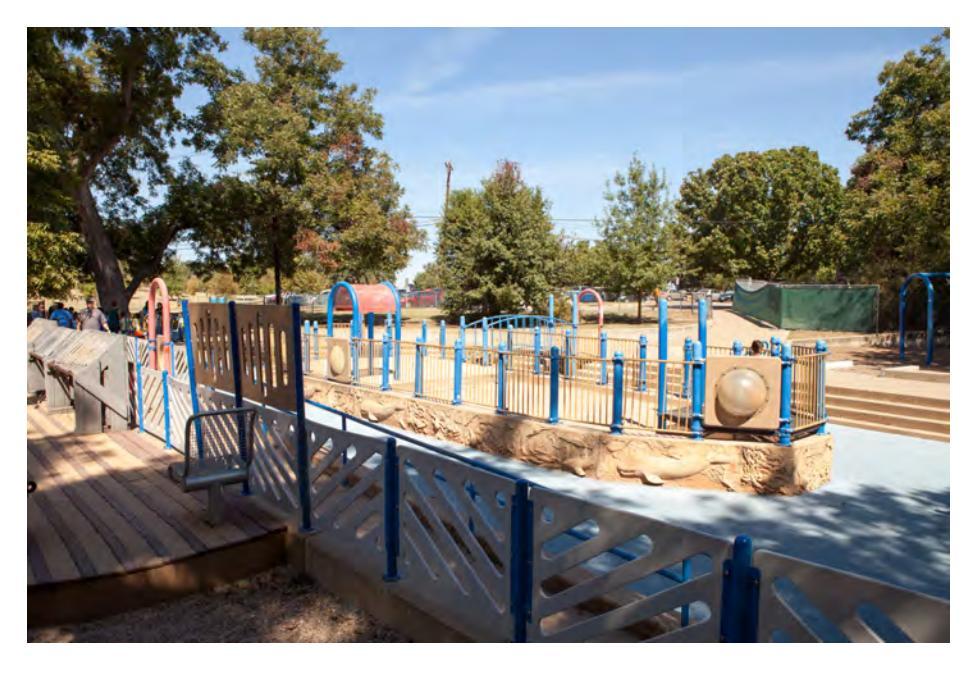
Zilker Playscape: The popular playscape is often overcrowded, and does not adequately address the differing needs of various age groups.

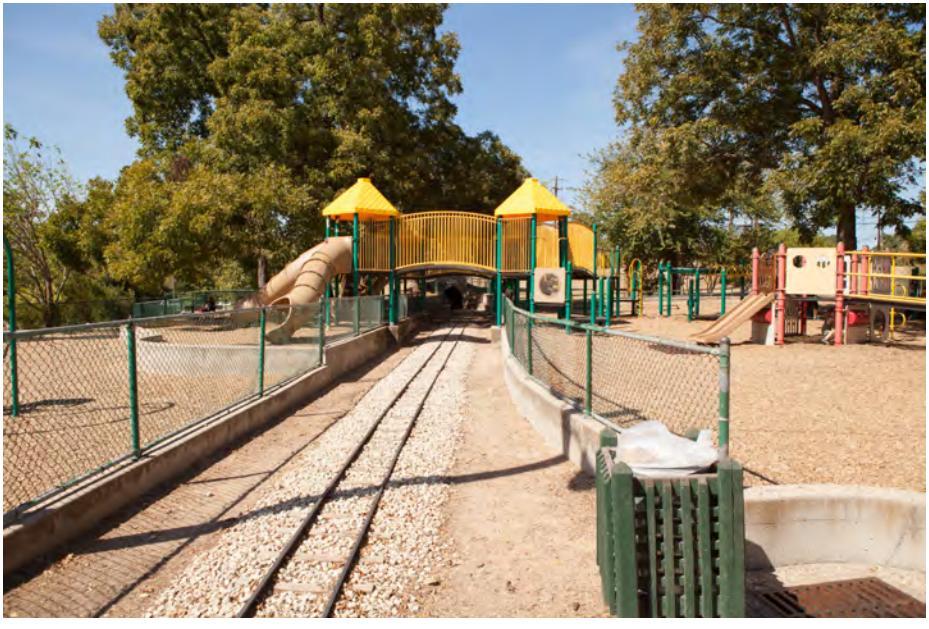
Zilker Playscape: The Zilker Zephyr makes a significant impact on the Playscape. Although a potential asset in differentiating areas for different age groups, the Zephyr trackway is not well integrated into the present playscape design.

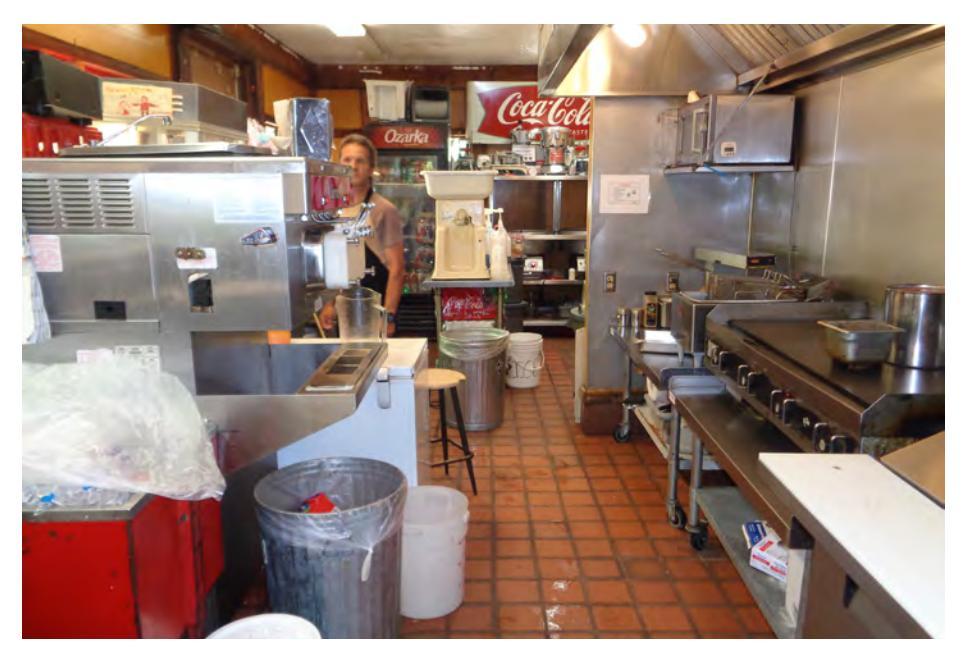
Zilker Café: The size of the Café is inconsistent with the number of visitors patronizing this amenity.

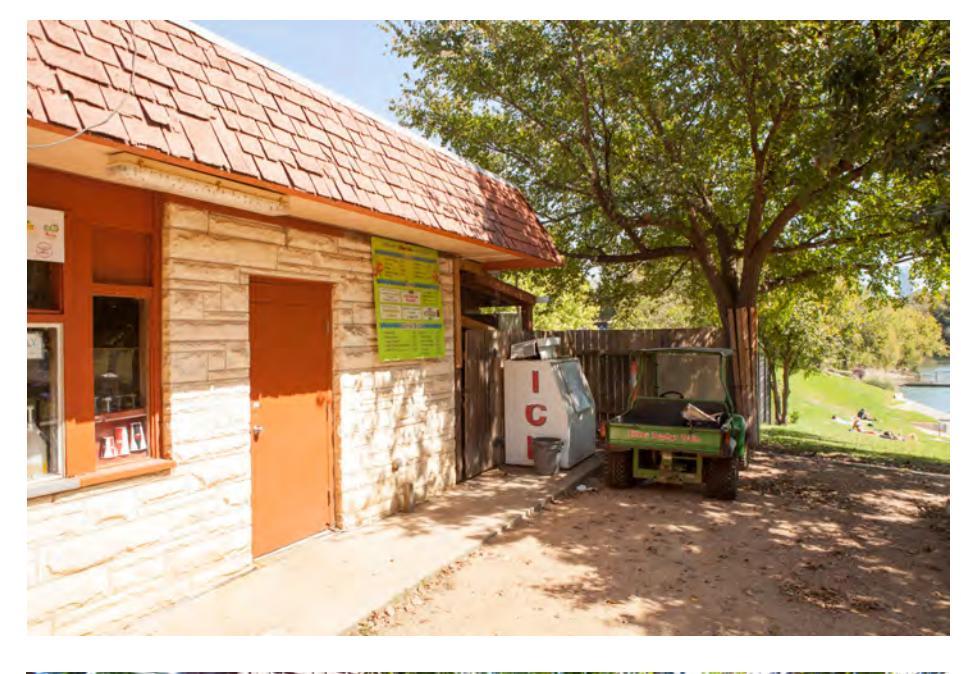
Zilker Café: Due to inadequate building area, the operators of the Café rely on exterior and offsite storage. The area shown here used for vehicular parking and storage is within the pool enclosure and drains into the pool.

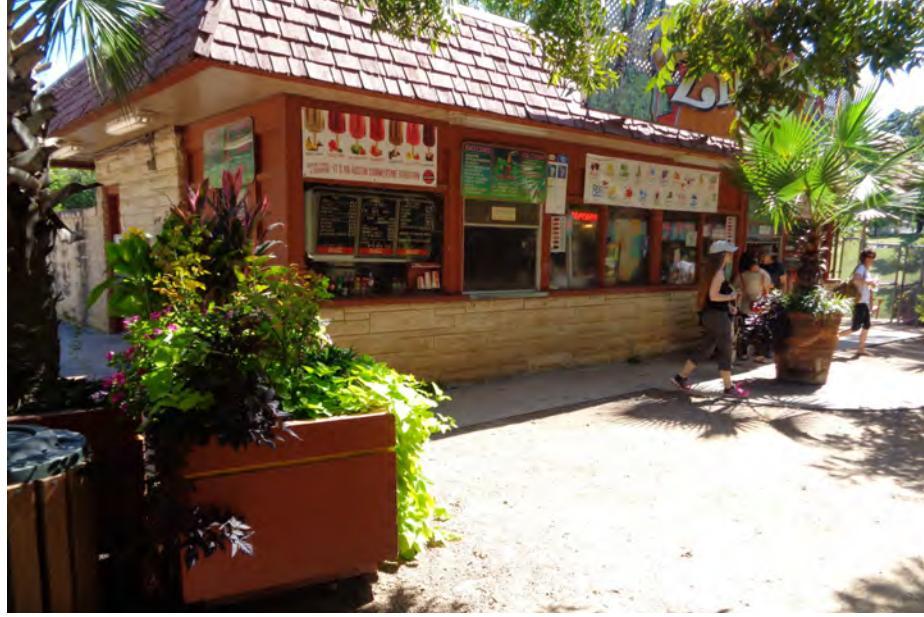
Zilker Café: The fabric of the Zilker Café dates to the early 1960s, when it was constructed to replace a predecessor damaged beyond repair by flooding.

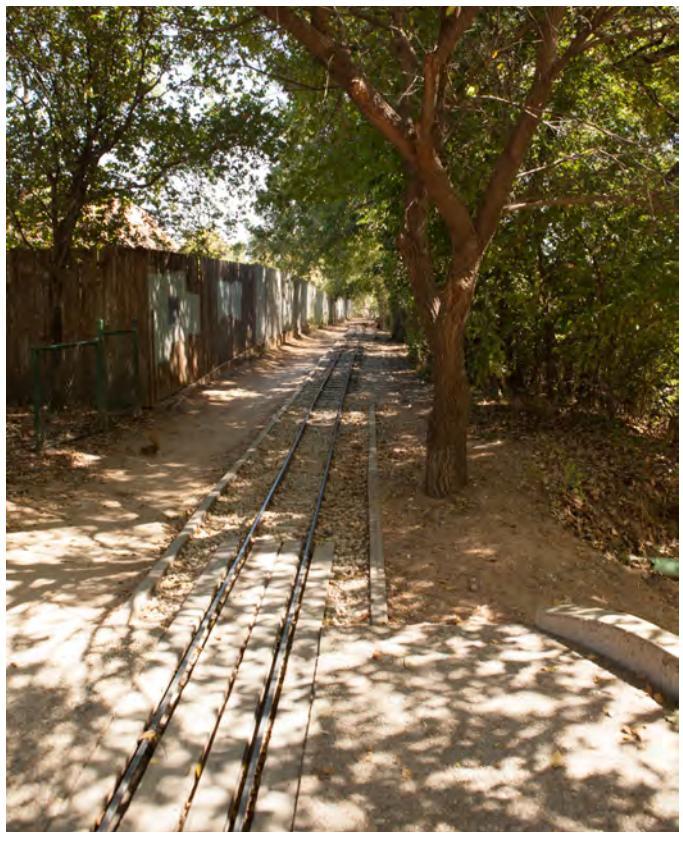
Zilker Zephyr: The right-of-way allocated to the Zilker Zephyr leaves an excessively narrow pathway between the track and the enclosure of the maintenance yard.

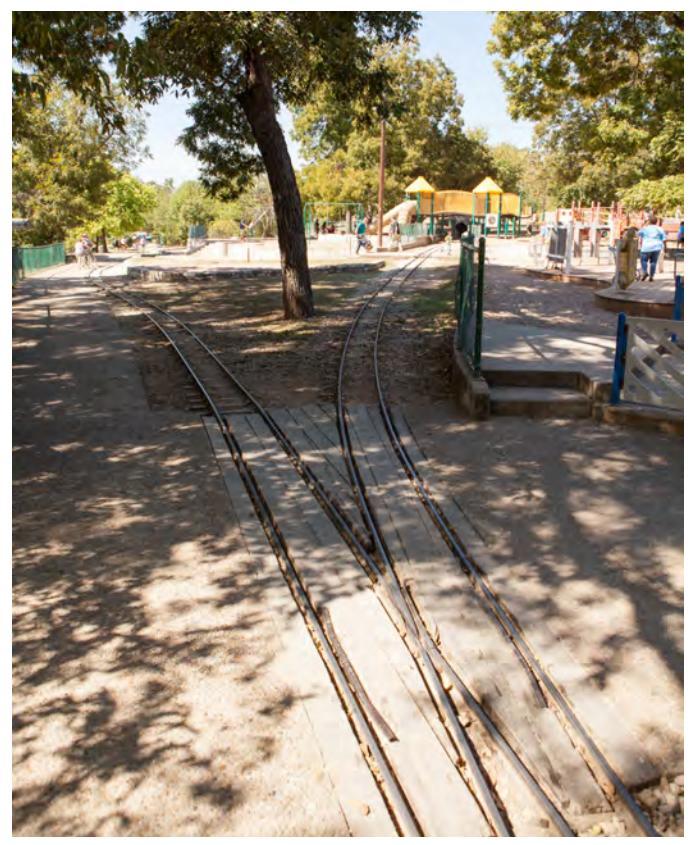
Zilker Zephyr: The Zilker Zephyr has been in service since the early 1960s. The track, which is visibly irregular and variable in gauge, appears to be approaching the end of its serviceable lifespan.

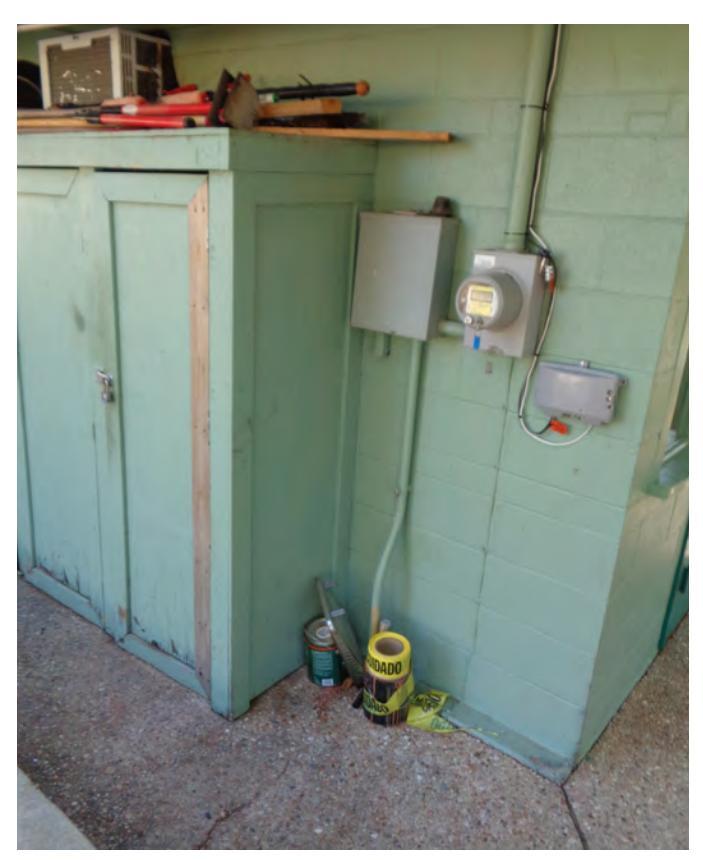
Zilker Zephyr: Deficient storage, as here at the Zephyr depot, is a common throughout the Bathhouse Zone.

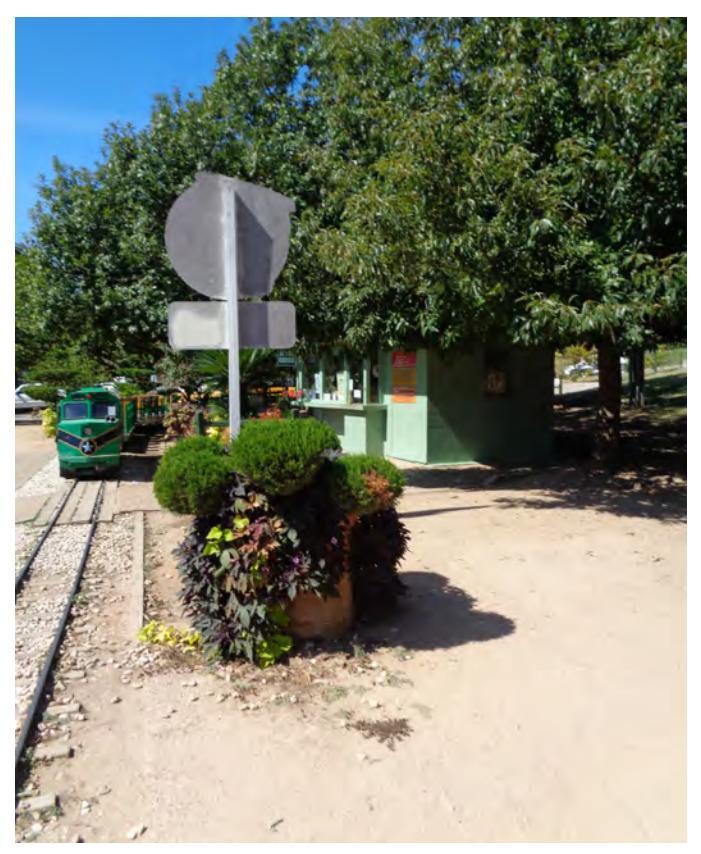
Zilker Zephyr: The Zilker Zephyr is uncomfortably positioned in the most densely-developed, and intensely visited area of the park.

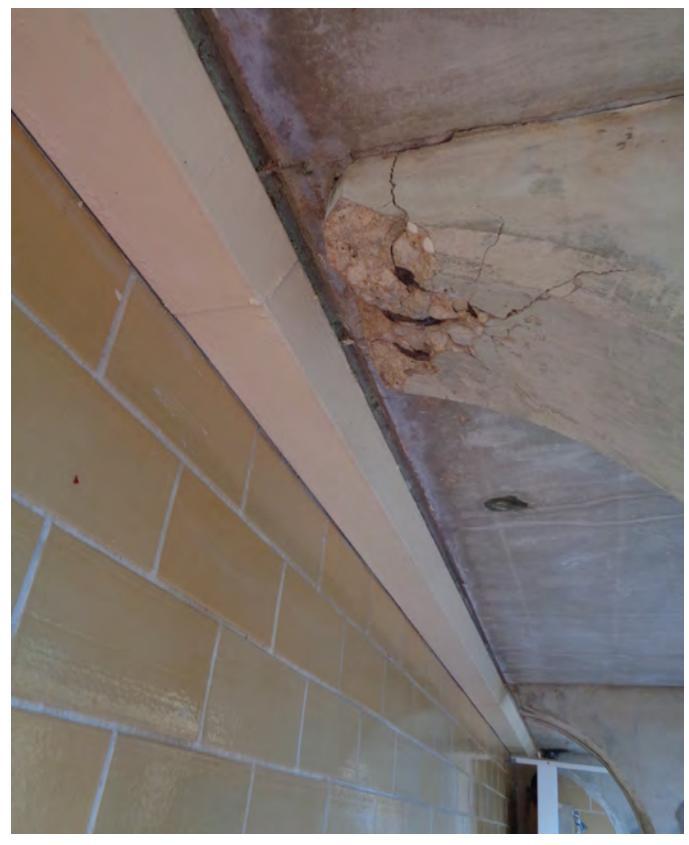
Bathhouse Men's Changing Area: The concrete canopy structures in the mens' and womens' changing areas are in poor condition, with a significant percentage exhibiting spalling concrete and exposed reinforcing.

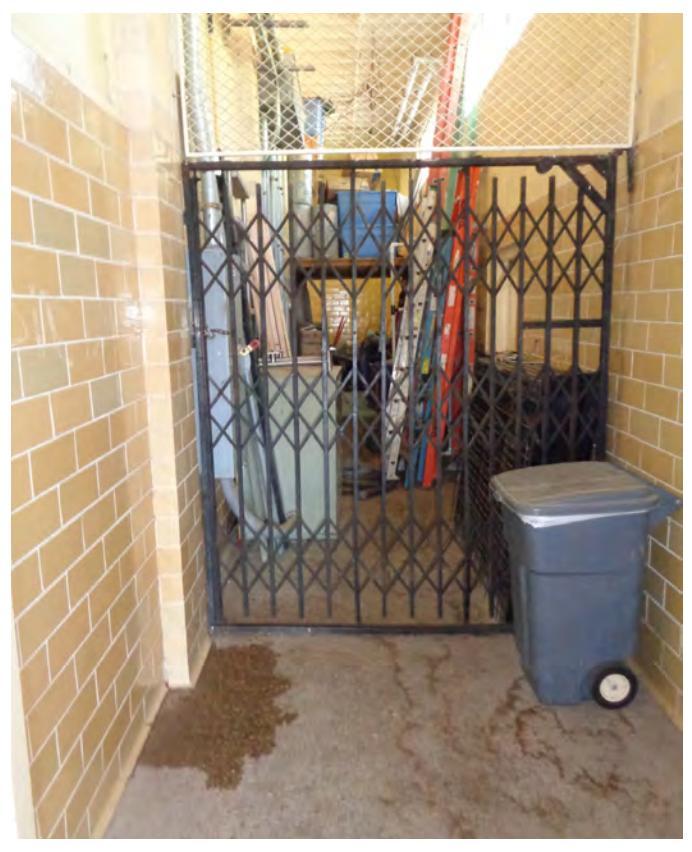
Bathhouse Men's Changing Area – Entry Corridor: This corridor is used both for storage (including the incorporation of an improvised mezzanine) and for the location of portions of the electrical service for the Bathhouse.

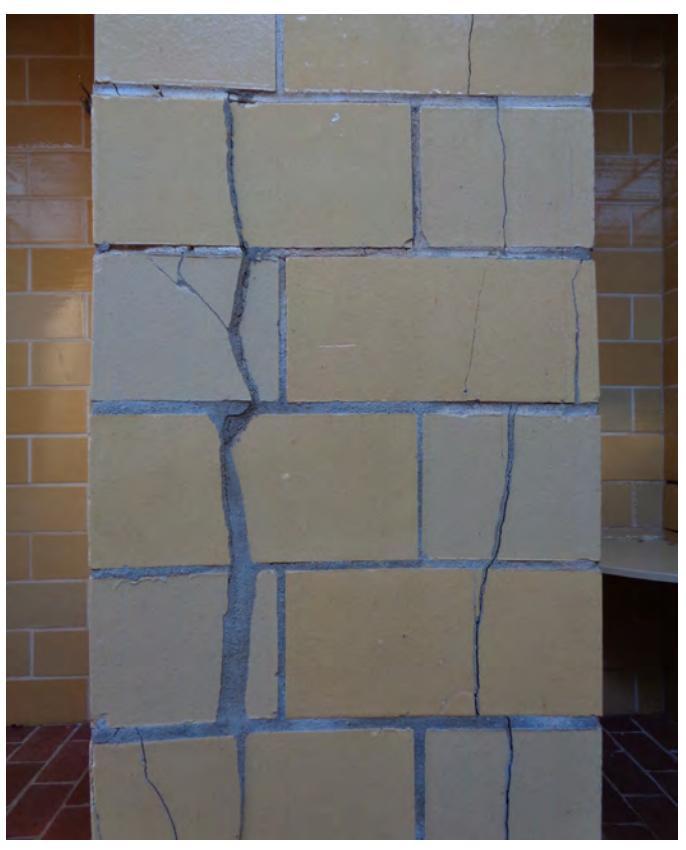
Bathhouse Men's Changing Area: A typical example of structural deterioration of the glazed structural tile partitions in the mens' and women's changing areas. This appears to be the consequence of a flaw in the original building design, which did not include dedicated foundations for these partitions.

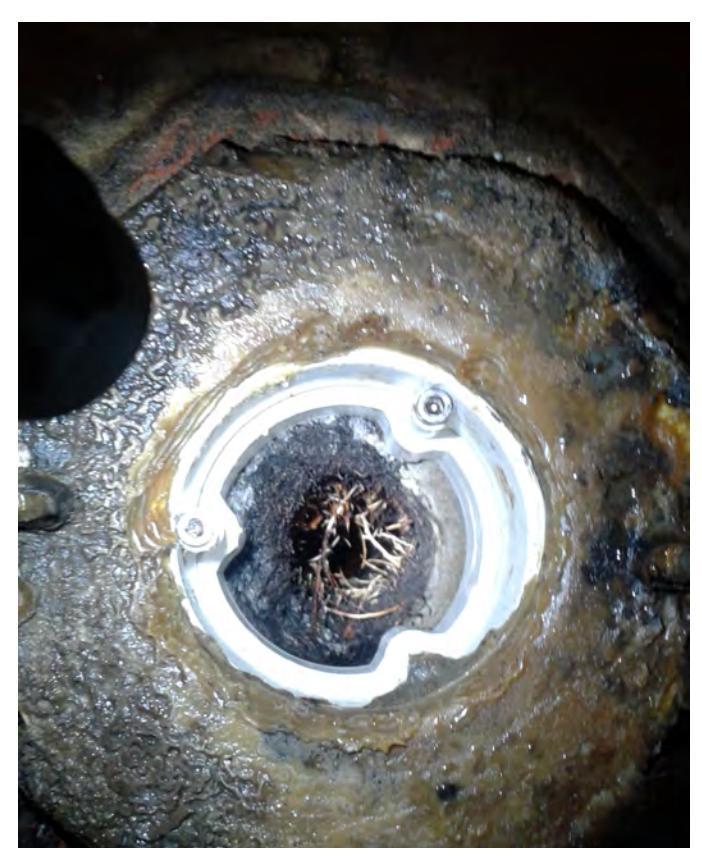
Bathhouse Men's Changing Area: An example of the failure of a sanitary sewer line in the Mens' Changing Area restrooms. Much of the existing plumbing within the Bathhouse is seventy years old and in poor physical condition.

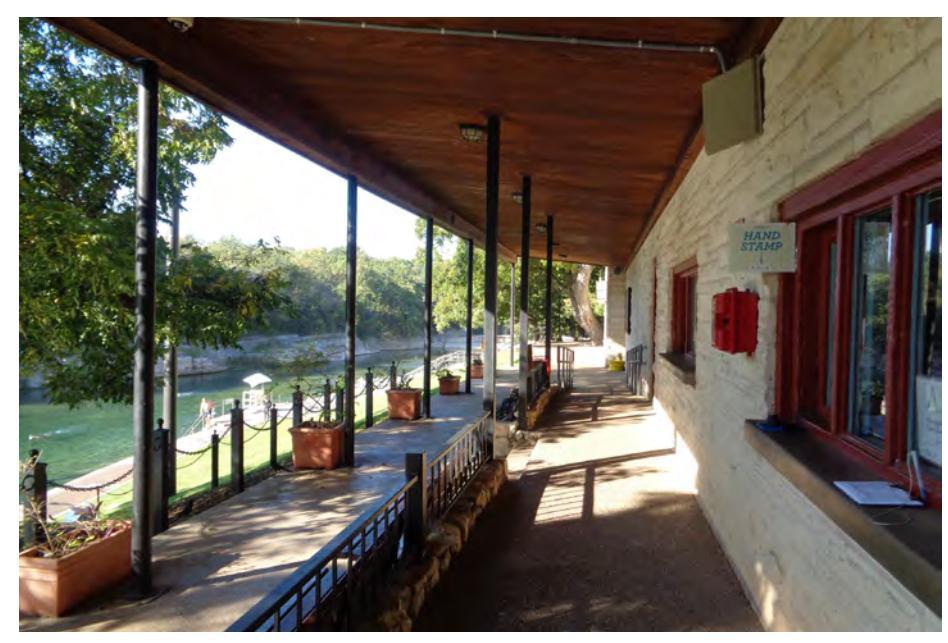
Bathhouse Spectators' Gallery: The Spectators' Gallery serves as the principal means of access to and from the north side of the pool. The Gallery was not intended for this purpose.

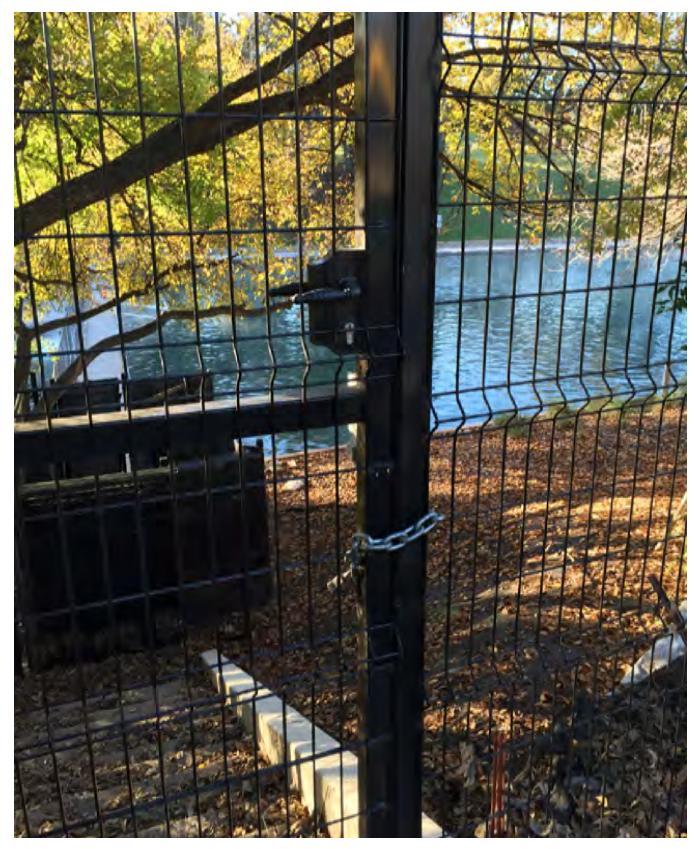
Pool Enclosure: Emergency egress from the pool enclosure is a matter of significant concern. Exits from the enclosure do not comply with current code requirements, a deficiency compounded by features such as locked gates.

At present, the number and location of emergency exits from the north side of the pool are conspicuously deficient with respect to the requirements of the Building Code. Per visitor data provided by PARD, the north side of the pool should be provided per code with not less than four means of egress, with a total width of not less than 25'. Current egress from the north side of the pool, consisting in terms of clearly identified exits of a single turnstile at the main entrance with a clear egress width of less than three feet, is dangerously deficient.

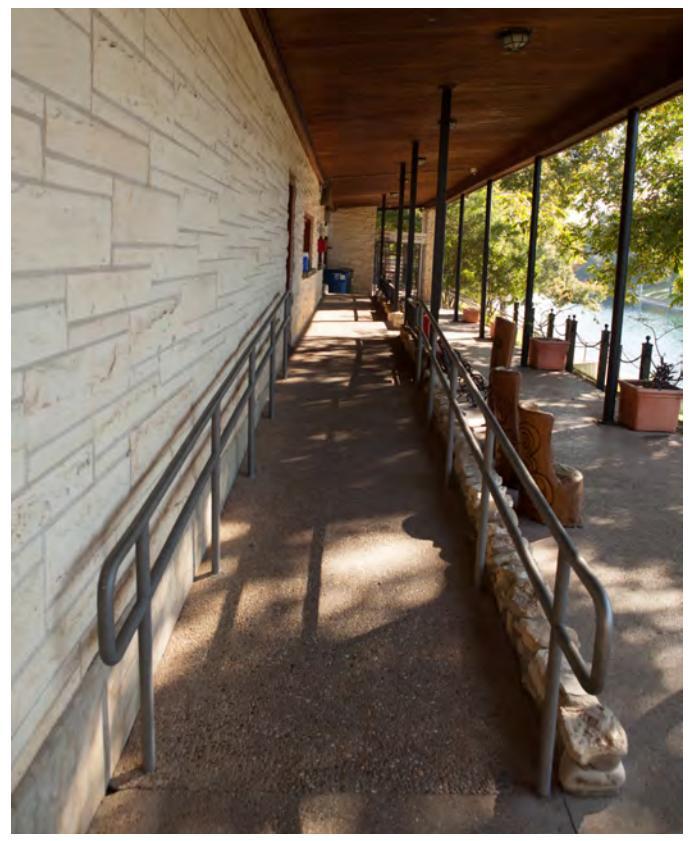
Pool Enclosure: Emergency egress from the pool enclosure is through the Spectators' Gallery. This is a very narrow pathway given the potential number of people within the pool enclosure.
