## ZILKER PARK IMPROVEMENTS AT THE BATHHOUSE ZONE

# BATHHOUSE KEY FINDINGS

# PRELIMINARY RECOMMENDATIONS

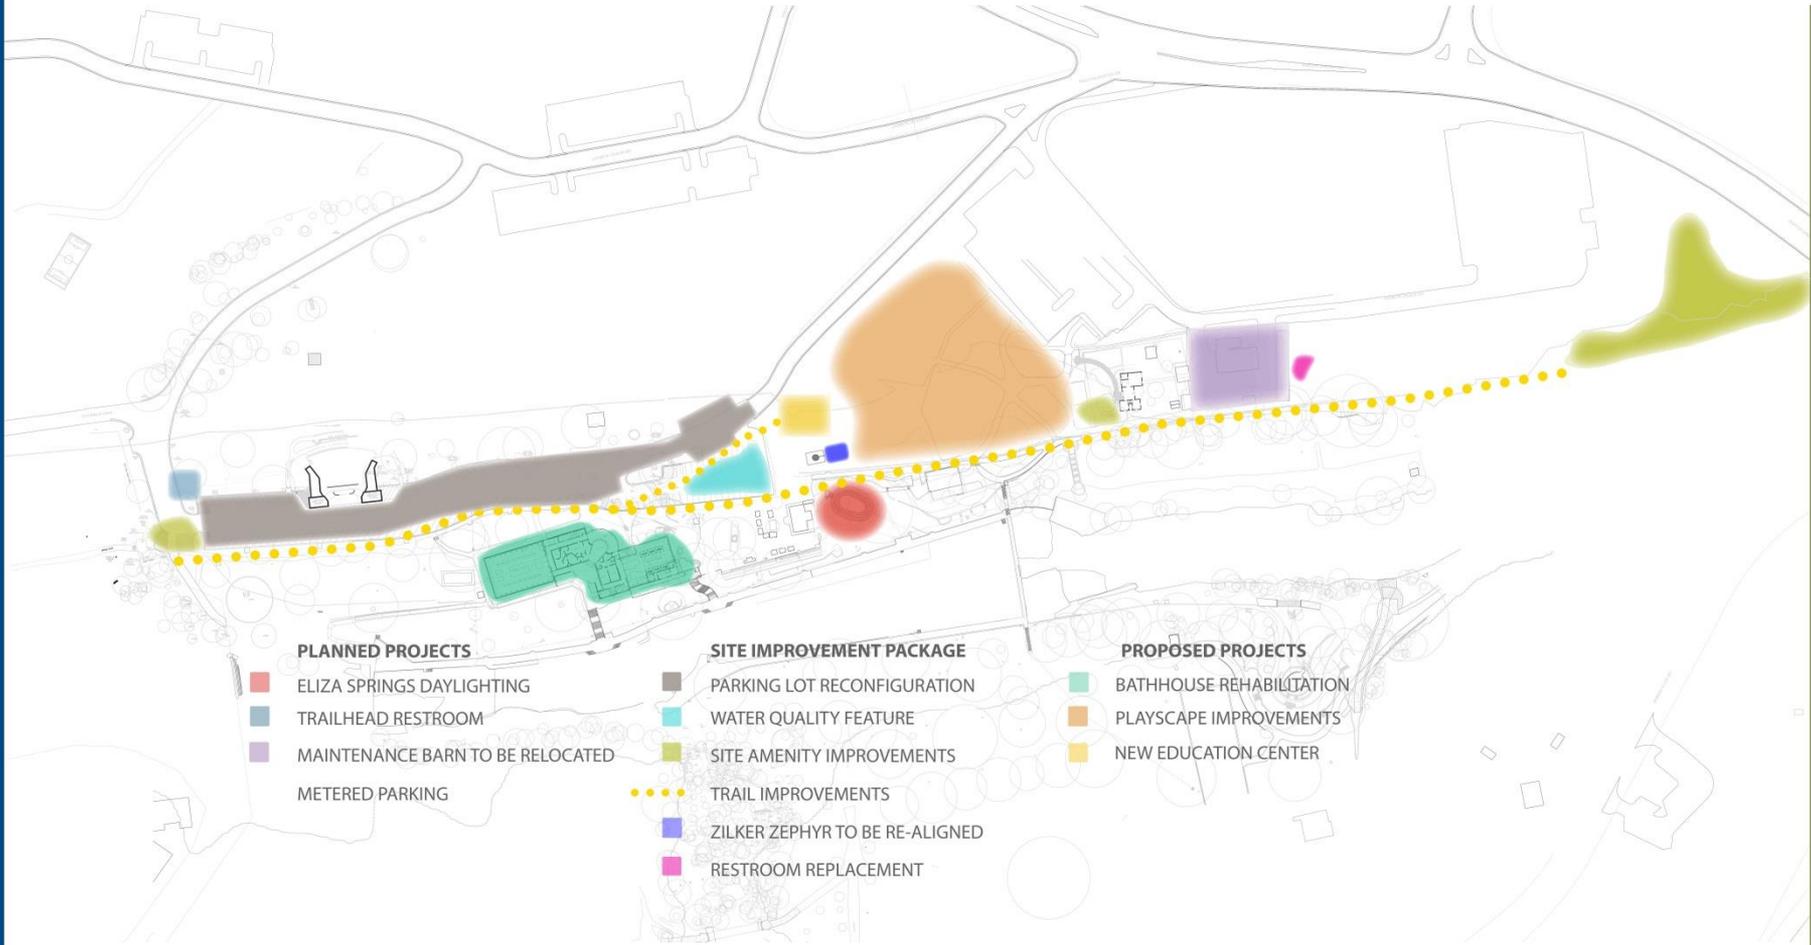
# SITE PLAN RECOMMENDED PROJECTS

**PLANNED PROJECTS**

- ELIZA SPRINGS DAYLIGHTING
- TRAILHEAD RESTROOM
- MAINTENANCE BARN TO BE RELOCATED
- METERED PARKING

**SITE IMPROVEMENT PACKAGE**

- PARKING LOT RECONFIGURATION
- WATER QUALITY FEATURE
- SITE AMENITY IMPROVEMENTS
- TRAIL IMPROVEMENTS
- ZILKER ZEPHYR TO BE RE-ALIGNED
- RESTROOM REPLACEMENT

**PROPOSED PROJECTS**

- BATHHOUSE REHABILITATION
- PLAYSCAPE IMPROVEMENTS
- NEW EDUCATION CENTER

- Planned Projects
  - Eliza Daylighting, Trailhead Restroom, Maintenance Barn Relocation, Metered Parking
- Site Improvements Package
  - Parking Lot Reconfiguration, Water Quality Feature, Site Amenities, Trail Improvements, Zephyr Realignment, East Restroom Replacement
- Proposed Projects
  - Bathhouse Rehabilitation, Playscape Improvements, Education Center

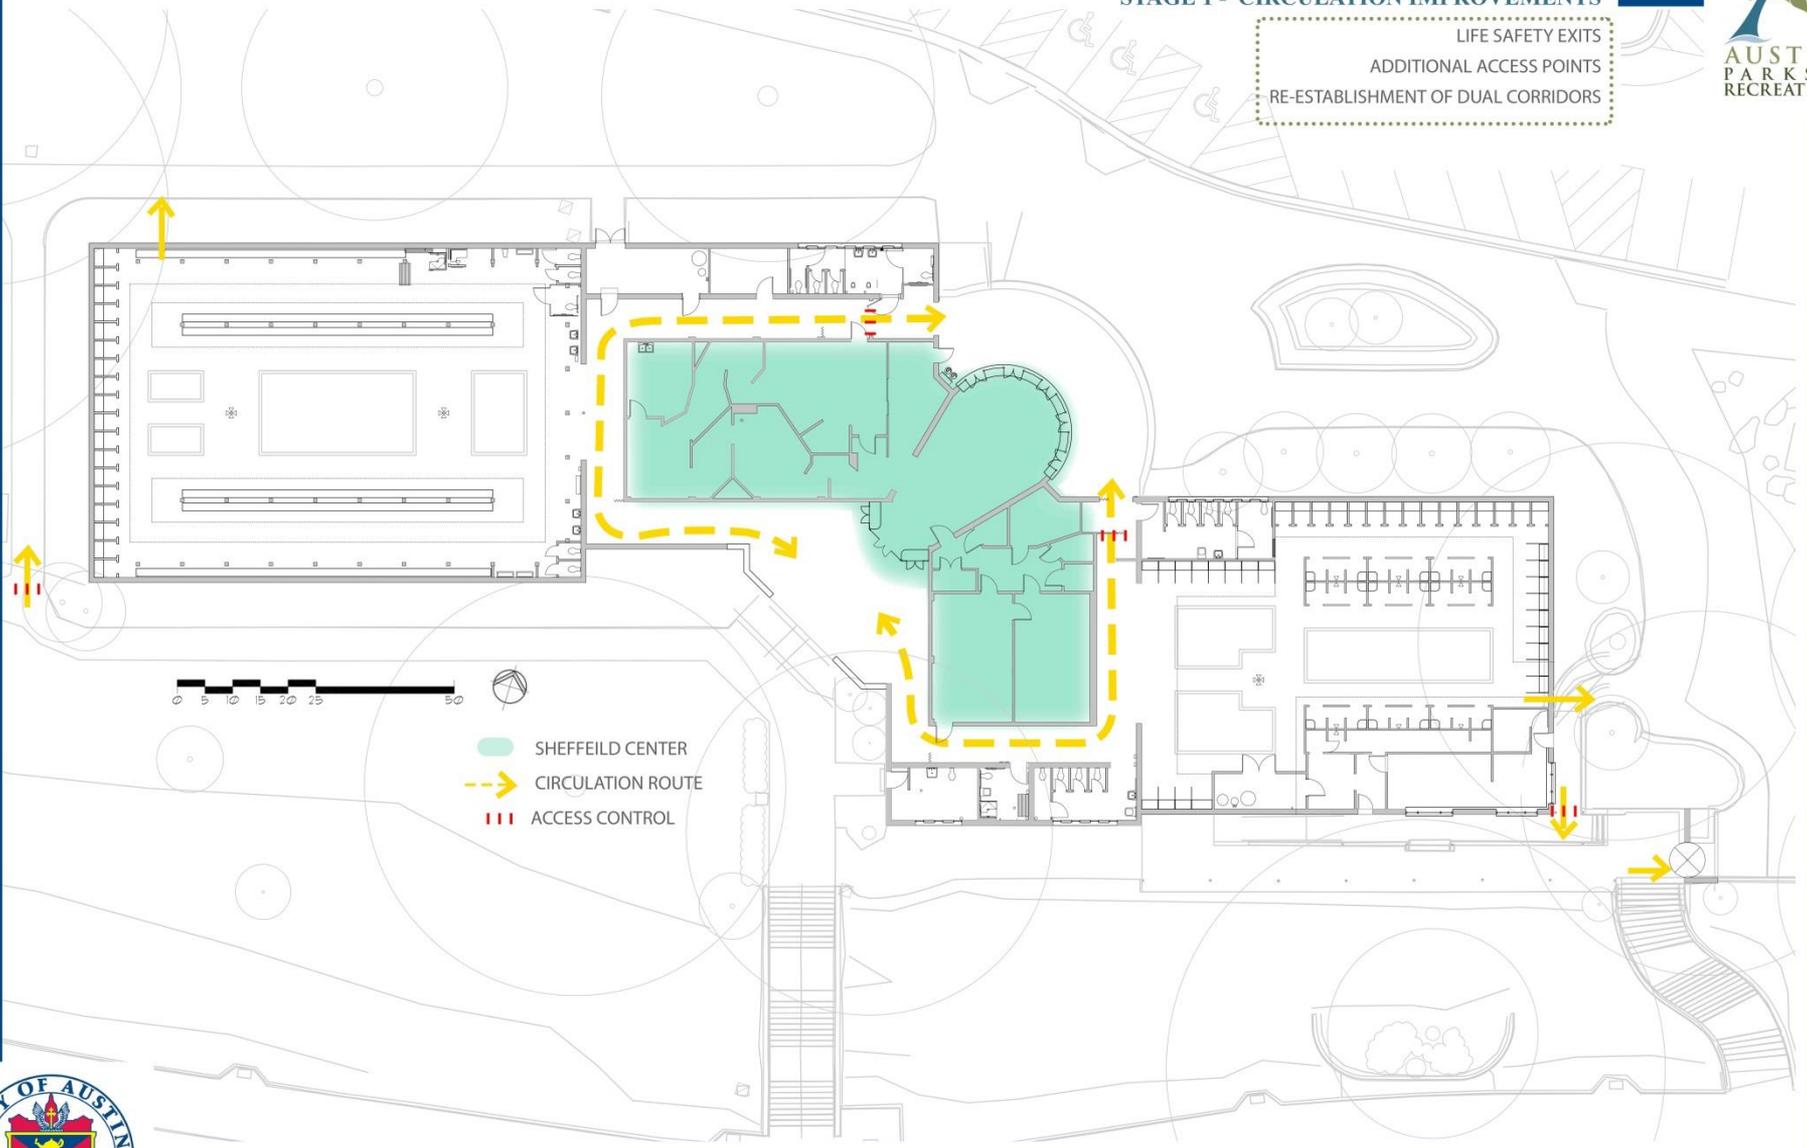
## STAGE 1 - CIRCULATION IMPROVEMENTS

- LIFE SAFETY EXITS
- ADDITIONAL ACCESS POINTS
- RE-ESTABLISHMENT OF DUAL CORRIDORS

- SHEFFIELD CENTER
- CIRCULATION ROUTE
- ACCESS CONTROL

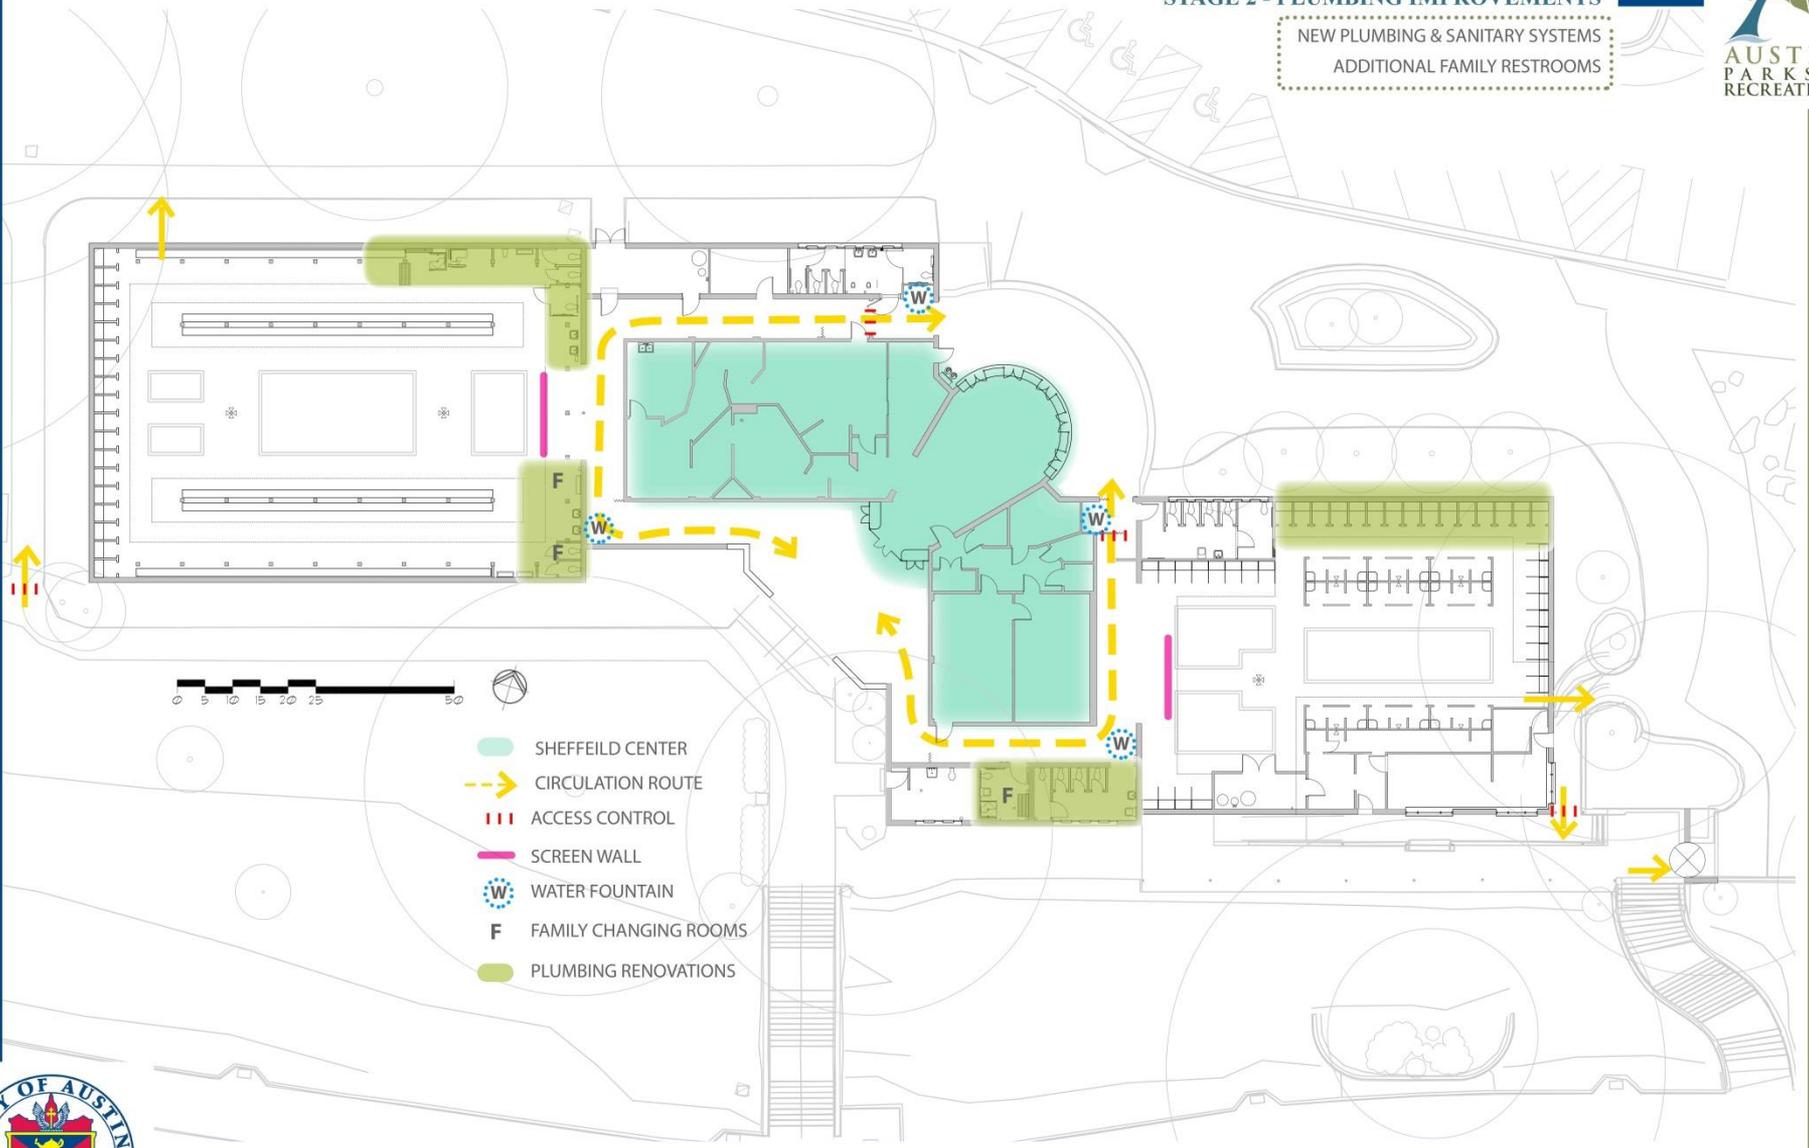
## STAGE 2 - PLUMBING IMPROVEMENTS

NEW PLUMBING & SANITARY SYSTEMS  
ADDITIONAL FAMILY RESTROOMS

- SHEFFIELD CENTER
- CIRCULATION ROUTE
- ACCESS CONTROL
- SCREEN WALL
- WATER FOUNTAIN
- FAMILY CHANGING ROOMS
- PLUMBING RENOVATIONS

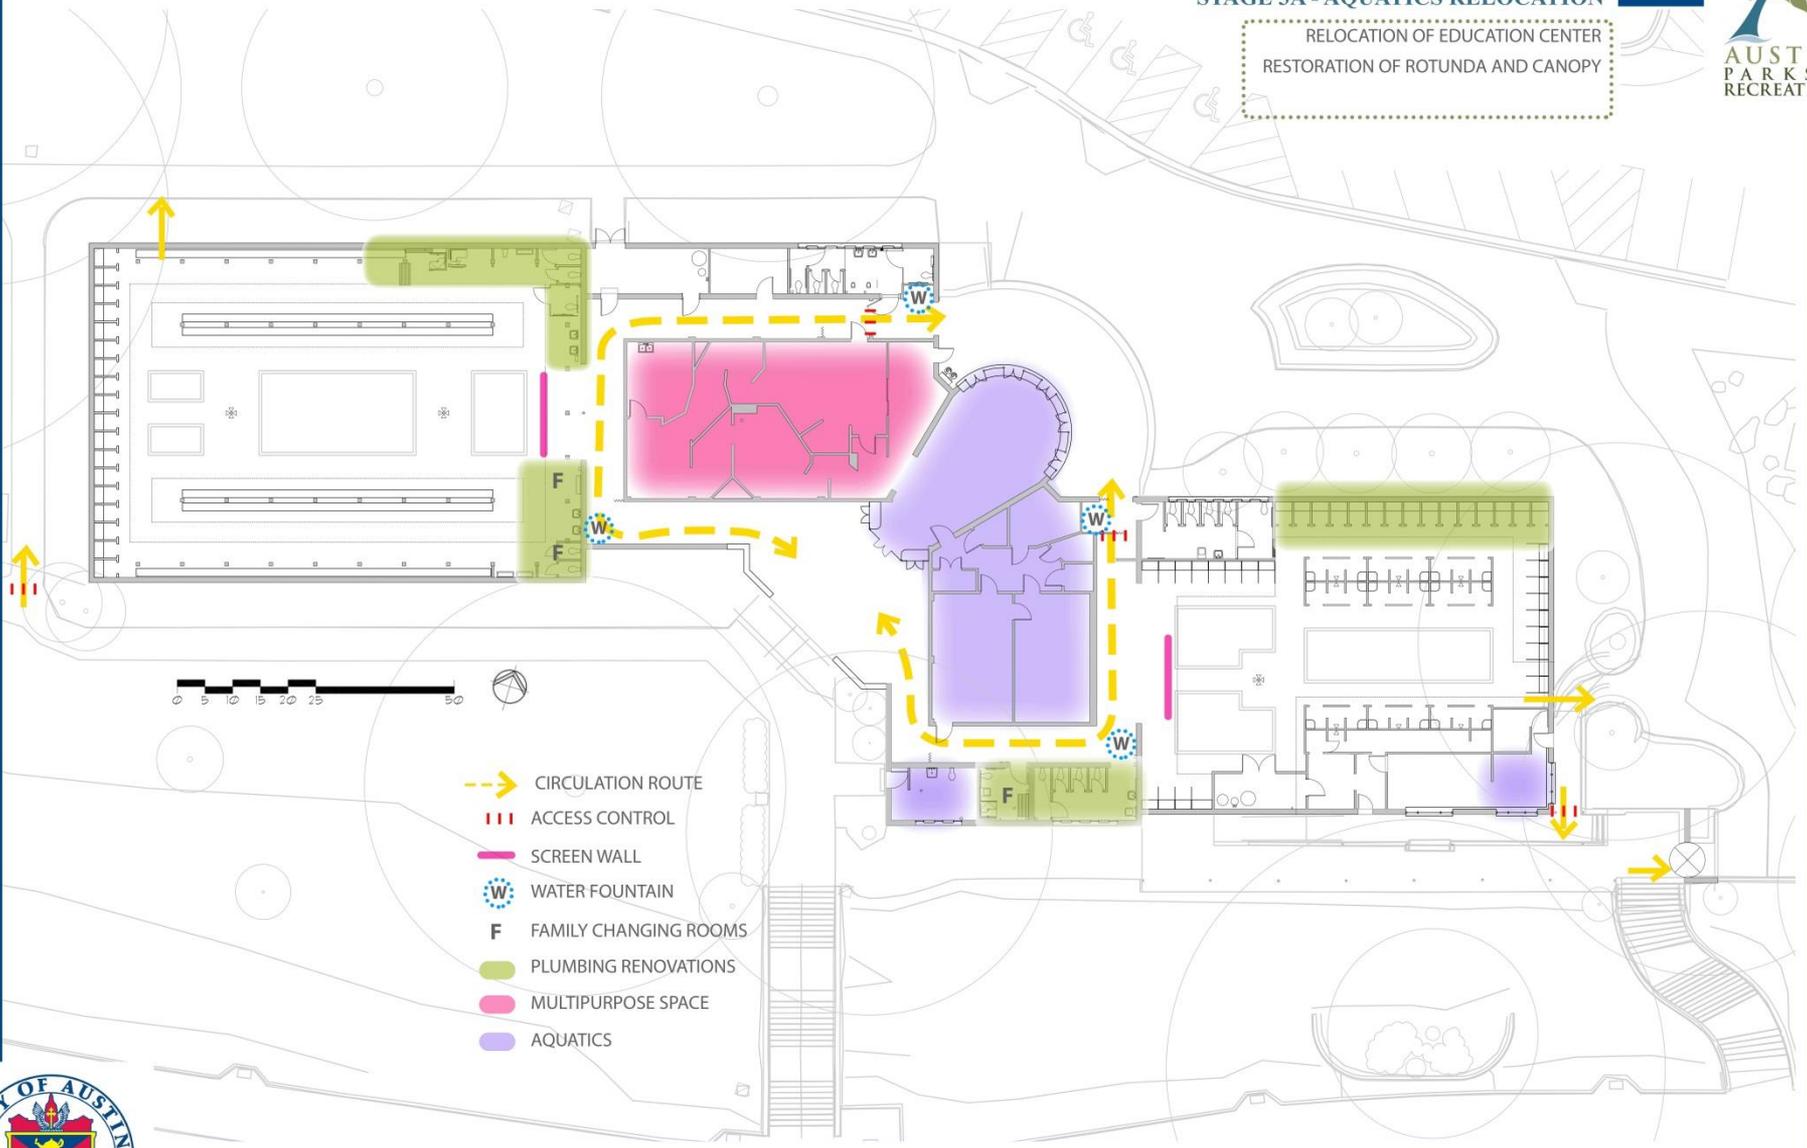
## STAGE 3A - AQUATICS RELOCATION

RELOCATION OF EDUCATION CENTER  
RESTORATION OF ROTUNDA AND CANOPY

- > CIRCULATION ROUTE
- ACCESS CONTROL
- SCREEN WALL
- W WATER FOUNTAIN
- F FAMILY CHANGING ROOMS
- PLUMBING RENOVATIONS
- MULTIPURPOSE SPACE
- AQUATICS

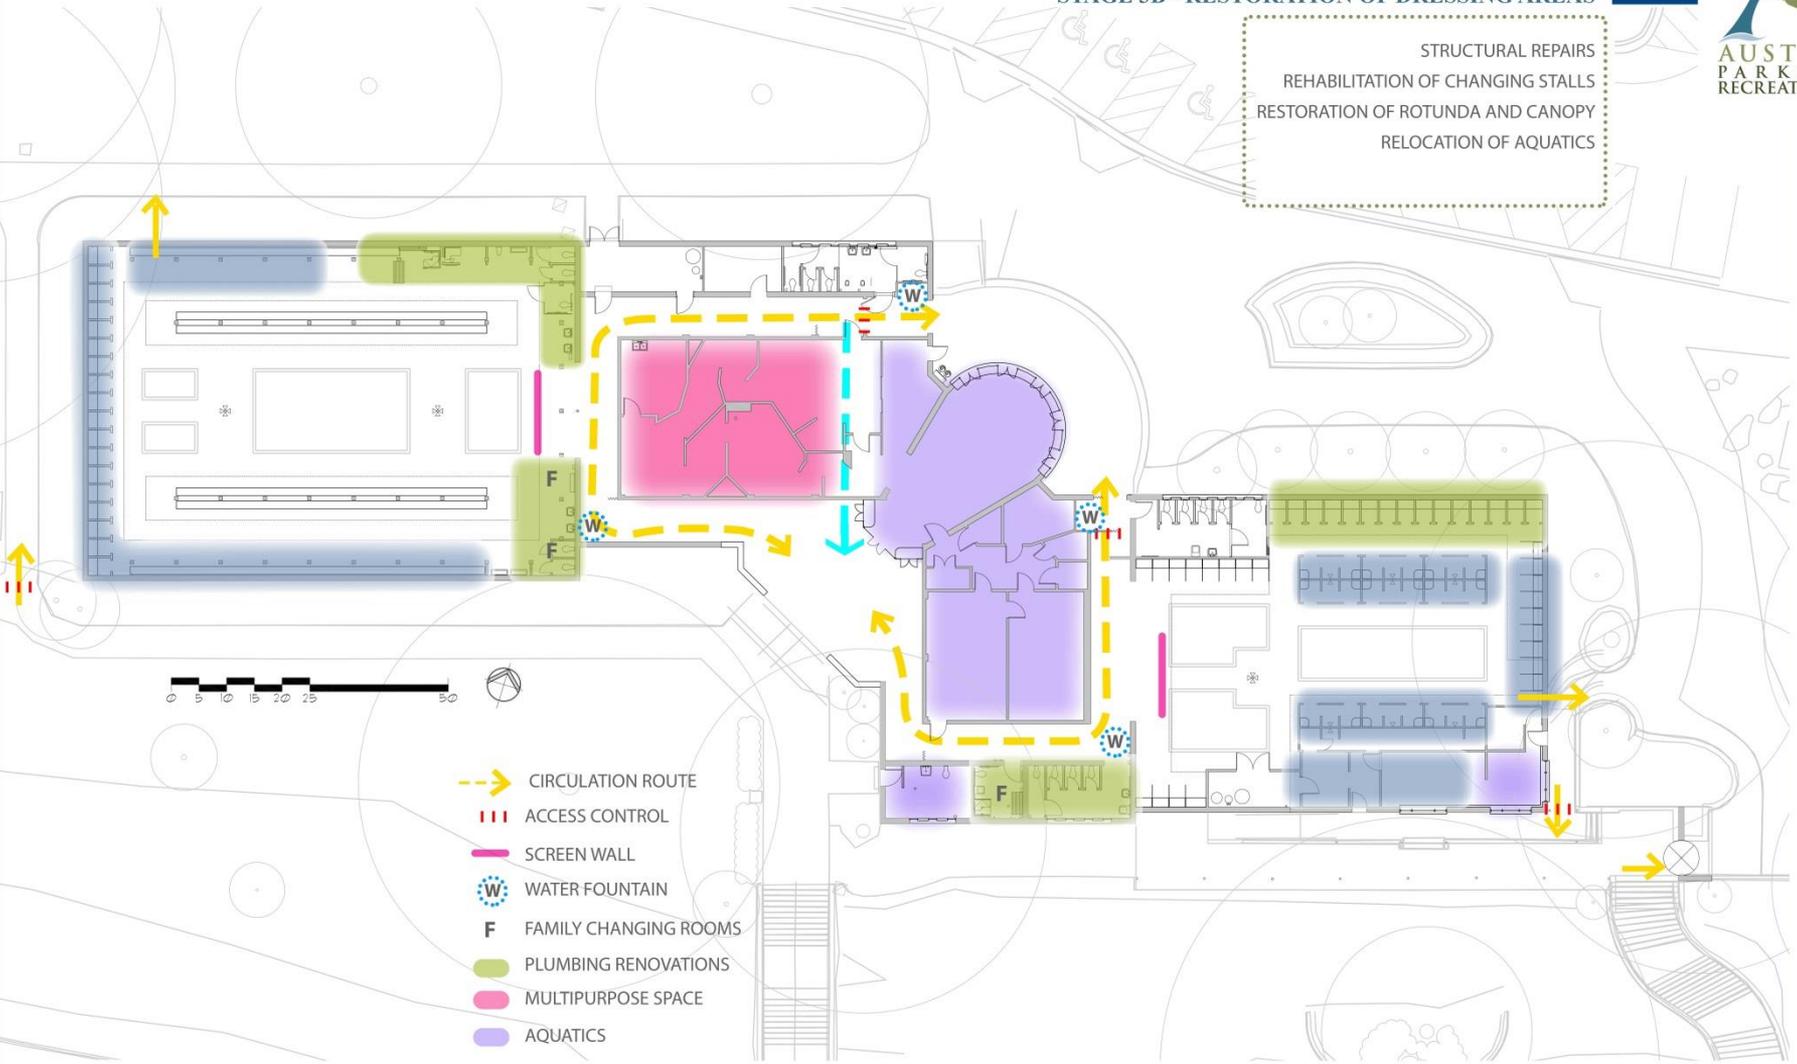
## STAGE 3B - RESTORATION OF DRESSING AREAS

STRUCTURAL REPAIRS  
REHABILITATION OF CHANGING STALLS  
RESTORATION OF ROTUNDA AND CANOPY  
RELOCATION OF AQUATICS

- CIRCULATION ROUTE
- ||| ACCESS CONTROL
- SCREEN WALL
- W WATER FOUNTAIN
- F FAMILY CHANGING ROOMS
- PLUMBING RENOVATIONS
- MULTIPURPOSE SPACE
- AQUATICS
- DRESSING ROOM RESTORATIONS
- ALTERNATE ROUTE
