# Country Club Creek (east and west) Watershed

## Watershed Overview

## Site Photographs

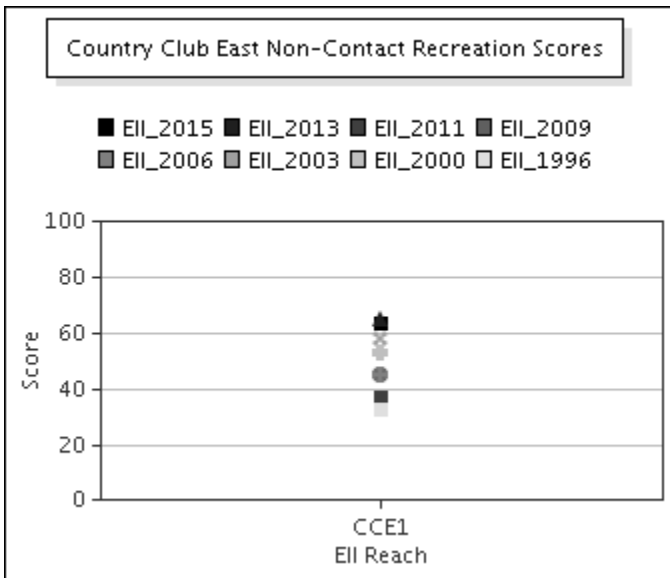
Score Summary – Reach scores for each sample year (Continued from previous page)
