Eanes Creek Watershed

Summary Sheet

Data Summary Graphs – Dissolved Oxygen and Temperature (Downstream to Upstream by Year)

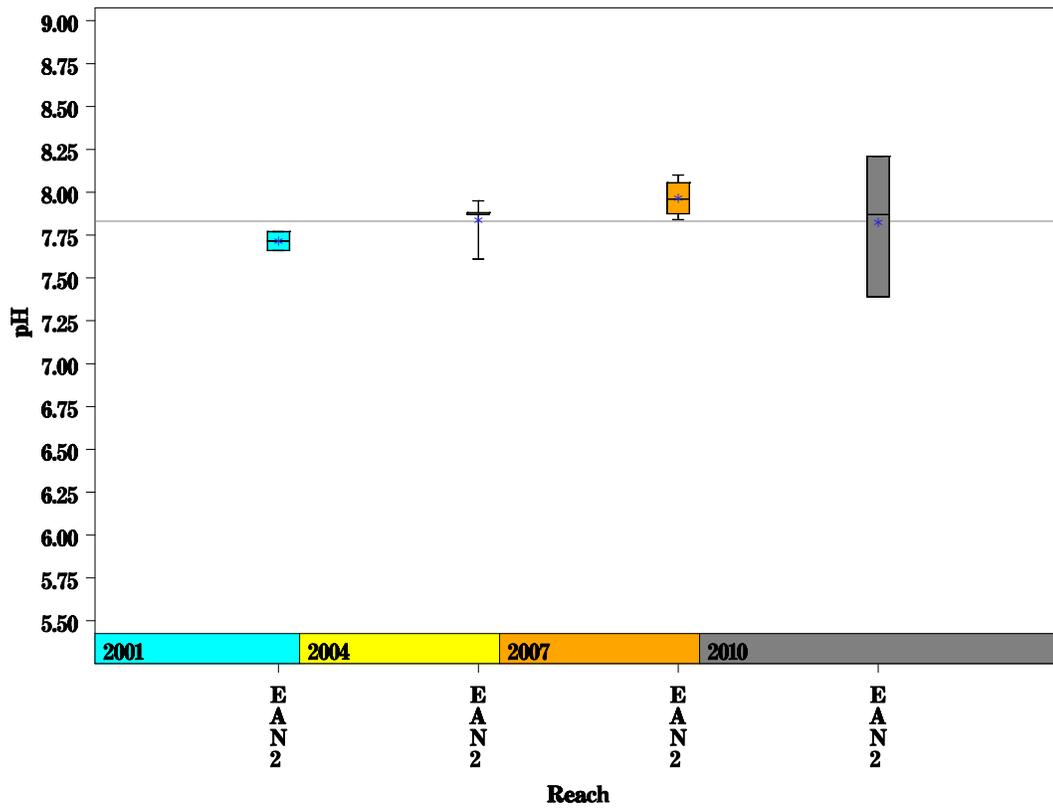
Parameter=PH Unit=Standard units Watershed=Eanes Creek

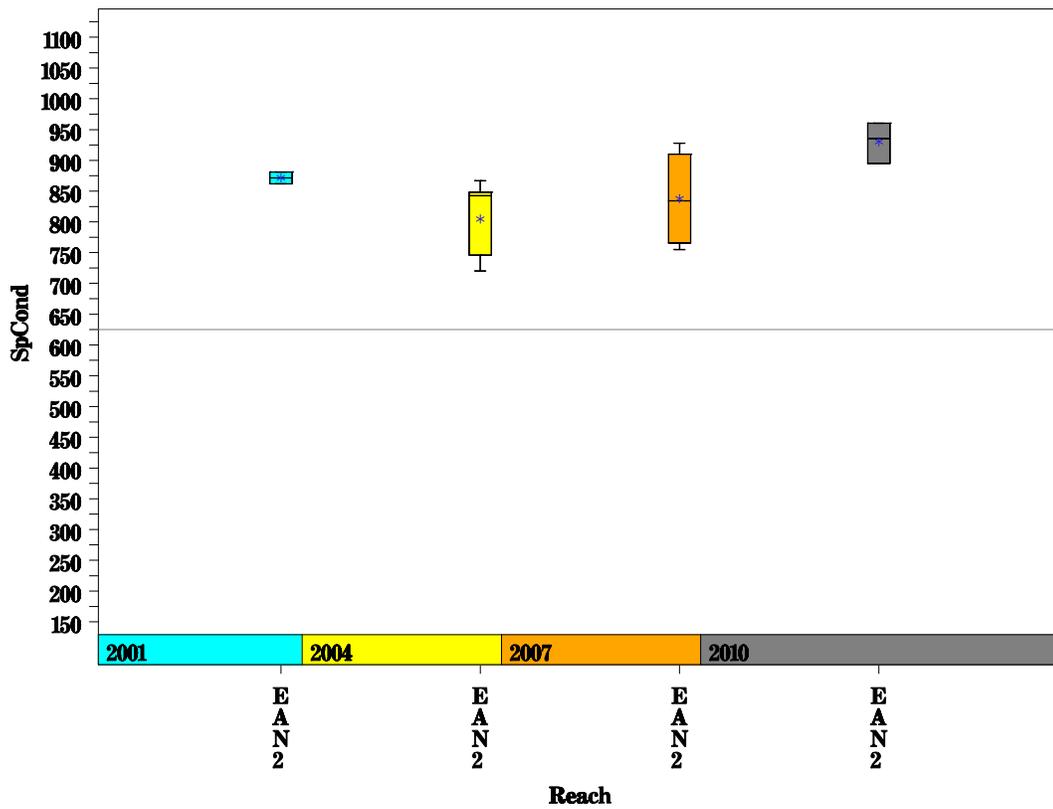
Parameter=CONDUCTIVITY Unit=uS/cm Watershed=Eanes Creek

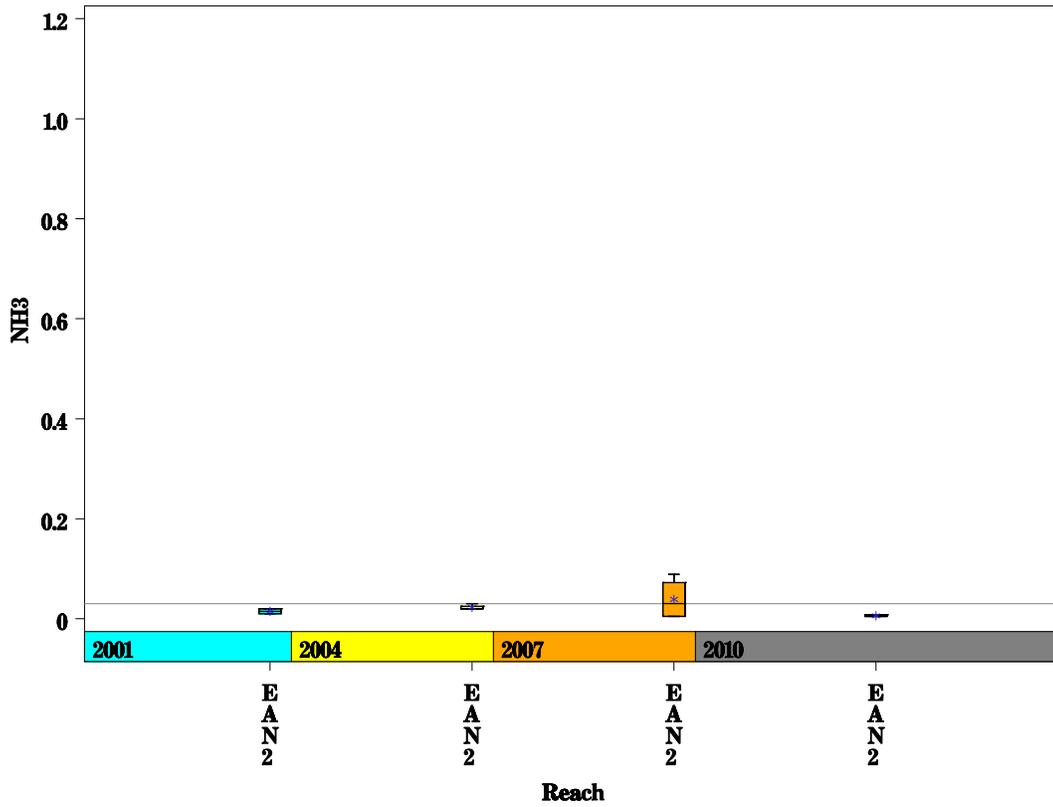
Parameter = AMMONIA AS N Unit = MG/L Watershed = Eanes Creek

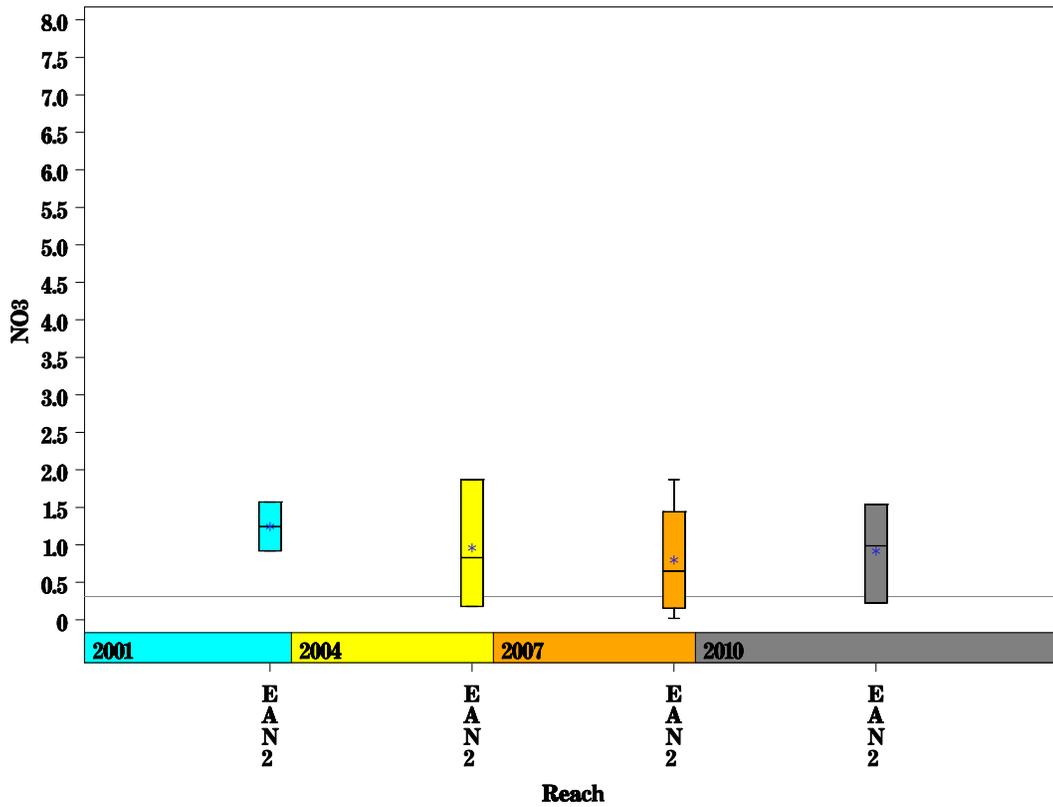
Parameter = NITRATE AS N Unit = MG/L Watershed = Eanes Creek

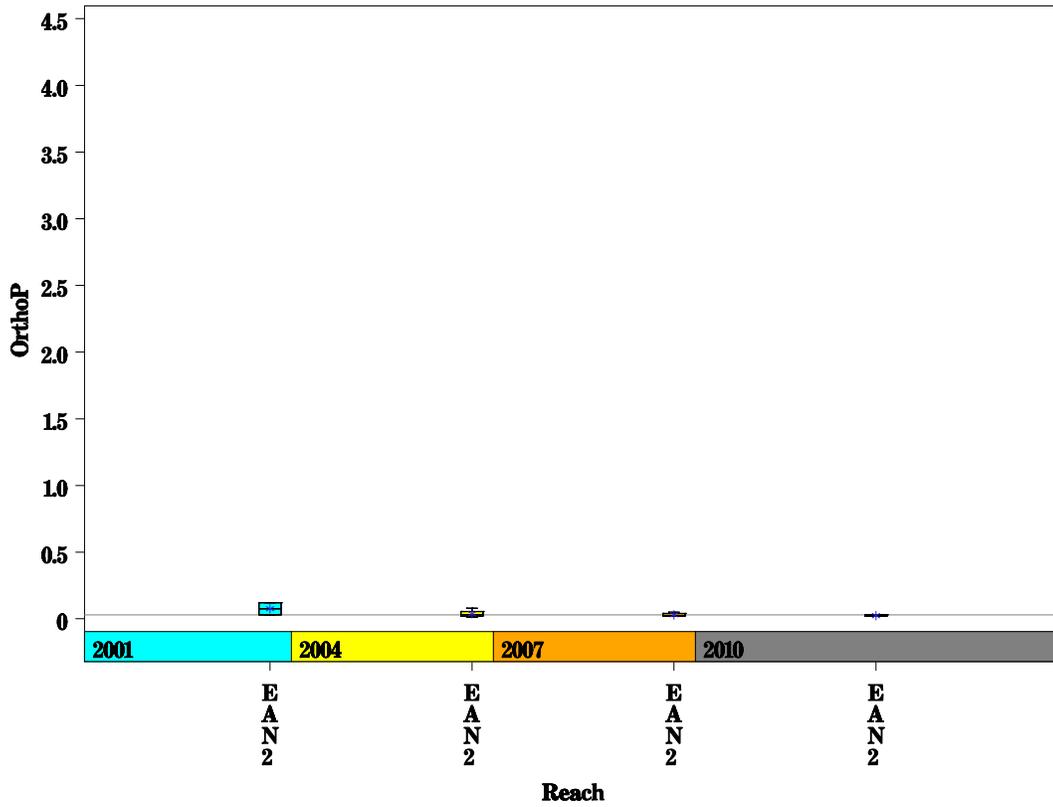
Parameter = ORTHOPHOSPHORUS AS P Unit = MG/L Watershed = Eanes Creek

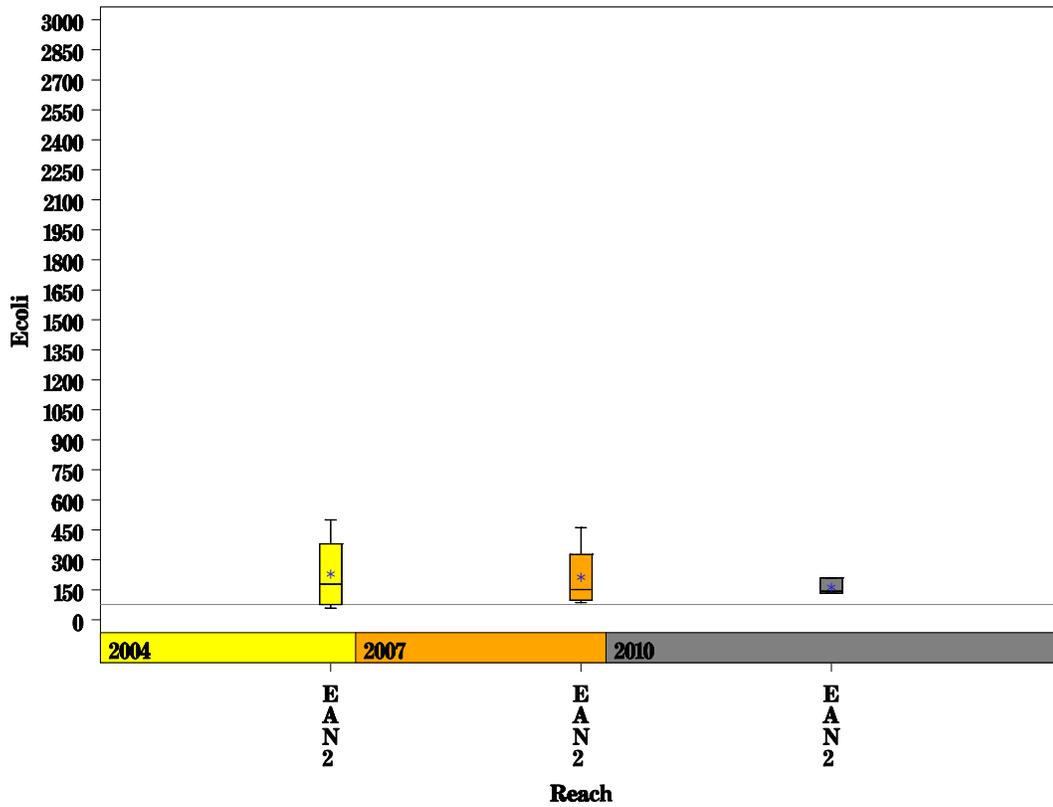
Parameter = E COLI BACTERIA Unit = MPN/dL Watershed = Eanes Creek

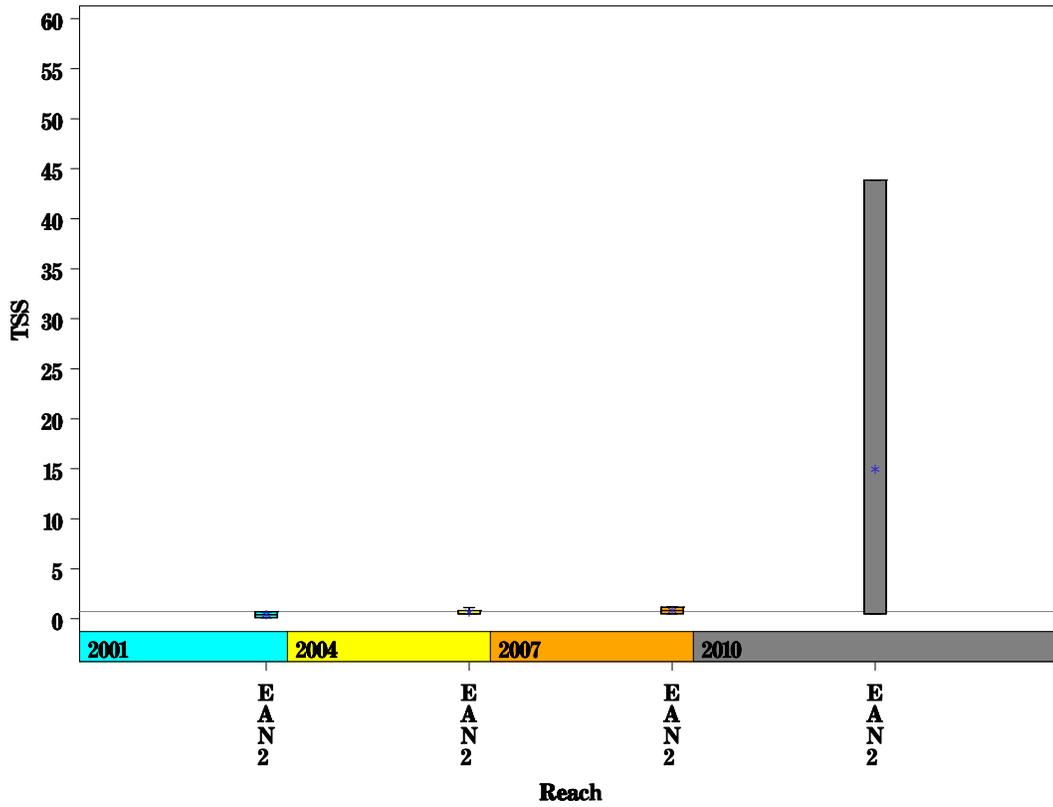
Parameter = TOTAL SUSPENDED SOLIDS Unit = MG/L Watershed = Eanes Creek

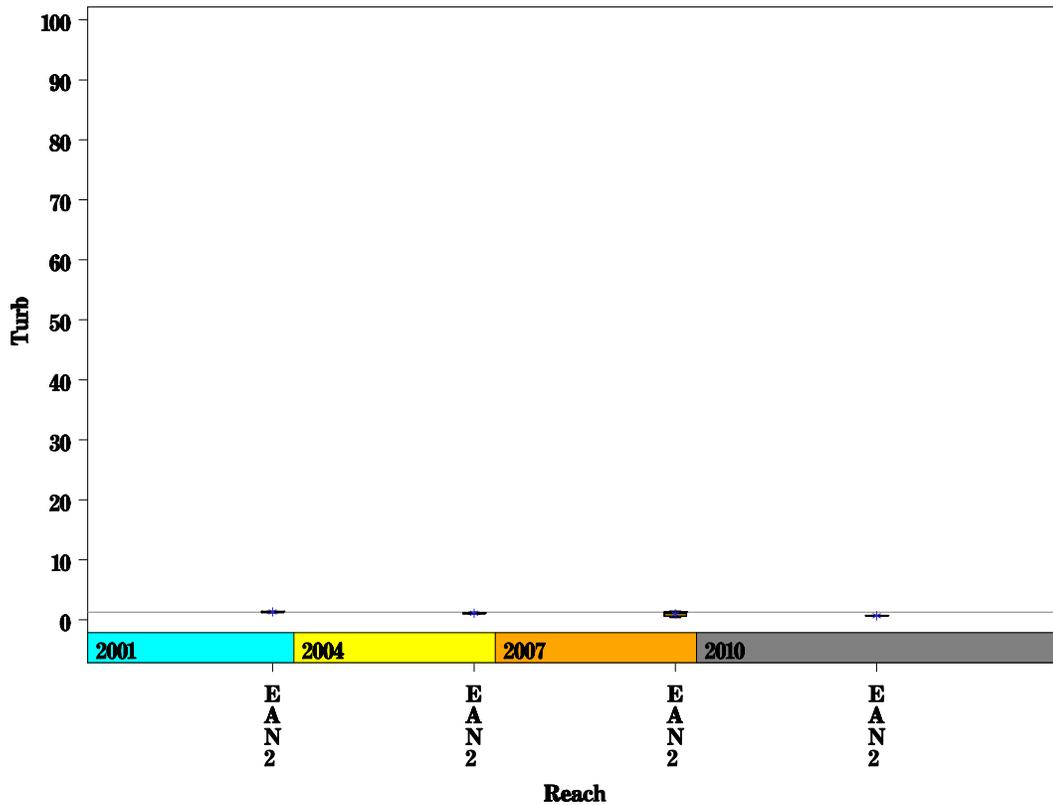
Parameter = TURBIDITY Unit = NTU Watershed = Eanes Creek

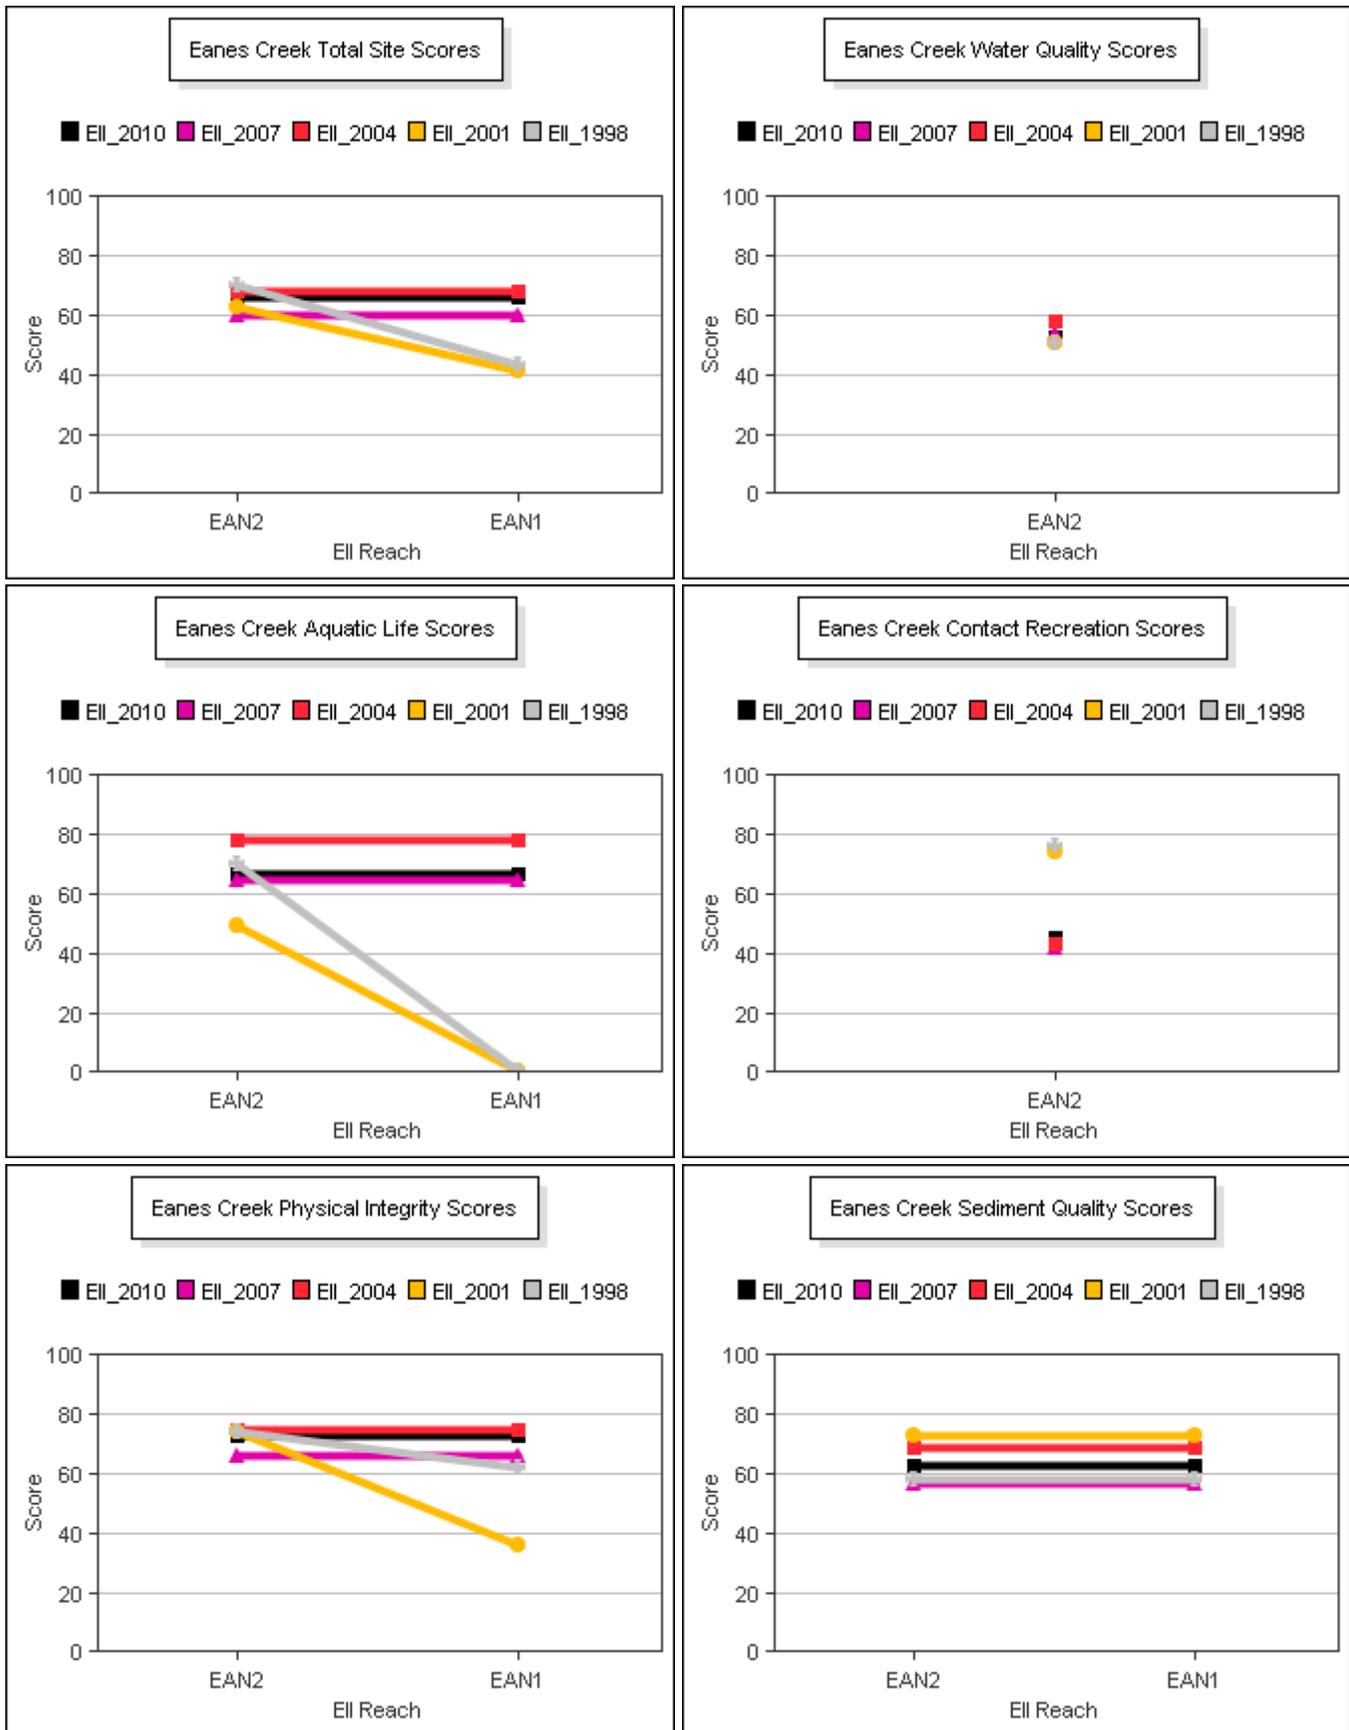
Score Summary – Reach scores for each sample year
