# Eanes Creek Watershed

## Summary Sheet

Data Summary Graphs – Dissolved Oxygen and Temperature (Downstream to Upstream by Year)

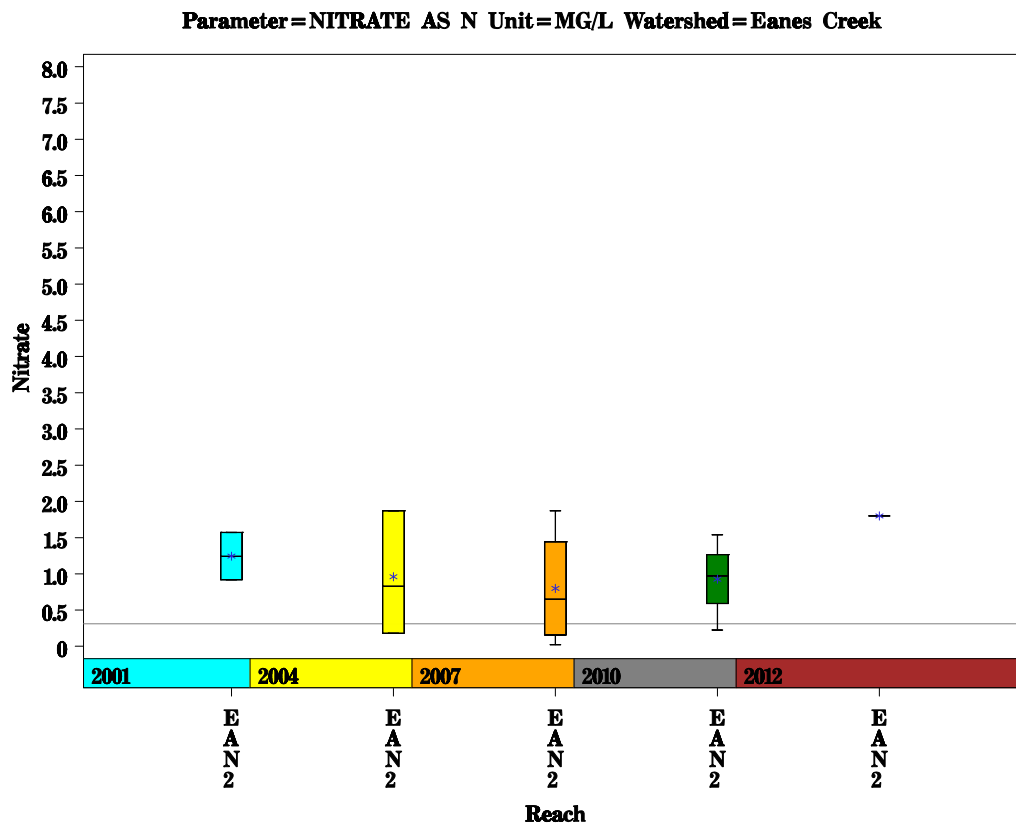
Data Summary Graphs – Ammonia and Nitrate/Nitrite (Downstream to Upstream by Year)
