Harris Branch Watershed

Summary Sheet

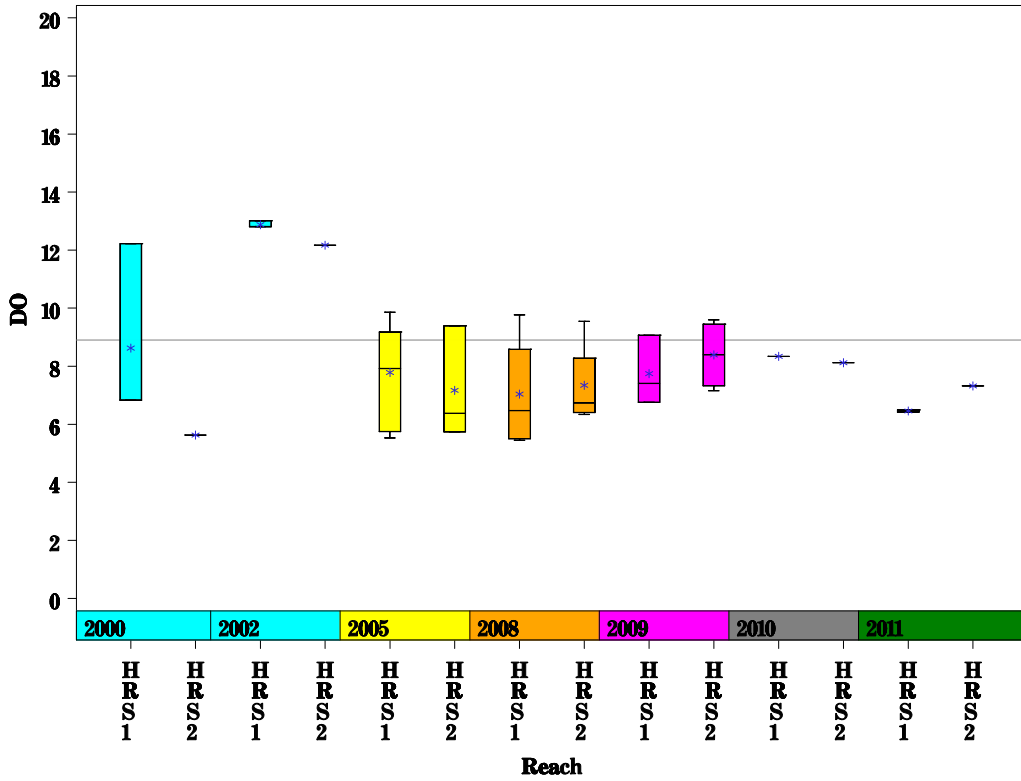
Parameter=DISSOLVED OXYGEN Unit=MG/L Watershed=Harris Branch

Data Summary Graphs – Dissolved Oxygen and Temperature (Downstream to Upstream by Year)

| Summary | Parameter | Mean | Max | Min | Discussion |
|---|---|---|---|---|--|
| Physicochemical | D.O. mg/l | 7.3 | 8.3 | 6.4 | Within normal range |

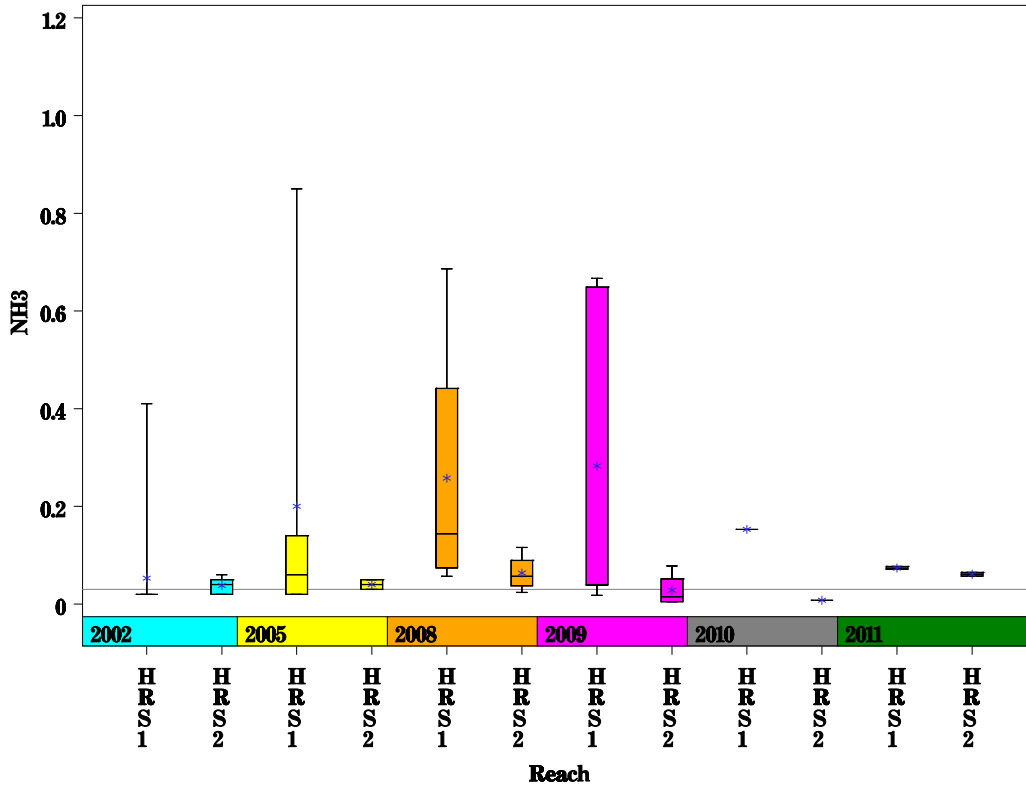
Parameter=AMMONIA AS N Unit=MG/L Watershed=Harris Branch

Data Summary Graphs – Ammonia and Nitrate/Nitrite (Downstream to Upstream by Year)

| Summary | Parameter | Mean | Max | Min | Discussion |
|---|---|---|---|---|--|
| Nutrients | NH ₃ mg/l | 0.075 | 0.153 | 0.008 | Generally above average, some high values at site 1201 |

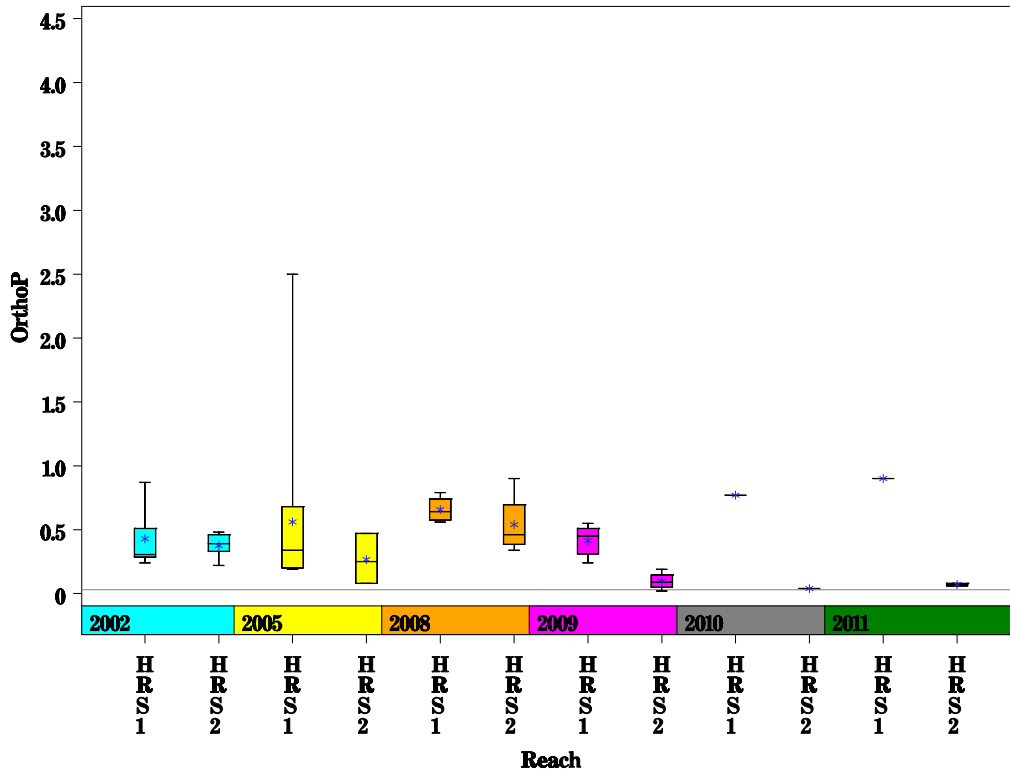
Parameter = ORTHOPHOSPHORUS AS P Unit = MG/L Watershed = Harris Branch

Data Summary Graphs – Orthophosphate and E.coli (Downstream to Upstream by Year)

| Summary | Parameter | Mean | Max | Min | Discussion |
|---|---|---|---|---|--|
| | Ortho P mg/l | 0.534 | 0.900 | 0.040 | Consistently high values at site 1201 |
