**MEREDITH STREET STORM DRAIN IMPROVEMENT  
PROJECT  
PRELIMINARY ENGINEERING REPORT**

**City of Austin  
Watershed Protection Department  
Watershed Engineering Division**

*Preliminary Engineering Report  
COA-WED 2013-[LKA]*

*September 2013*

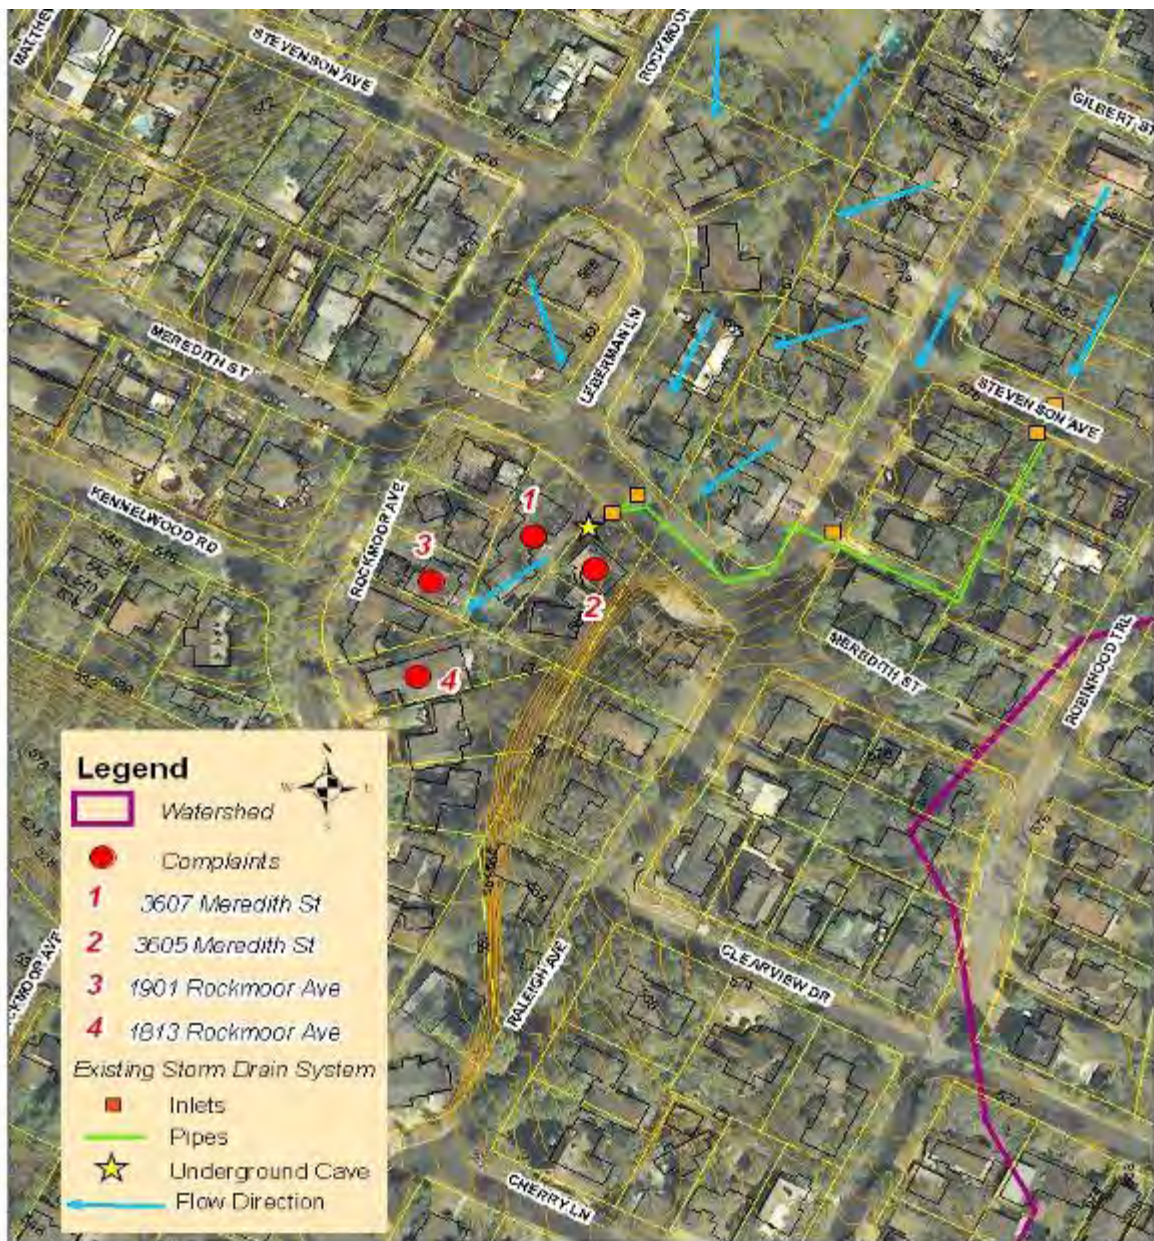
Structures with reported complaints of building flooding are identified in **Figure 2**.

**Figure 2. Meredith St. Complaints and Existing Storm Drain (Meredith SDS),  
Not To Scale (NTS)**

- January 2012 – Storm event caused flooding of 3607 and 3605 Meredith St. The high watermarks were about 16 inches above the ground surface. Citizens complained again about the ongoing flooding issues.

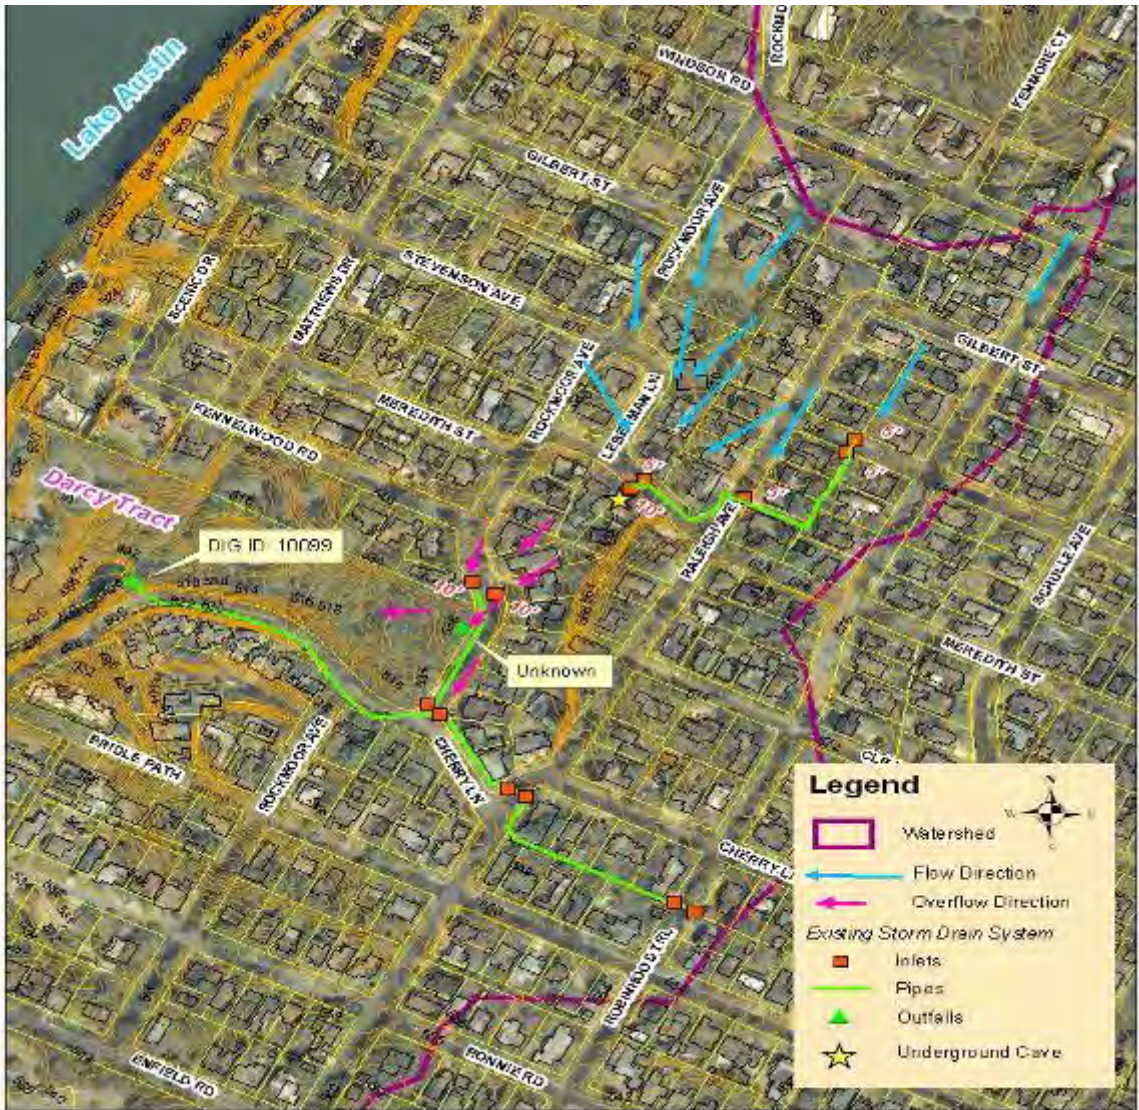
Roads within the project area have curbs and gutters. Observations of the terrain show that when the cave is full, overflowing water travels in the southwesterly direction across the private properties at 3605, 3607 Meredith St. and 1813, 1815 Rockmoor Ave. to Rockmoor Ave., where it is captured partially by two 10-foot inlets that are part of the downstream storm drain system. The downstream system is aligned along Rockmoor Ave., and Cherry Ln., and discharges to Lake Austin at an outfall on the Darcy tract, a private property located at 1804 Rockmoor Ave. (see **Figure 3**). The excess flow appears to cross Rockmoor Ave., and travel to the natural ditch in the northeastern corner of the Darcy tract. The ditch conveys the excess flow to Lake Austin.

**Figure 3. Existing Storm Drain Systems in Project Area: Meredith SDS (upper) and Cherry SDS (lower), NTS**

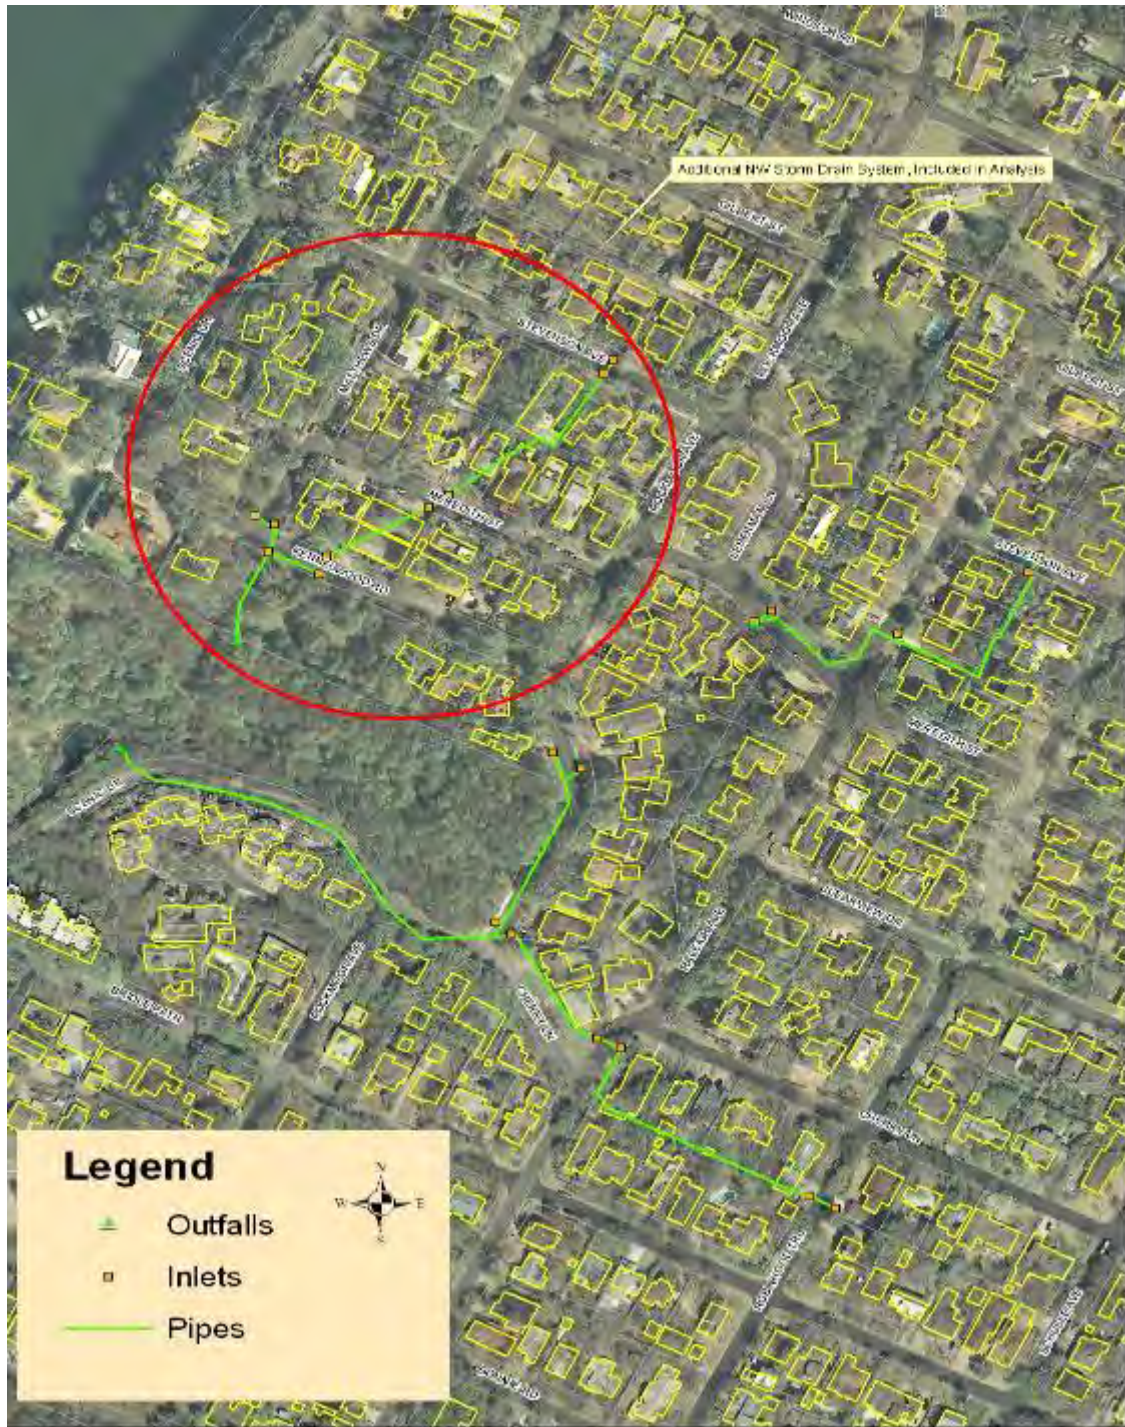
**Figure 4. NW Storm Drain System, NTS**

Additional information was obtained for the existing storm drain system, referred to as the NW SDS, located northwest of the Meredith St. project area. The system is partially located beneath buildings and aligned through private properties, meaning that future upgrades might involve

The downstream storm drain system, mentioned above, was modeled in StormCAD as well. The inlet locations and sizes were confirmed by field survey. The locations and elevations of the remainder of the existing system were based on the City’s data records. Both the Meredith SDS (north) and the Cherry SDS (south) are shown in **Figure 4** with detailed descriptions and overflow water paths.

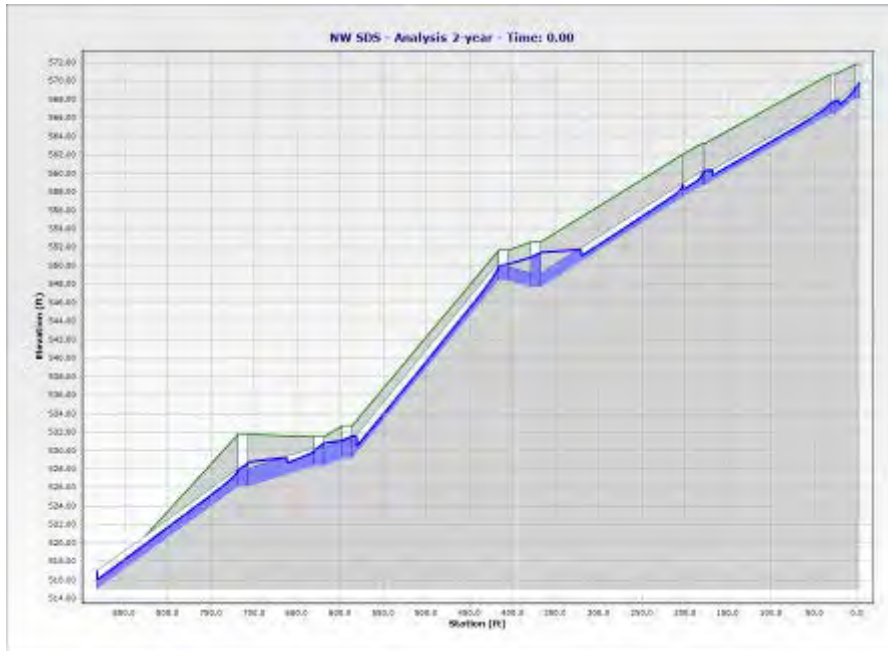
**Figure 6. NW Storm Drain System Main Trunk, 2-year storm profile**

However, being undersized in general, these three systems currently provide varying levels of service. According to the modeling results, the NW SDS appears to be in compliance with the DCM for the 2-year storm, and can handle the 10-year storm with some inlet ponding and the 25-year storm with inlet ponding and possible flooding of the vacant lot at Kennelwood Dr. The 100-year storm is the biggest issue for this system. The existing condition hydraulic grade lines (HGL) for the NW SDS are shown in **Figures 6** through **9**.

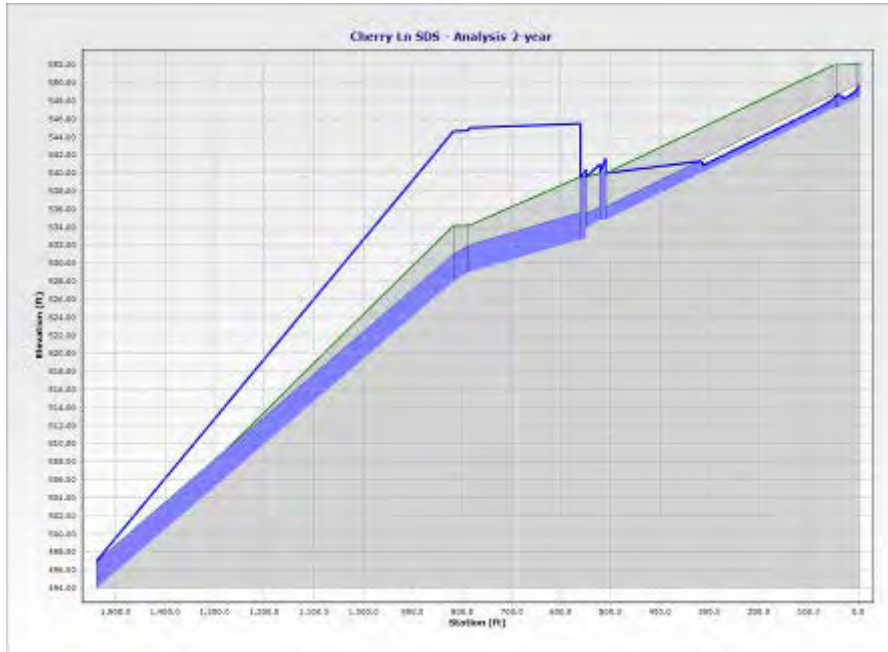
**Figure 10. Cherry Storm Drain System Main Trunk, 2-year storm profile**

excess flow in the street, the runoff flows naturally down Cherry Ln. to Lake Austin, causing no issues for the private properties. However, the excess flow in the street could cause a traffic hazard on Cherry Ln. The existing condition HGL for the Cherry SDS are shown in **Figures 10** through **13**.

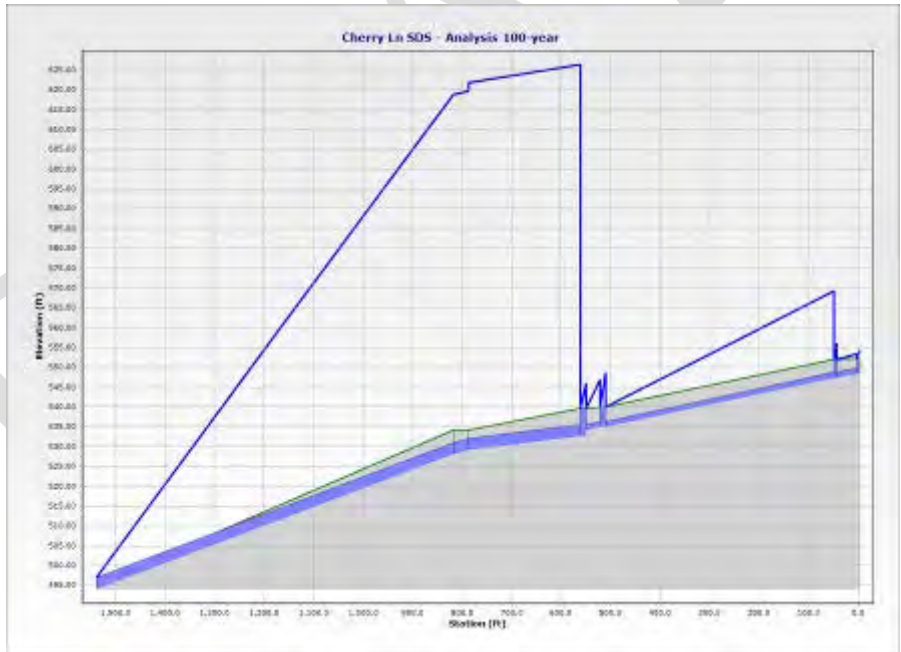
**Figure 13. Cherry Storm Drain System Main Trunk, 100-year storm profile**

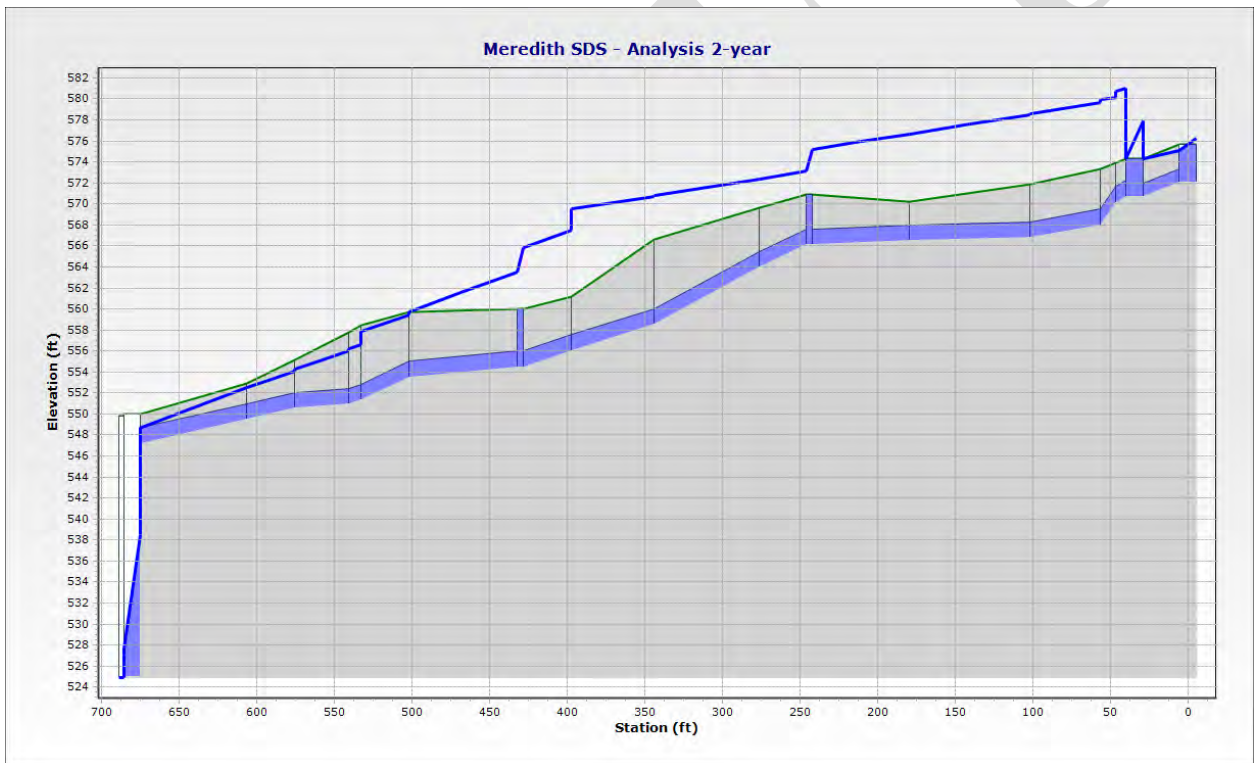
**Figure 14. Meredith Storm Drain System Main Trunk, 2-year storm profile**

The Meredith SDS is undersized. StormCAD analysis shows flooding issues for all four storm events. The need for improvements to this storm drain system is the driving factor behind this preliminary engineering study. The existing condition hydraulic grade lines for the Meredith

SDS are shown in **Figures 14** through **17**. Starting with the 10-yr event, the inlet cannot pass the incoming flows, resulting in an HGL well above the ground surface. This causes flooding of the properties immediately downstream of the cave (refer to **Figures 14 - 17**). The analysis assumes that the flows are contained within the storm drain system, i.e., the manhole covers are bolted shut and flow does not escape at the downstream inlets.

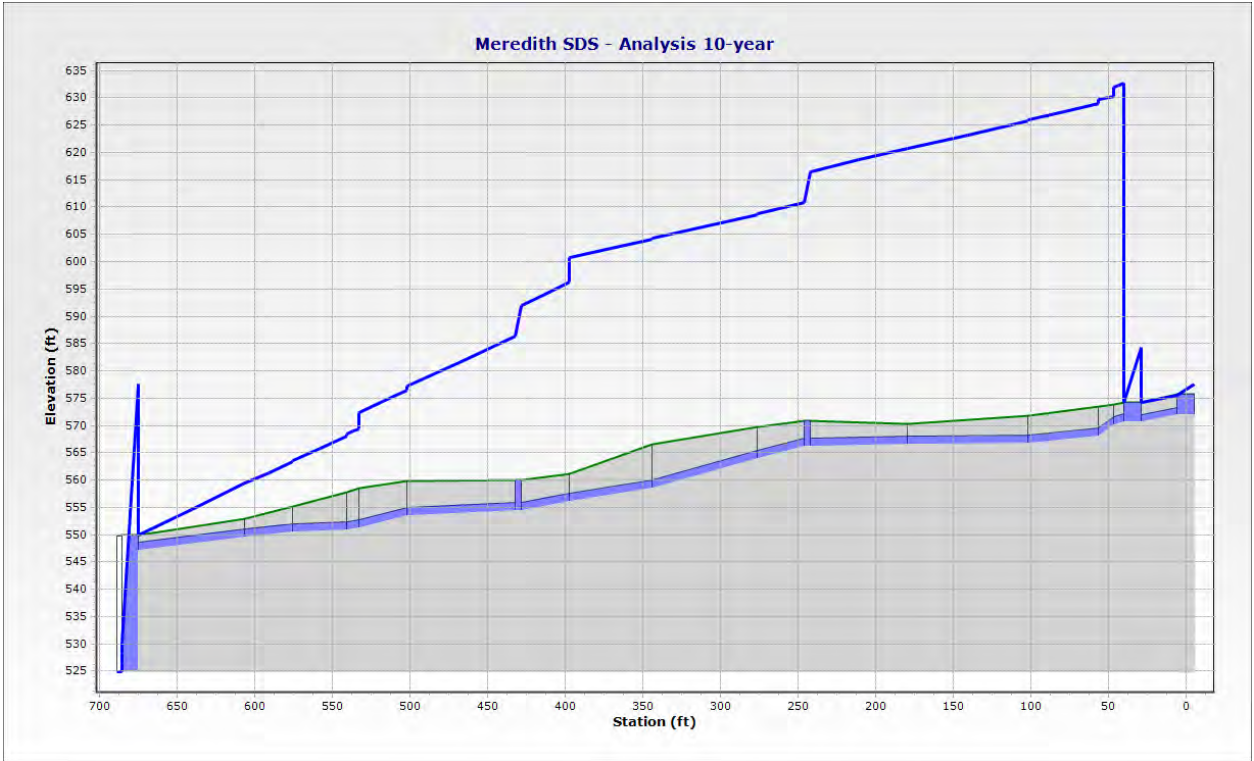
**Figure 15. Meredith Storm Drain System Main Trunk, 10-year storm profile**

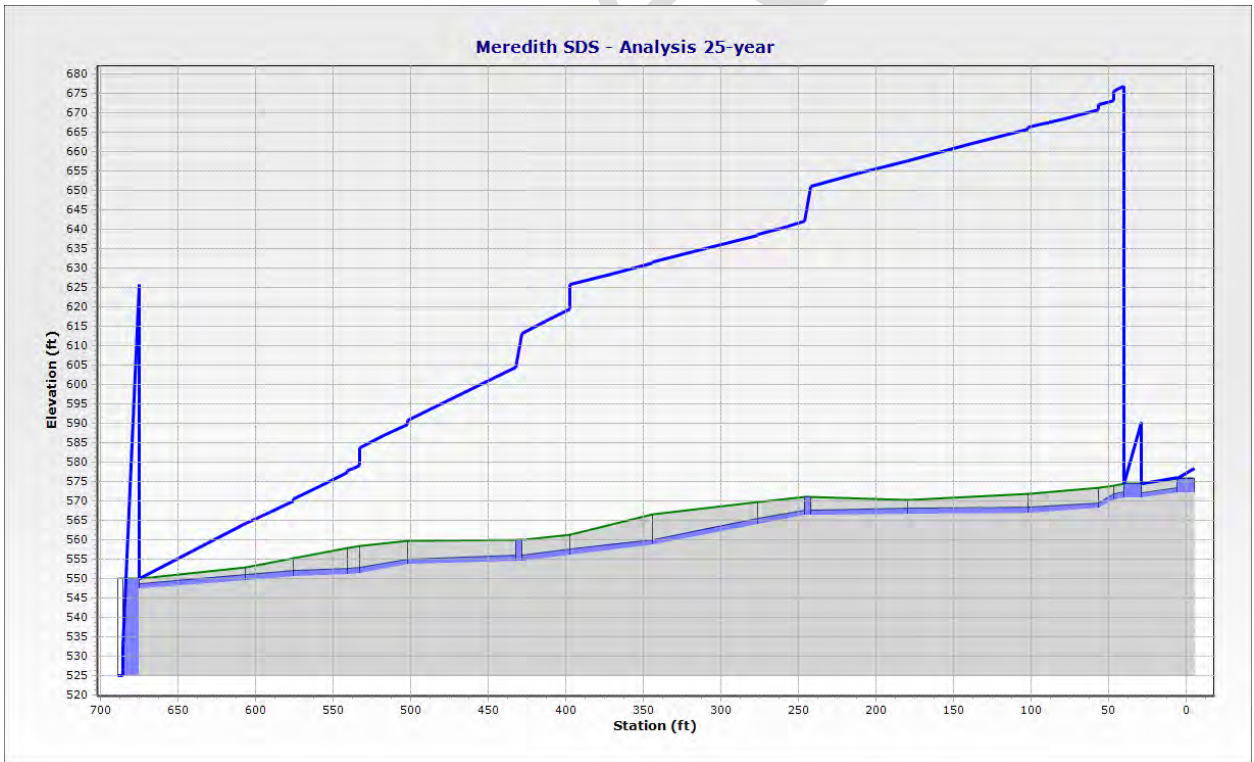
**Figure 16. Meredith Storm Drain System Main Trunk, 25-year storm profile**

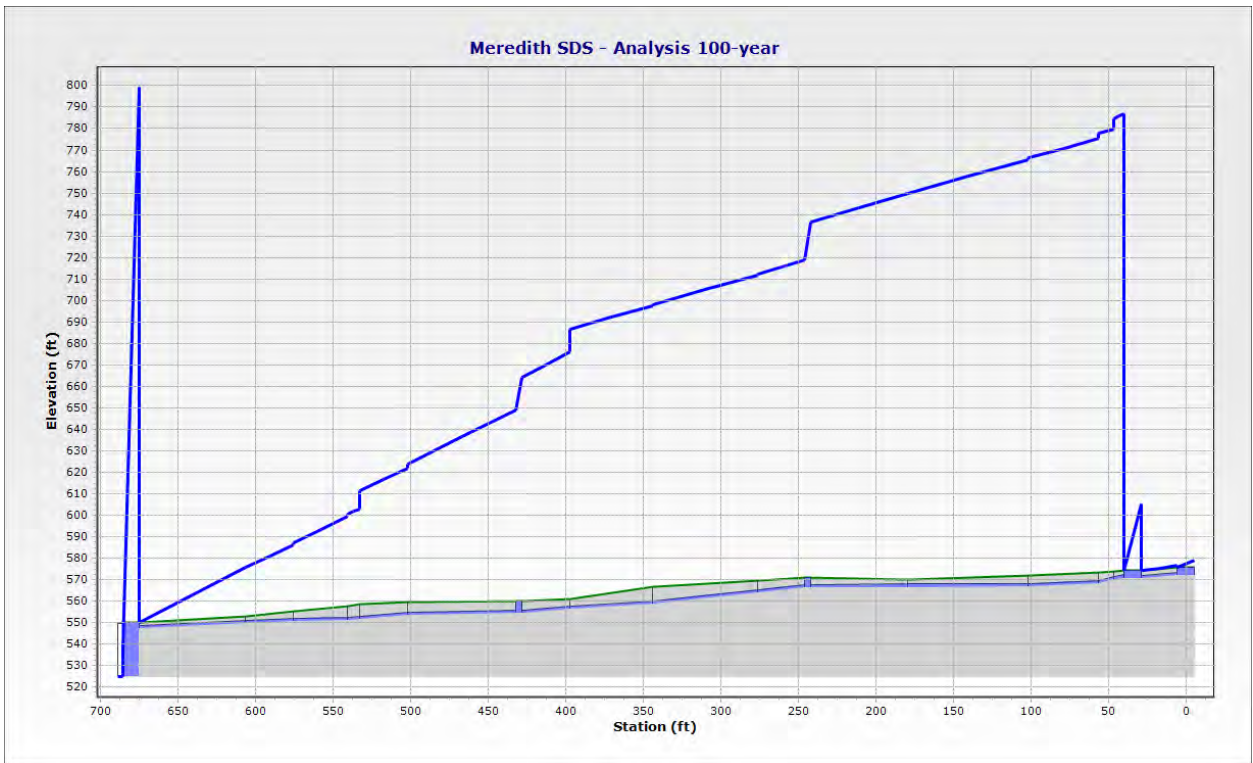
**Figure 17. Meredith Storm Drain System Main Trunk, 100-year storm profile**

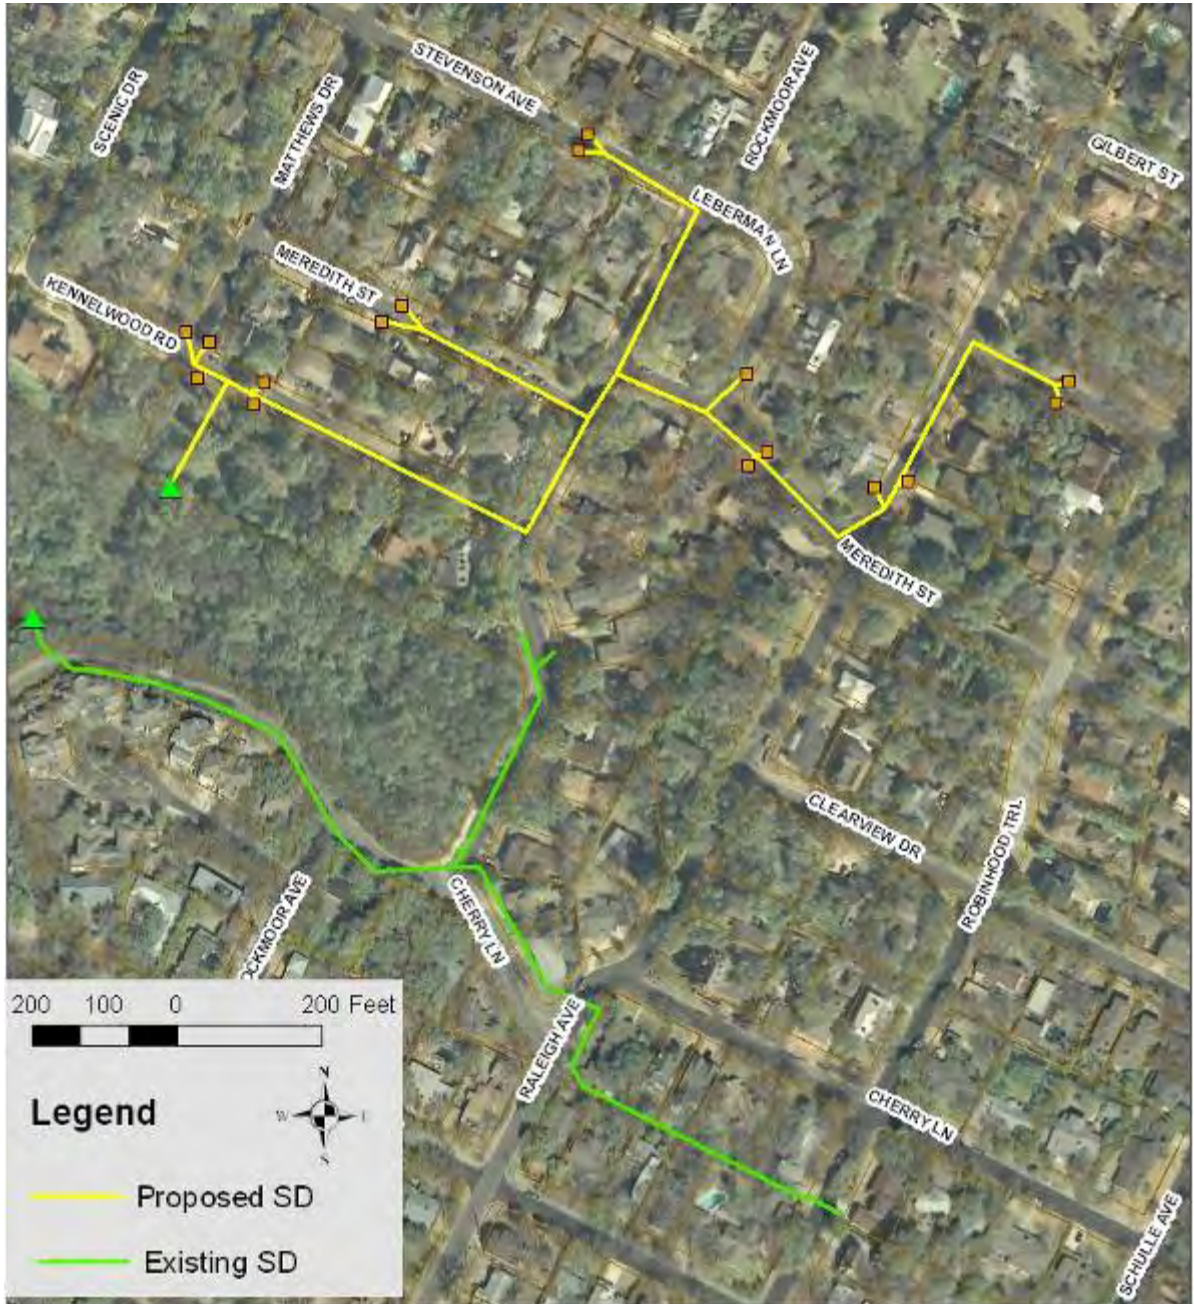
Figure 20. Alternative 1

improvements will be needed to stabilize erosion at the outfall, and an easement will need to be acquired to convey runoff from the outfall to Lake Austin. The estimated cost for this alternative is approximately \$5,000,000.

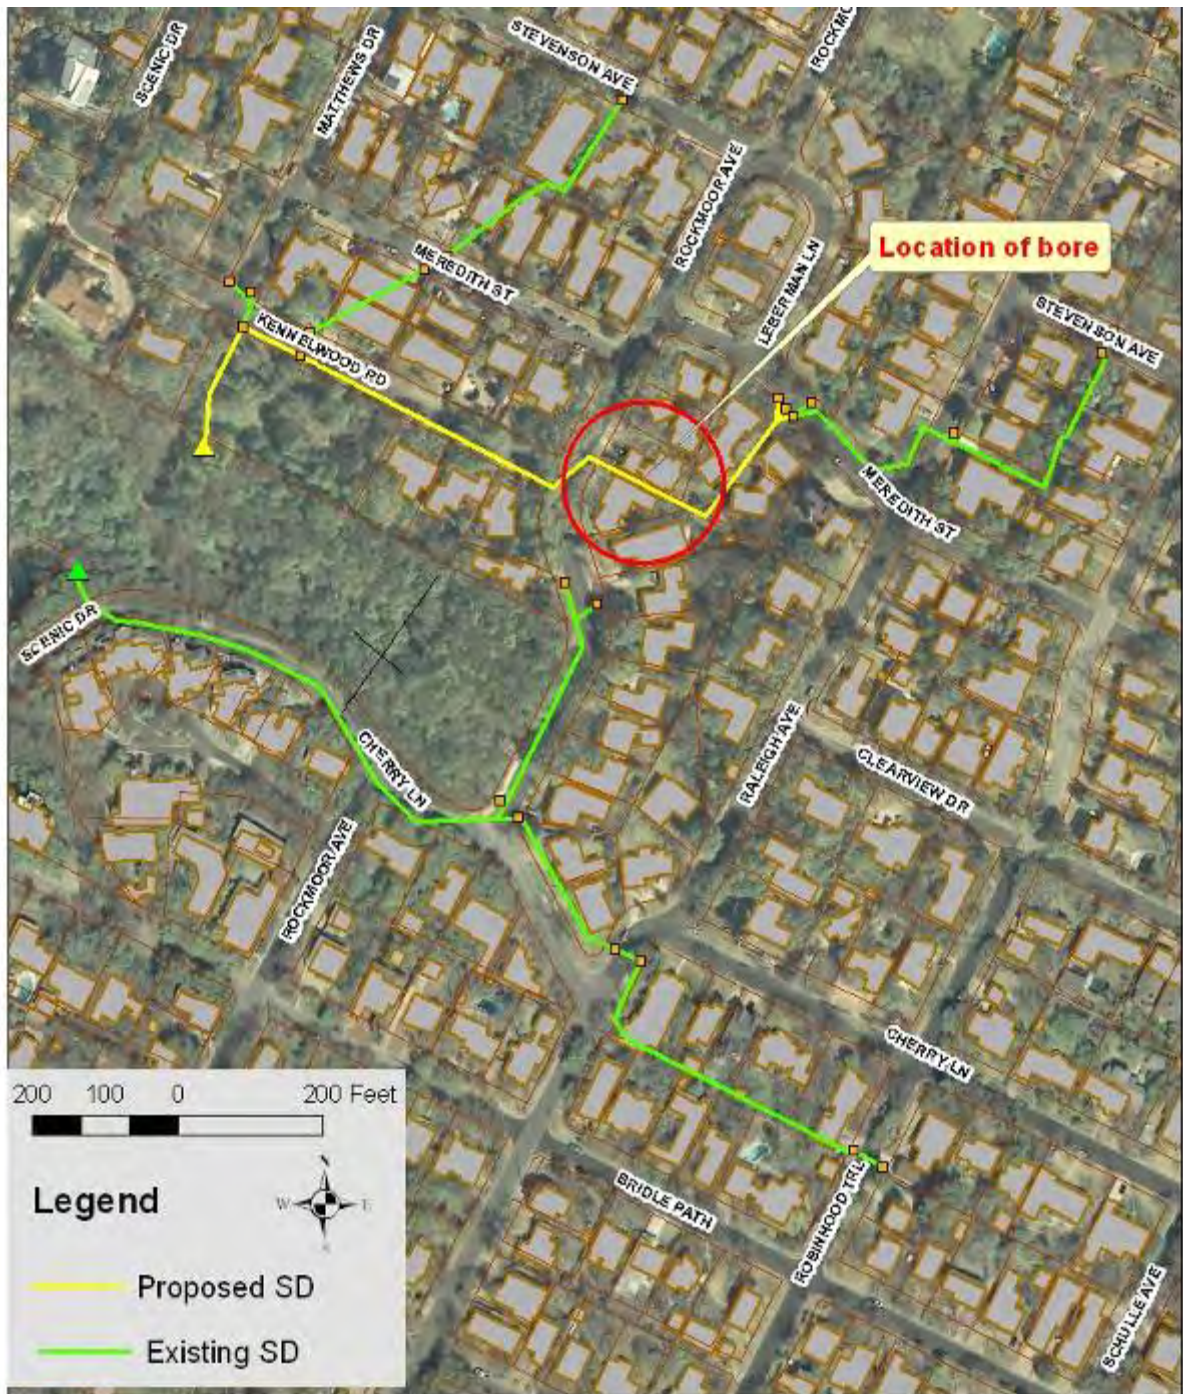
**Alternative 2.** This alternative focuses on immediate drainage issues without upgrading the upstream section of the Meredith SDS where no drainage complaints have been recorded. It includes a boring between the houses at 1815 and 1901 Rockmoor Ave. with alignment along Kennelwood Rd. and discharge at the outfall, located 1804 Rockmoor Ave. ([refer to Figure 21](#)). Additional improvements will be needed to stabilize erosion at the outfall, and an easement will need to be acquired to convey runoff from the outfall to Lake Austin. This alternative includes multiple utility conflicts along Kennelwood Rd. that will need to be resolved. The estimated cost for this alternative is approximately \$3,900,000.

**Figure 21. Alternative 2**

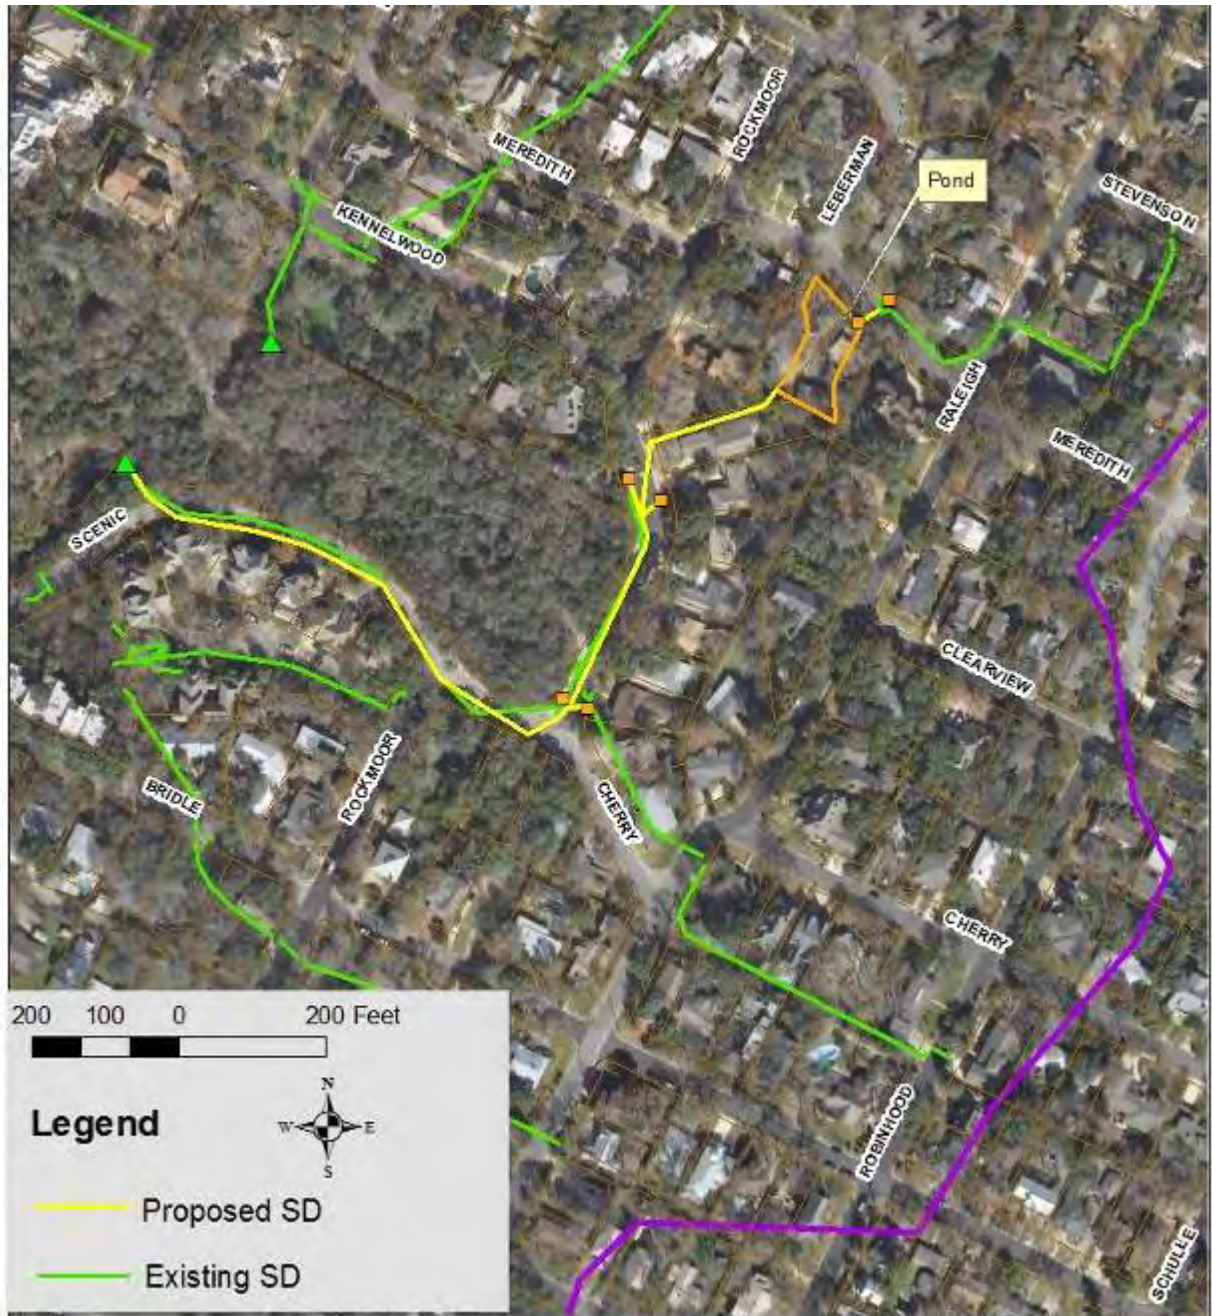
conceptual design is that of a concrete-walled detention pond with depth variation of 8.5 to 10 feet. This alternative requires the upgrade of the existing 36-inch discharging pipe to a 66-inch pipe all the way to the outfall on 1804 Rockmoor Ave. (refer to **Figure 23**). The estimated cost for this alternative is approximately \$5,000,000.

**Figure 23. Alternative 4**

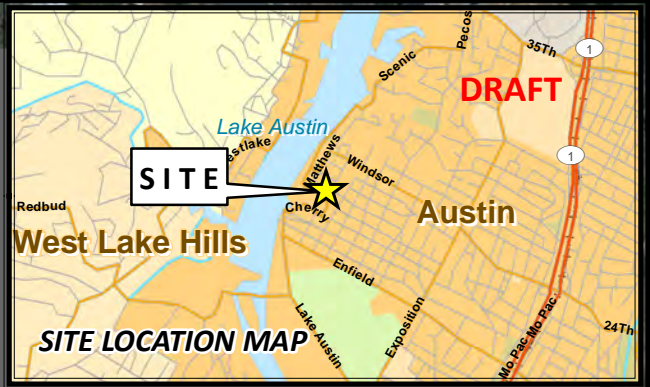
**FIGURE**  
**2A**

- BORING
- PROPOSED ALIGNMENT OPTION No. 2
- SUBSURFACE PROFILE BASELINE

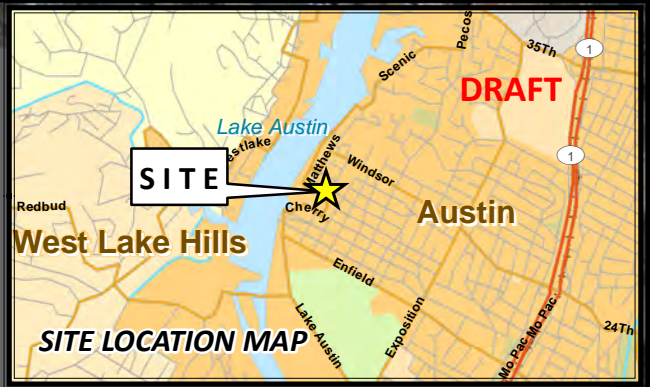
**FIGURE**  
**2B**

- BORING
- PROPOSED ALIGNMENT OPTION No. 3
- SUBSURFACE PROFILE BASELINE

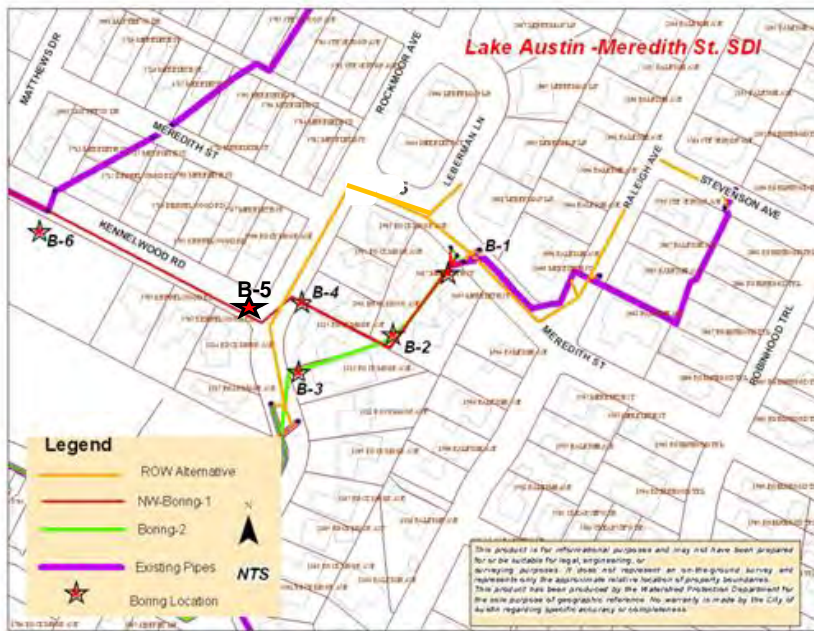
**Figure 1.** Site map showing Meredith Street and Rockmoor Avenue and borehole locations (Raba Kistner Consultants, Inc.). Borehole locations B-1 through B-5 approximately defines the boundaries of the quarry operation that took place in early 1900s. Sinkholes and caves were observed during the quarrying of the Edwards Limestone. Edwards Limestone, Georgetown Limestone and Del Rio Clay still outcrop in and around the site.

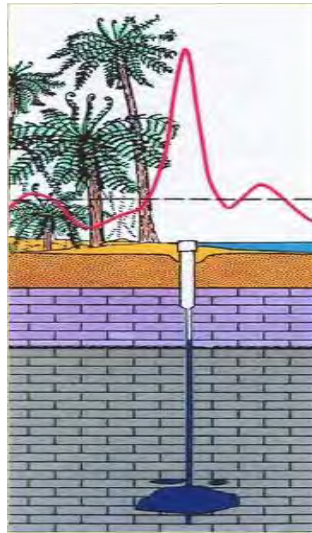
Natural electrical (NP) currents occur everywhere in the subsurface. In karstic investigations, we are concerned with the slowly varying direct currents (DC) that give rise to a surface distribution of natural potentials due to the flow of groundwater within permeable and/or conduit materials. Differences of potential are most commonly in the millivolt range and can be detected using a pair of non-polarizing electrodes and a sensitive measuring device (i.e., a voltmeter). It should be noted that water movement should be present within or surrounding a cave in order to determine a void or cave location (Figure 6). Positive and negative NP values are attributed to changes in the flow conditions and the resistivity distribution of the subsurface. The source of NP anomalies can be also due to changes in topography, soils, and geologic conditions. NP measurements made on the surface are the product of electrical current due to groundwater flow and the subsurface resistivity structure. NP anomalies do not provide information on the depth of their sources.

**Figure 6.** A schematic limestone section showing a cave and a corresponding positive NP anomaly. Polarity of NP anomalies (+/-) depends on the resistivity/conductivity of the geologic environment and hydrogeologic conditions. NP anomalies are also created by lithologic changes in the subsurface. There is no depth information inferred from these NP anomalies.

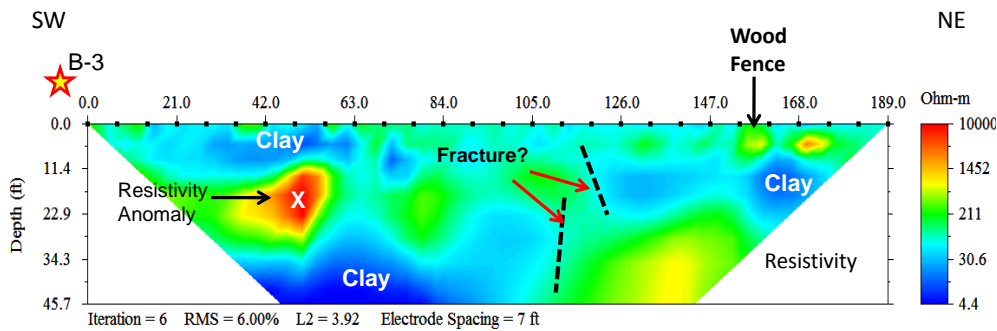
**Figure 7.** Resistivity data along the segment A of profile G1. Locations of the wood fence and borehole location of B-3 are given for references.

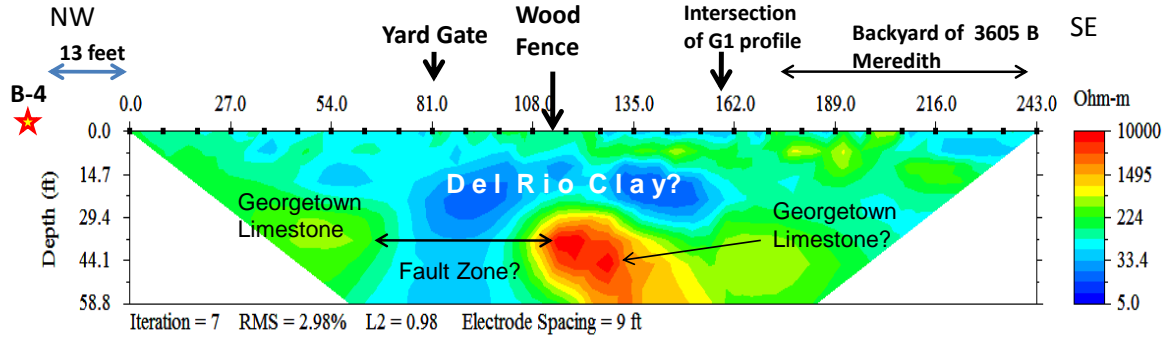
We have observed very similar resistivity anomalies across Del Rio Clay and Georgetown Limestone where major known faults are involved (Antioch Fault Zone in Onion Creek).

**Figure 9.** Resistivity data along profile G2. Borehole location B-4 on Rockmoor Avenue, yard gate and wood fence are shown for reference purposes. A low resistivity zone between the yard gate and the wood fence could be caused by a fault or fault zone.

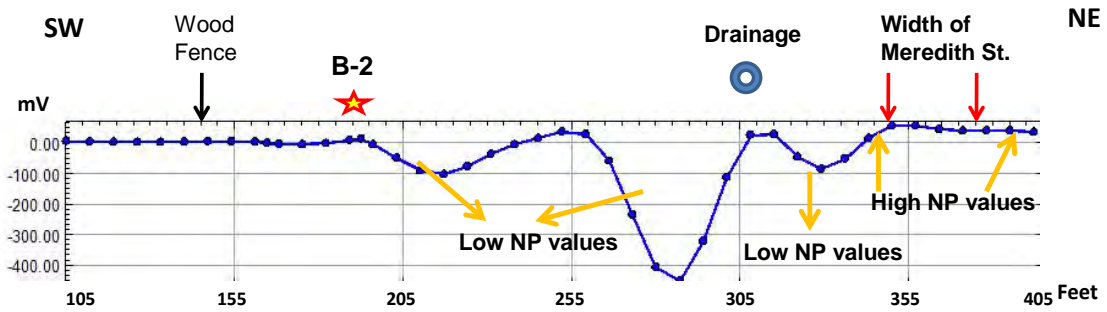
Figure 11 shows the NP data along the combined segments of B and C of profile G1. Locations of the wood fence, borehole location B-2, drainage for the driveway and the width of the Meredith Street are given for reference purposes. Locations of high (positive) and low (negative) NP values are marked in Figure 11.

**Figure 11.** NP data along the combined segments of B and C of profile G1. Note the presence of high and low NP values along the profile. Both high and low NP values could be caused by karstic features.

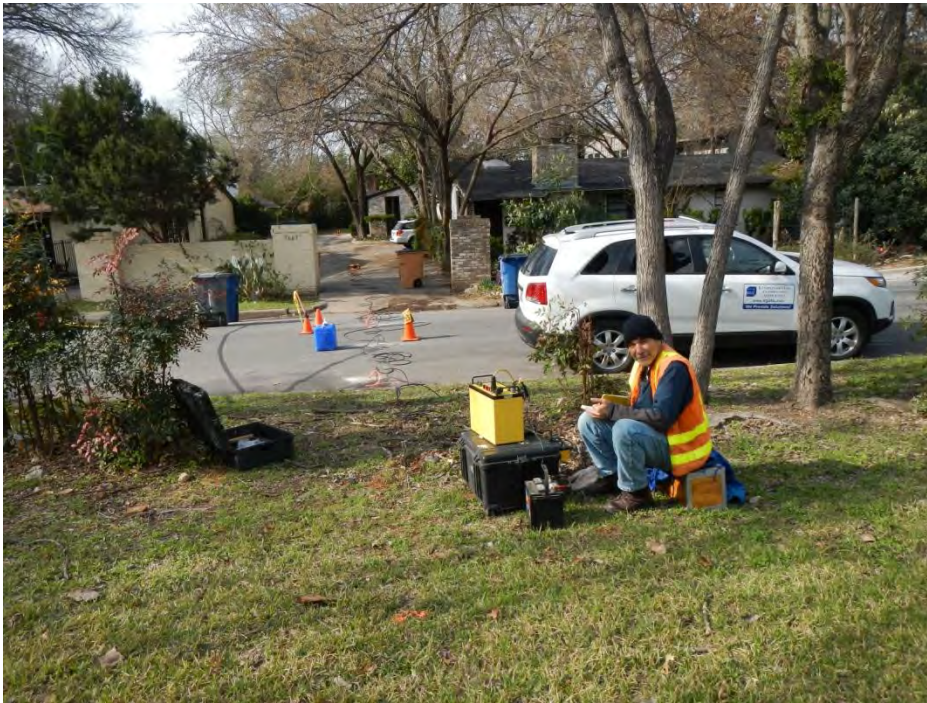
**Picture 1.** Resistivity survey along profile G1 on segments B and C. The road and asphalt driveway were drilled using a generator to insert the electrodes.

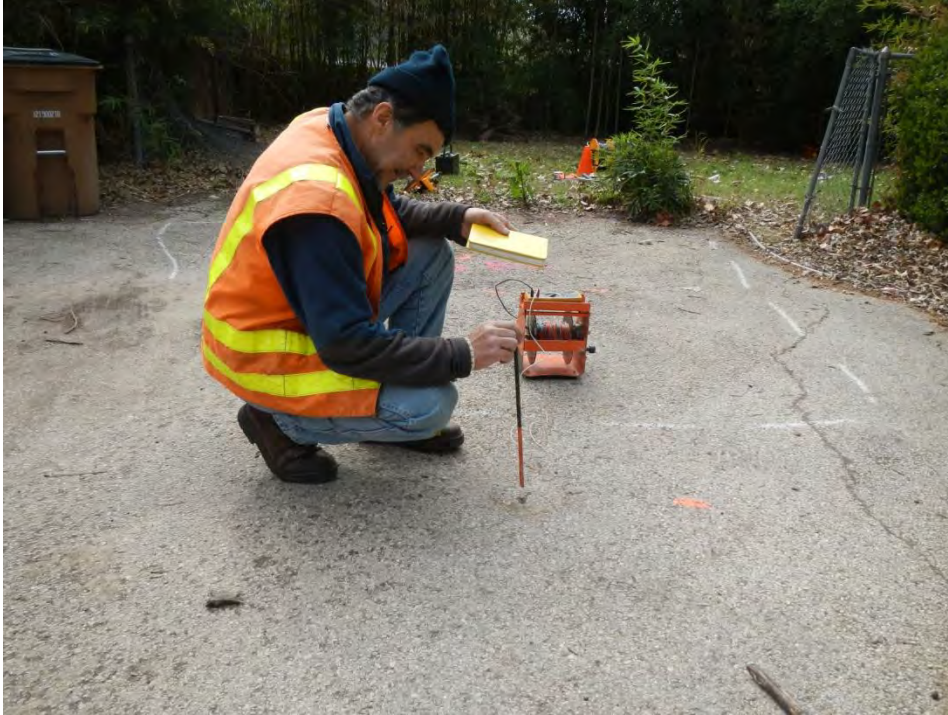
**Picture 2.** Natural potential survey along the segments of B and C of profile G1. A slim NP electrode was used in the holes that were drilled using a generator.

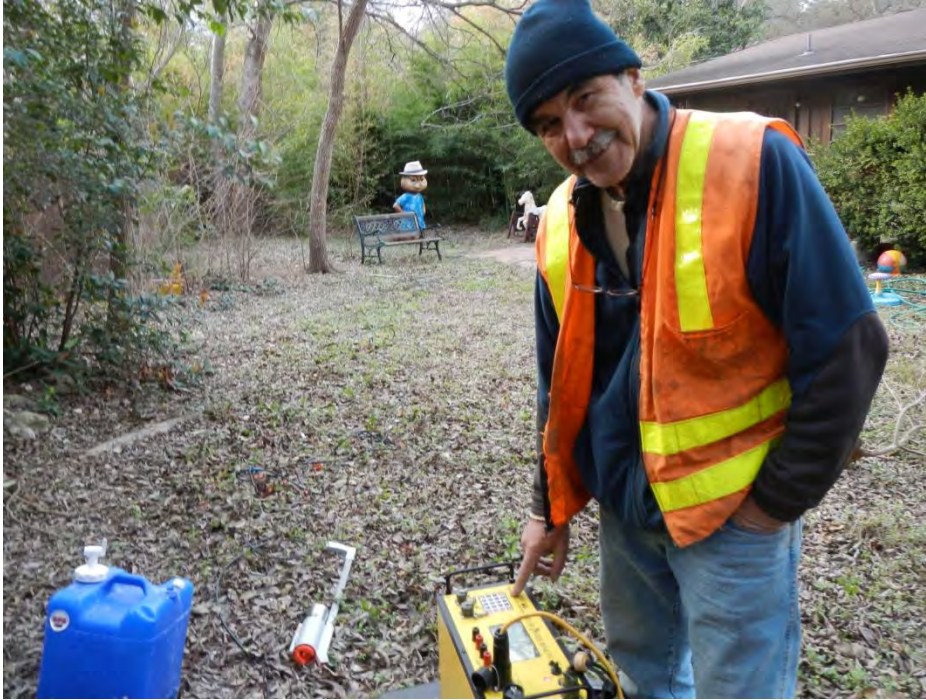
**Picture 3.** Taking resistivity survey along profile G2. The recording resistivity unit was set in the backyard of 3605 B Meredith Street. There are rocks outcropping to the east, which appear to be Georgetown Limestone.
