# **Anderson Mill Road**

# **COA Environmental Resource Inventory of Anderson Mill Road Improvements Project, Spicewood Springs Parkway to US HWY 183, Austin, Texas**

Project No: 60550489  
September 18, 2017

**PROJECT MEMORANDUM - DRAFT  
HYDROGEOLOGIC REPORT AND PHASE I KARST FEATURE SURVEY  
Anderson Mill Road Improvements Project –  
Spicewood Springs Parkway to US HWY 183  
Austin, Travis County, Texas**

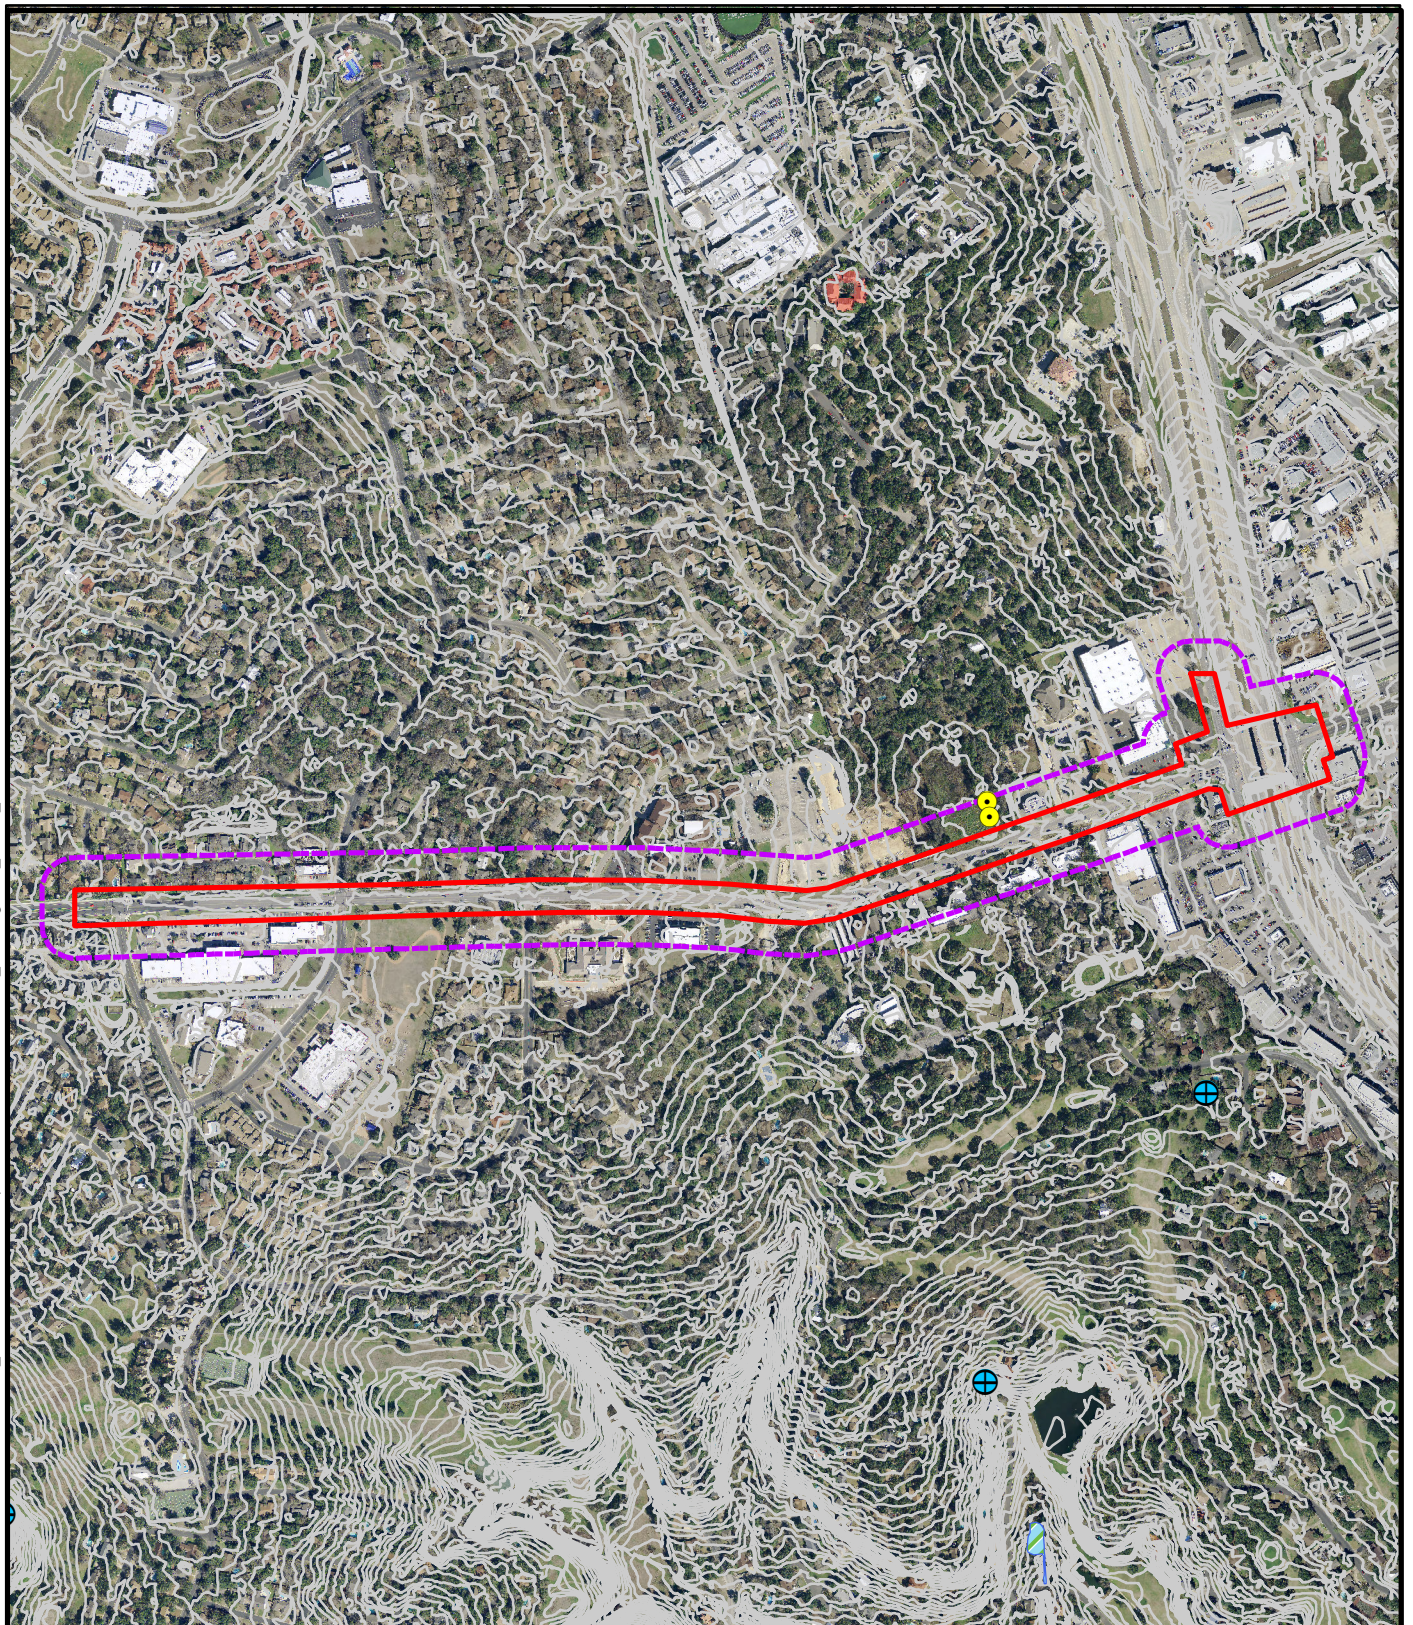
**FIGURE 5 - CRITICAL ENVIRONMENTAL FEATURES  
AND WELL LOCATION MAP**  
**ANDERSON MILL ROAD IMPROVEMENTS**  
**SPICEWOOD PARKWAY TO US 183**  
**AUSTIN, TRAVIS AND WILLIAMSON COUNTIES, TEXAS**

Based on the field survey and review of available literature, two karst features or point recharge features were identified within the project area. No other CEFs were observed within the project area. We contacted the Watershed Protection and Development Review (WSPDR) Department of the COA to see if any previous geologic data was available for these two features. Ms. Sylvia Pope, with WSPDR, provided a brief history and background information for the two features identified. An easement for the water quality/CEF buffer zone established for the features was also forwarded for review. We understand that there are previous karst surveys, environmental assessments and ERI studies that have been conducted for the site, but none of this information has been made available at this time, other than general confirmation of the limited descriptions and measurements of the karst features presented below. Brief descriptions of the two features as observed during the karst survey are provided below. A map showing the approximate location of the two karst features identified is provided in *Figures 5 and 6*.

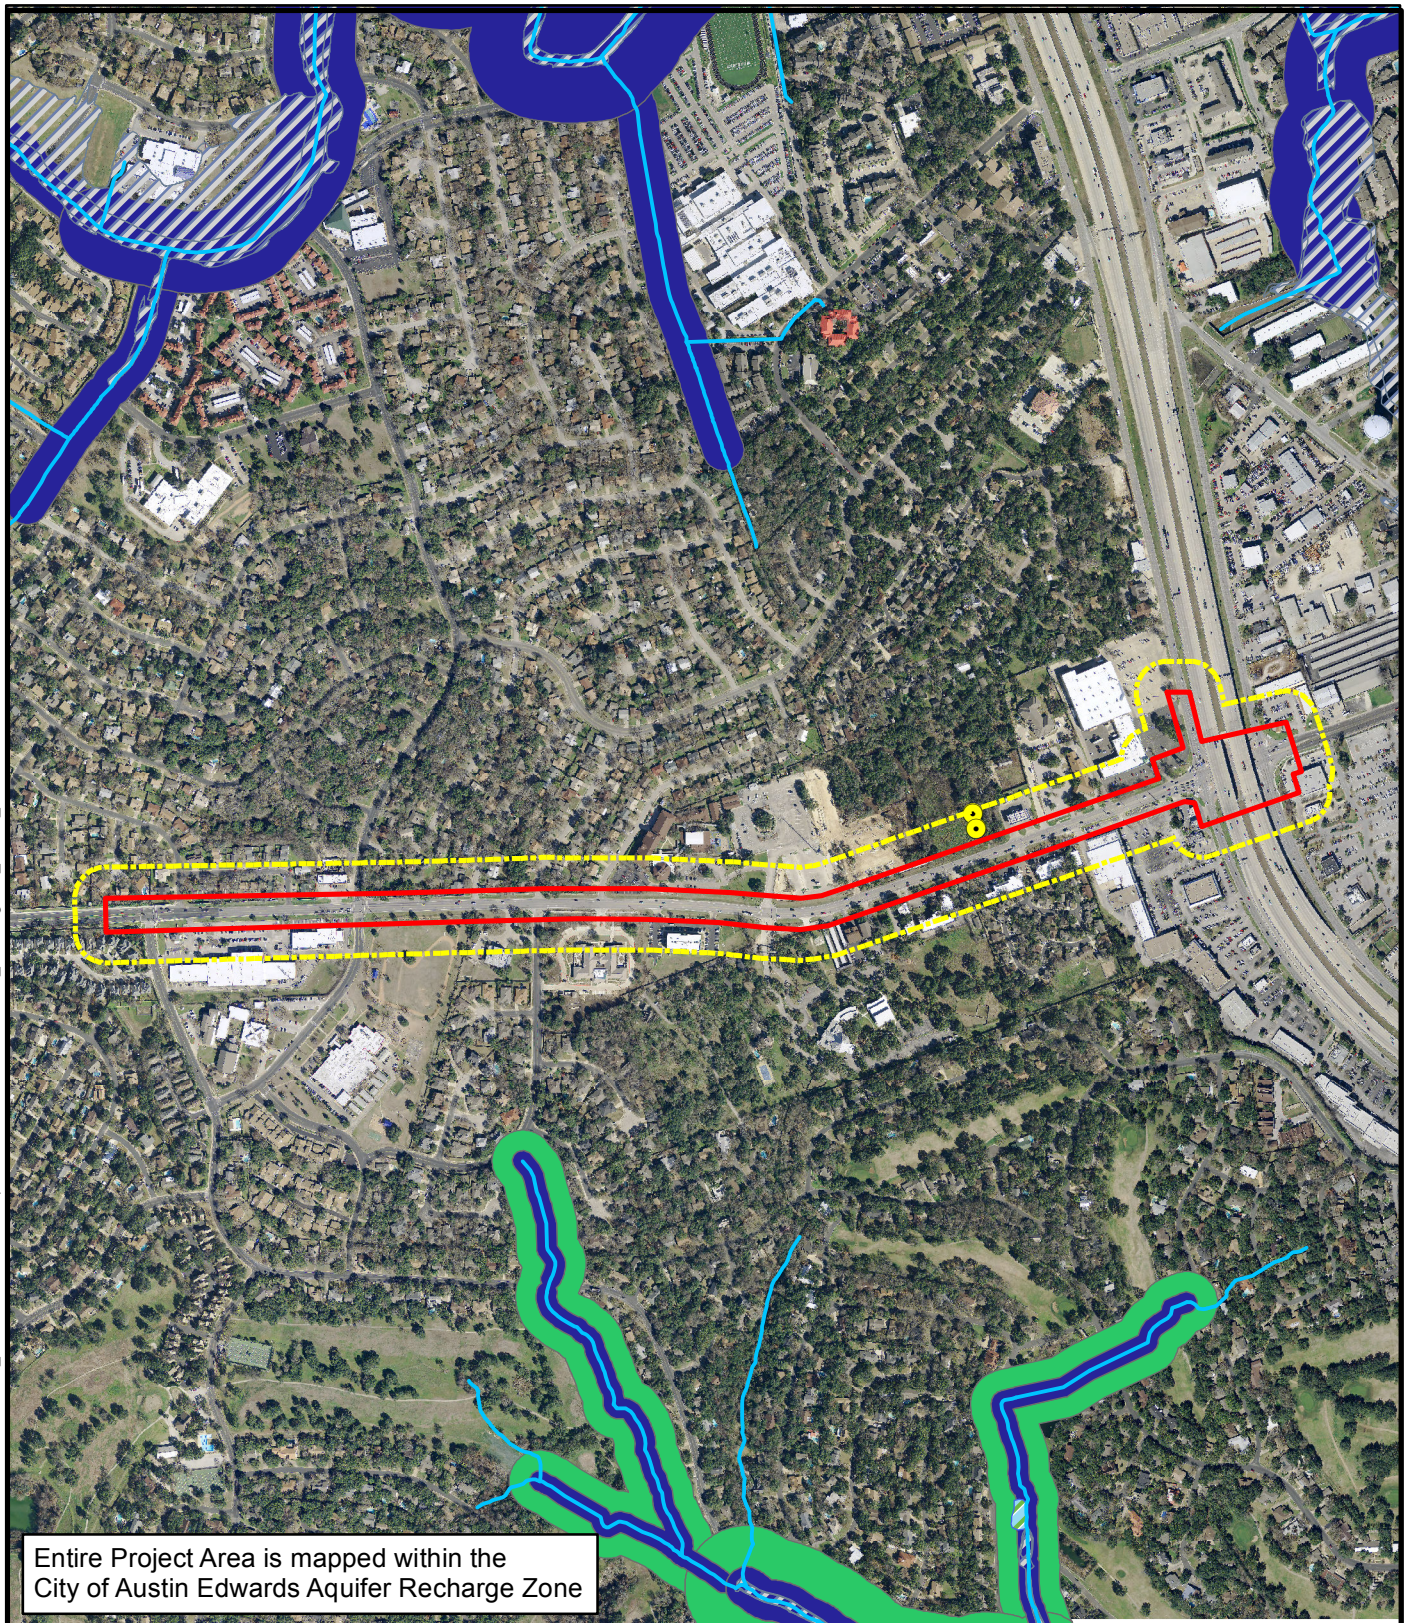
**FIGURE 6 - ENVIRONMENTAL CONSTRAINTS  
ANDERSON MILL ROAD IMPROVEMENTS  
SPICEWOOD PARKWAY TO US 183  
AUSTIN, TRAVIS AND WILLIAMSON COUNTIES, TEXAS**

Entire Project Area is mapped within the  
City of Austin Edwards Aquifer Recharge Zone

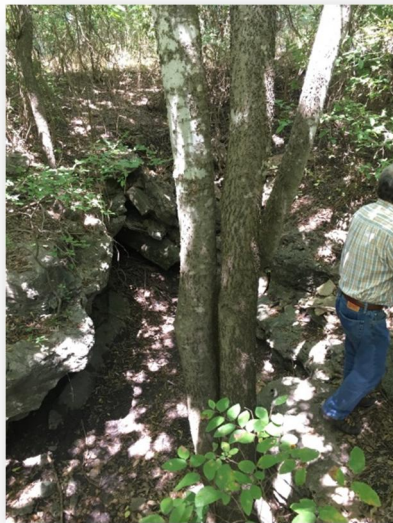
**Karst Feature No. 1 (S-1) - Sinkhole** - This feature appeared as an open sinkhole measuring approximately 30 feet long by 18 feet wide and dropping about 10 feet to a moderately soil filled compact floor. The feature developed along a vertical joint fracture bearing approximately N340° W. Evidence of dry, intermittent, very shallow drainages or rivulets about 12 to 16-inches across and no more than two inches deep were noted draining towards the western perimeter of the feature, indicating that the feature receives surface water runoff during rain events. An open bedding plane was also noted near the floor on the north-northeast side of the feature, extending about 15 feet horizontally into the subgrade. Very slight airflow was detected at the time of our site visit. It was reported that the landowner previously conducted an excavation of the sinkhole in 2015 in order to open the open bedding plane or cave passage at the north end. The excavation was later terminated due to safety concerns that additional excavation could potentially lead to collapse. Based upon the characteristics observed in the field,

the relative infiltration rate for this feature was determined to be moderate and it was evaluated as “sensitive” per the TCEQ’s Edwards Aquifer Protection Program. Silt fencing was noted around the perimeter of the feature. We understand that this feature is called the Anderson Mill Road/ZFB sinkhole by the WSPDR staff.

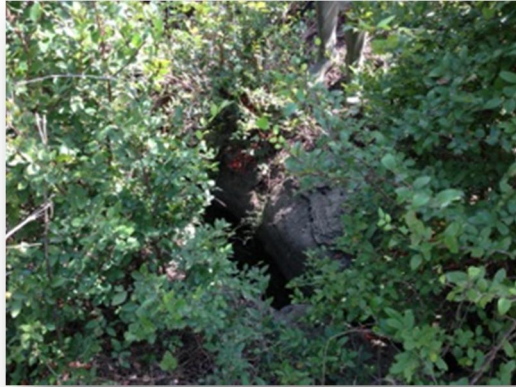
**Karst Feature No. 1 (S-2) - Sinkhole** - This feature appeared as an open sinkhole measuring approximately 12 feet long by 2 feet wide and dropping vertically about 4 feet to a rubble floor. The sinkhole apparently developed along a solution enlarged fracture bearing approximately N320°W. The feature narrows with depth, with evidence of continued subsurface drainage extending into the subgrade along the downgradient wall. Very slight airflow was detected at the time of our site visit. Based upon the characteristics observed in the field, the relative infiltration rate for this feature was determined to be moderate and it was evaluated as “sensitive” per the TCEQ’s Edwards Aquifer Protection Program. Based on our conversation with WSPDR staff, we understand that this feature is located within the catchment basin

of, and is likely associated with the nearby Anderson Mill Road/ZFB sinkhole (S-1) described above.
