COA Environmental Resource Inventory of Anderson Mill Road Improvements Project, Spicewood Springs Parkway to US HWY 183, Austin, Texas

Project No: 60550489
September 18, 2017

Environmental Resource Inventory

**PROJECT MEMORANDUM - DRAFT
HYDROGEOLOGIC REPORT AND PHASE I KARST FEATURE SURVEY
Anderson Mill Road Improvements Project –
Spicewood Springs Parkway to US HWY 183
Austin, Travis County, Texas**

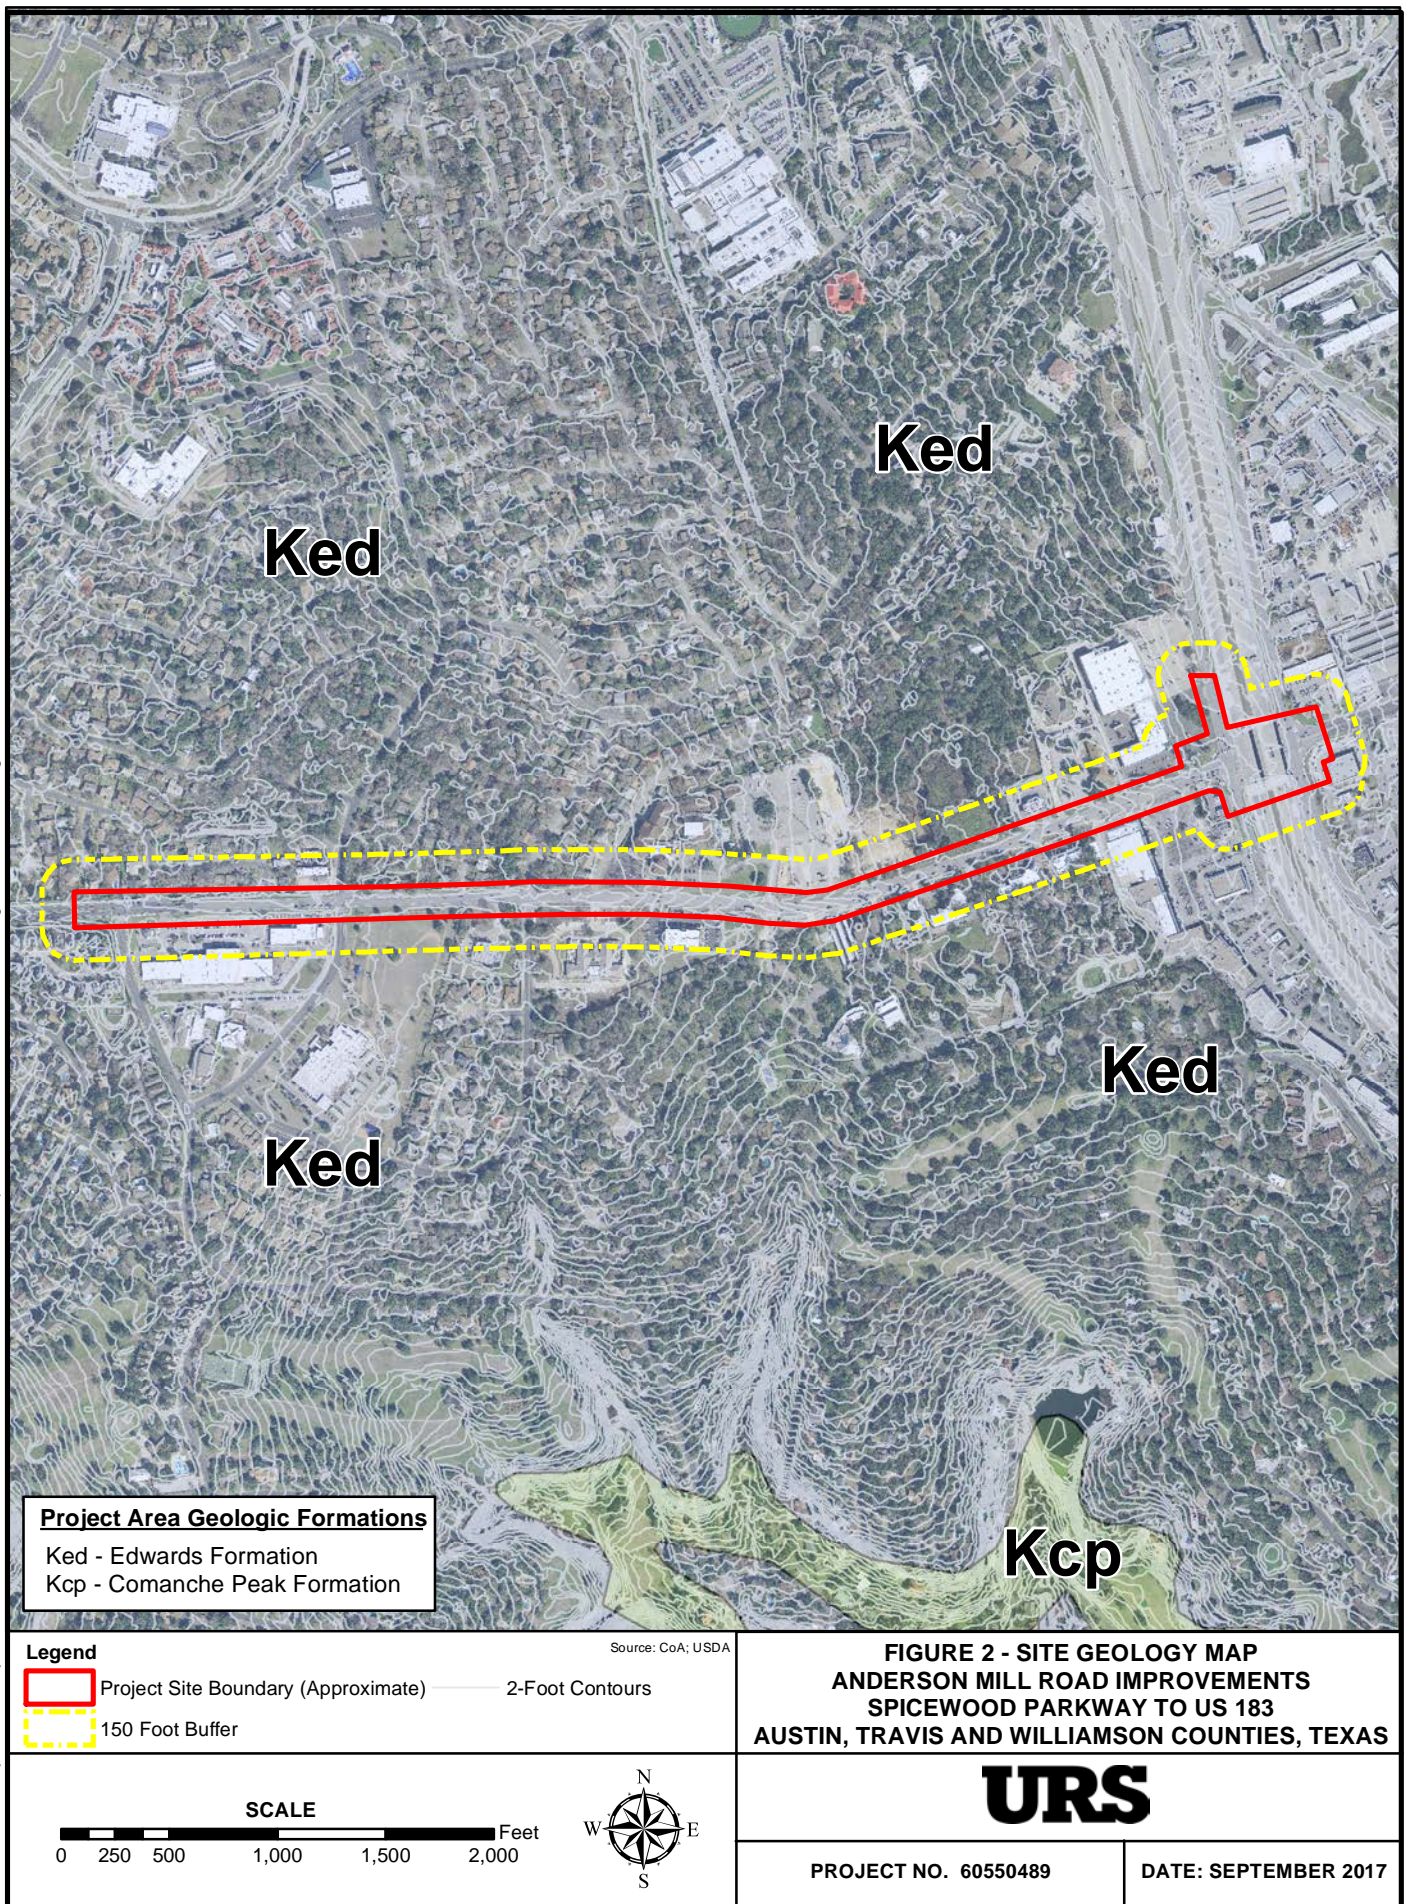
According to the Geologic Map of the Austin Area, Texas (Garner and Young 1976) and general field observations, the project area is underlain by the Edwards Limestone Formation (Ked). The Edwards Formation consists of limestone, dolomitic limestone, and marl; hard, pure variable bedding; solution features common; silicified fossils locally evident; thin soils typical. A map of the bedrock geologic units mapped across the project area is provided in the attached Figure 2.

According to the *Geologic Map of the Austin Area, Texas* (Garner and Young 1976), no major faults or major fractures are shown on the property, nor was evidence of such observed during our assessment of the project area. A Geologic Map of the project area is provided in *Figure 2*.

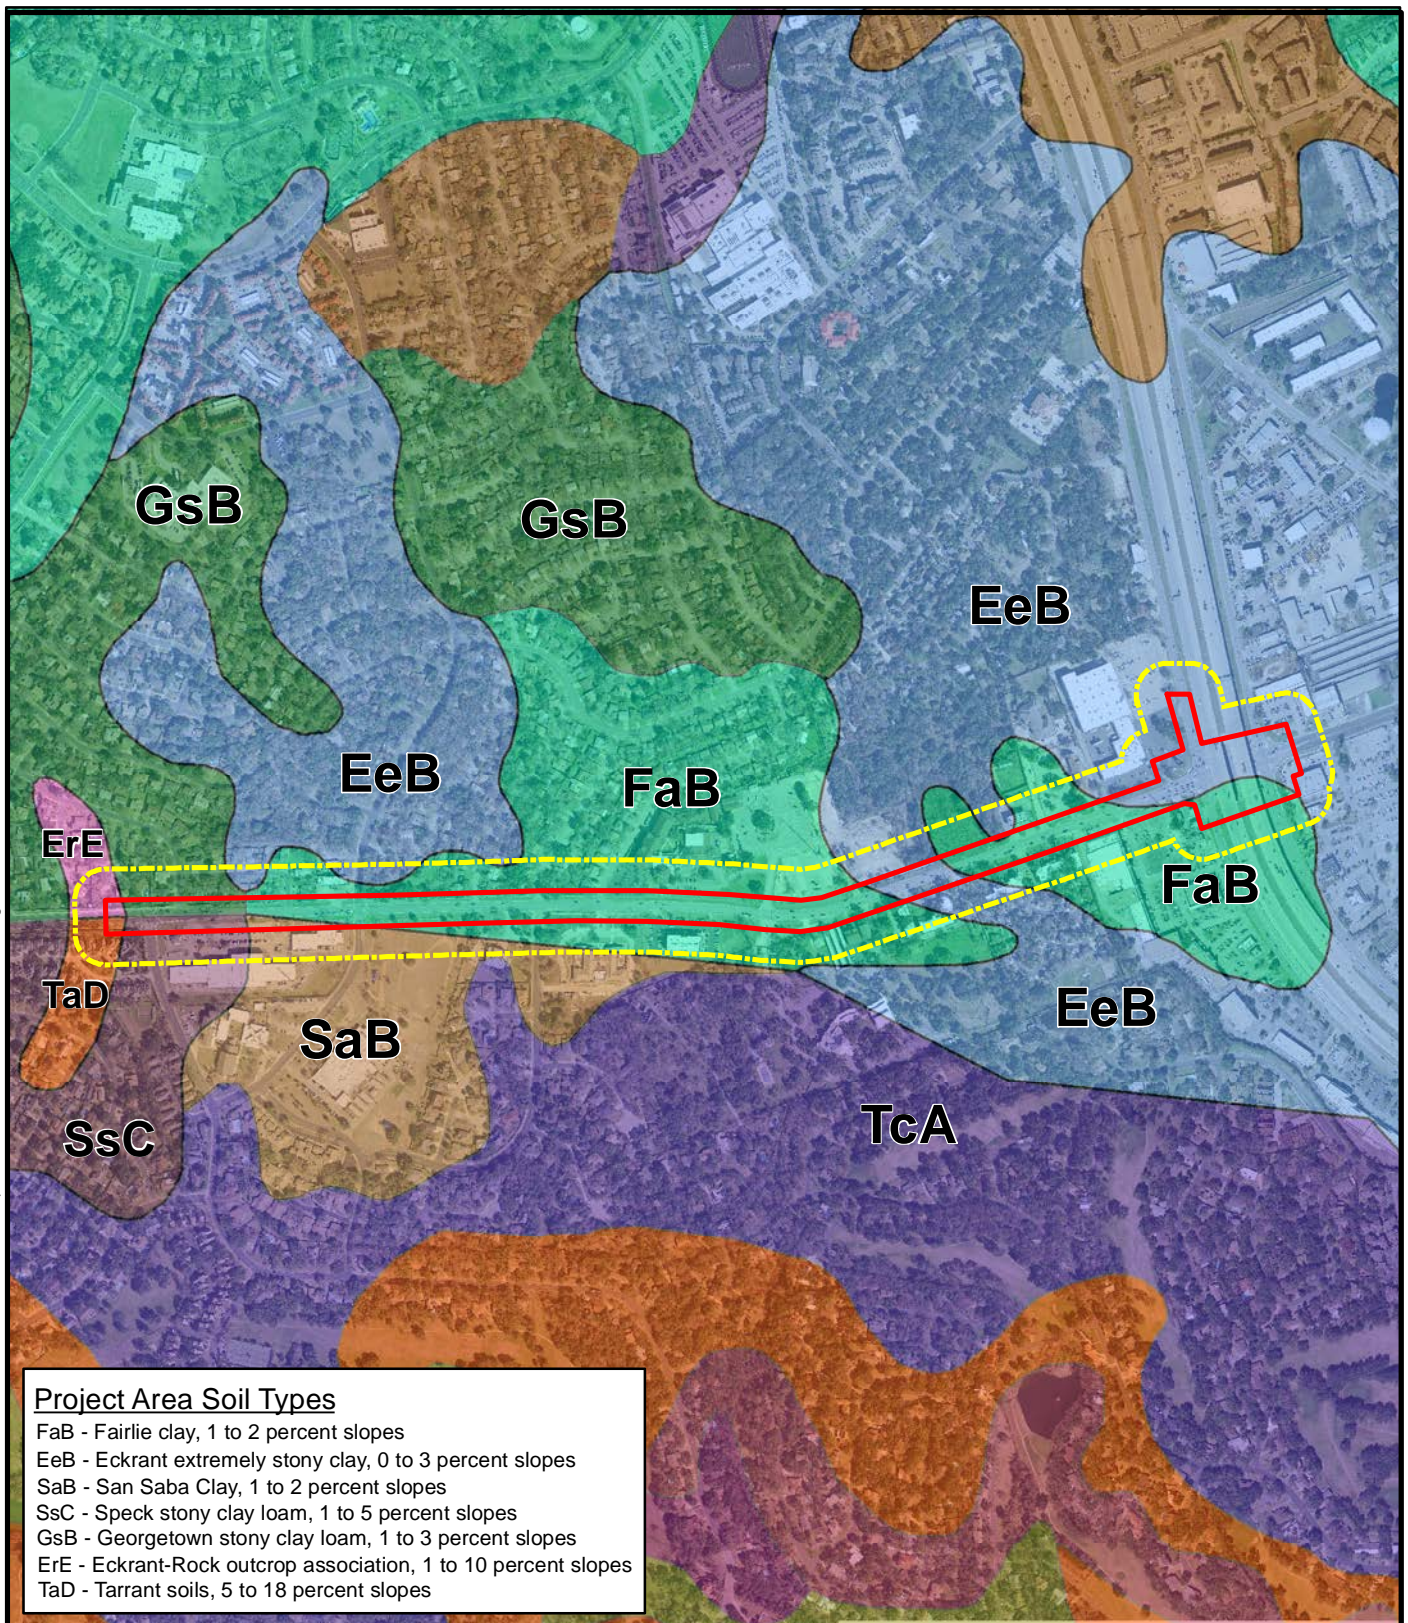
FIGURE 4 - SITE SOIL MAP
ANDERSON MILL ROAD IMPROVEMENTS
SPICEWOOD PARKWAY TO US 183
AUSTIN, TRAVIS AND WILLIAMSON COUNTIES, TEXAS

Project Area Soil Types

FaB - Fairlie clay, 1 to 2 percent slopes
EeB - Eckrant extremely stony clay, 0 to 3 percent slopes
SaB - San Saba Clay, 1 to 2 percent slopes
SsC - Speck stony clay loam, 1 to 5 percent slopes
GsB - Georgetown stony clay loam, 1 to 3 percent slopes
ErE - Eckrant-Rock outcrop association, 1 to 10 percent slopes
TaD - Tarrant soils, 5 to 18 percent slopes

The soils on the project area are generally thin and rocky. According to the *Soil Survey of Williamson County, Texas*, soils of the Fairlie Clay series (approximately 62%) are mapped across the majority of the project area, followed by the Eckrant Series (approximately 25%). In general, soils that formed on the outcrop of the Edwards Formation are typically composed of dark brown, grayish brown, and reddish brown, silty to clayey loams (SCS 1974, 1983). Other soils mapped in the project area include San Saba (SaB), Speck (SsC), Georgetown (GsB), and Tarrant (TaD) Soils. All of these soil units are hydrologically described as Group "D" soils, which have a very slow infiltration rate (high runoff potential) when wet. They consist mostly of clays that have a high shrink-swell potential, soils that have a permanent high water table, soils that have a clay layer near the surface, and soils that are shallow over nearly impervious material. These soils have a very slow rate of water transmission. A Site Soils Map of the project area is provided in *Figure 4*.

Using available soil publications and GIS ArcMap data layers, the percentages of soil units mapped in the project area and their general thicknesses is provided below. The project site contains seven soil types derived from the Web Soil Survey service provided by the United States Department of Agriculture (USDA). The western portion of the project site occurs along the Travis/Williamson County line, thus the project site includes more than one soil survey area. The survey areas may have been mapped differently, resulting in discrepancies in map units or soil properties across soil survey area boundaries. In Travis County, the project site contains three soil units:

- Speck stony clay loam, 1 to 5 percent slopes (SsC)
 - § Thickness = 1.6 feet
 - § 4.6% of the project site
- San Saba clay, 1 to 2 percent slopes (SaB)
 - § Thickness = 3.5 feet
 - § 2.3% of the project site
- Tarrant soils, 5 to 18 percent slopes (TaD)
 - § Thickness = 1 foot
 - § 0.7% of the project site

In Williamson County, the project site contains the following four soil units:

- Fairlie clay, 1 to 2 percent slopes (FaB)
 - § Thickness = 4.5 feet
 - § 61.8% of the project site
- Eckrant extremely stony clay, 0 to 3 percent slopes (EeB)
 - § Thickness = 1.3 feet
 - § 25.5% of the project site
- Georgetown stony clay loam, 1 to 3 percent slopes (GsB)
 - § Thickness = 4.5 feet
 - § 4.3% of the project site
- Eckrant-Rock outcrop association, 1 to 10 percent slopes (ErE)
 - § Thickness = 1 foot
 - § 0.7% of the project site

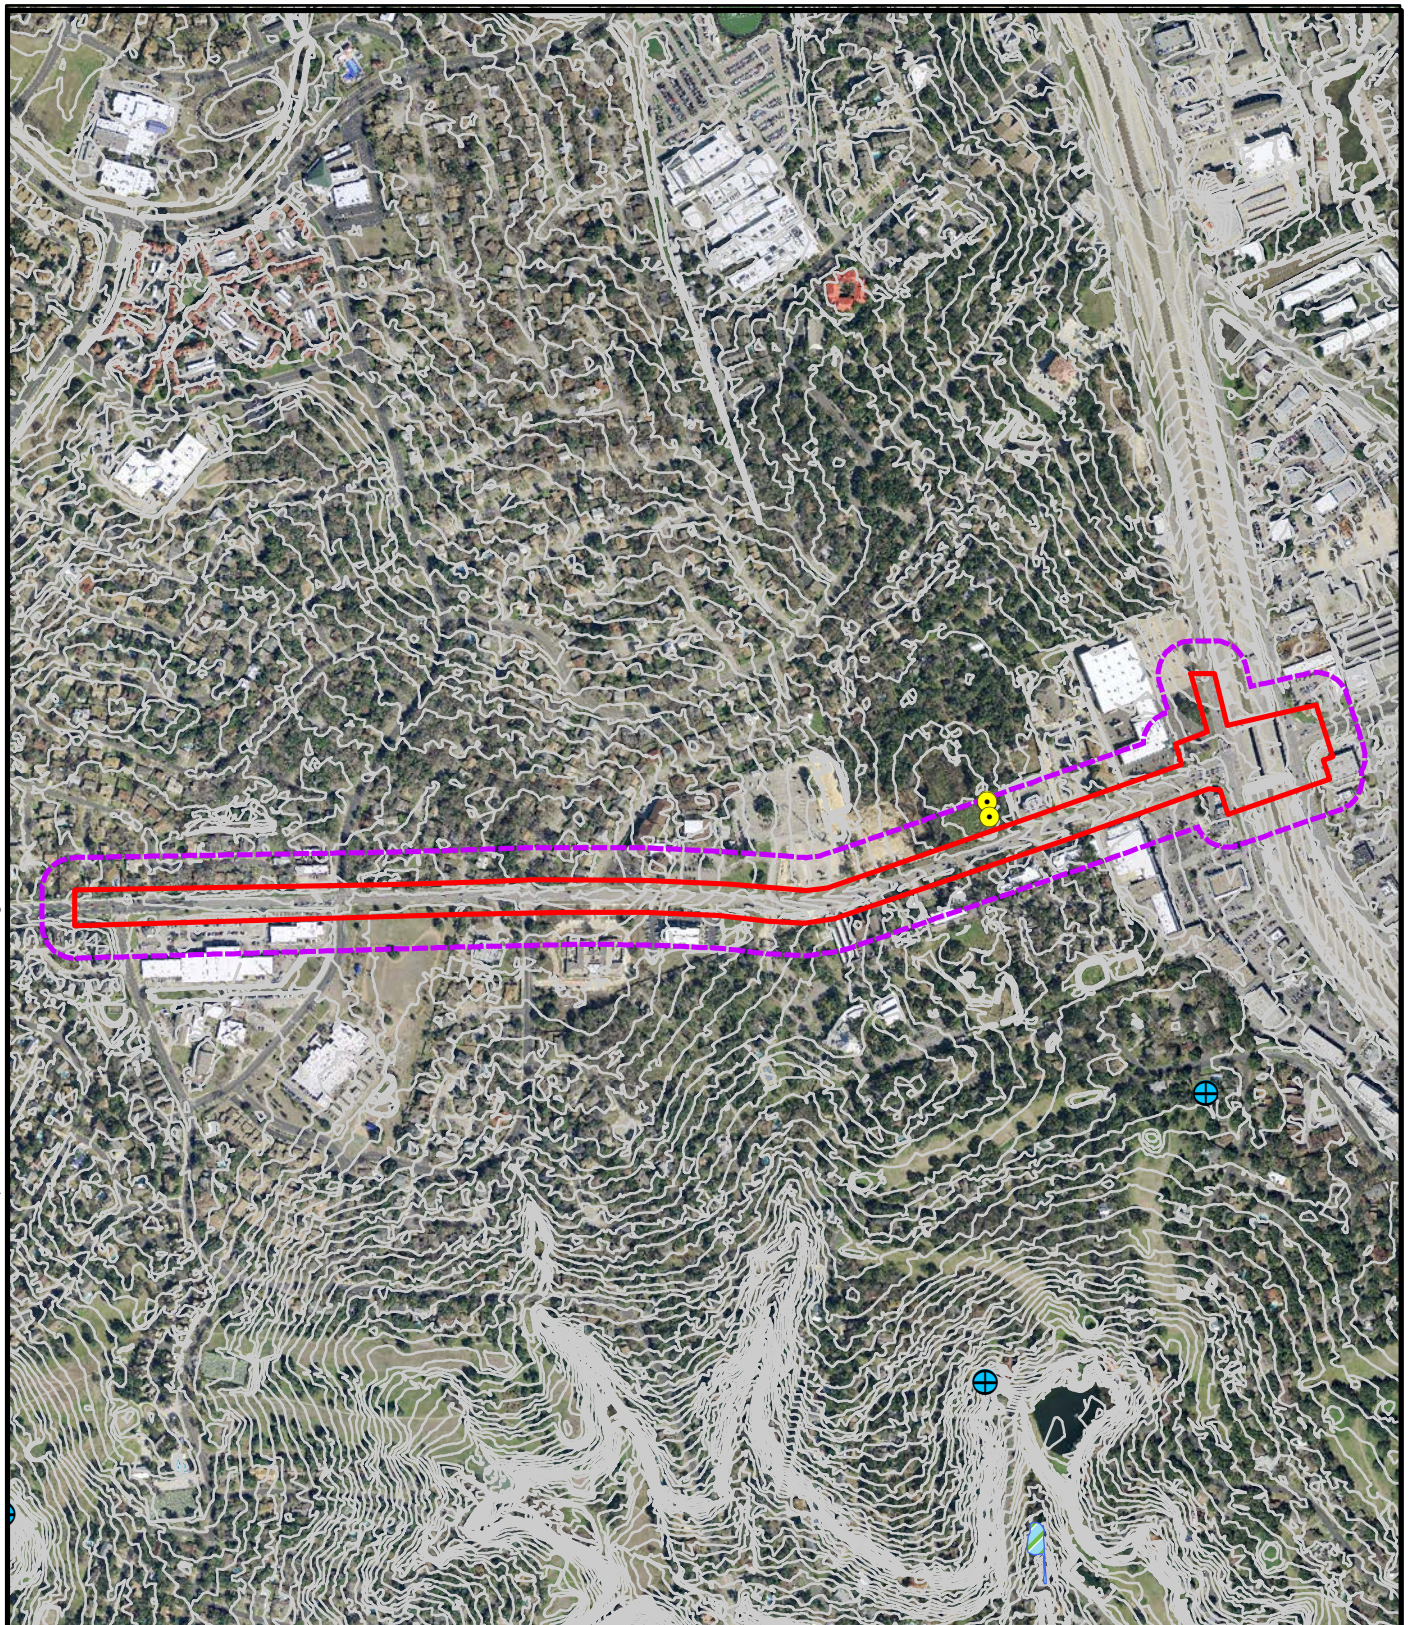
**FIGURE 5 - CRITICAL ENVIRONMENTAL FEATURES
AND WELL LOCATION MAP**
ANDERSON MILL ROAD IMPROVEMENTS
SPICEWOOD PARKWAY TO US 183
AUSTIN, TRAVIS AND WILLIAMSON COUNTIES, TEXAS

Based on the field survey and review of available literature, two karst features or point recharge features were identified within the project area. No other CEFs were observed within the project area. We contacted the Watershed Protection and Development Review (WSPDR) Department of the COA to see if any previous geologic data was available for these two features. Ms. Sylvia Pope, with WSPDR, provided a brief history and background information for the two features identified. An easement for the water quality/CEF buffer zone established for the features was also forwarded for review. We understand that there are previous karst surveys, environmental assessments and ERI studies that have been conducted for the site, but none of this information has been made available at this time, other than general confirmation of the limited descriptions and measurements of the karst features presented below. Brief descriptions of the two features as observed during the karst survey are provided below. A map showing the approximate location of the two karst features identified is provided in *Figures 5 and 6*.

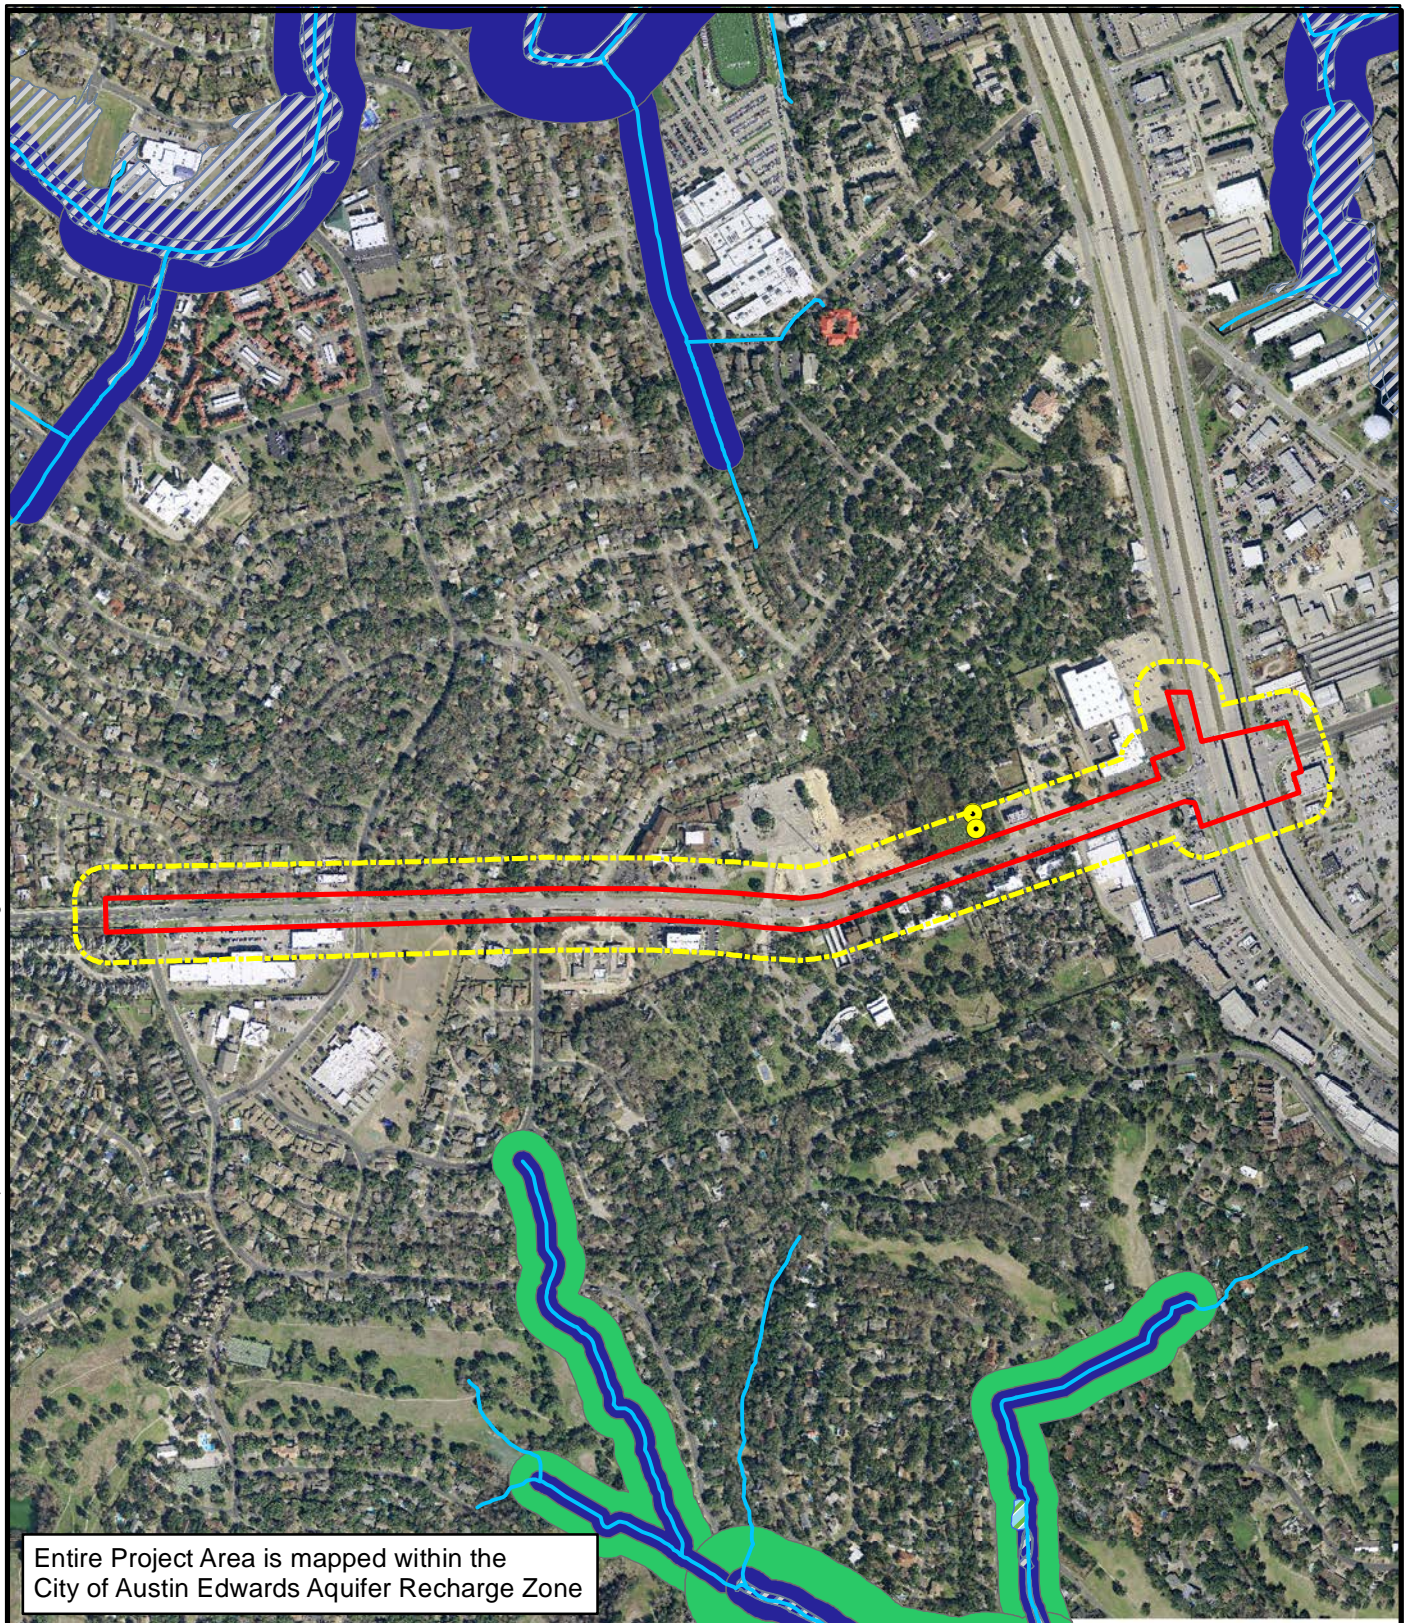
**FIGURE 6 - ENVIRONMENTAL CONSTRAINTS
ANDERSON MILL ROAD IMPROVEMENTS
SPICEWOOD PARKWAY TO US 183
AUSTIN, TRAVIS AND WILLIAMSON COUNTIES, TEXAS**

Entire Project Area is mapped within the
City of Austin Edwards Aquifer Recharge Zone

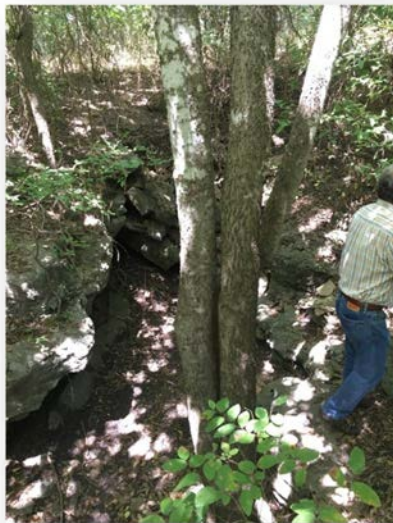
Karst Feature No. 1 (S-1) - Sinkhole - This feature appeared as an open sinkhole measuring approximately 30 feet long by 18 feet wide and dropping about 10 feet to a moderately soil filled compact floor. The feature developed along a vertical joint fracture bearing approximately N340° W. Evidence of dry, intermittent, very shallow drainages or rivulets about 12 to 16-inches across and no more than two inches deep were noted draining towards the western perimeter of the feature, indicating that the feature receives surface water runoff during rain events. An open bedding plane was also noted near the floor on the north-northeast side of the feature, extending about 15 feet horizontally into the subgrade. Very slight airflow was detected at the time of our site visit. It was reported that the landowner previously conducted an excavation of the sinkhole in 2015 in order to open the open bedding plane or cave passage at the north end. The excavation was later terminated due to safety concerns that additional excavation could potentially lead to collapse. Based upon the characteristics observed in the field,

the relative infiltration rate for this feature was determined to be moderate and it was evaluated as “sensitive” per the TCEQ’s Edwards Aquifer Protection Program. Silt fencing was noted around the perimeter of the feature. We understand that this feature is called the Anderson Mill Road/ZFB sinkhole by the WSPDR staff.

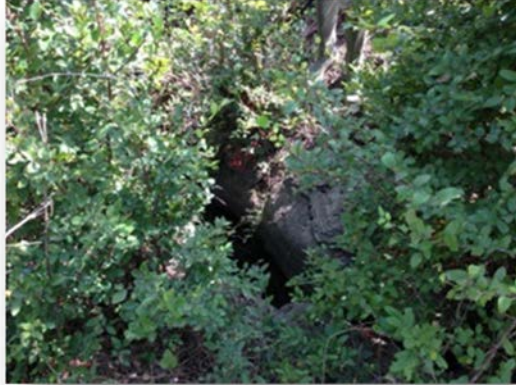
Karst Feature No. 1 (S-2) - Sinkhole - This feature appeared as an open sinkhole measuring approximately 12 feet long by 2 feet wide and dropping vertically about 4 feet to a rubble floor. The sinkhole apparently developed along a solution enlarged fracture bearing approximately N320°W. The feature narrows with depth, with evidence of continued subsurface drainage extending into the subgrade along the downgradient wall. Very slight airflow was detected at the time of our site visit. Based upon the characteristics observed in the field, the relative infiltration rate for this feature was determined to be moderate and it was evaluated as “sensitive” per the TCEQ’s Edwards Aquifer Protection Program. Based on our conversation with WSPDR staff, we understand that this feature is located within the catchment basin

of, and is likely associated with the nearby Anderson Mill Road/ZFB sinkhole (S-1) described above.
