# Facilities Master Plan

NOVEMBER, 2003

## Austin Public Library System

# Austin Public Library System Facilities Master Plan

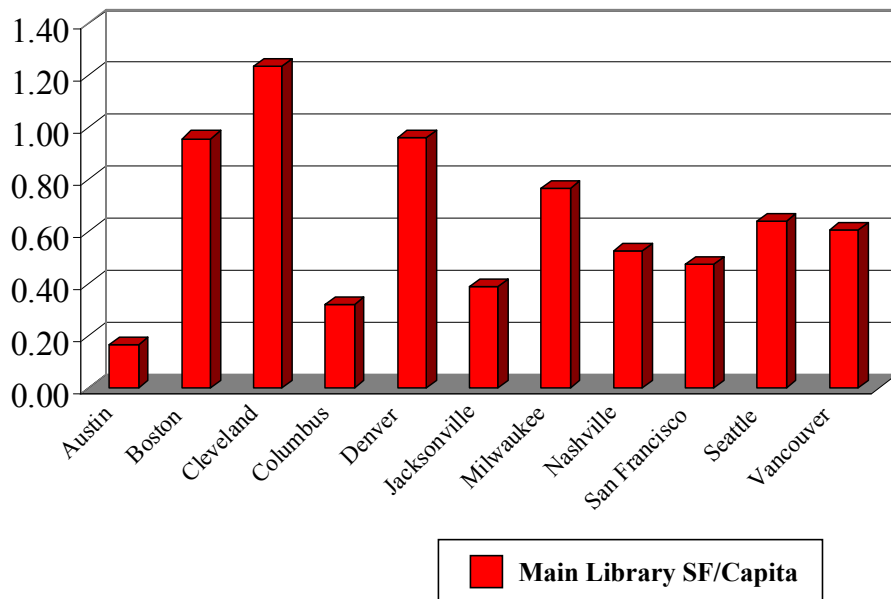
**Central Library  
Square Feet Per Capita**

Austin's Public Library system has only 35 percent (110,633 SF) of its total square footage in a Central Library facility and 65 percent in branch facilities (206,069)\*, as compared with other comparable urban library systems that typically have well over 50 percent of the total library SF in Central Library space.

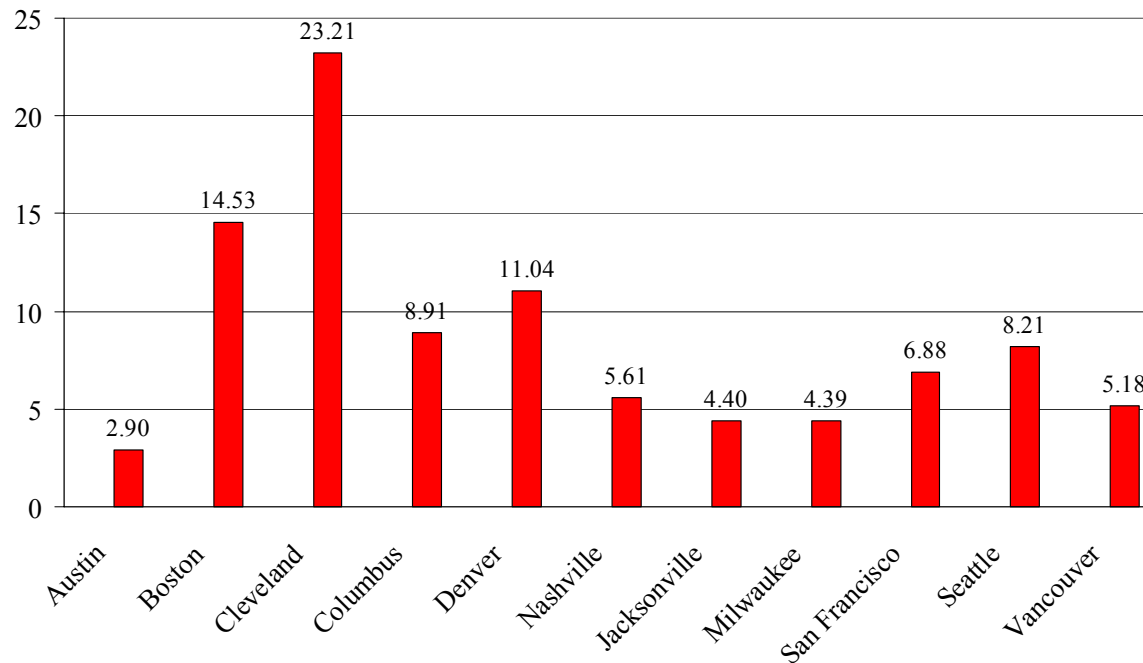
### FY 2003 Annual Materials Expenditures Per Capita

Analysis of library data from Public Library Data Service Statistical Report, 2003 edition found the following: As compared with peer cities, Austin spent less on materials (\$2.90 on materials per capita) as compared with the upper quartile of \$5.97 for other peer cities.

Public Libraries Serving	Reporting Libraries	Mean	High	Upper Quartile	Median	Lower Quartile	Low
500,000 to 999,999	56	\$5.23	\$14.53	\$5.97	\$4.58	\$3.51	\$1.50

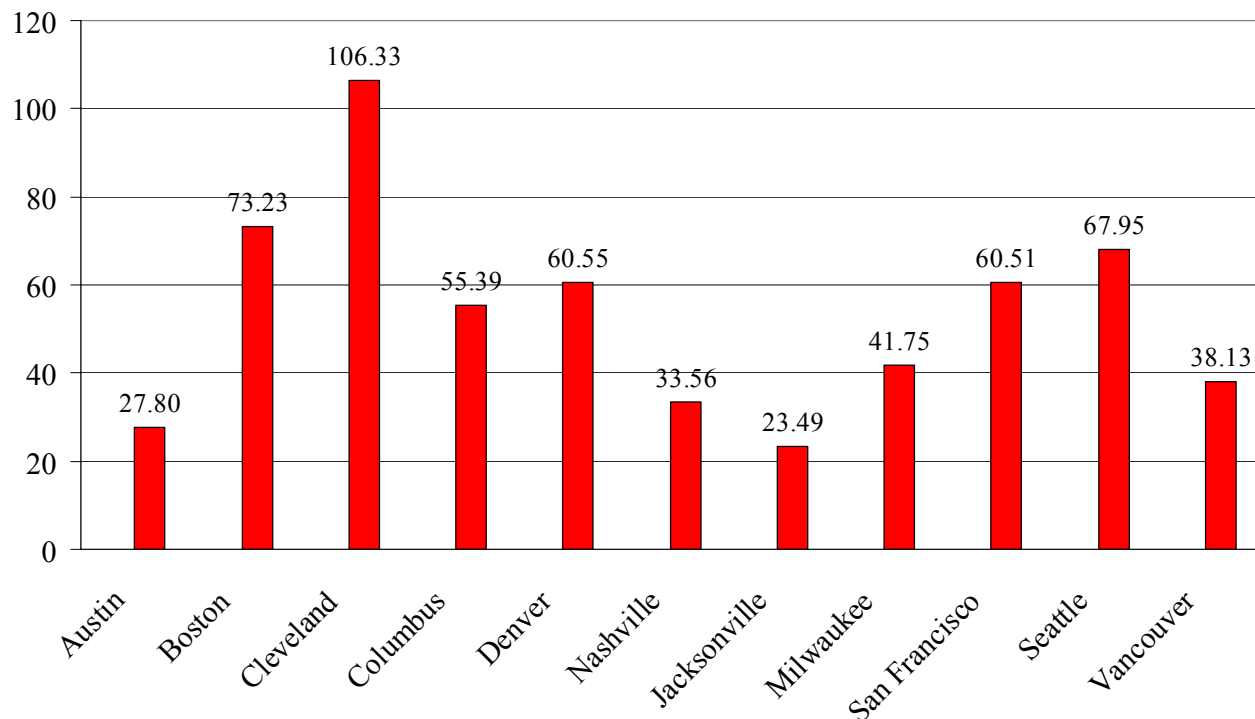
### FY 2003 Annual Expenditures Per Capita

Analysis of library data from Public Library Data Service Statistical Report, 2003 edition found the following: As compared with peer cities, Austin's annual operating expenditures (\$27.80) were less than the upper quartile of other peer libraries (\$40.93).

Public Libraries Serving	Reporting Libraries	Mean	High	Upper Quartile	Median	Lower Quartile	Low
500,000 to 999,999	56	\$34.03	\$75.63	\$40.93	\$32.49	\$21.71	\$12.31

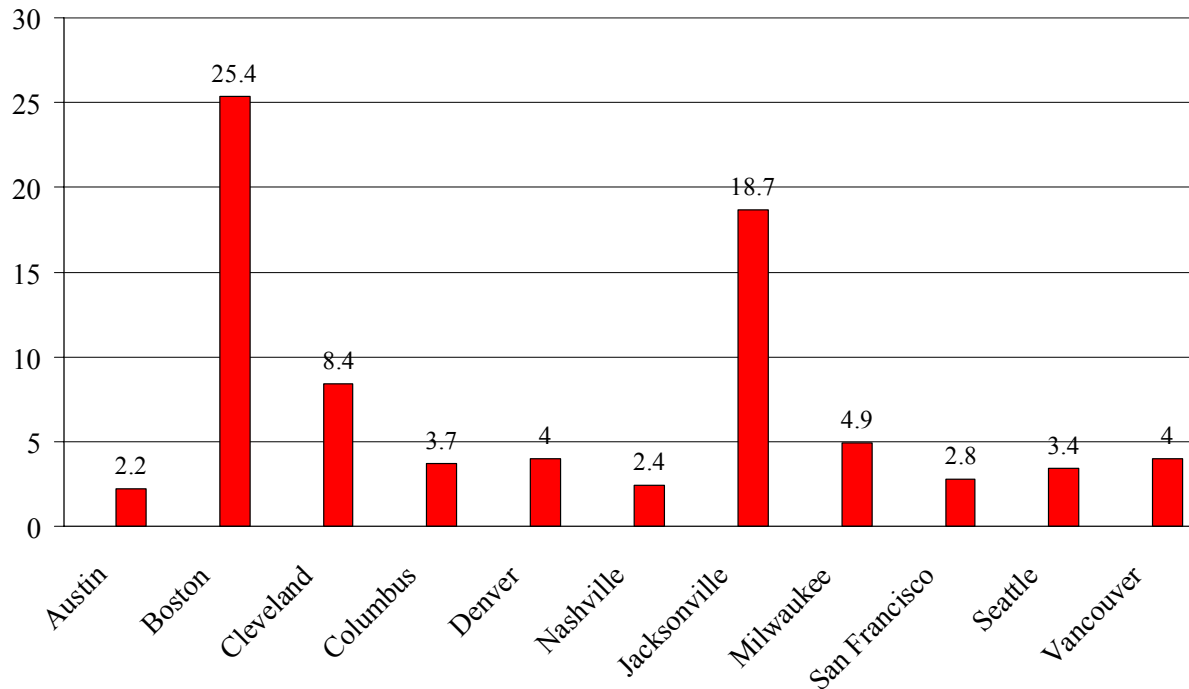
**FY 2003 Library Holdings Per Capita (in volumes)**

Analysis of library data from Public Library Data Service Statistical Report, 2003 edition found the following: As compared with peer cities, Austin has fewer materials holdings per capita (2.2 versus 3.0 of the upper quartile used in the Facilities Master Plan model) than other peer libraries.

Public Libraries Serving	Reporting Libraries	Mean	High	Upper Quartile	Median	Lower Quartile	Low
500,000 to 999,999	56	3.3	25.4	3.0	2.5	2.1	1.0

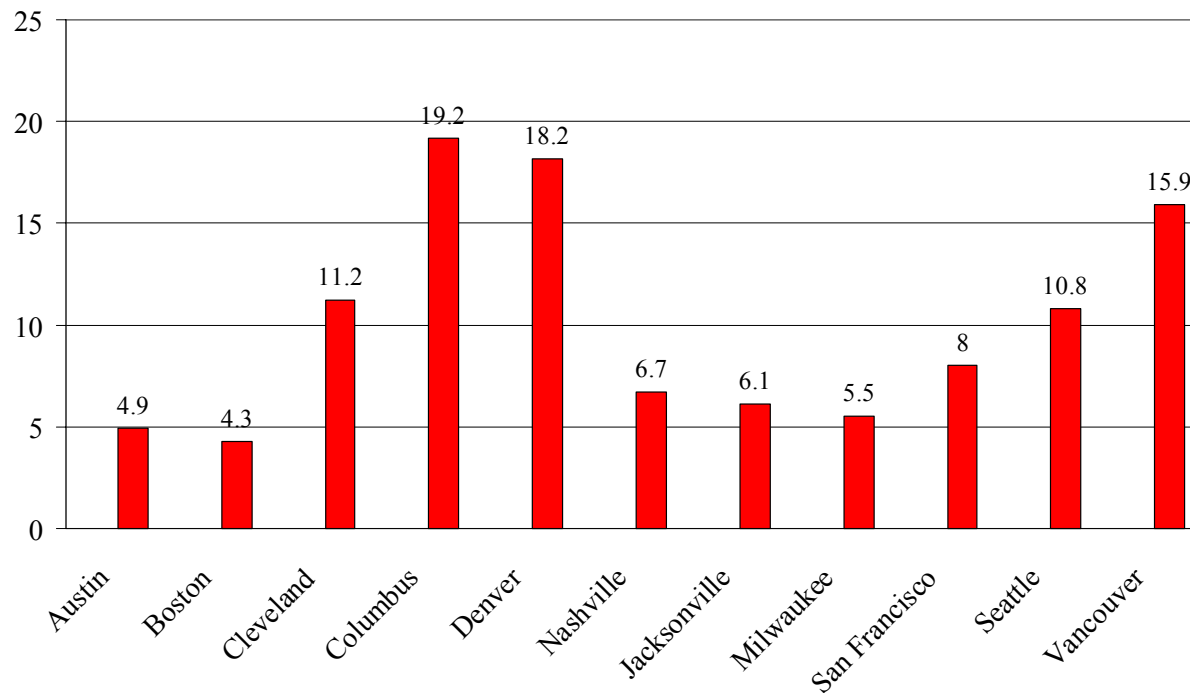
**FY 2003 Annual Circulation Per Capita**

Analysis of library data from Public Library Data Service Statistical Report, 2003 edition found the following: Austin Public Library's circulation of 4.9 per capita is significantly below the upper quartile average of 8.8 when compared to peer libraries.

Public Libraries Serving	Reporting Libraries	Mean	High	Upper Quartile	Median	Lower Quartile	Low
500,000 to 999,999	56	8.8	24.2	11.5	7.7	5.1	1.2

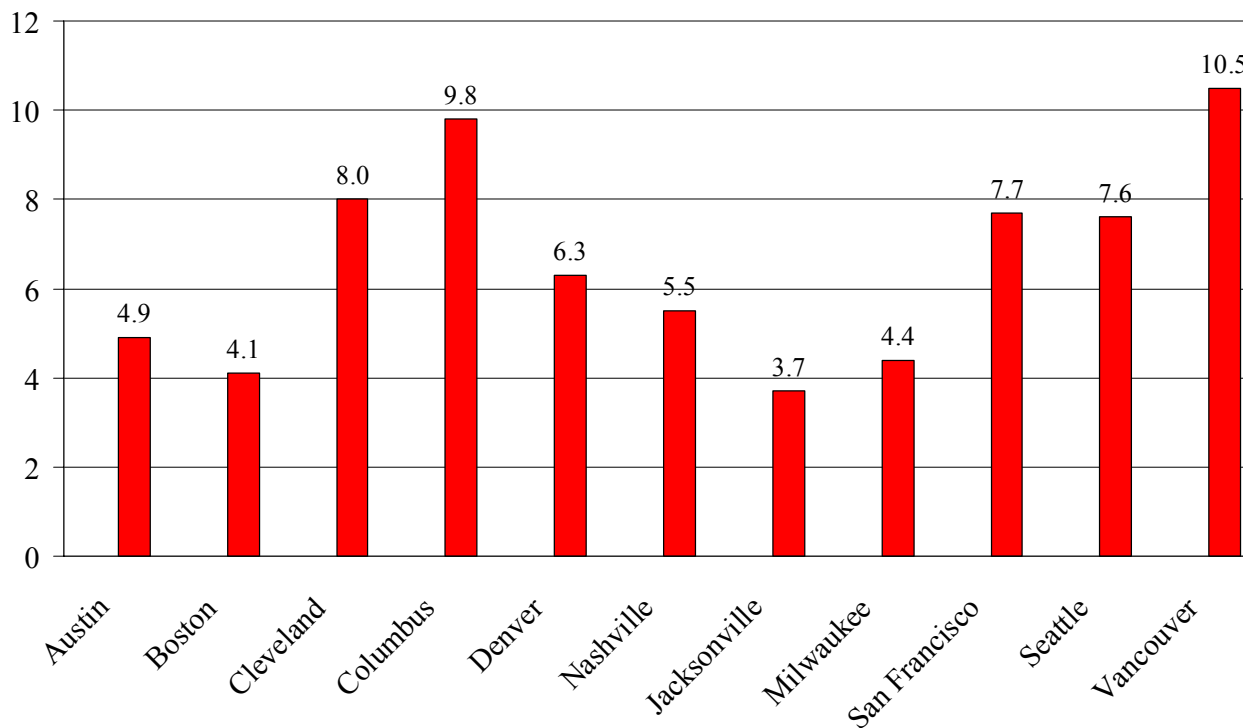
FY 2003 Annual Visits Per Capita

Analysis of library data from Public Library Data Service Statistical Report, 2003 edition found the following: Austin's libraries attracted 4.9 million visitors per capita during FY 2003, which is .9 visits per capita below the targeted upper quartile standing of 5.8 visitors/per capita.

Public Libraries Serving	Reporting Libraries	Mean	High	Upper Quartile	Median	Lower Quartile	Low
500,000 – 999,999	49	5.0	10.5	5.8	4.8	3.7	2.0

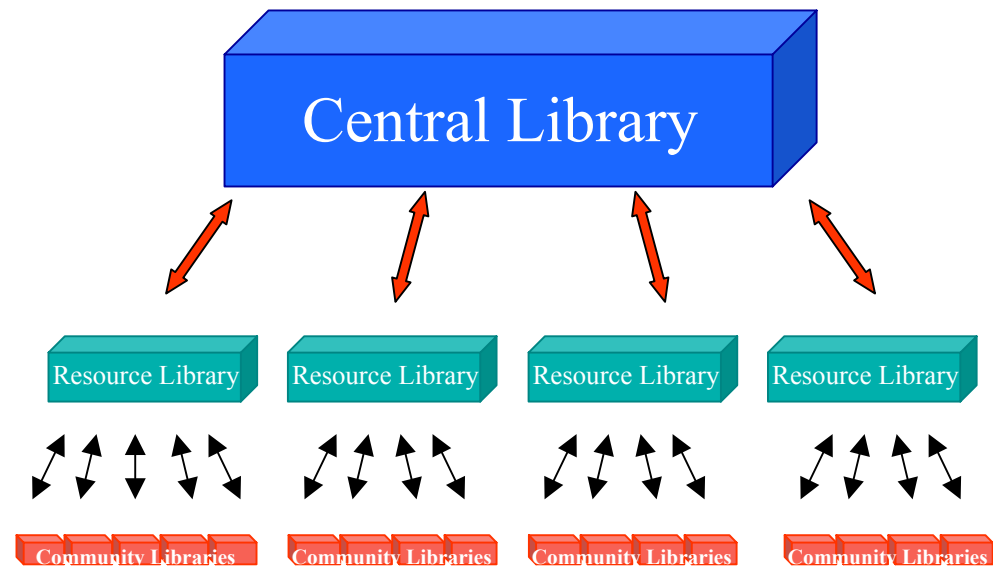
## The Library Network

The Facilities Master Plan recommendations build on the strengths of the existing system and promote equity of access to library users in all neighborhoods. The Austin Public Library System should take a multi-tiered approach to the provision of facilities that would provide additional support to the existing branches.
