This profile summarizes the characteristics of the watersheds in District 4; provides an overview of flooding, erosion, and water quality problems; and discusses past, current, and upcoming solutions.

Watershed Protection District 4 Profile

January 1, 2015

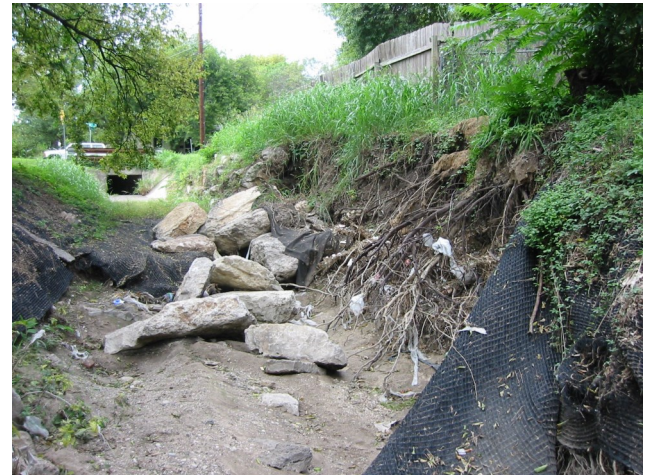
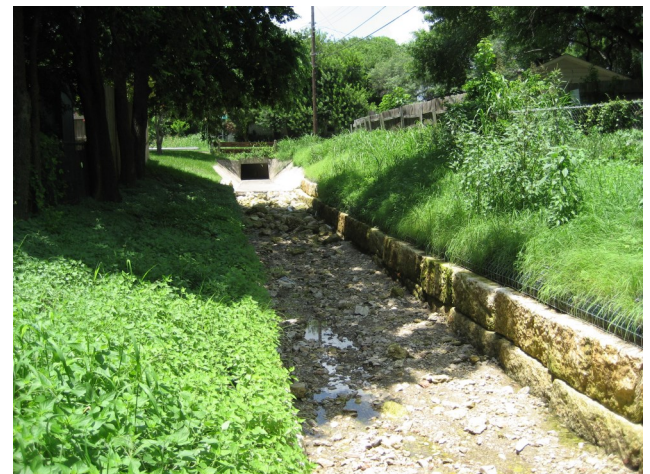
Before and after photos of a project to repair eroding banks and protect threatened property along the Jamestown tributary of Little Walnut Creek.

- **Capital Improvement Projects:** Since the watersheds in District 4 were largely developed before watershed regulations were in place, capital solutions are a key tool for this district. Watershed Protection has already constructed numerous projects in this district, including repairing eroding streambanks, like in the project featured below, and building regional stormwater ponds, like the South Metric pond shown above. Several projects are planned for the next five years as well, including a diversion tunnel beneath Mearns Meadow Drive that will reduce flooding impacts from Little Walnut Creek, restoration of a degraded tributary of Little Walnut Creek, and a regional stormwater pond to be constructed in partnership with Highland Mall.
