Eanes Creek Watershed

Summary Sheet

Water Quality Data – Temperature, Conductivity, pH, Dissolved Oxygen & E. coli for 2014 Sample Sites (Downstream to Upstream)

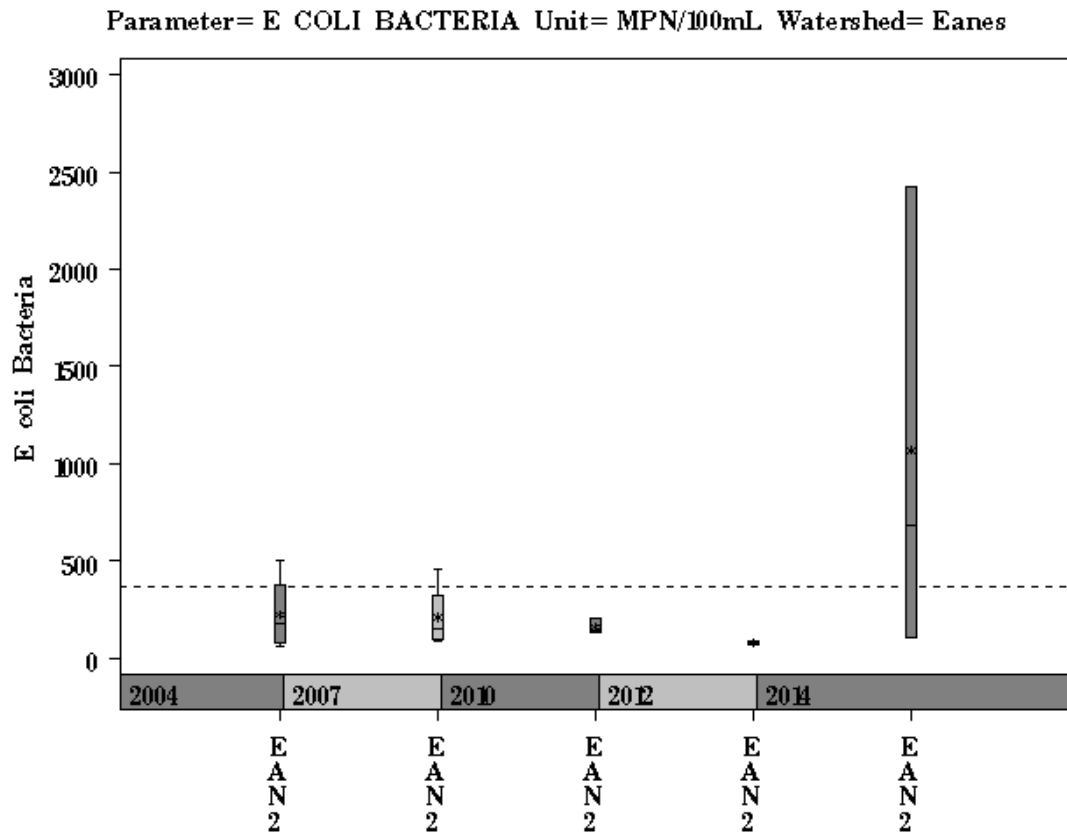
Data Summary Graphs – *E.coli* (Downstream to Upstream by Year)

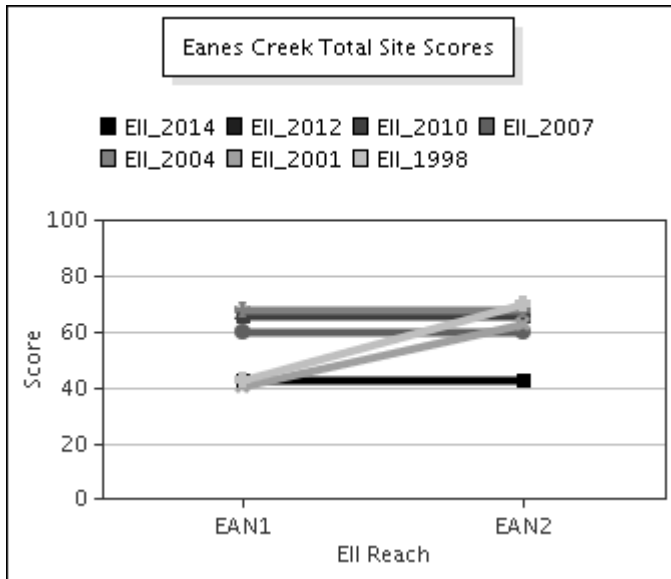
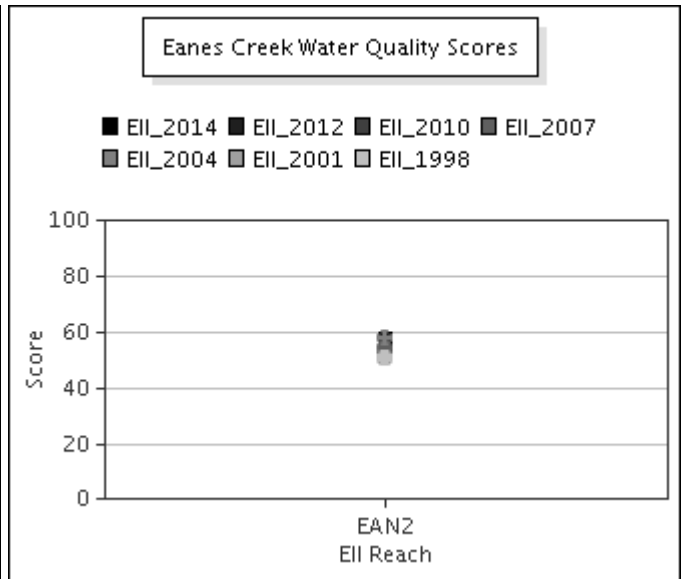
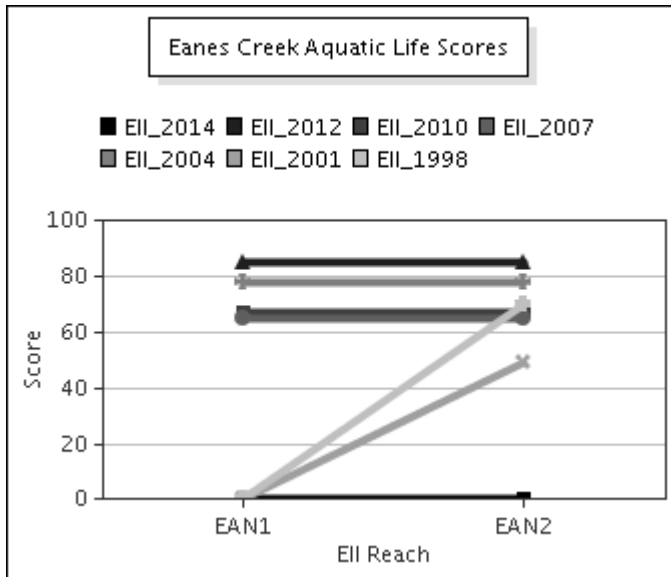
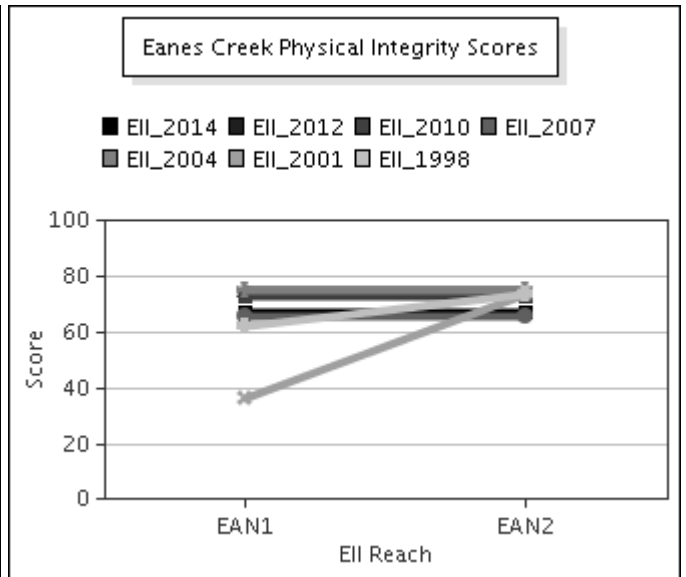
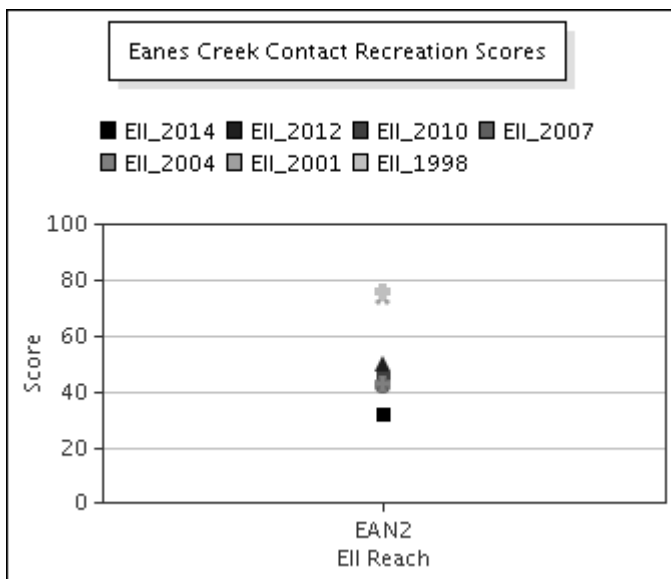
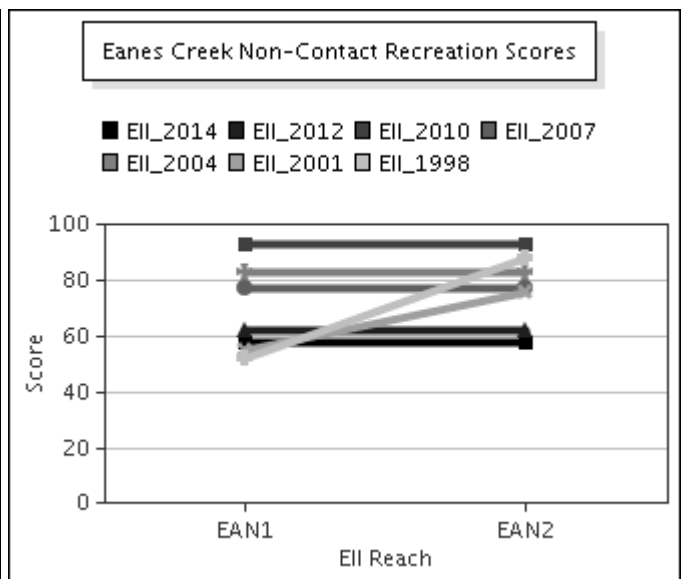
Score Summary – Reach scores for each sample year
