Taylor Slough North Watershed

Summary Sheet

Water Quality Data – Temperature, Conductivity, pH, Dissolved Oxygen & E. coli for 2014 Sample Sites (Downstream to Upstream)

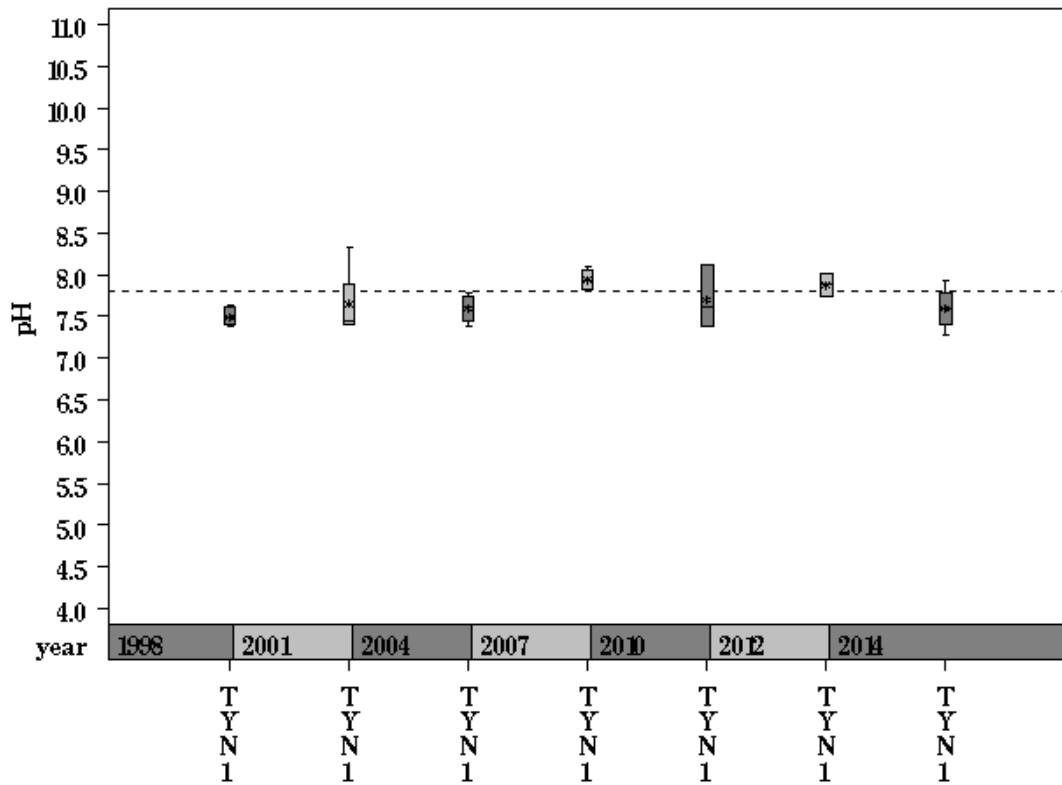
Parameter= PH Unit= Standard units Watershed= Taylor Slough North

Data Summary Graphs – pH and Conductivity (Downstream to Upstream by Year)

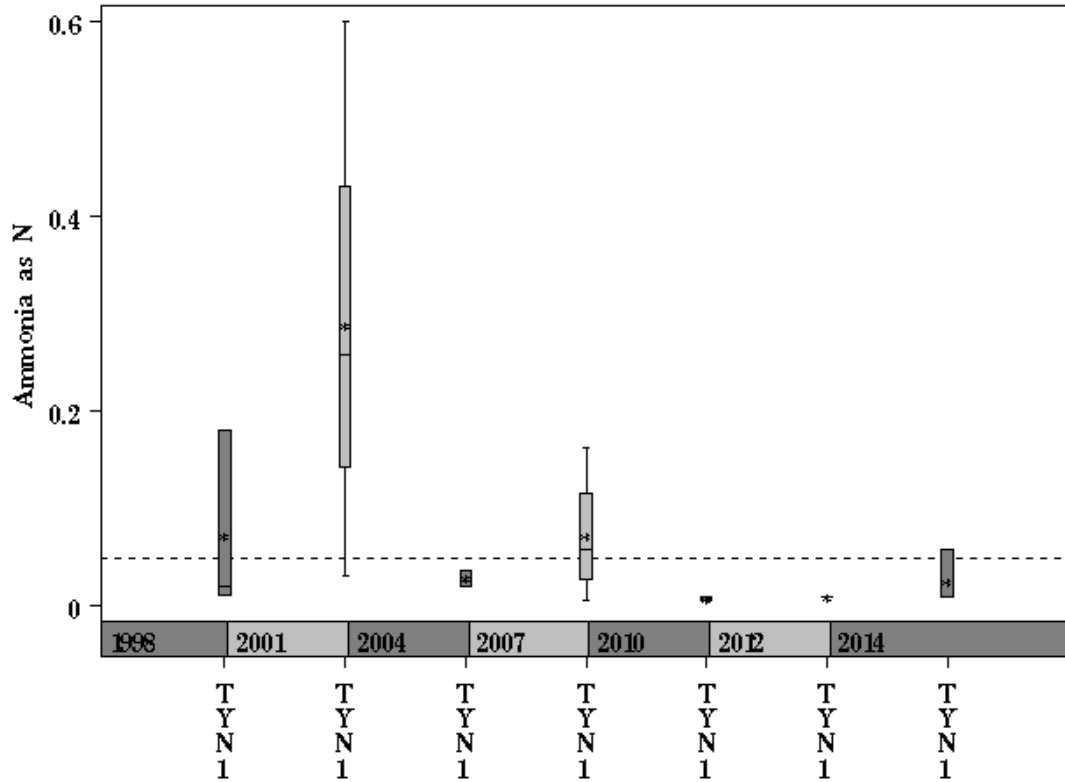
Parameter= AMMONIA AS N Unit= mg/L Watershed= Taylor Slough North

Data Summary Graphs – Ammonia and Nitrate/Nitrite (Downstream to Upstream by Year)
