Existing Conditions Assessment

Dougherty Arts Center

City of Austin
Parks and Recreation Department

15 September 2010

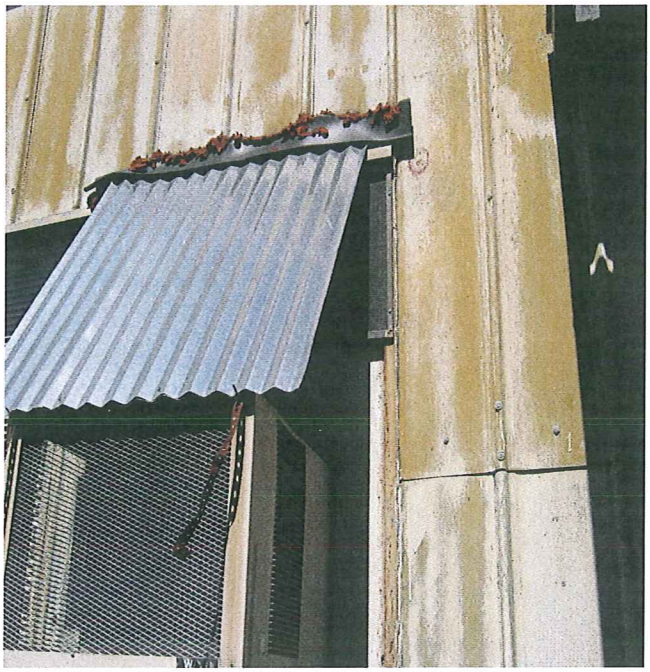
11 A/B. Exterior of East and West side of Area B. Presumed original metal windows and wall panels installed in 1947.

12. Typical asbestos wainscoting in Area B.

13. Failing metal panel cladding in Area C.

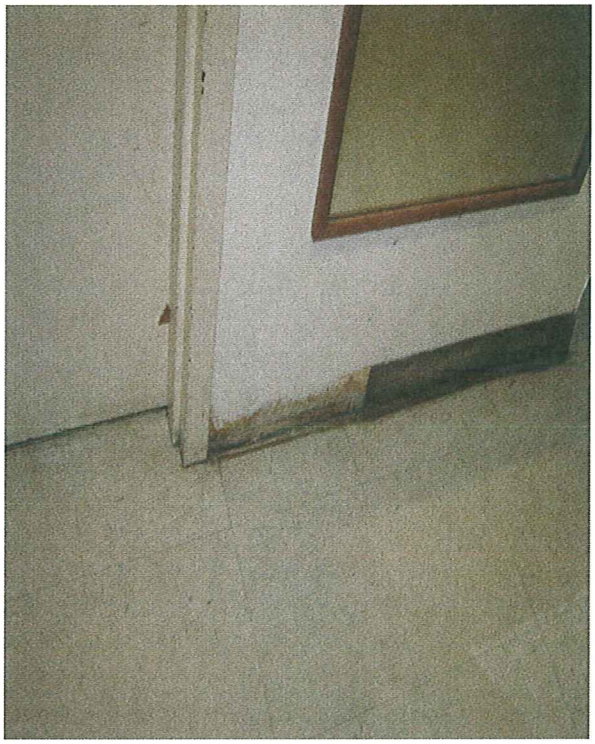
14. Exterior condition of Area C, emphasizing distinction between original and replacement wall panels.

15. Base conditions in Area C.

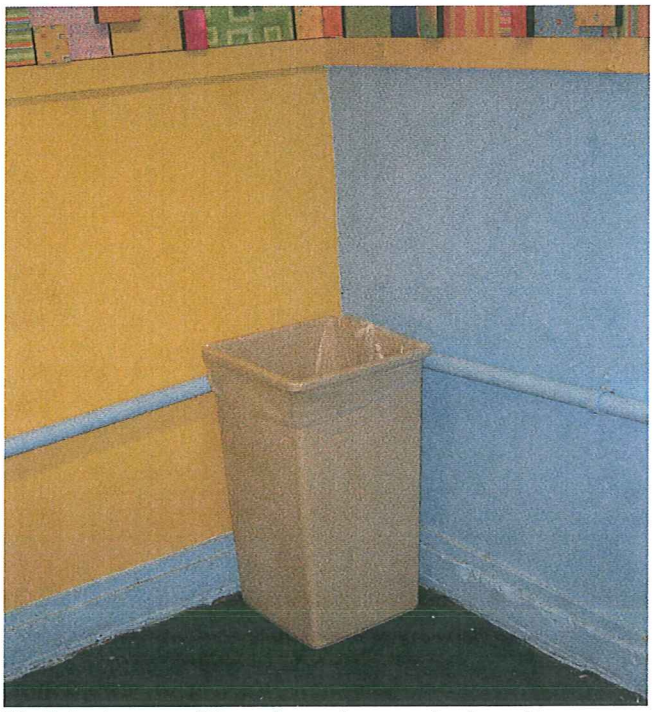
22. Interior conditions in Area E.

23. Interior conditions in restrooms in Area E.

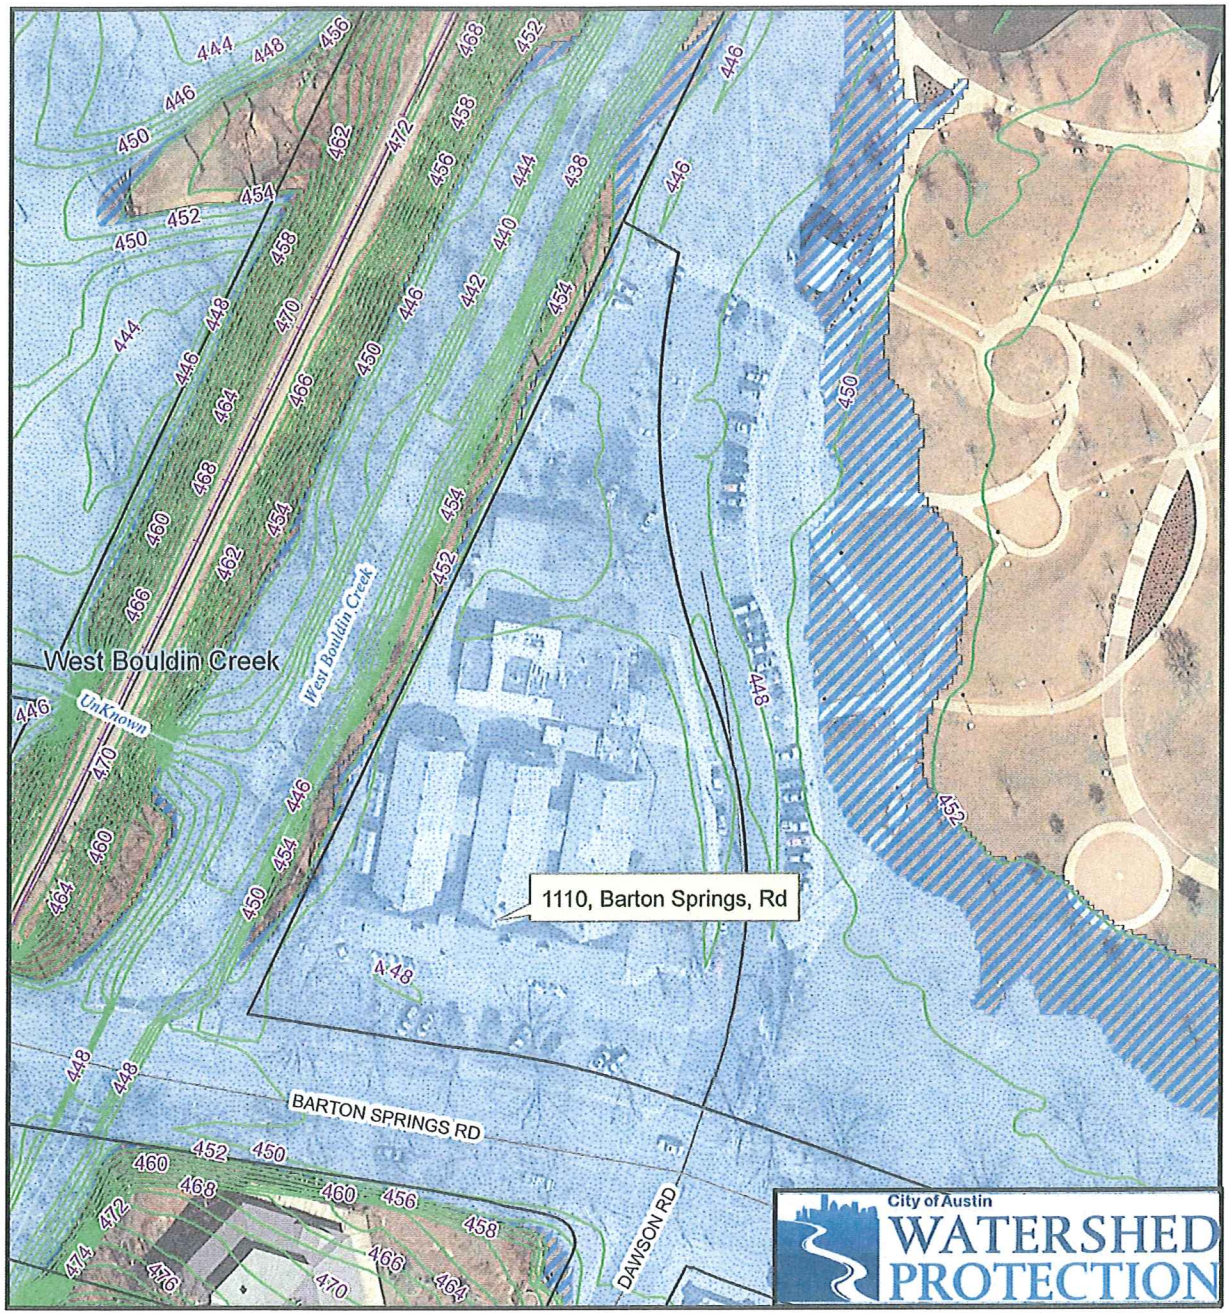
28. Typical tile conditions throughout Area E

29. Typical exterior conditions of Area E.

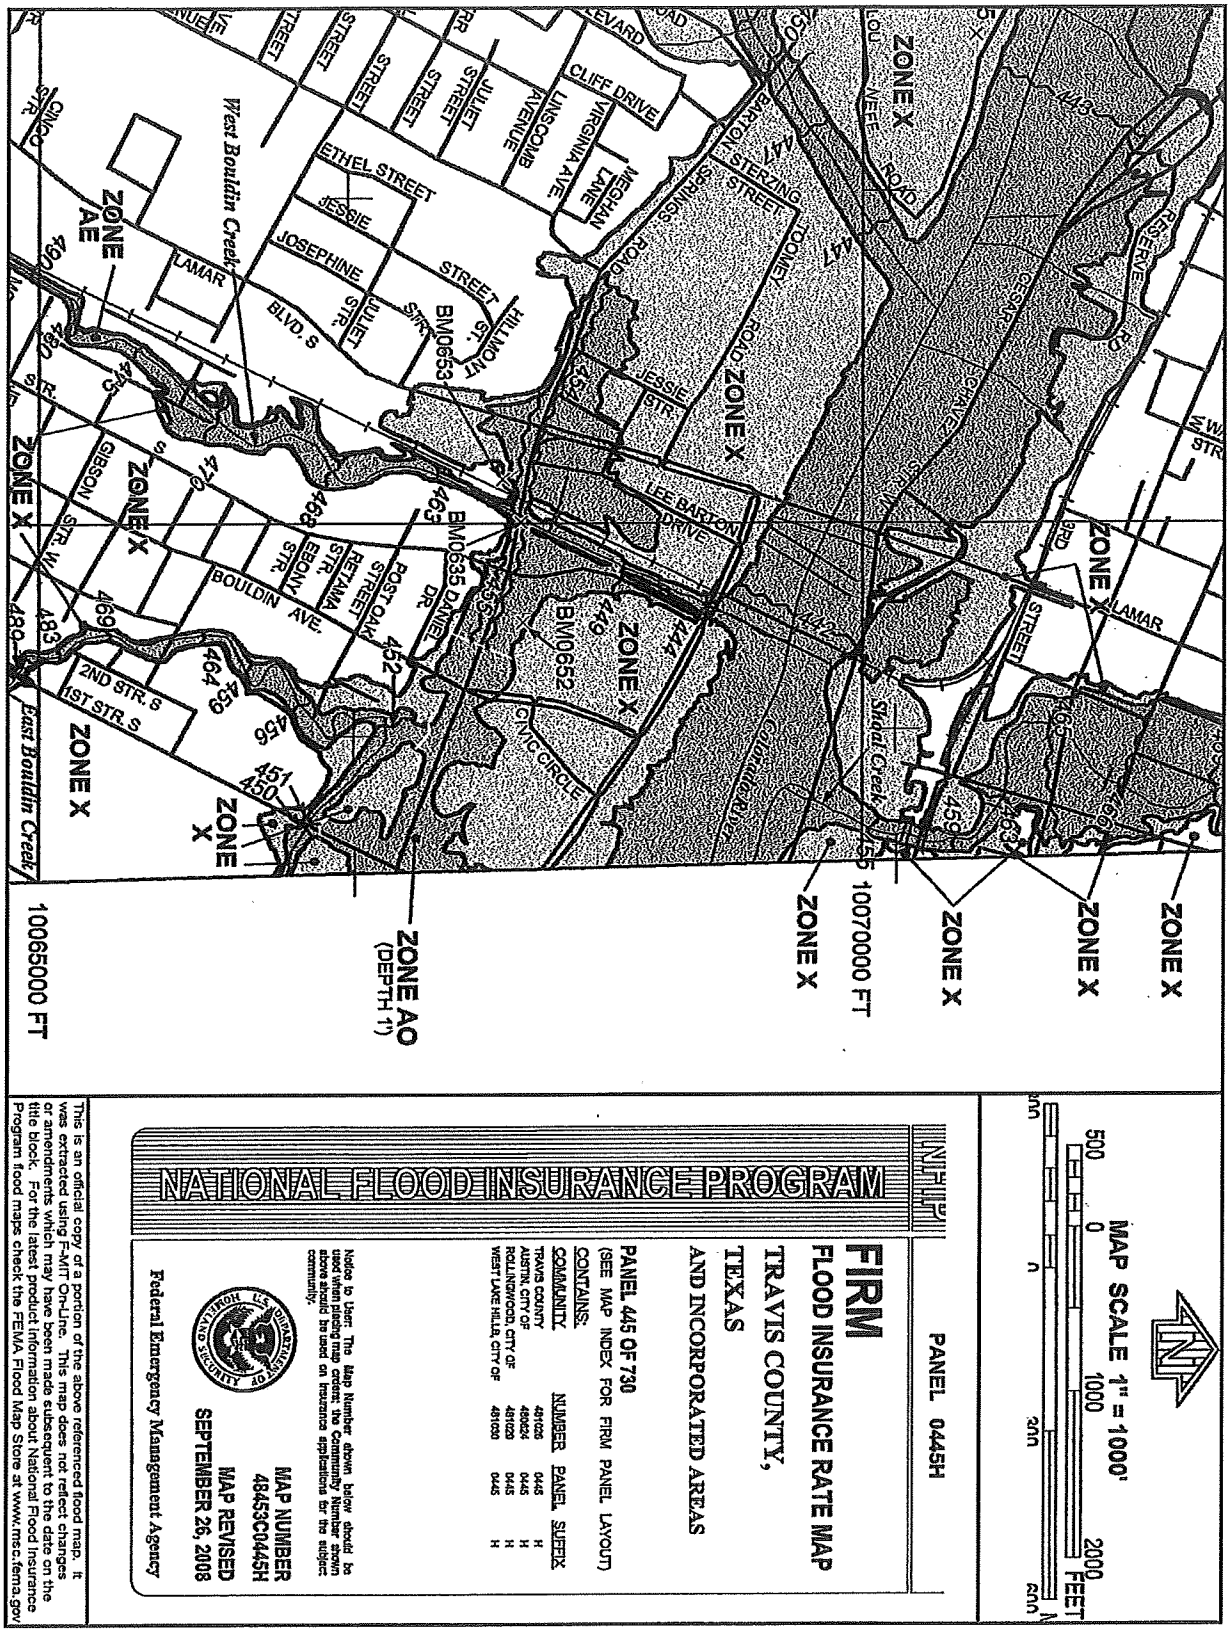
32. FEMA Frimette (site-specific flood insurance rate map) illustrating the vicinity of the Dougherty Arts Center.

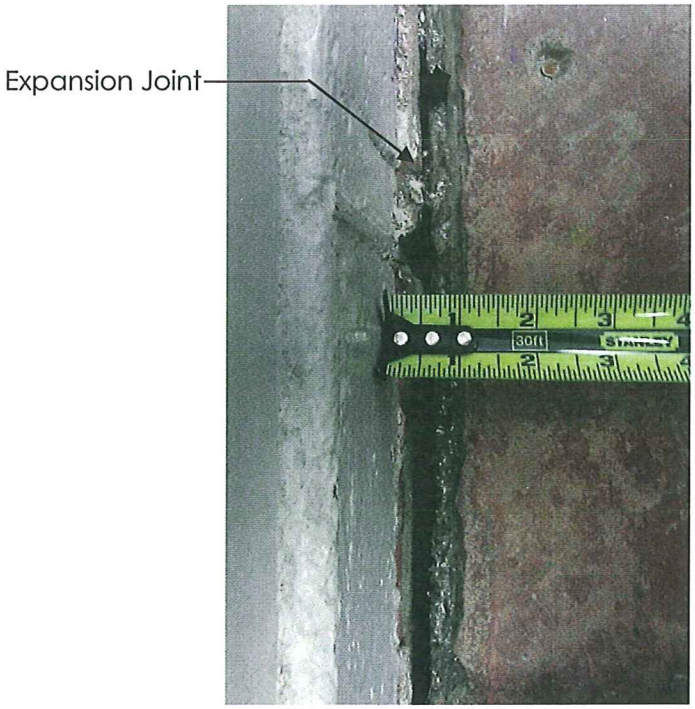
Photo 1: Expansion joint between perimeter grade beam and slab

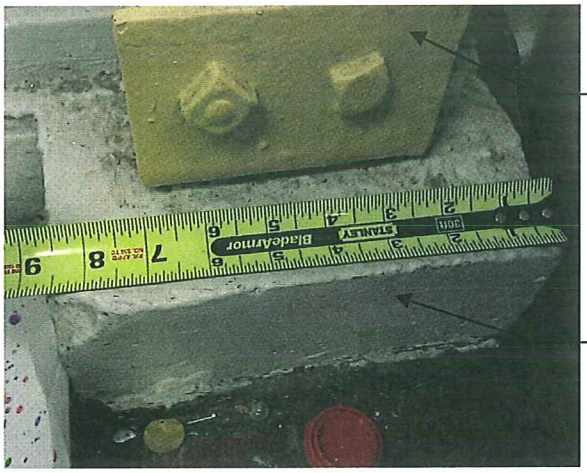
Photo 3: Concrete plinth below column

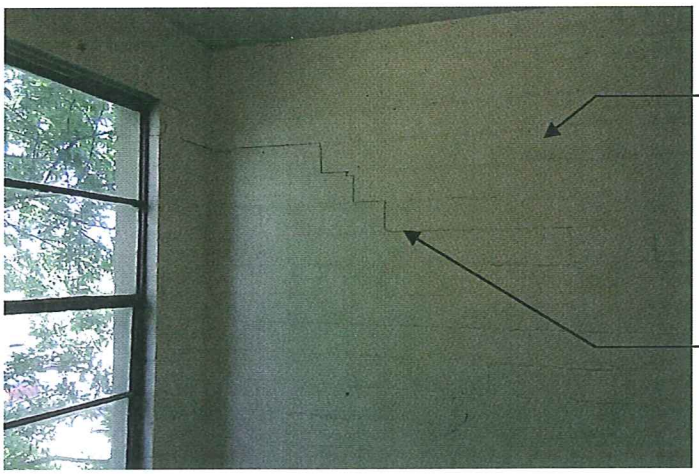
Photo 4: Cracks in CMU wall at east staircase

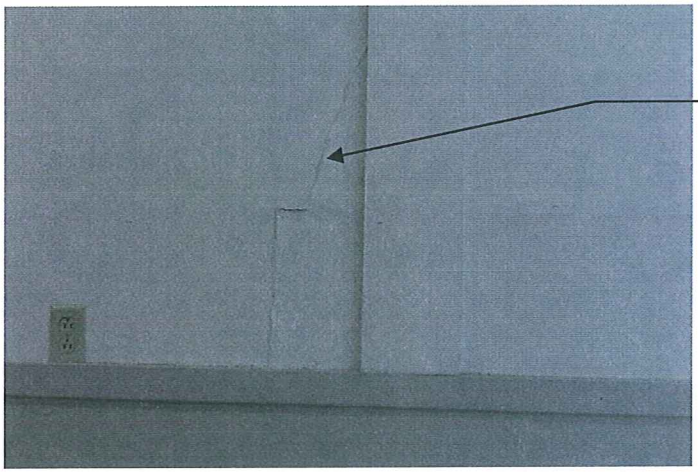
Photo 5: Cracks in gypsum board

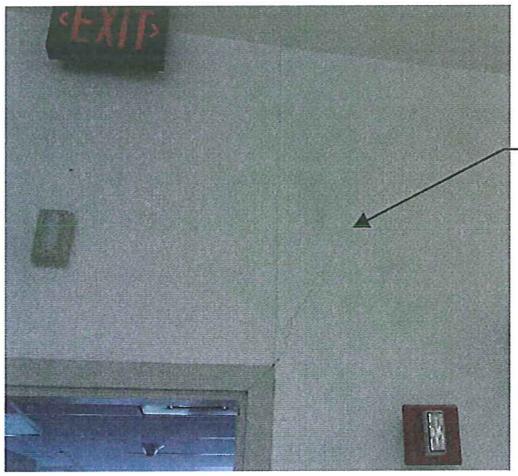
Photo 6: Cracks in gypsum board

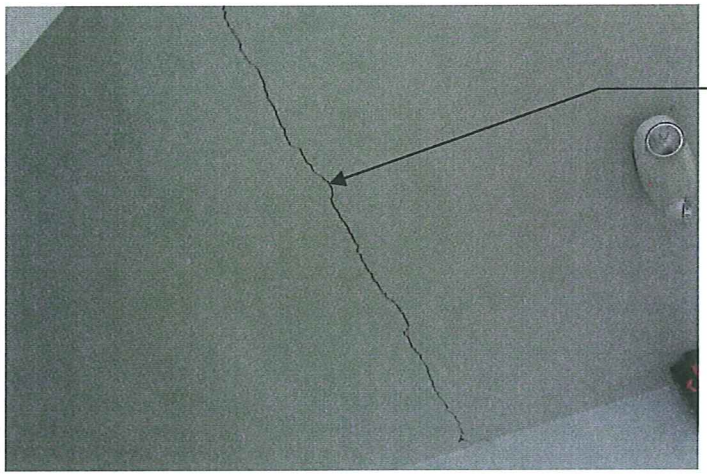
Photo 7: Cracks in gypsum board

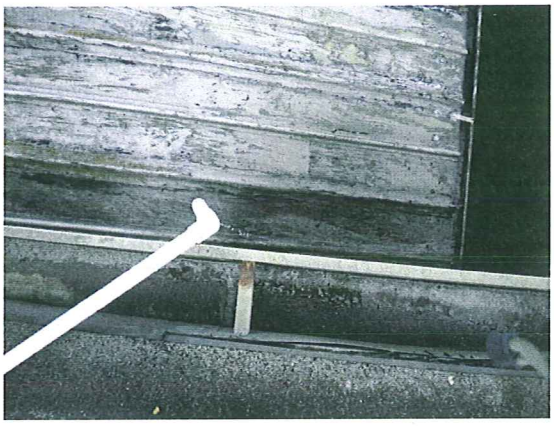
1.2 The condensate drainage from the rooftop units on the 1991 front remodel drains over the edge of the roof onto the ground, ponding in a corner. This is in violation of current code requirements and makes a problem on the ground, with standing water.

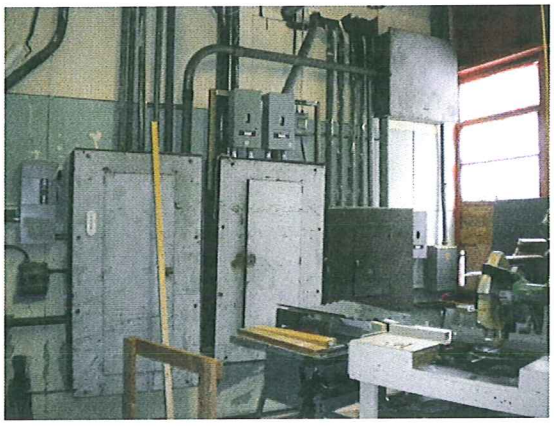
2.1 Some of the original electrical panels, installed in 1947, remain, but none are in use. It appears that much of the electrical systems were replaced in the 1980s

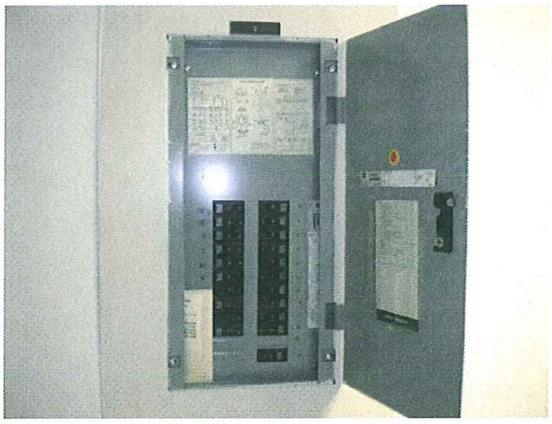
2.2 The front wing was remodeled in 1991 and the electrical gear in that area dates from that time.

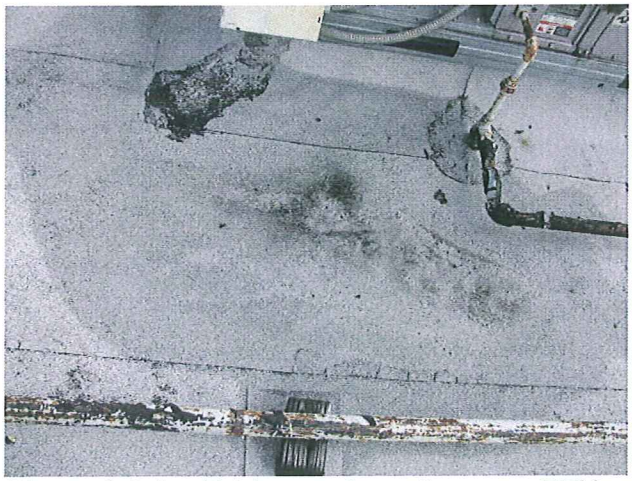
Photo A-2.4 Evidence of ponding near RTU.

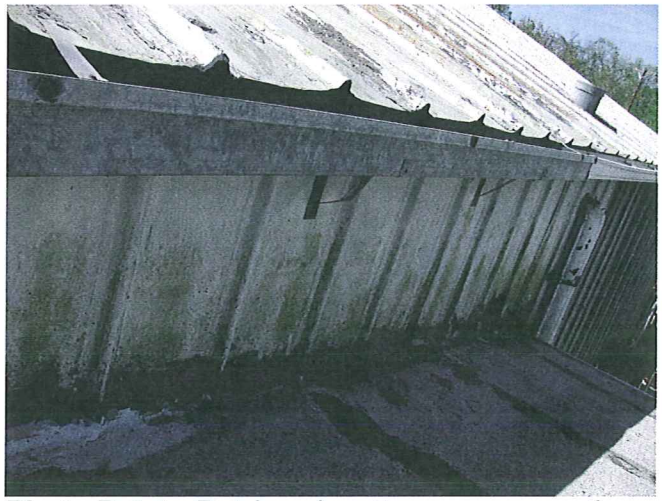
Photo B-1.4 Patchwork gutters – some sections are still serviceable; others are failed.
