# **Appendix A – Project Area Maps**

# East Bouldin Creek and Annie Street Storm Sewer Improvements

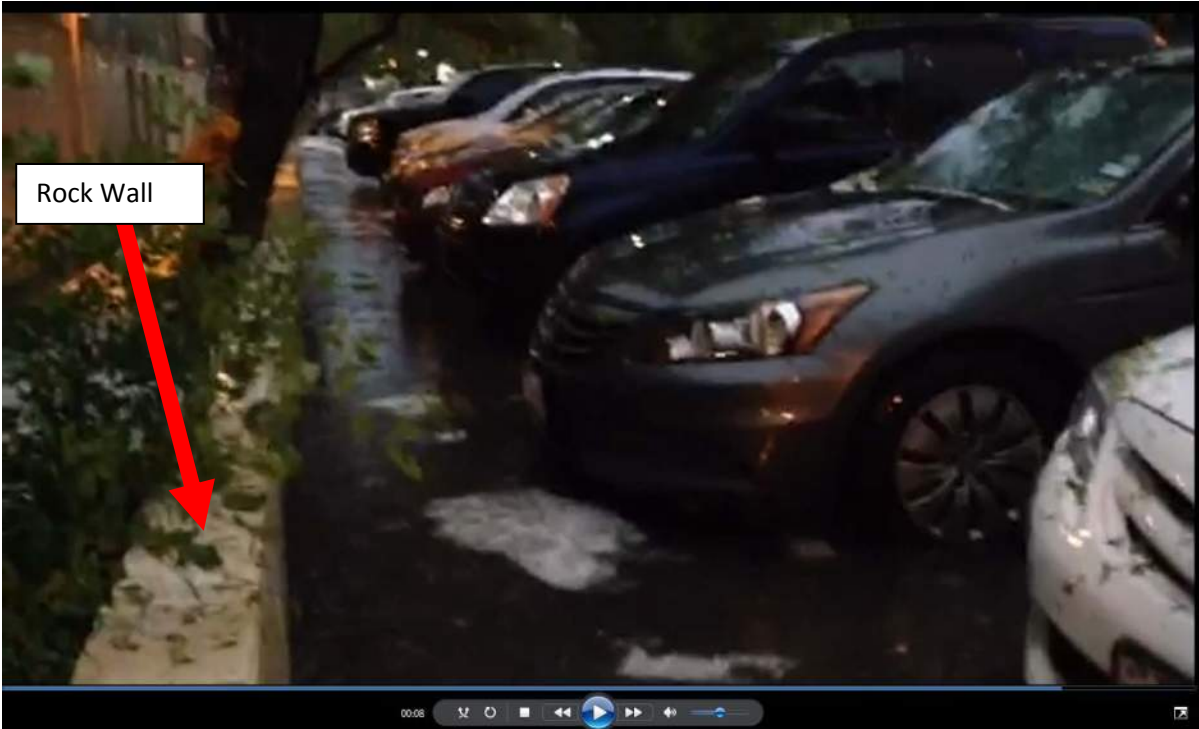
Photo 3 – rock wall constructed by Courtyard Condominiums to keep water out of complex

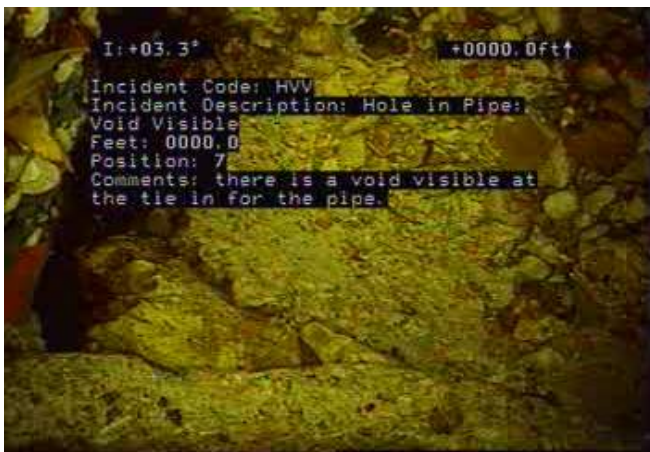
HVV - Hole in Pipe: Void Visible @ 0.0 ft. there is a void visible at the tie in for the pipe.

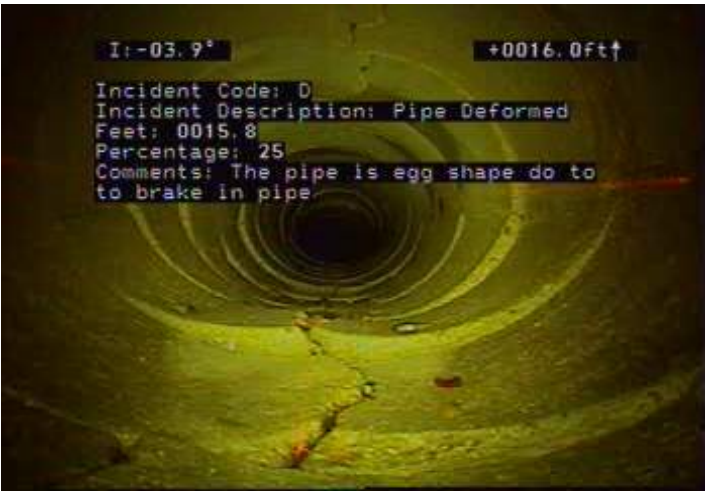
D - Pipe Deformed @ 15.8 ft. The pipe is egg shape do to to brake in pipe

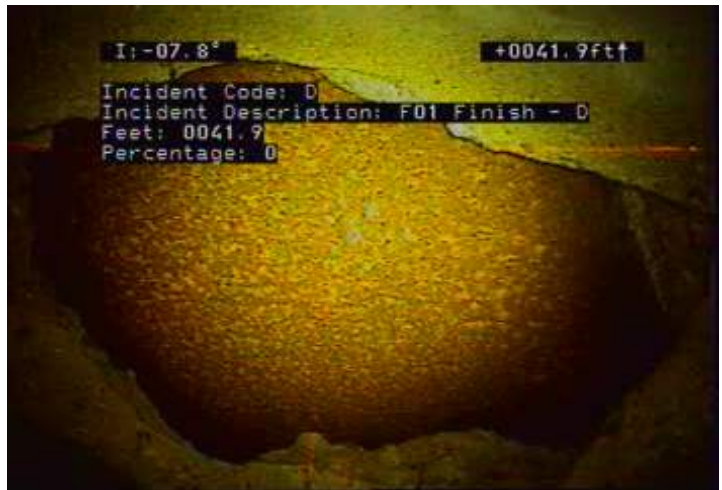
D - Pipe Deformed @ 41.9 ft.

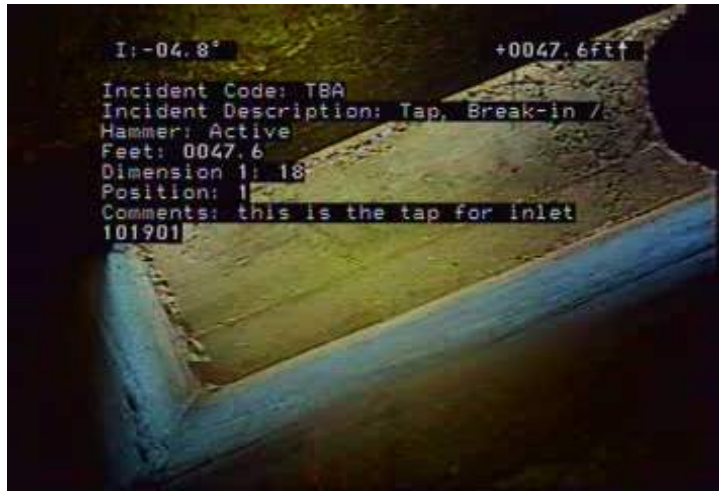
TBA - Tap, Break-in / Hammer: Active @ 47.6 ft. this is the tap for inlet 101901

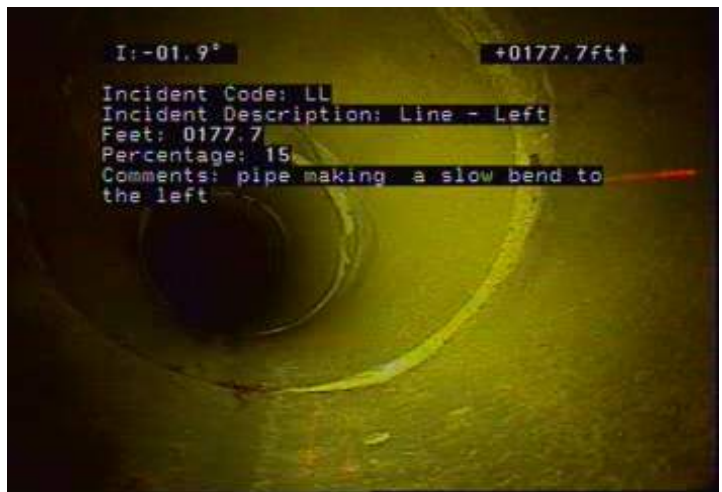
LL - Line - Left @ 177.7 ft. pipe making a slow bend to the left

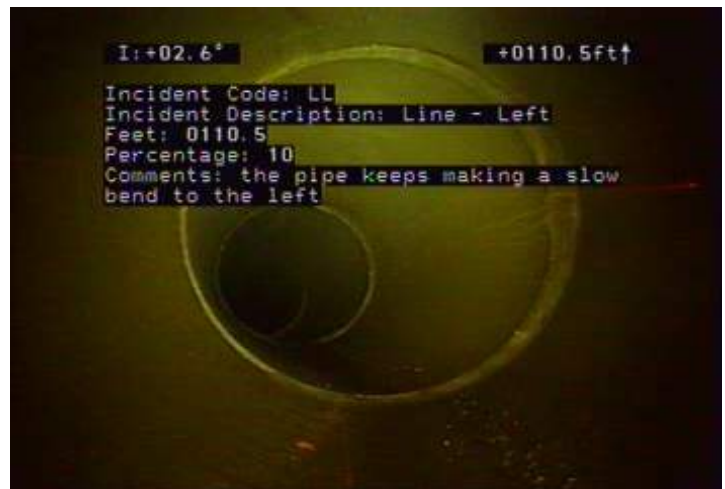
LL - Line - Left @ 110.5 ft. the pipe keeps making a slow bend to the left

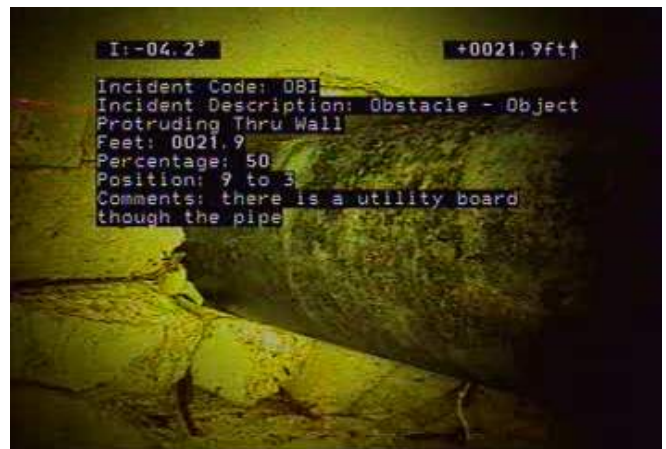
21.9	OBI	Obstacle - Object Protruding Thru Wall	9 to 3	there is a utility board though the pipe
	21.9	B	Pipe Broken	3	pipe is broken due to utility board though the pipe

OBI - Obstacle - Object Protruding Thru Wall @ 21.9 ft. there is a utility board though the pipe

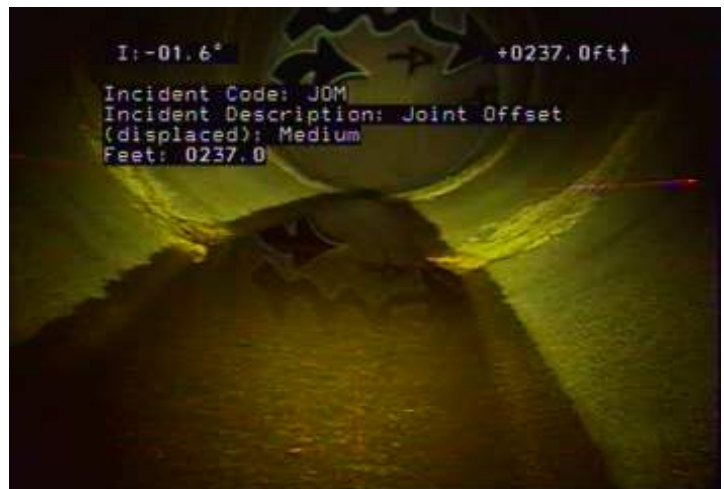
JOM - Joint Offset (displaced): Medium @ 237.0 ft.
