THE NORTH GROUNDS

ZILKER PONDS

SANDBOX GROVE

TREE COURT

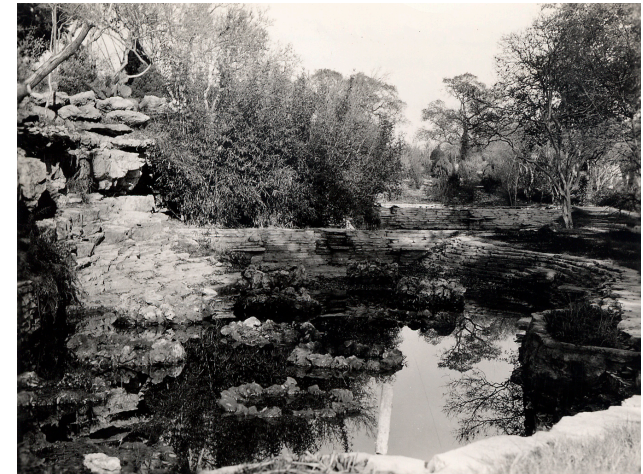
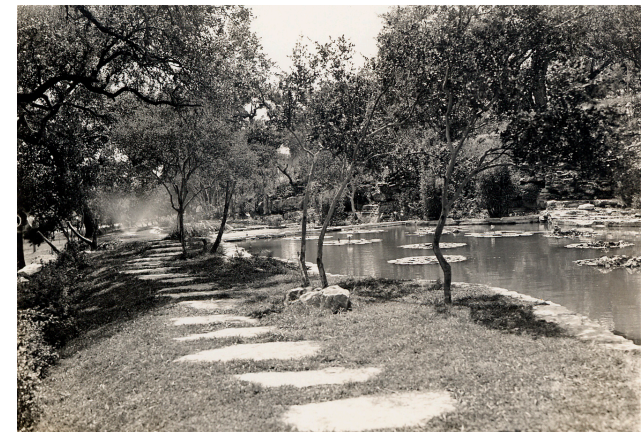
Zilker Ponds in use. They were maintained by City maintenance personnel, and they were filled using City drinking water (Source: Jack Robinson, former Director, Parks and Recreation Department). Note the spray fountain in the lower photo. PICA 01001, Austin History Center, Austin Public Library, above. PICA 20146, Austin History Center, Austin Public Library, below.

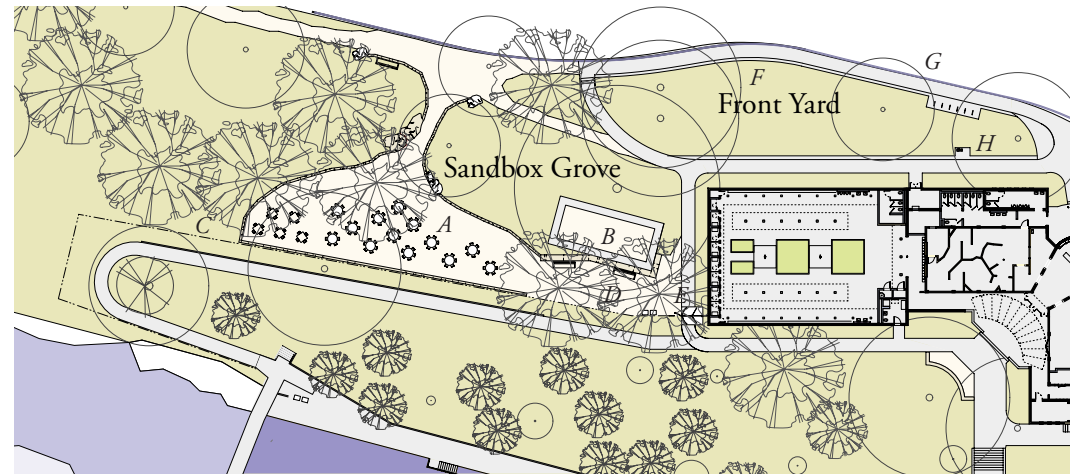
Sandbox Grove and Front Yard

Two views of the Sandbox Grove. The grass is worn, even during an exceptionally wet season (below). The sandbox itself is unmaintained.

- A. Replace worn dirt with new crushed granite surface, creating new picnic area.
- B. Replace sand with decorative gravel to attractive opportunity for public art installation.
- C. New decorative fence.
- D. Using a low stone retaining wall to define the space, create a new observation area.
- E. New exit turnstile.
- F. Widen sidewalks to reduce foot-traffic wear.
- G. New bike racks.
- H. New drinking fountain.

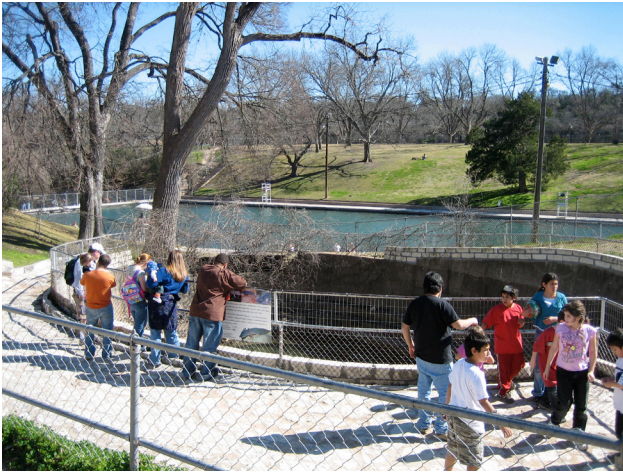
Eliza Spring holds a unique position in both the cultural and the ecological history of the park. It is the home of the largest population of the endangered Barton Springs salamander, and its concrete amphitheater construction is credited to Andrew Zilker himself. It is simply too important to let it remain in such poor condition and in such isolation, marooned as it is behind the concession stand.

Despite its location, tucked behind the concession stand, Eliza Spring is a popular park destination.

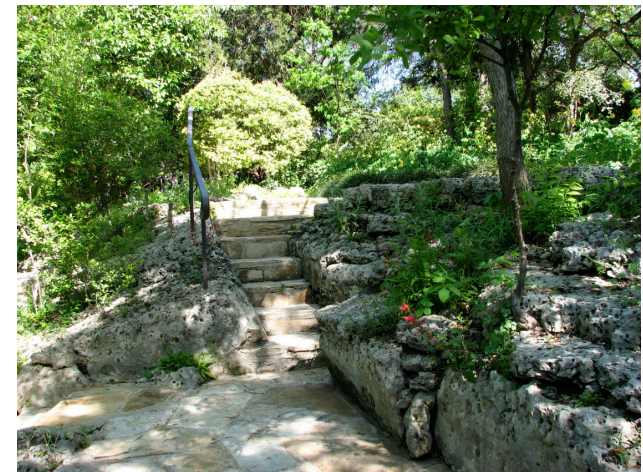
A shady Hill Country boulder garden, with native limestone boulders added to an existing rock ledge, and planted with flowering and trailing shrubs and perennials. A garden in this style could replace the grassy slope below the Bathhouse

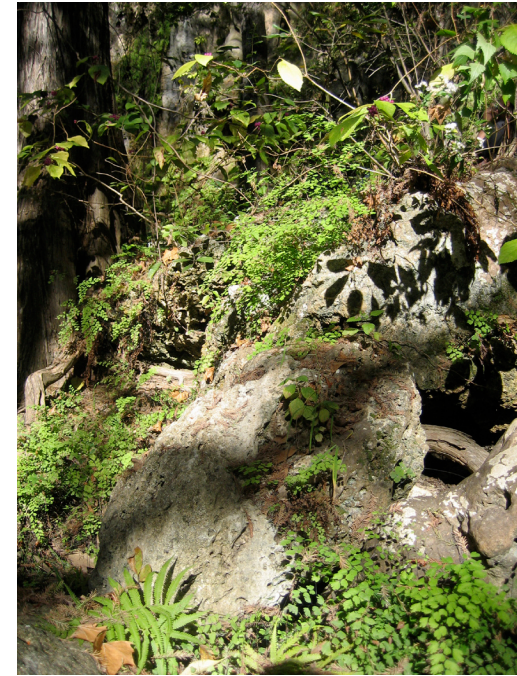
Naturalizing planting beds and boulders can help recreate some of the natural environment that would originally have been around Barton Springs.
