Zilker Park Bathhouse Zone Feasibility Study

Draft for City of Austin Parks + Recreation Department

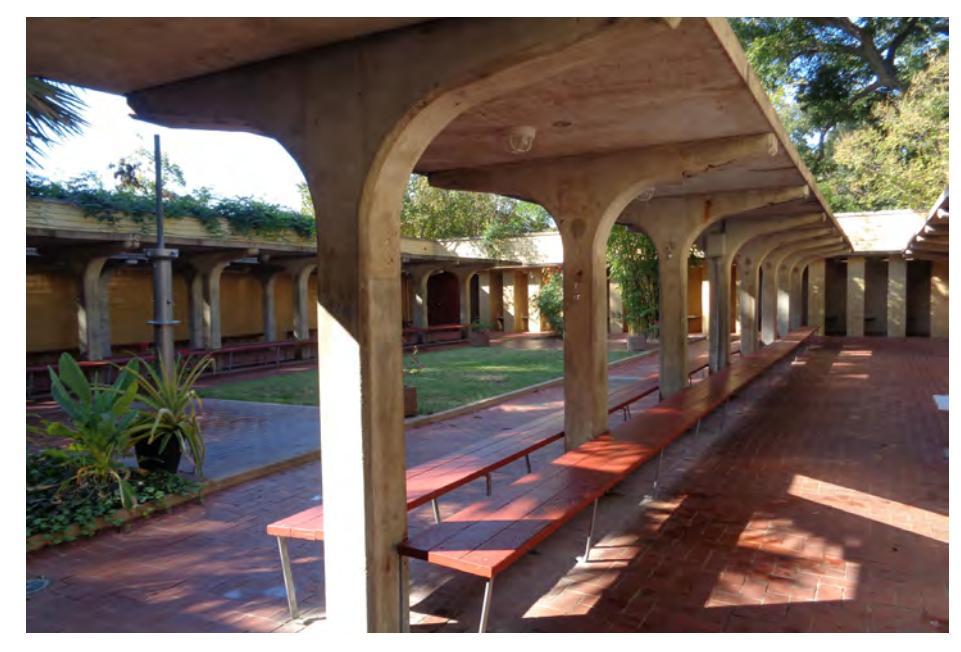
Bathhouse Mens' Changing Area: The mens' changing area specifically preserves much of the original design intent, although the louvered steel doors that originally closed the individual dressing cubicles are no longer existent.

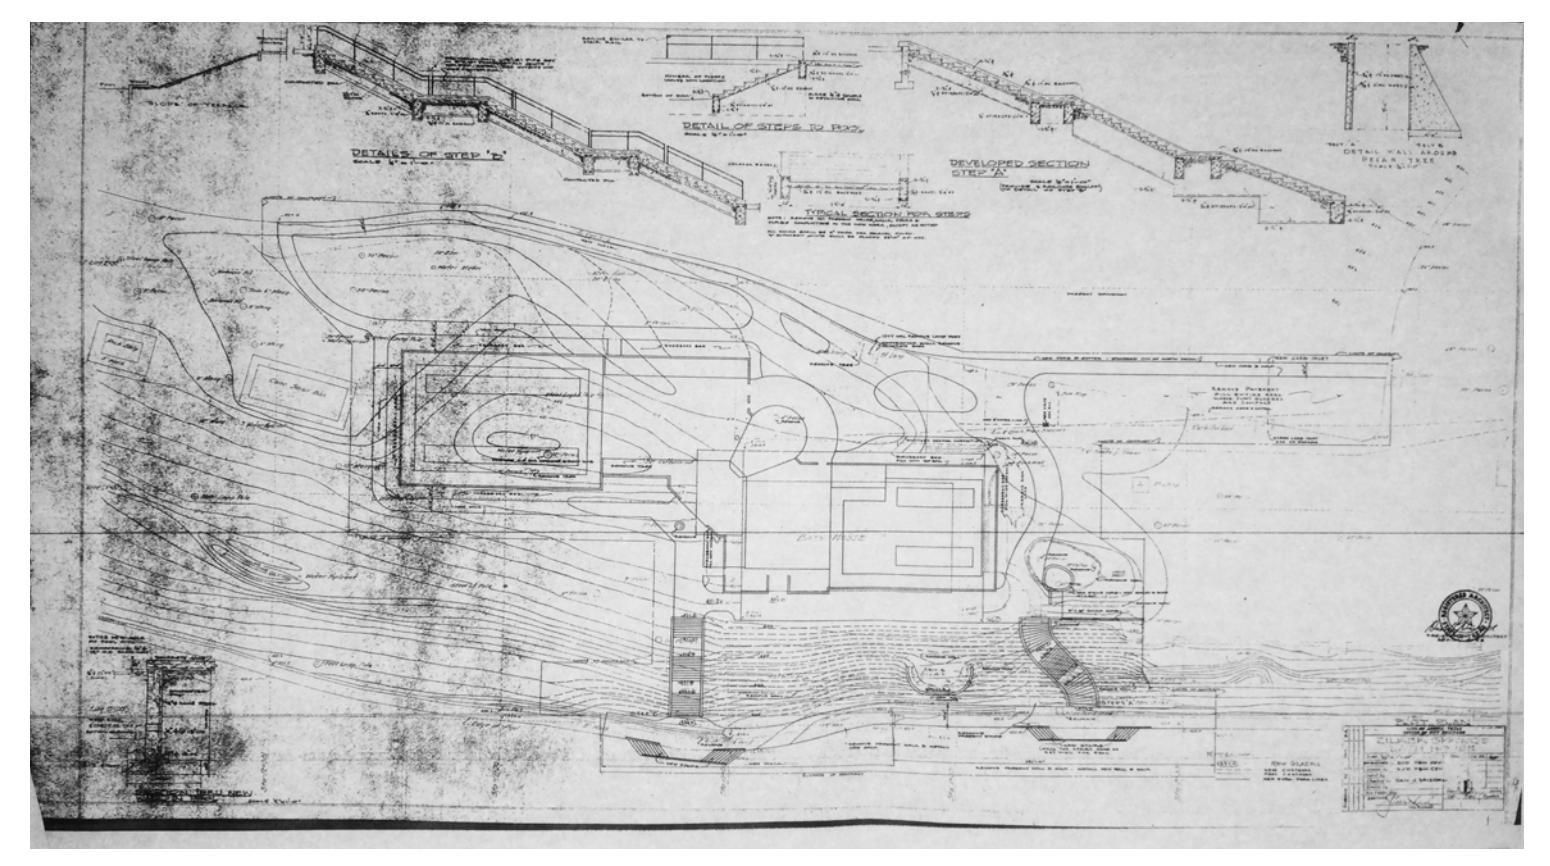
Pool Enclosure and Bathhouse: Original Construction Plan dated 1945. Of note are the fact that the fence enclosing the pool was not included in the original design, that the present Spectator's Gallery is a legacy of the preceding bathhouse (and preserves intact a portion of the foundation of that destroyed building), and that the reconfiguration of the northeast corner of the existing parking lot was anticipated in the design of the current building.
