Vegetation Management Plan Pond Embankments

Hornsby Bend Biosolids Management Plant

Austin Water Utility
2210 South FM 973
Austin, Texas 78725

Baer Engineering Project No. 142069-8i.013
October 12, 2015

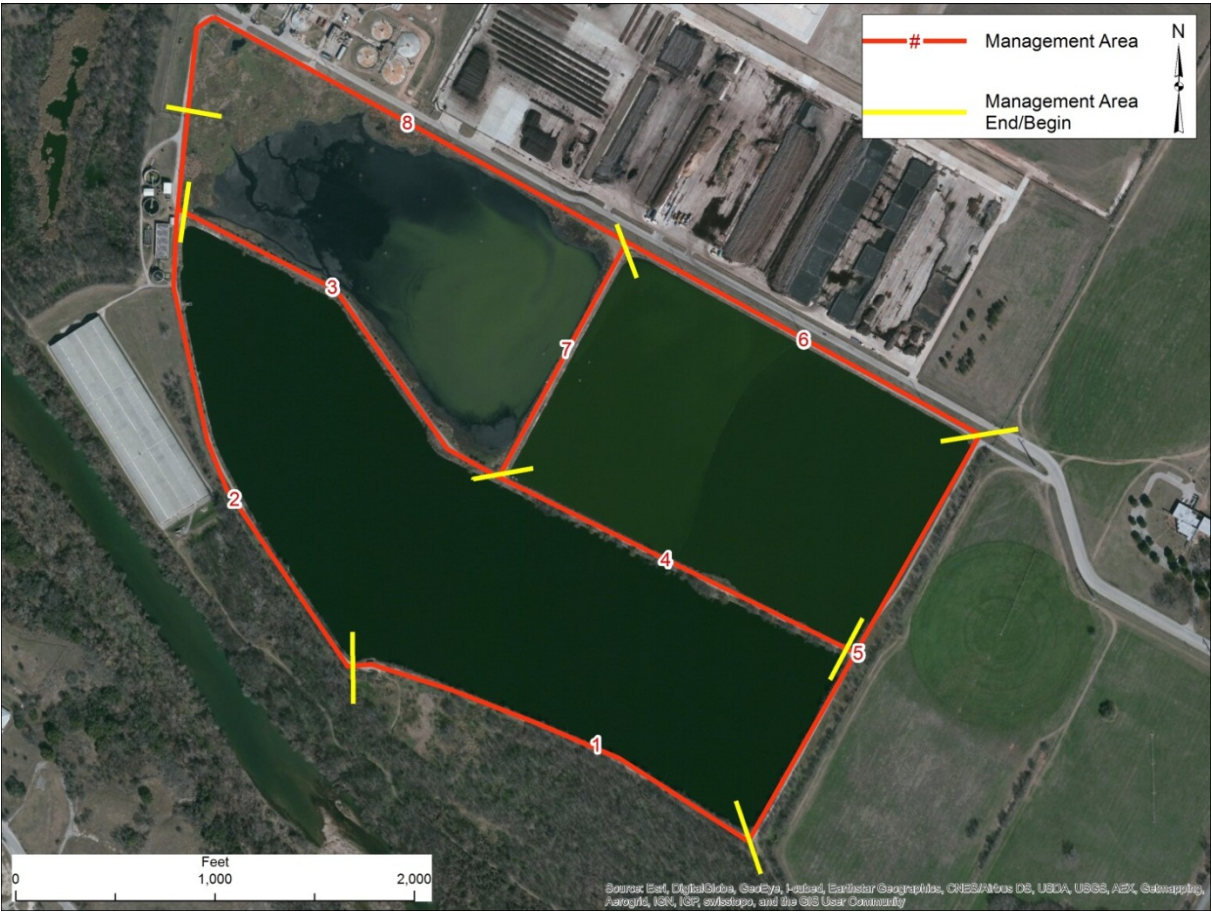
Figure 1. Hornsby Bend Biosolids Management Plan overview of the eight management areas

In order to keep the majority of the berm intact during tree removal, we have separated the berms surrounding the ponds into eight management areas. For reference, **Figure 1** depicts these areas. Within management areas 1 through 5, trees and their root systems will be removed. To maintain its integrity, the berm must be repaired immediately following root extraction. Berm repairs should be accomplished in accordance with the appropriate berm specifications for soil placement, compaction, and materials testing. Removing trees with DBH's greater than or equal to eight inches will require mitigation following COA mitigation calculations. Management areas 6, 7, and 8 do not have any existing trees.
