2015 Parks and Recreation Department Transition Plan
Public Facility ADA Self-Assessment Survey
City of Austin, Texas

Adams-Hemphill Neighborhood Park

Alamo Pocket Park

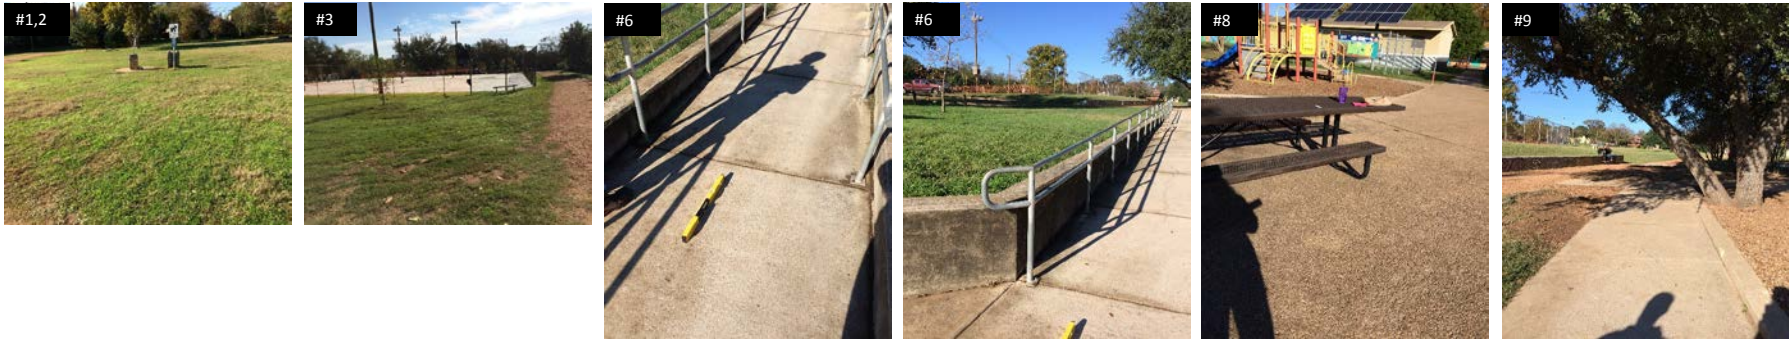
ITEM NO.	GIS ID	BARRIER	CODE HEADING 2012 Texas Accessibility Standards	VIOLATION	RECOMMENDED ACTION	QUANTITY	BUDGETED COST	PRIORITY LEVEL
1*	Drinking Fountain: 52	Accessible Route	206.2.2 Within a Site	The drinking fountain is not on an accessible route.	Construct a compliant accessible route.	25	\$ 750	2
2*	Mutt Mitt: 192, 193	Accessible Route	206.2.2 Within a Site	The 2 pet dispensers are not on an accessible route.	Relocate at least one element to be adjacent to an accessible route.	1	\$ 200	3
3*	Sports Courts: 534, 1025, 1148	Accessible Route	206.2.2 Within a Site	There are 3 sport courts that are not on an accessible route.	Construct a compliant accessible route to at least one of each type of sport court.	65	\$ 1,950	2
4	Trash Can: 1676- 1678	Accessible Route	206.2.2 Within a Site	The 3 trash cans are not on an accessible route.	Relocate at least one element to be adjacent to an accessible route.	1	\$ 200	3

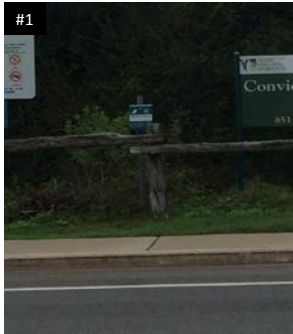
ITEM NO.	GIS ID NUMBER	BARRIER	CODE HEADING 2012 Texas Accessibility Standards	VIOLATION	RECOMMENDED ACTION	QUANTITY	BUDGETED COST	PRIORITY LEVEL
1*	Mutt Mitt: 20	Accessible Route	206.2.2 Within a Site	The only pet dispenser is not on an accessible route.	Relocate the element to be adjacent to an accessible route.	1	\$ 200	3
Budgeted Repair Cost							\$ 200	
Design Cost							\$ 50	
Project Management							\$ 63	
Contingency							\$ 47	
Proposed Budget							\$ 359
