#15. McGuire

Watershed Protection Development Review

3.14 #15 ,MCGUIRE

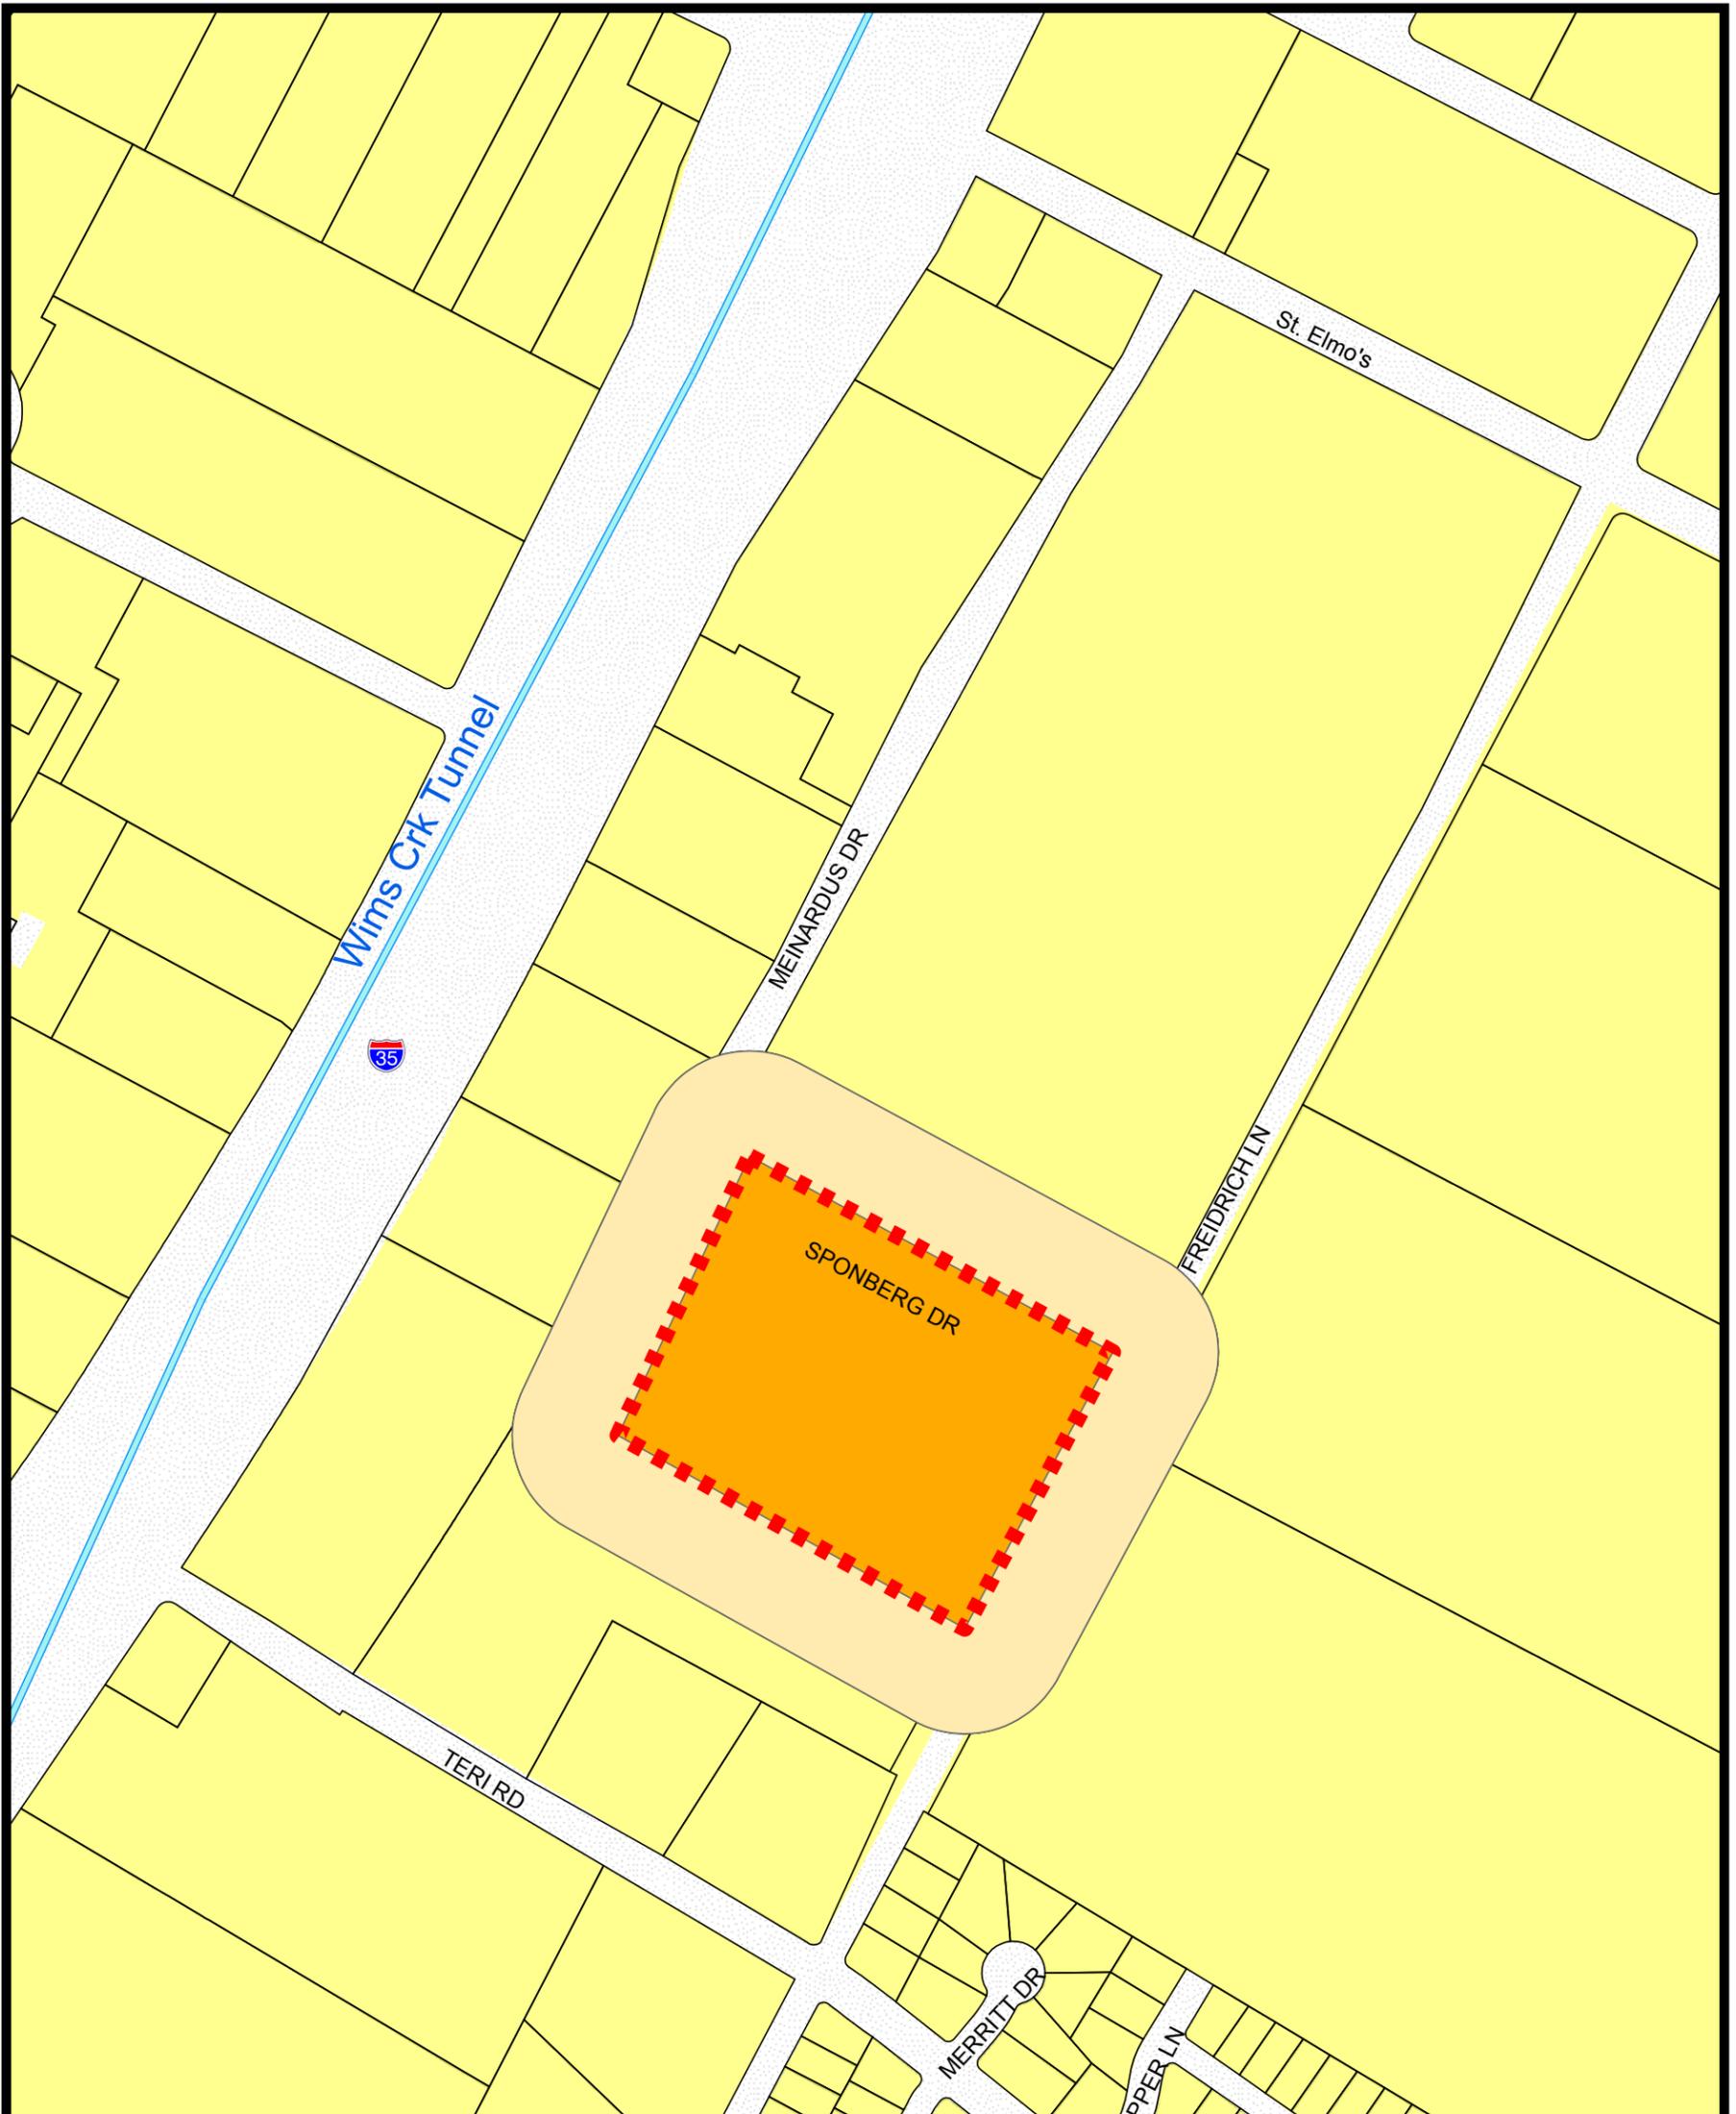
Location: The McGuire landfill is owned by the University of Texas, and is located in south Austin, at 4500 Freidrich Lane.

Extent: The URM report estimated the size of the landfill to be approximately 13 acres. Several investigations have been performed at this property and adjacent properties to delineate the extent of the landfill. The investigations indicated that the depth of trash extends from approximately 5 to 20 feet below ground surface and covers an area of approximately 7 acres. In 1988 clean fill was placed to level the site. Today, the site appears to be roughly graded, although there is still some evidence of ridges.

Prior Use: The location map for this landfill in the 1984 URM report shows the area of the landfill and surrounding properties as undeveloped. Today commercial developments are located adjacent to the north, east, and west, of the site. In addition, immediately south of the site is an apartment complex and a church. A water quality pond was constructed on COA property immediately north of the site at Freidrich Lane and the easement for Sponberg.

Groundwater: Shallow groundwater is reported at depths of 3 to 17 feet below the ground surface.

Current Conditions: Current conditions associated with this site may pose a current or future material concern to human health or the environment, based on the following factors:

- proximity of structures adjacent to the landfill,
- presence of surface water bodies within the boundary of the landfill,
- unrestricted public access.

Additional actions may be warranted at this site.
