- Transportation Safety Improvements Completed –

Cameron Road at US 183 Frontage Road

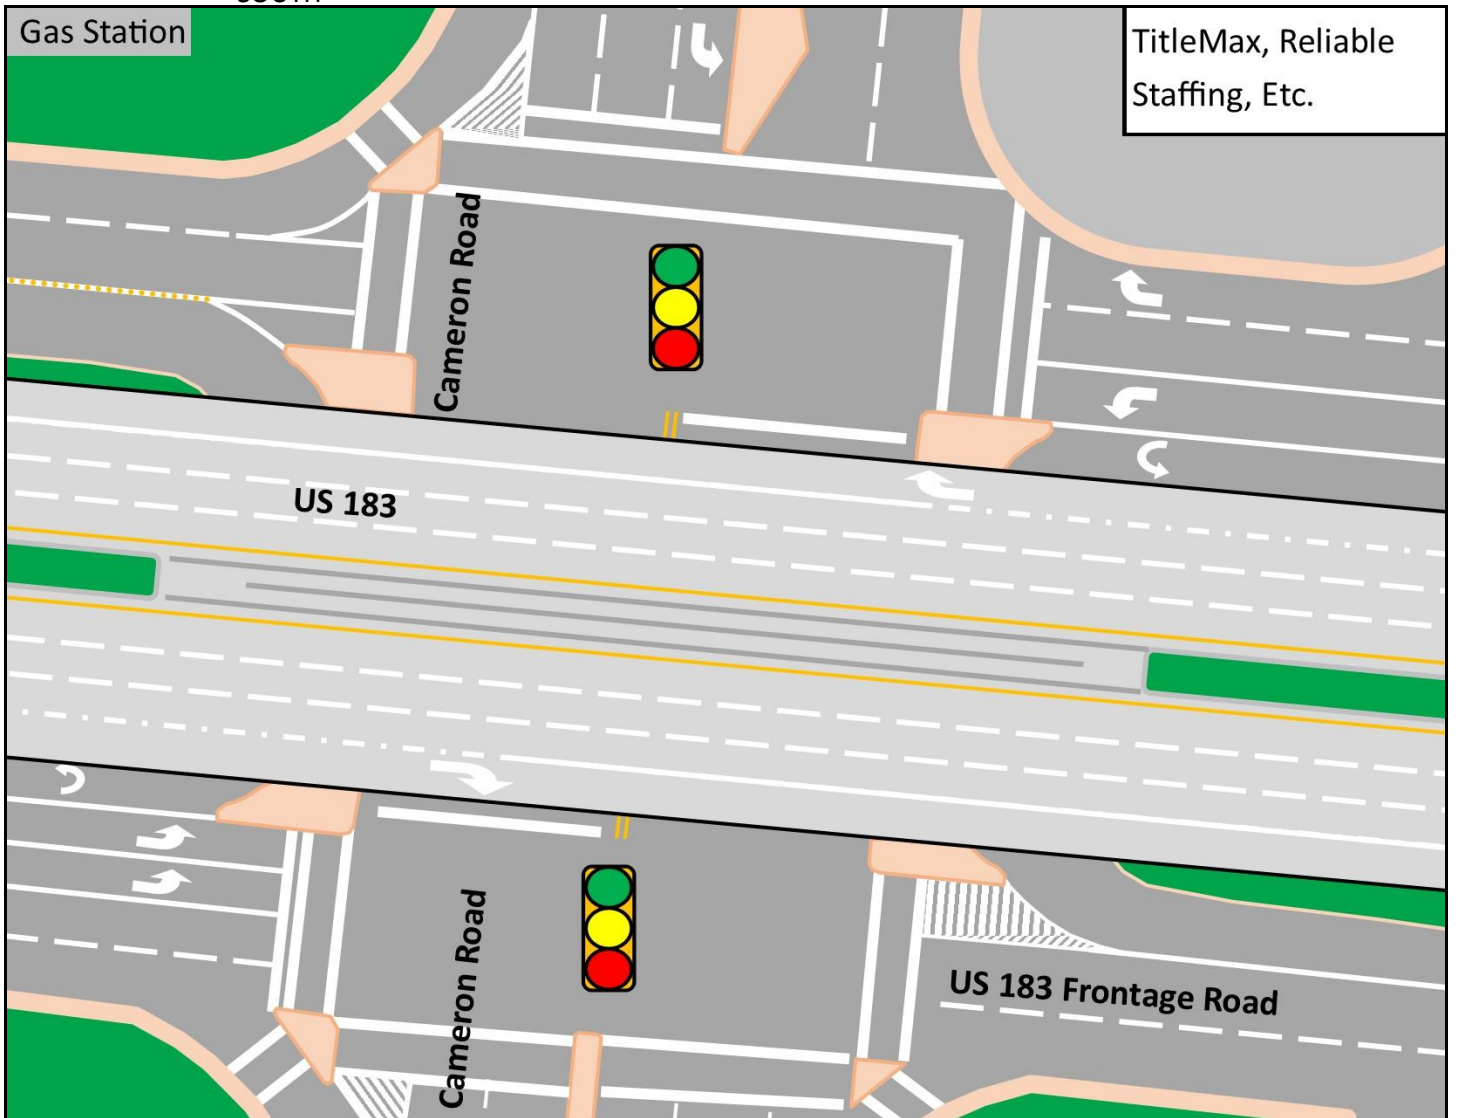
BEFORE

Reduce documented incidents of vehicle/pedestrian and vehicle/vehicle crashes at the intersection of Cameron Road and the US 183 Frontage Road by installing enhanced pedestrian safety features and a new traffic signal warning device.

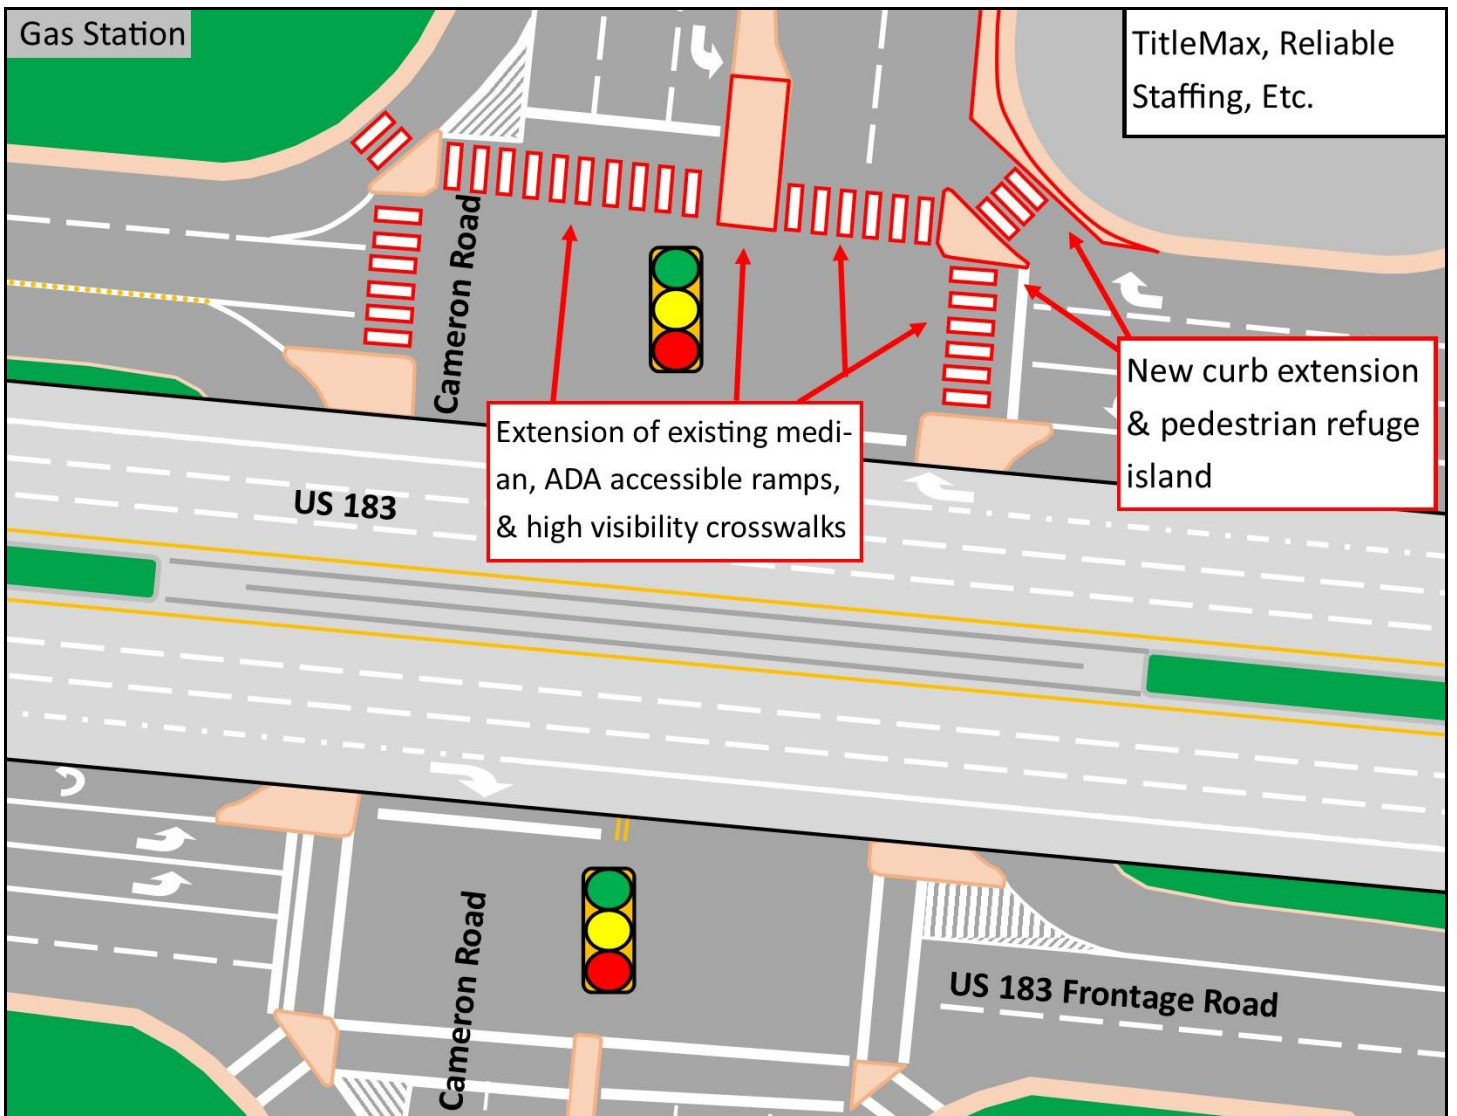
AFTER

- Constructing a new right-turn channelized island/pedestrian refuge island at the northeast corner of the intersection.
- Lengthening the existing raised median on the north side of the intersection to provide a pedestrian refuge space mid-crosswalk.
- Adding high-visibility continental crosswalks to all pedestrian crossing points on the north side of the US 183 overpass.
- Constructing an advanced warning flasher on the eastbound frontage road, ahead of the traffic signal at US 183 Frontage and Cameron Road. The signal will flash only when the signal ahead is red for eastbound vehicles in order to alert drivers to slow down and stop ahead.
