#33. Harmon

3.26 #30, WINGFIELD AND # 33, HARMON

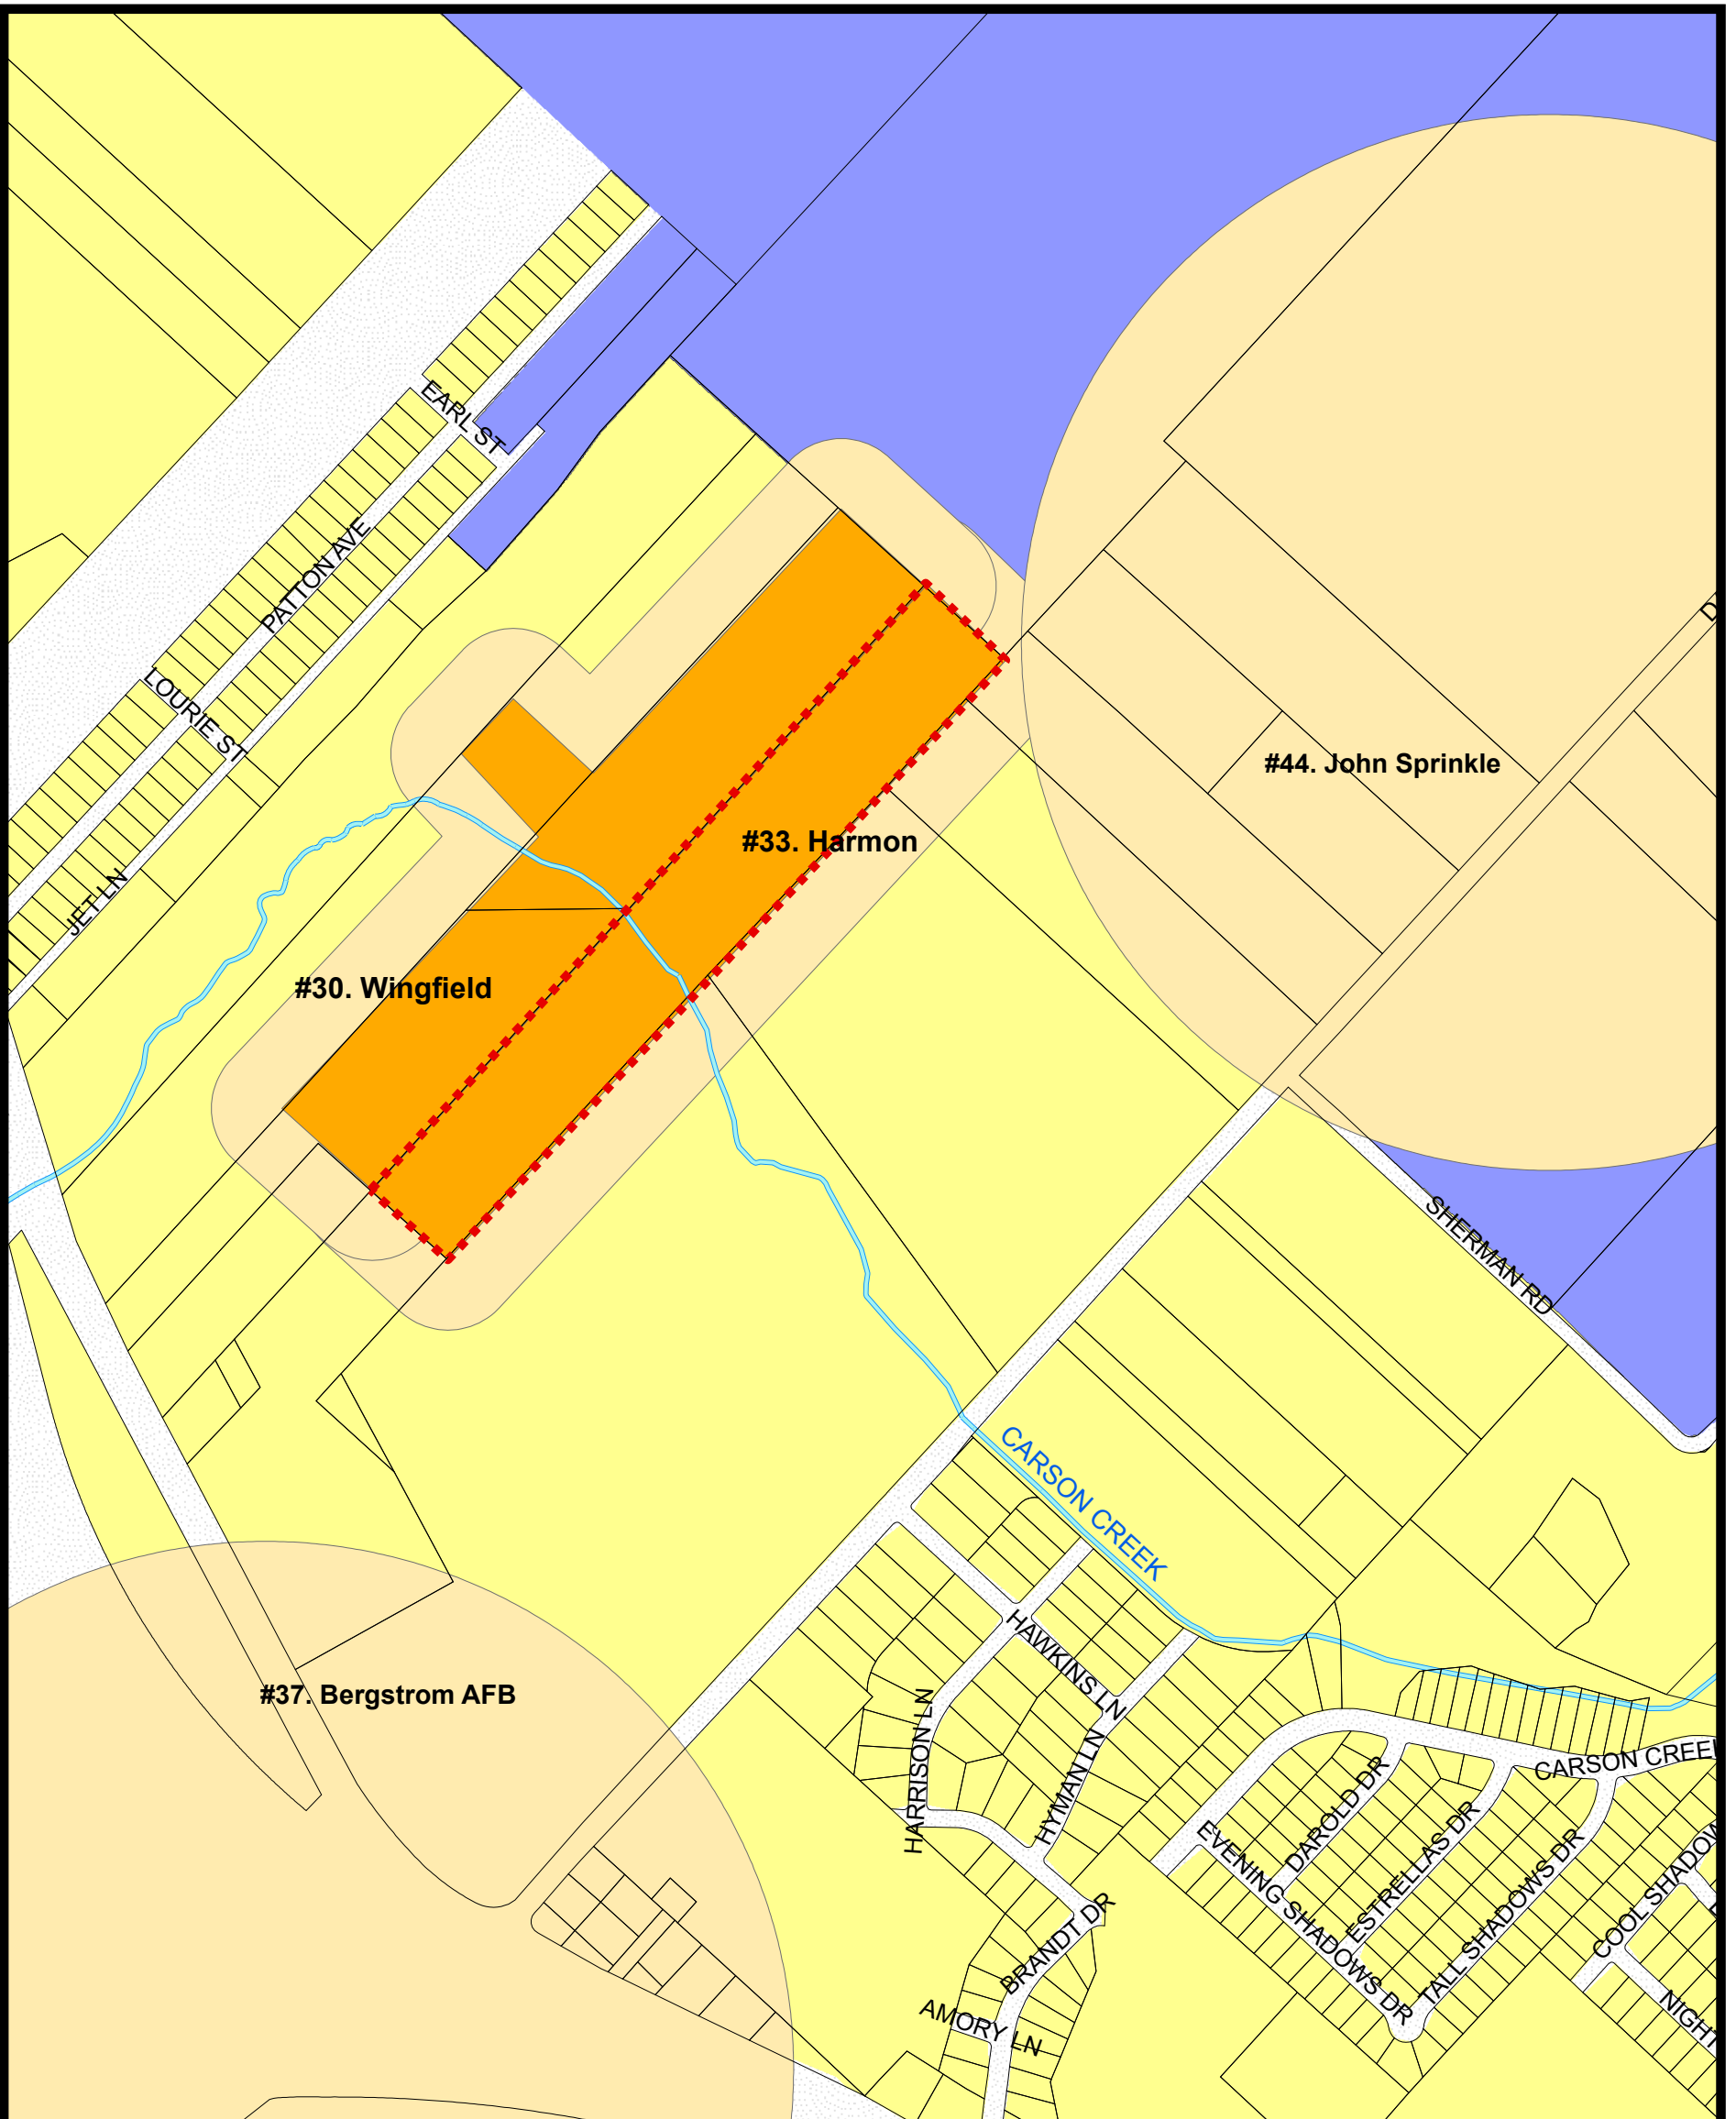
Location: The Wingfield landfill and Harmon landfill are each owned by a private entity, and are located adjacent to each other in south Austin, just northeast of the interchange at Hwy 71 and Hwy 183. The Wingfield and Harmon landfills are landfills operated by different entities on two different (but abutting) tracts of land. It appears that both operations were placing waste in the same quarry that extended across both properties.

Current condition: May pose a current or future material concern to human health or the environment, based on the following factors:

- proximity of structures adjacent to the landfills,
- exposed landfill materials due to erosion at the stream bank,
- presence of surface water bodies within the landfills,
- reported use of the pond by nearby residents for fishing and swimming, and
- presence of seeps/leachate from the landfills.
