# **Appendix A – Project Area Maps**

# East Bouldin Creek and Annie Street Storm Sewer Improvements

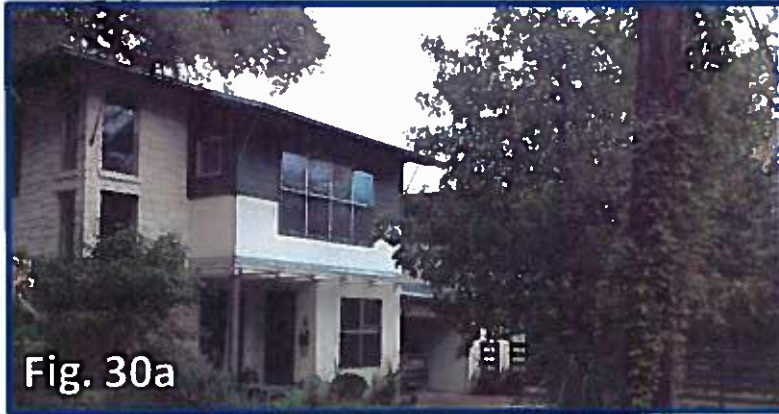
Fig. 30a

Within a block of 304 W. Mary St. several houses have been built in the past 5 years leading to more and higher velocity runoff into an already undersized drainage system (*Fig. 30 a-d*). More construction

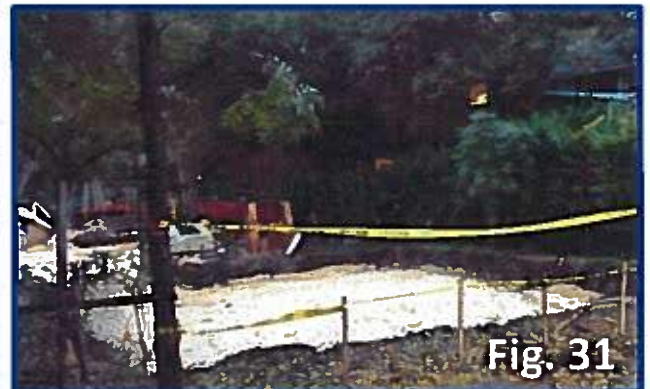
Fig. 31

is underway (*Fig. 31*) with no improvements in flood control. Commercial development continues unabated along S. Congress (*Fig. 32*). Rainwater runoff is being handled by the same storm drains that existed when many streets were unpaved and bungalows dotted the landscape. We are not completely opposed to new development, but we are opposed to the resulting increase in rainwater runoff.

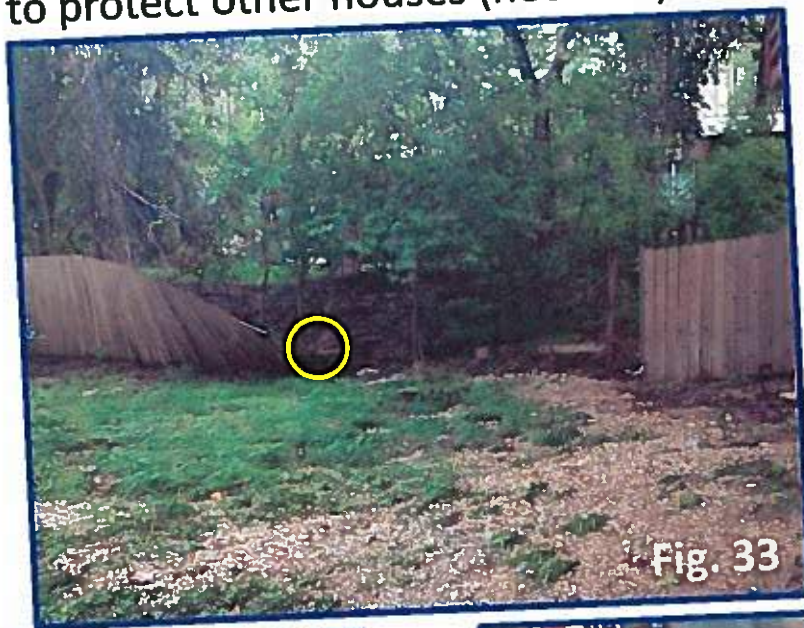
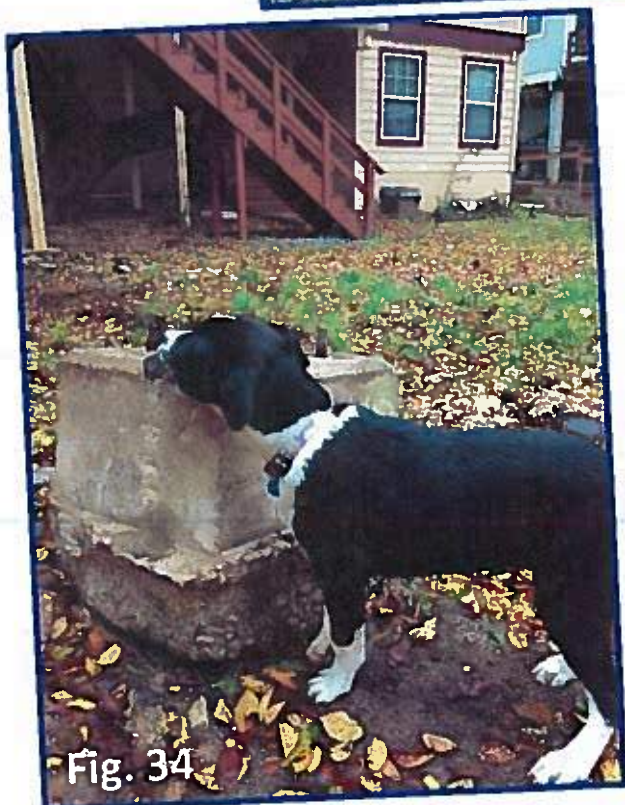
When we began repairs to the fence on the east side of our backyard after the April flash flood, a large block of concrete was discovered against the old fence (area circled in Fig. 33). This block measure ~20 inches on each side (Fig. 34) and is nearly identical to the signal light anchors in South Austin, including the four iron bolts on top (Fig. 35). This 600 lb. concrete block was moved here by a flood or was placed here as landfill to protect other houses (not ours) from flash floods.

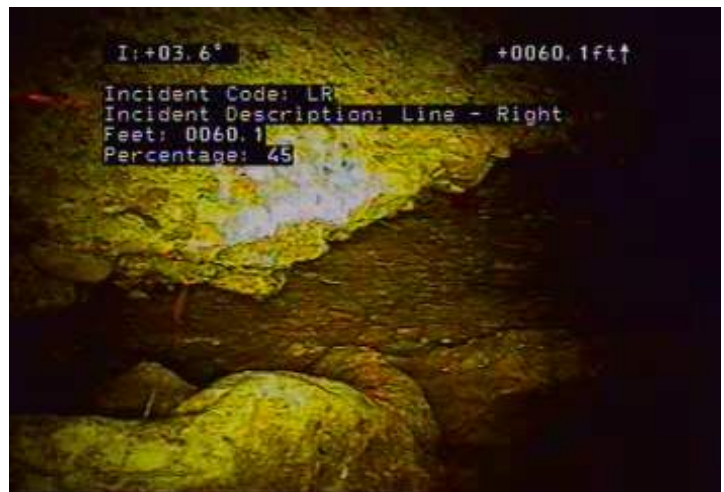
LR - Line - Right @ 60.1 ft.

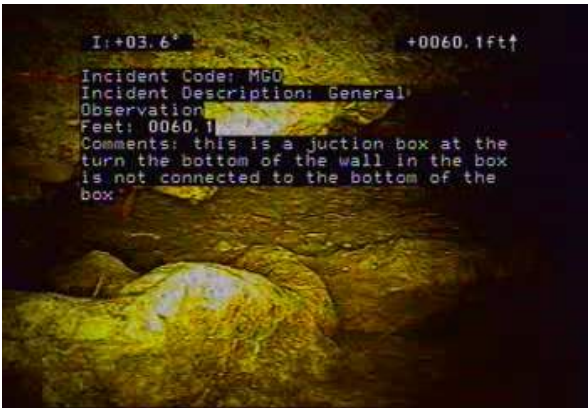
MGO - General Observation @ 60.1 ft.  
this is a junction box at the turn the bottom of the wall in the box is not connected to the bottom of the box

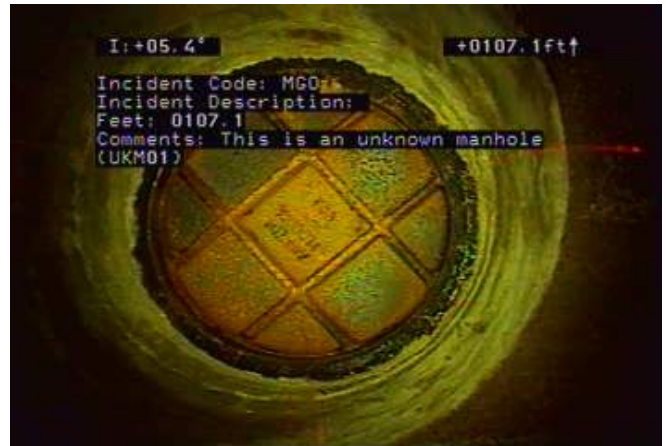
MGO - General Observation @ 107.1 ft.  
This is an unknown manhole (UKM01) we located this location at 407 W Annie St

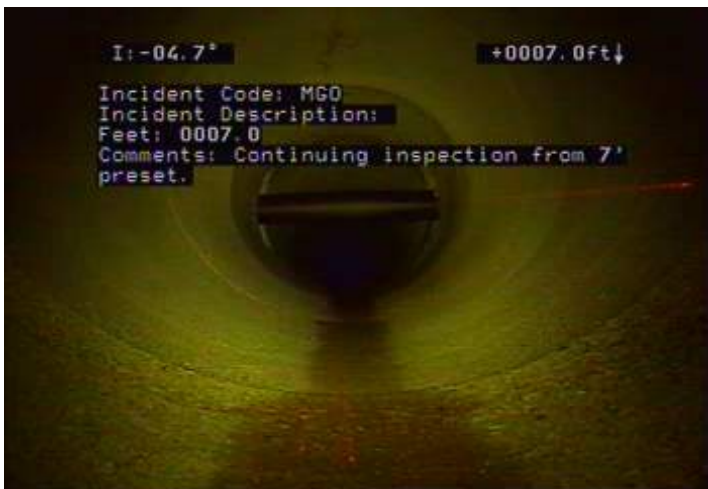
MGO - General Observation @ 7.0 ft. Continuing inspection from 7' preset.

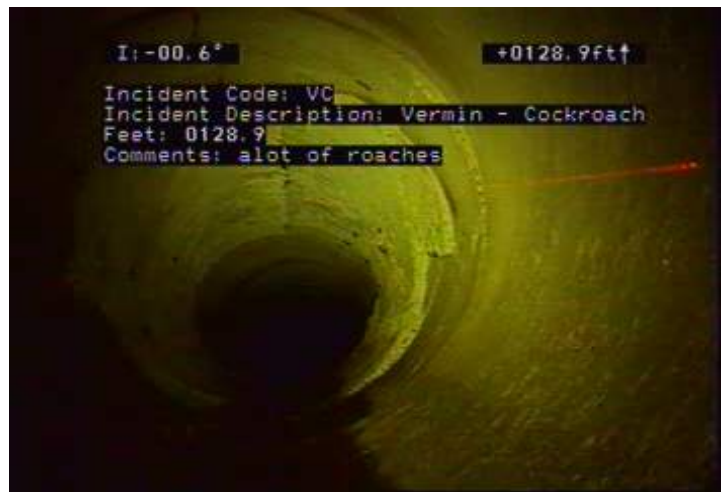
VC - Vermin - Cockroach @ 128.9 ft. alot of roaches
