Re: Austin Memorial Park Assessment

**EXISTING CONDITIONS ASSESSMENT REPORT**

Re: **Austin Memorial Park Cemetery  
Existing Conditions Assessment Report**

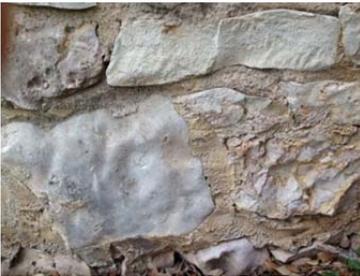
Figure A –Limestone with yellow mortar patch, note the variation in limestone surface from smooth to rough

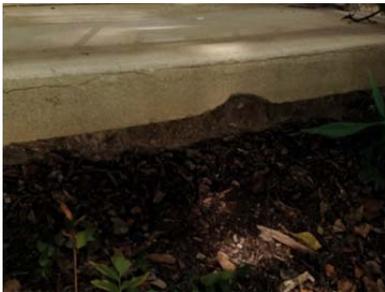
The most severe chipping occurs at the lower leading edge of the concrete balconets. (see figure F)

Figure F – Chipping at concrete balconet

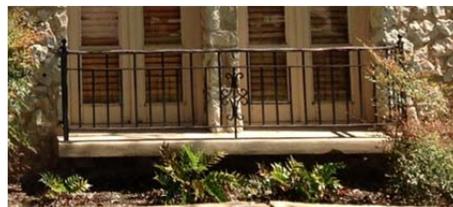
Figure J1

Wrought Iron railings appear in three places at the building; at the balconets on the southside of the main office and at either side of the arcade. The balconet railings are more ornate and appear to be original, The top rails have suffered from corrosion and are in need of repair, while the other simpler rails are in adequate shape. (see figure J,J1,J2)

- Figure J- Wrought Iron rails at north side
- Figure J1- Decorative original rail at South side balconet
- Figure J2- Corrosion at balconet rail

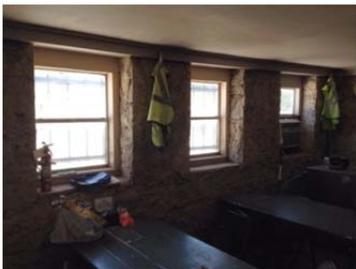
Figure Q- Interior of Break room area showing the five windows on the north end of the building

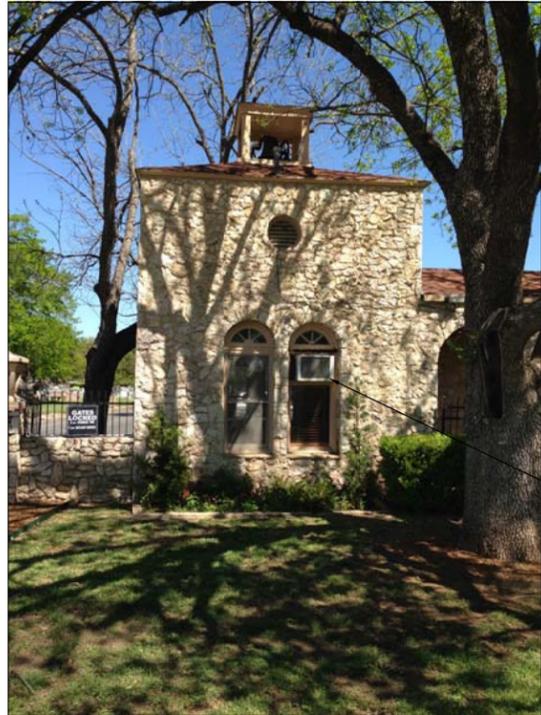
Figure 15 - South Elevation at Belltower

WINDOW UNIT A/C  
AT BELLTOWER OFFICE

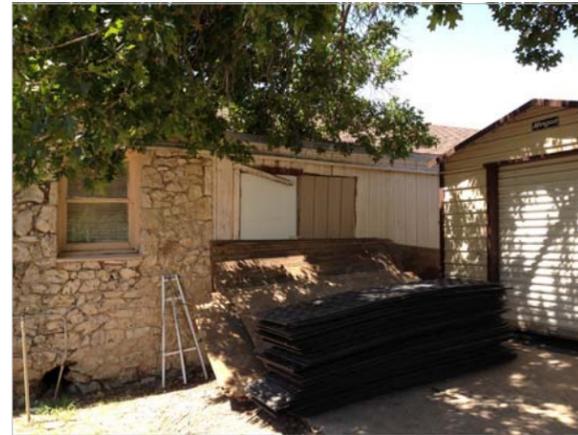
Figure 19 - Original Stone Structure with replaced T-1 11 Exterior walls South East end of building

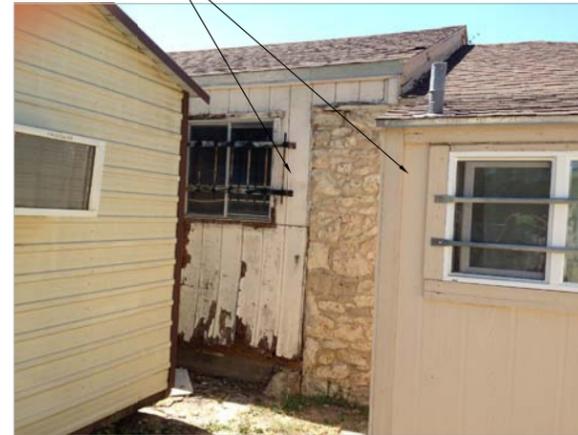
Figure 18 - Original Stone Structure with replaced T-1 11 Exterior walls at North East end of building, metal building in foreground

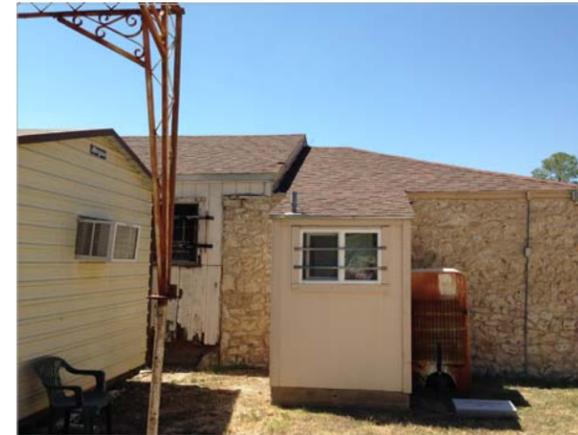
Figure 17 - Restroom Addition at Break Room with Composite patterned "T-1 11" exterior siding

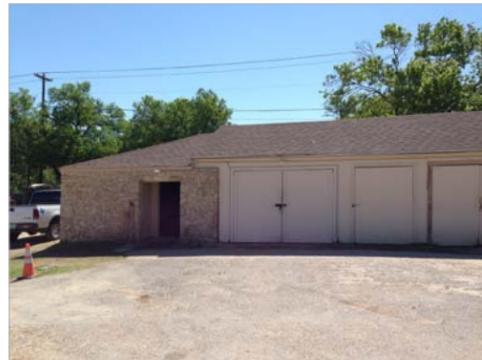
Figure 24 - North west corner of garage facing west

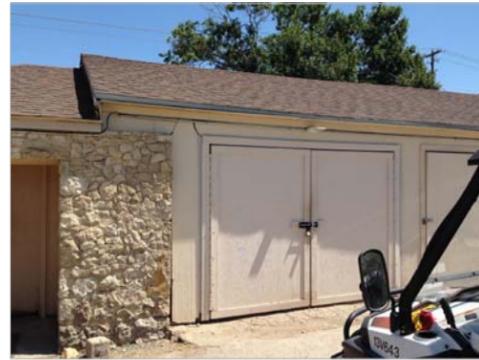
Figure 23 - Garage Area and Stone extension, note roof overlap at breakroom and garage connection

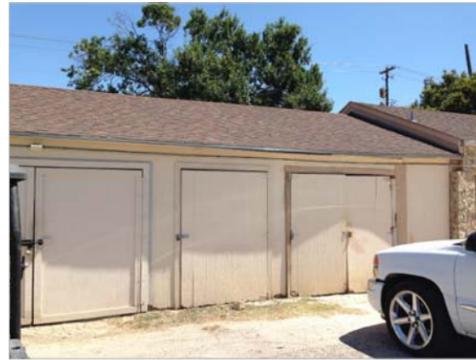
Figure 22 - Garage Area facing west

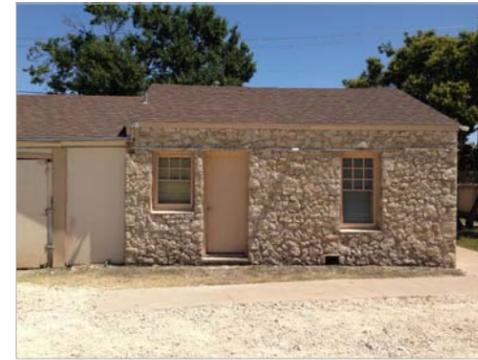
Figure 21 - Stone Office at South end facing west
